## PEAK INNOVATION CENTER Roof & Site Drainage Improvements

## Drainage Infrastructure Analysis & Improvements "Phase 4" Work Scope

Presented to Fort Smith Public Schools Board

November 17, 2025

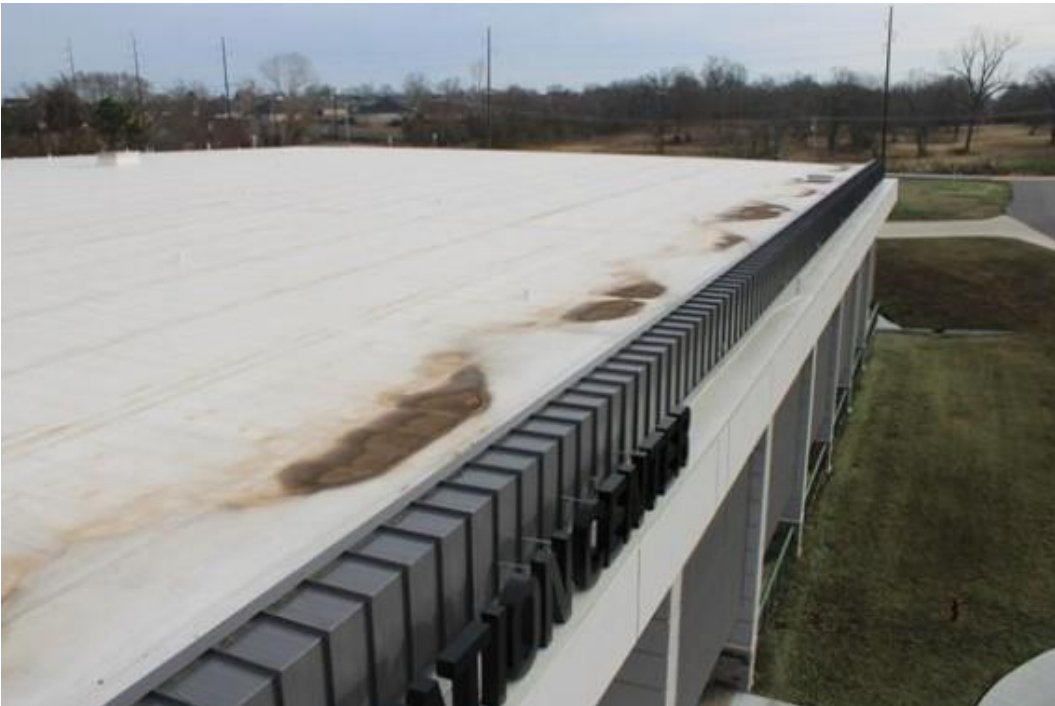
Envista’s evaluation of the 14 roof drains on the main roof, the four roof drains on the canopy, and their vertical conductors and horizontal branches were sized as required for the roof area covered and the flow rates required for each roof drain. Therefore, Envista concluded that *the roof drainage for the south facet of the East Wing was sized in general accordance with the requirements of the NSPC.*

Envista reviewed the secondary roof drain requirements in the IPC, Section 1108, Secondary (Emergency) Roof Drains, which revealed the following:

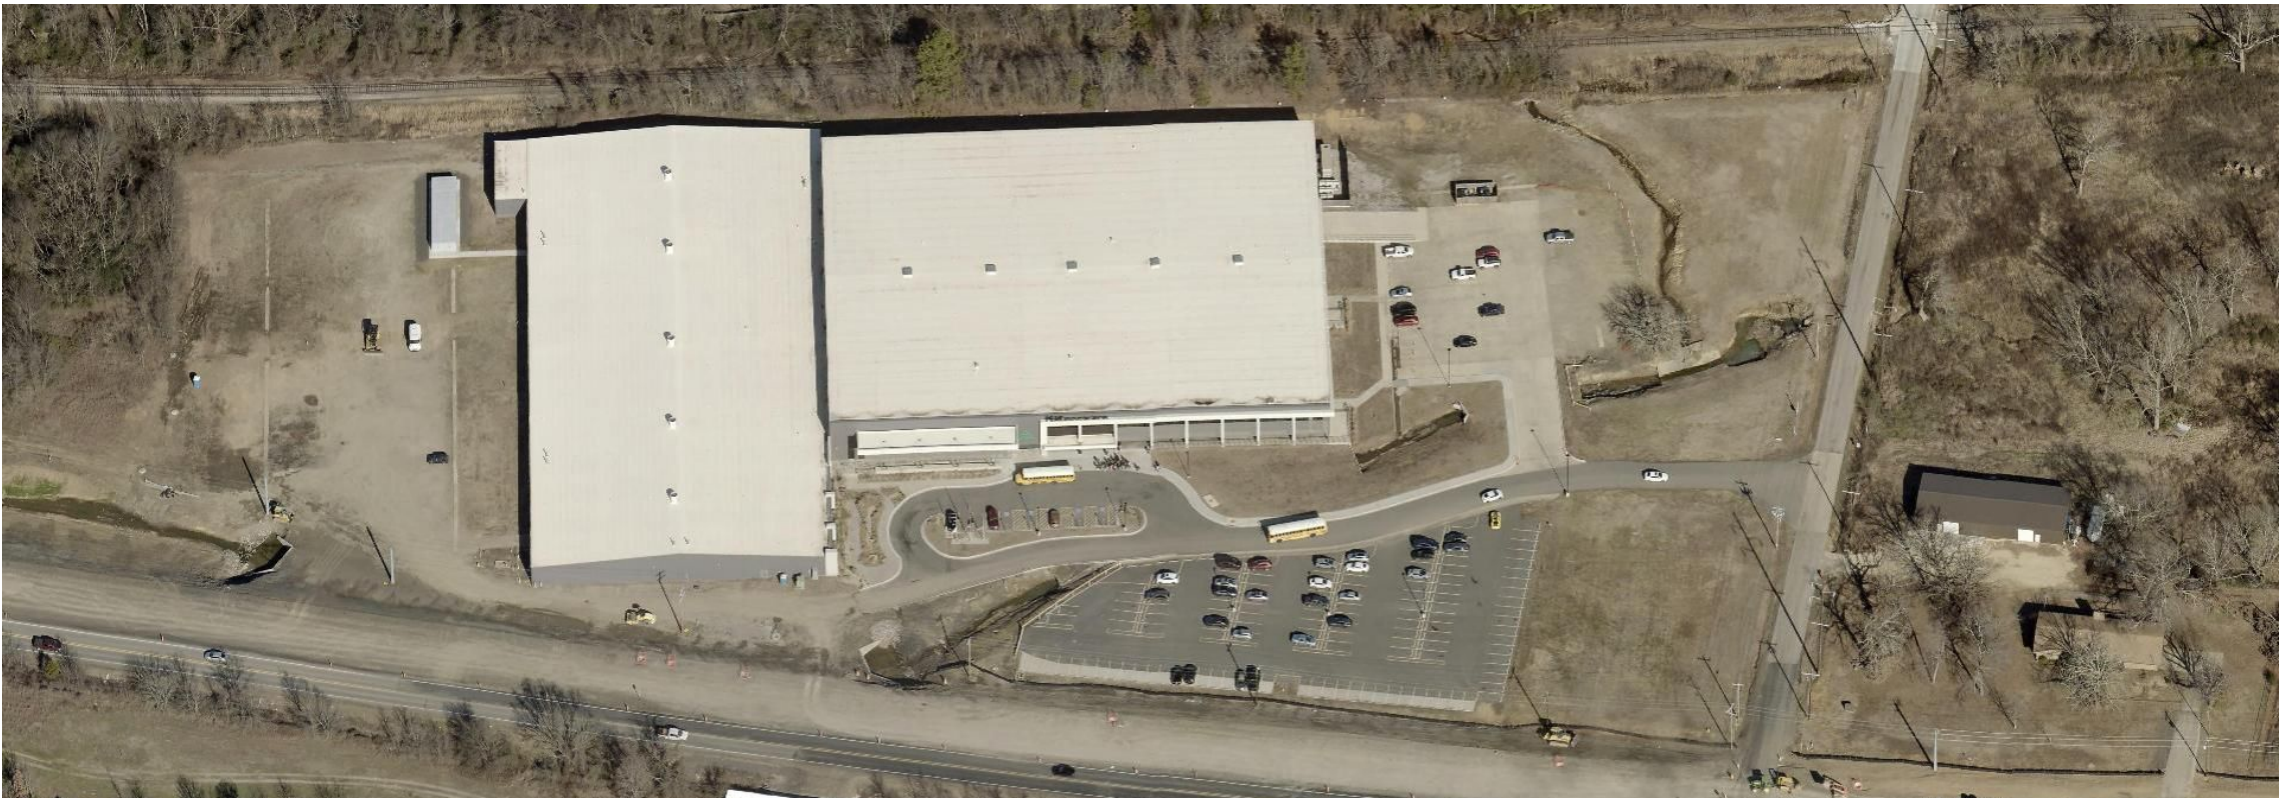
**PEAK Innovation Center Drainage Basin:** 160 acres, split between FSM & Barling
