Bleacher Safety Inspection Report

Winfield Central Middle School
OS150 Park Street,
Winfield, IL 60190

W24-604A Main Gym

Winfield Middle School / Main Gym	
Bleachers:	1 Bank
Manufacturer:	Kodiak Bleacher Company
Operation:	Powered
Capacity:	243Net Seating
Banks:	North 6 Rows, 3 Sections, 74'
Rise x Run:	9-5/8" x 24"
End Rails:	42 1/2"
Aisles:	3 @ 52"
ADA:	1 @ 36" and 2 @ 66"
Power:	3 Floor Friction, (2) single wide track 8" x 4" standard 1" Bore
Wheels:	1-1/4"x 5" x 1/2" axle

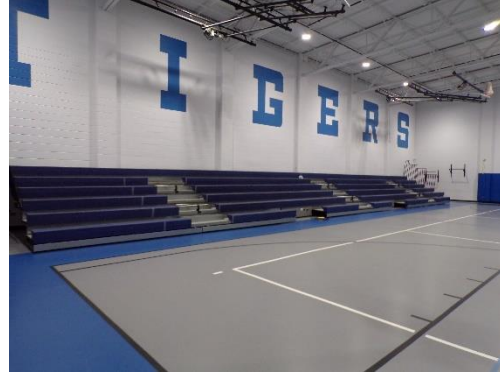
Seats:
Repairs: <ul style="list-style-type: none">(2) Broken seats, right middle section, rows 1 and 3. 2 men 2 hrs to replace.

Replace (2) seats.	\$850.00
Total for all materials delivered and installed	\$850.00
