Pana HS Valley Repair

Photo Report

Facility: Pana High School

Title: Valley Damage Report

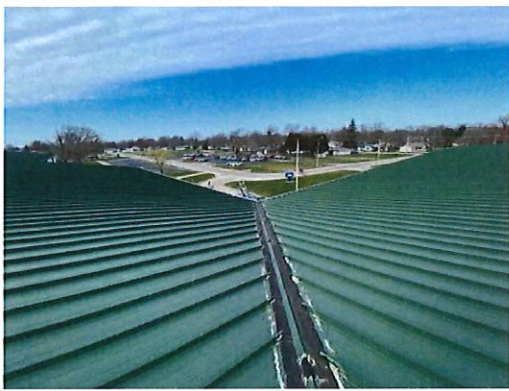
Photo 1

Leaks in the Gym are coming from the damaged valley.

- Install coating and fabric per manufacturer's recommendations to seal valleys (~200' total)
- Replace worn out pipe boots throughout roof (10 EA)

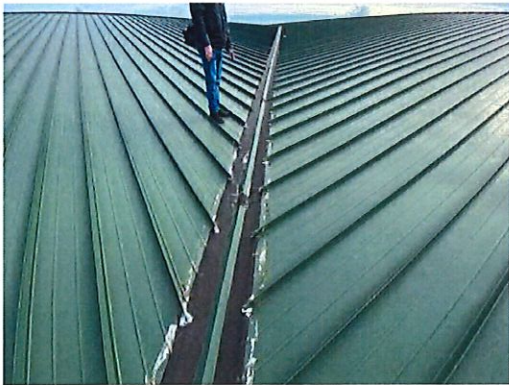
Photo 2

Valley had been repaired with peel and stick EPDM in the past.

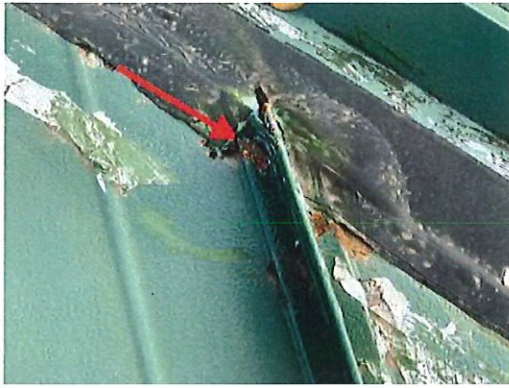
Photo 4

Rusted valley and end of panel. The EPDM actually trapped moisture causing the panels and valley closure to rust.

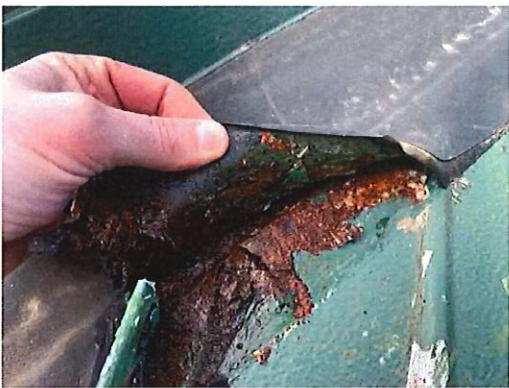
Photo 6

Valley is very rusted in areas.
