Lake View Sewer line Repair Update, 3-30-26

Ran into complications of orangeburg
piping

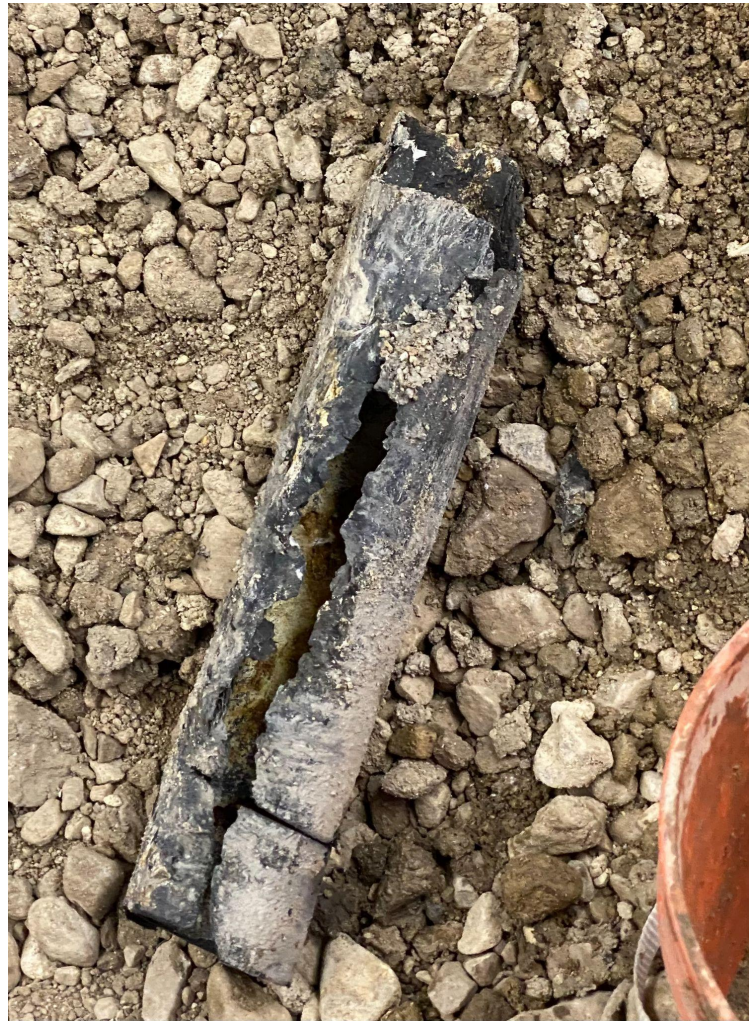
Orangeburg pipe, or bituminous fiber pipe, was a popular, lightweight sewer and conduit material used primarily from the 1940s to the 1970s, manufactured by layering wood pulp and coal tar pitch. Originally produced in the 1890s for electrical conduit, its use surged post-WWII due to metal shortages and a housing boom, but it is notorious for failing after 30-50 years

A rotted piece of old orangeburg pipe filled with dirt.

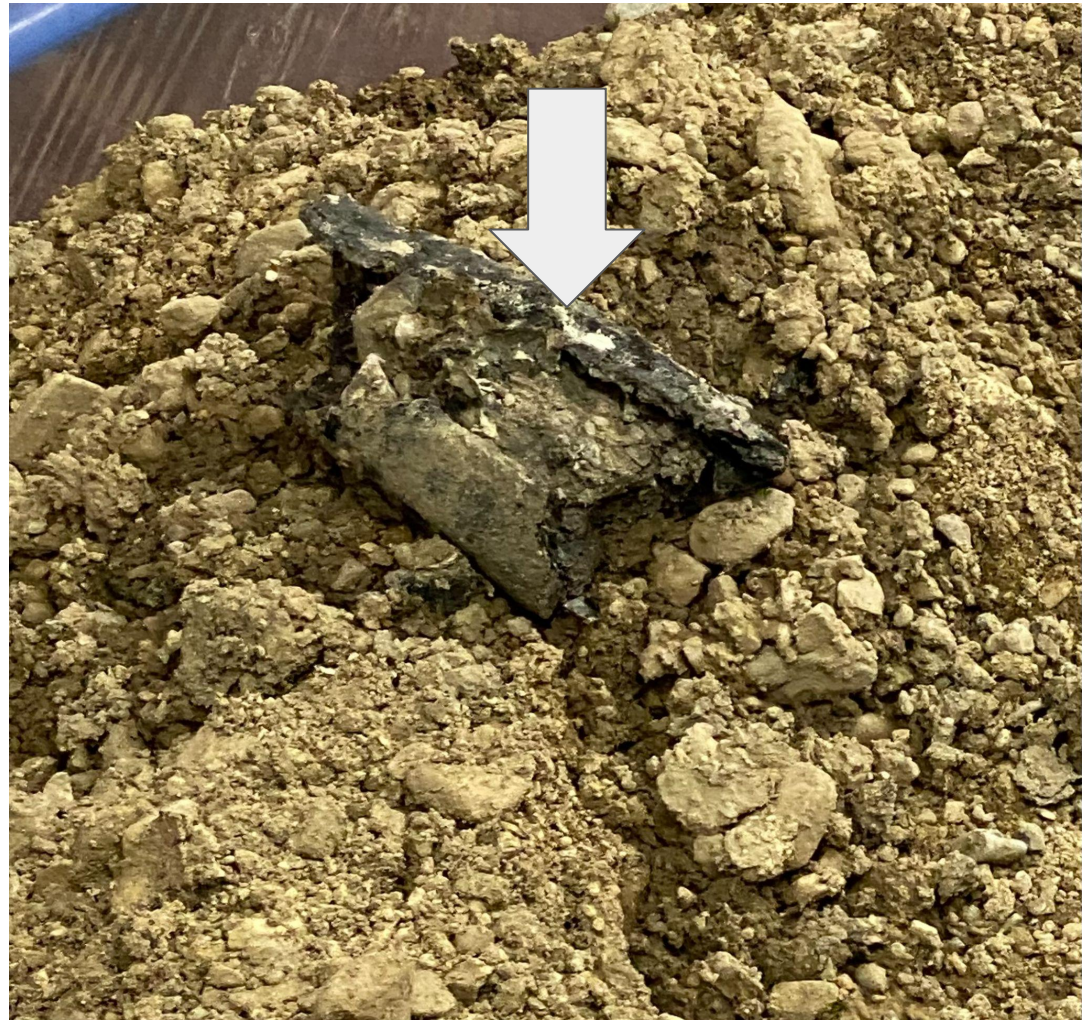
The new lining is as rigid as PVC, commonly used for sewer pipe

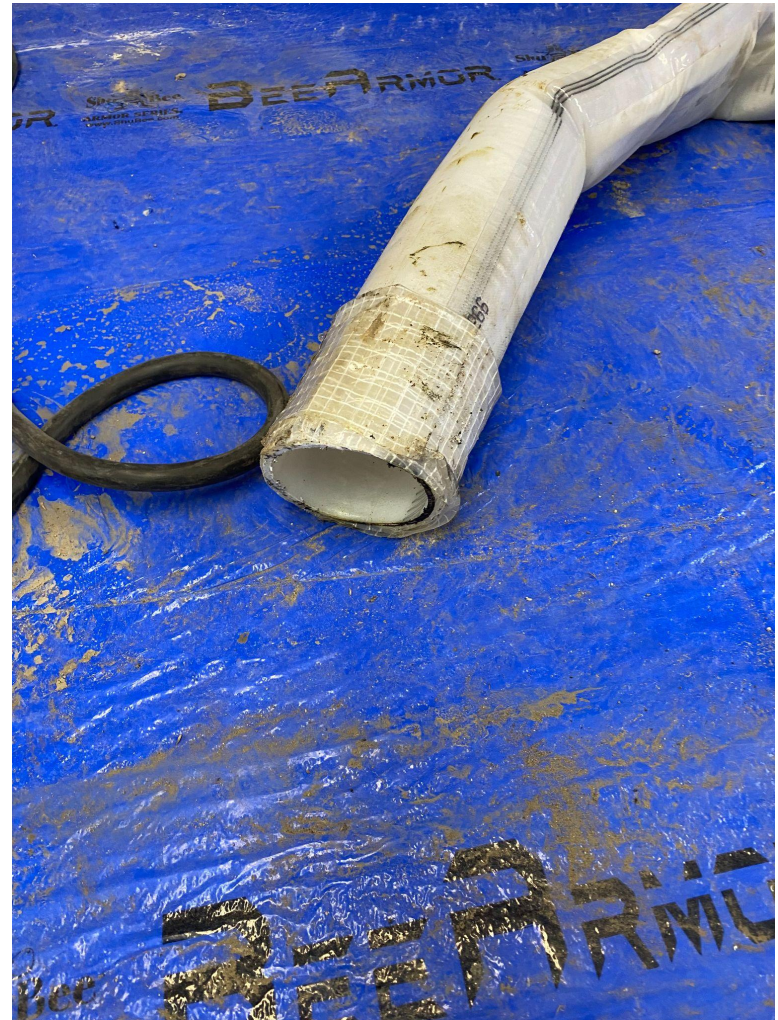
Hallway at Lake View

The hallway is protected.
The contractor had to cut a hole to replace some of the collapsed orangeburg pipe

We are concerned this is the same issue in other parts of Lake View and also North Park. We suggest starting the process to investigate a cost to line and replace all sewer pipe at both Lake View and North Park this summer.

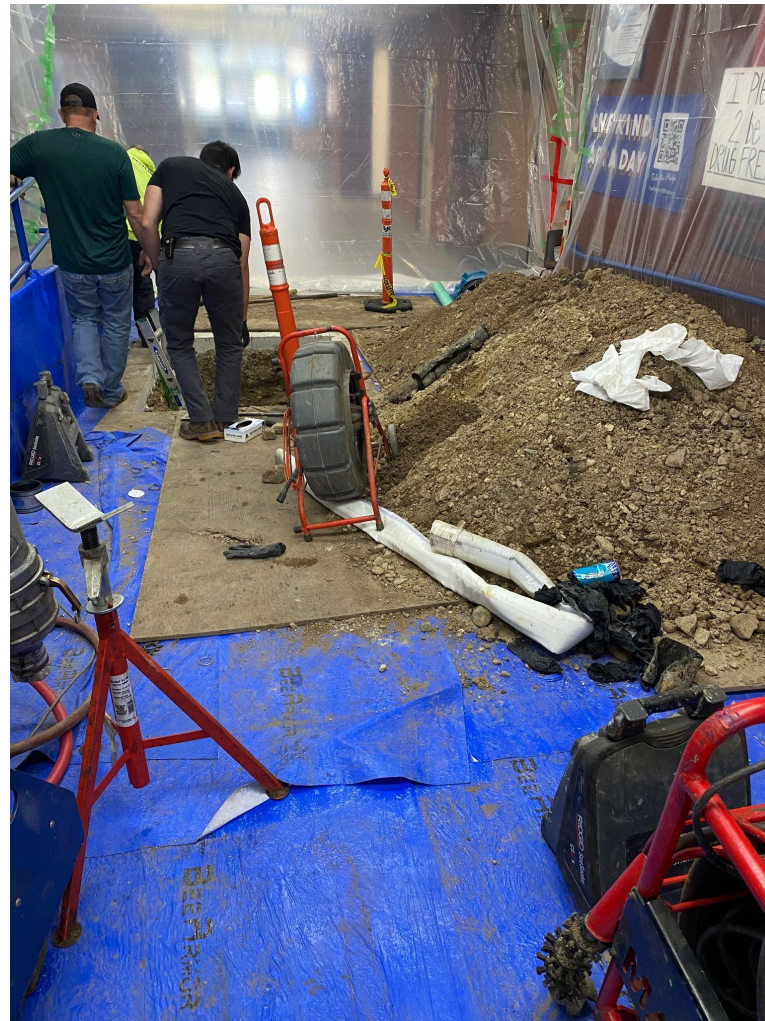
The amount of dirt pulled out to access the pipe. Their plan is to still be finished lining the old buried pipe this week. Replacing the old pipe in tunnels will take place this summer.

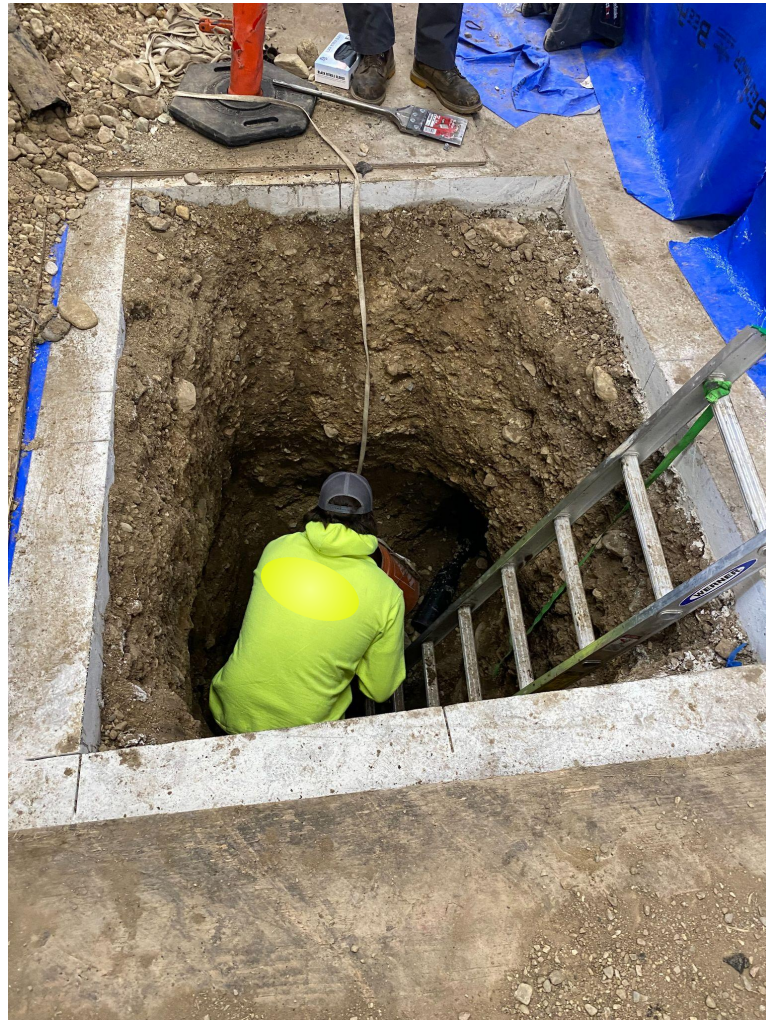
Depth to replace old pipe.
