Certificate of Substantial Completion

ARCHITECTS OBSERVATION REPORT

Lawhon Elementary Renovations

Punch List

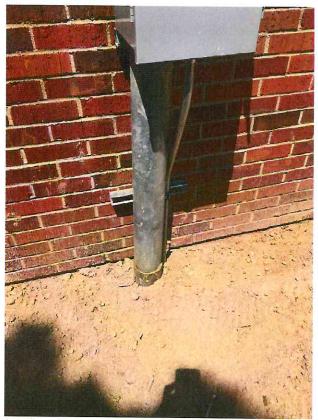
Missing strap at Unistrut for disconnect serving building "A".

- 27. Provide straps and struts at Panel A1.
- 28. Provide straps and struts at Panel A2.
- 29. Provide typewritten panel schedules.
- 30. Provide additional straps at electrical panel in "C" electrical room.

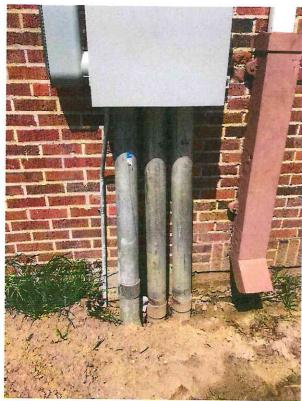
Missing straps and Unistrut for disconnect serving building "C".

- 7. Provide additional straps and strut at secondary entrance conduit at service entrance disconnect at "C" building.
- 8. Contractor shall demolish existing weatherheads and repair roof as required.
