Re: Roof Leaks

Memo

Northome School – Wall Investigation

September 25, 2023

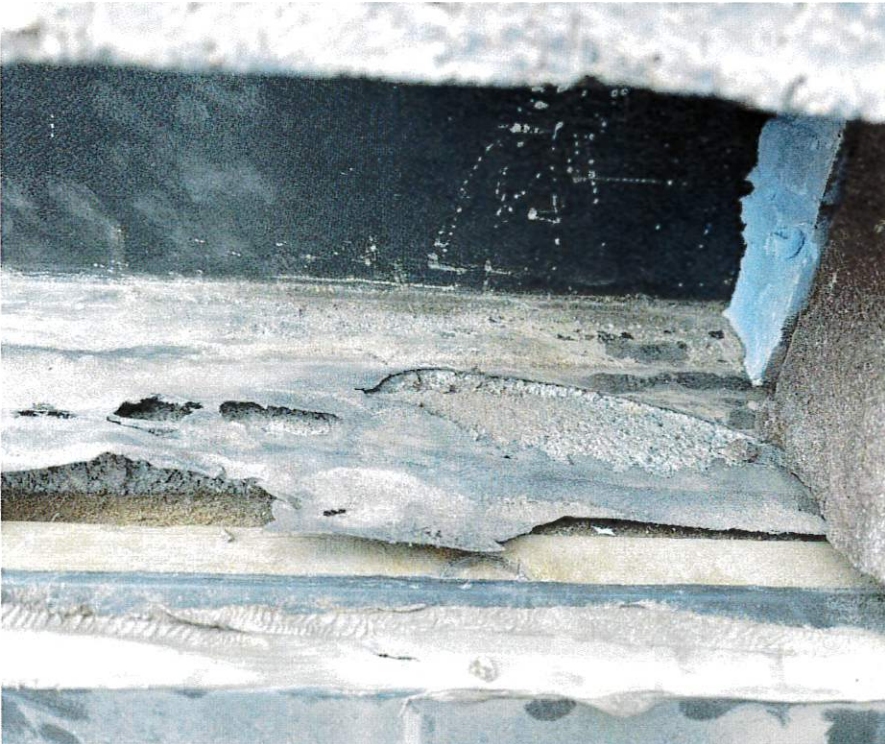
Through wall flashing appears to be worn through in multiple location @ test cut area.

Recommendation:
Replace through wall flashing or cover wall to eliminate need for through wall flashing.

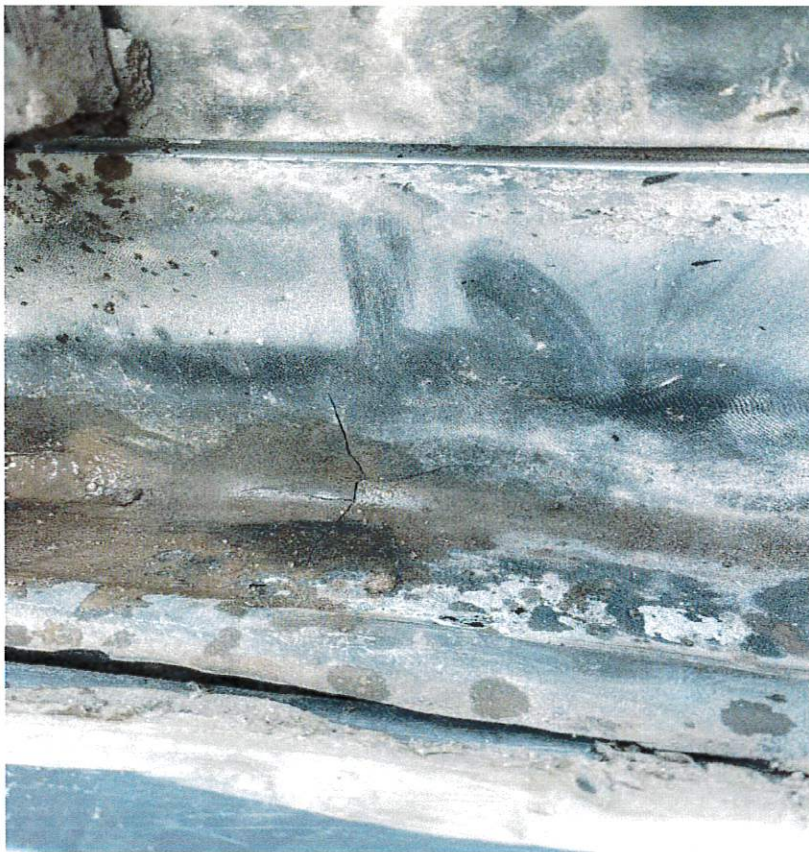
Though wall flashing is cracked at horizontal/vertical transition @ test cut area.

Recommendation:
Replace through wall flashing or cover wall to eliminate need for through wall flashing.
