Agenda of Committee Meeting

Safety and Security Committee Meeting

Robb Elementary School Attack Response Assessment and Recommendations

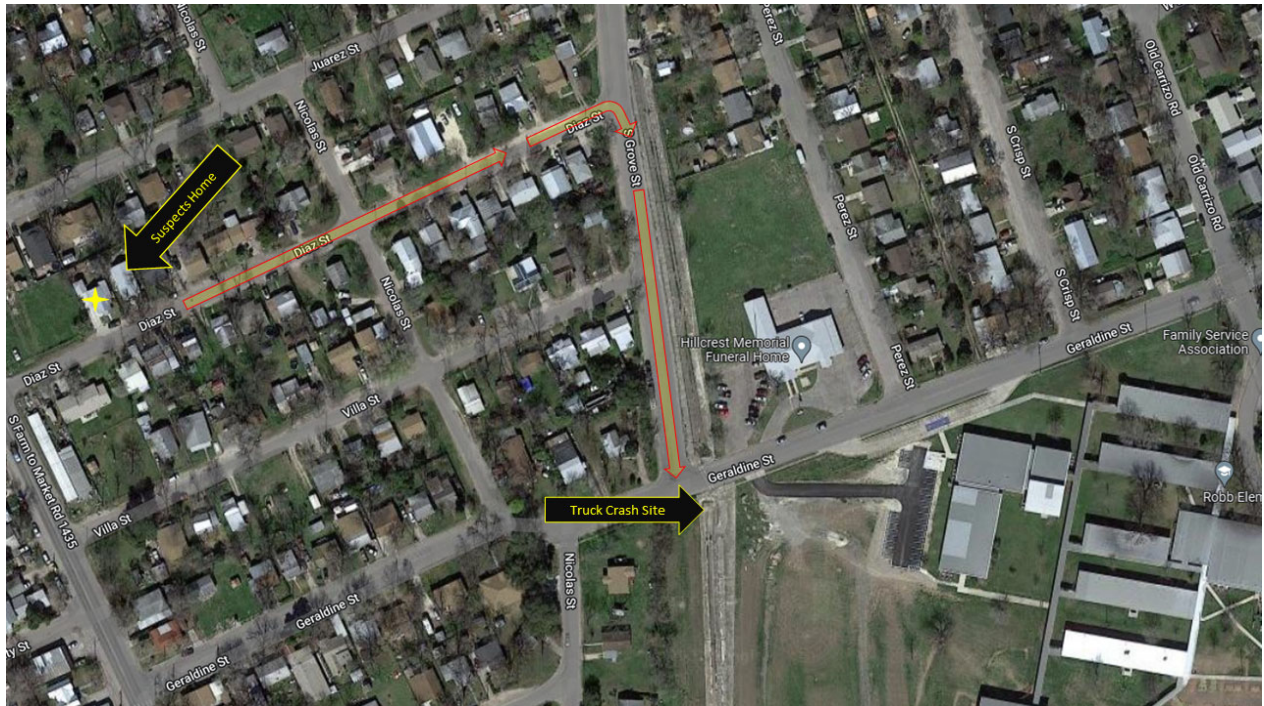
Figure 1. Overhead View

At 11:27:14, a female teacher (Female 1) exits the exterior door in the west hall propping the door open with a rock to prevent it from closing behind her (see Figure 2 for suspect entry point). (ISS)

At 11:30:14, the suspect, wearing dark clothing and carrying a bag, left the crash scene and climbed a chain-link fence onto the elementary school property. The suspect walked deliberately across the open grounds between the fence and the teachers' parking lot. The suspect moved towards the school buildings on the westmost side of the campus. Although a defect that might have been caused by a bullet was located on a building south of the affected structure, it could not be

At 11:32:08, the suspect reached the west teachers' parking lot adjacent to the affected building and fired through windows into the westmost rooms prior to entering the building. (FH and audio file from ISS)

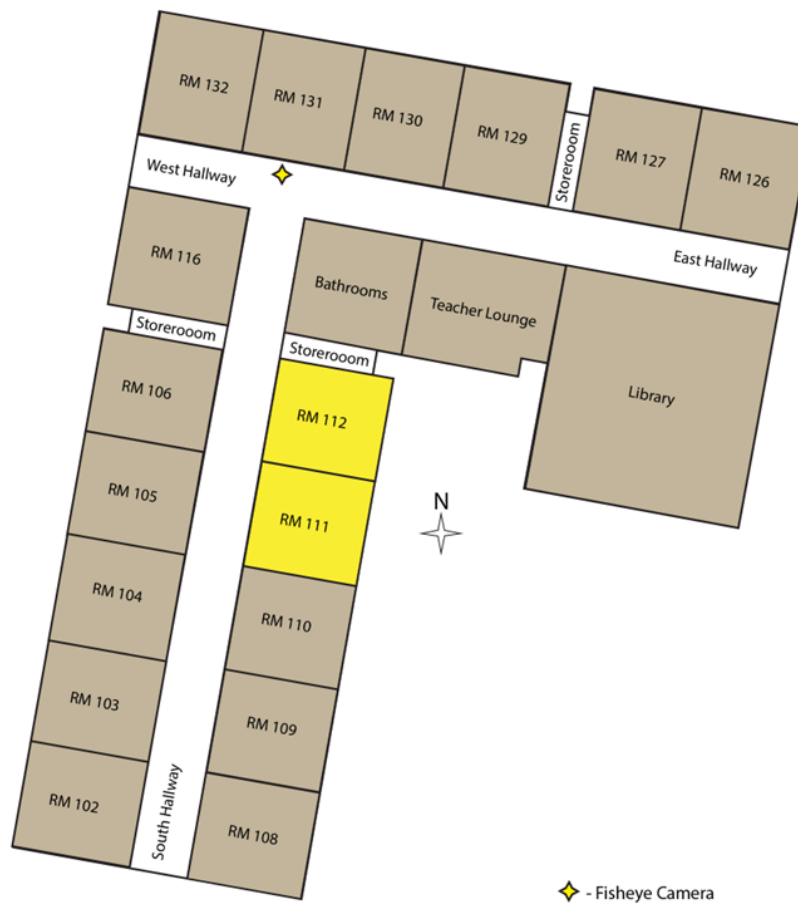
Figure 3. West Building Layout

Note: The internal school surveillance (ISS) video consisted of a ceiling-mounted camera that was situated at the intersection of three intersecting hallways (as indicated by the yellow star in Figure 3) This camera captured 1) the suspect's entry point, which was the short (West) hallway leading to an exterior door; 2) a second long hallway (South) with multiple classrooms on either side of the hall and an exterior door at the southmost end of the hall; and 3) a third hallway (East) that leads to other classrooms, restrooms, a teachers' lounge, a library, and an exterior door at the eastmost end of the hallway.

At 11:33:00, the suspect enters the school from the exterior door in the west hall while holding a rifle. The suspect looked around the hallway and then continued to walk down the west hallway before turning right (down the south hallway). The suspect walked past a series of rooms with closed doors and a firewall “break.” before making his way to room 111 and 112. (ISS)

The exterior walls of each classroom had two 3' x 4' windows near the opposing corners of each classroom (see Figure 3). The bottom of each window was approximately 3' from interior floor level, and they were equipped with mini blinds. From the exterior, the windows were approximately 4' from ground level. The windows were composed of a heavy aluminum frame with three lateral cross beams that held four (4) 1'x3' panes of tempered glass, as seen in Figure 7.

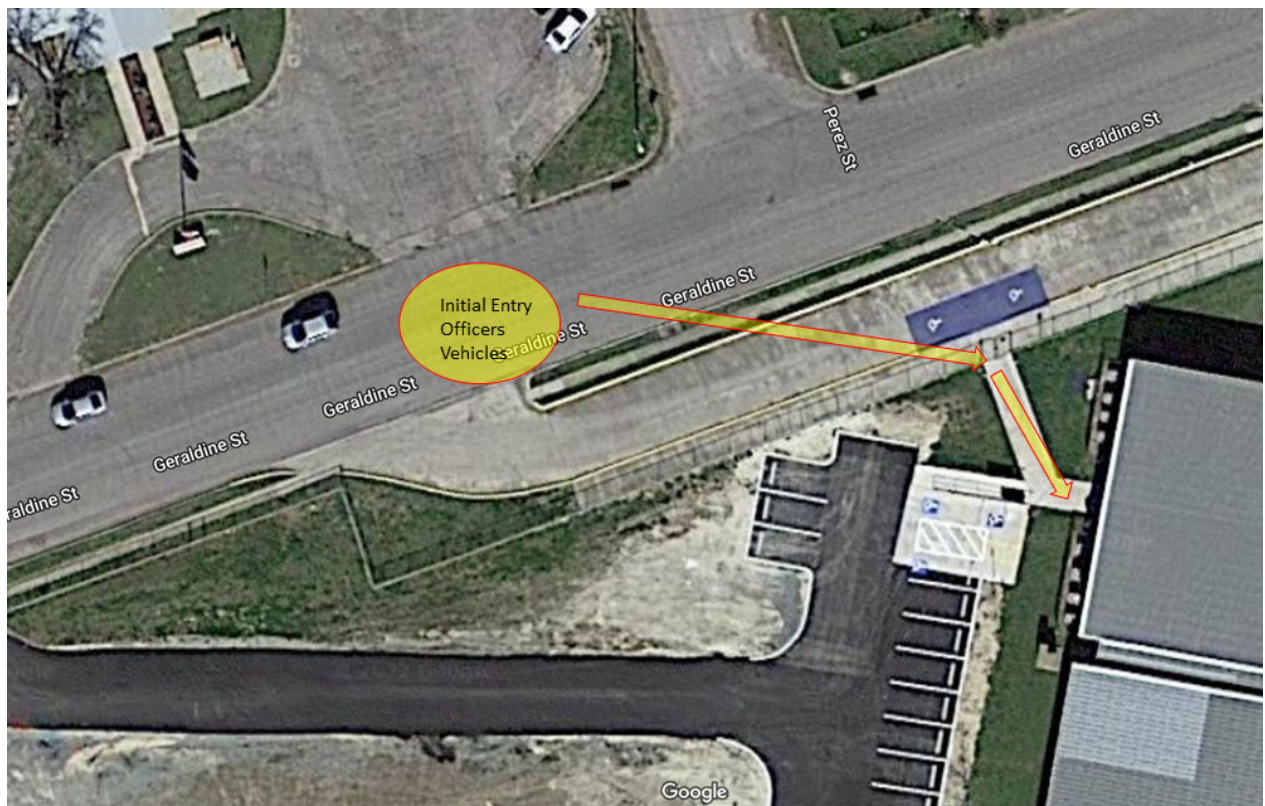
Figure 4. Officers Initial Entry into West Building

After the suspect made entry into the west building, three Uvalde Police Department (UPD) officers gathered on Geraldine Street (behind police vehicles) in front of the school drop-off / pick-up area. Then the officers, using a bounding overwatch tactic, move quickly (one at a time) to the west door.

At 11:35:55, all three Uvalde Police Department (UPD) officers entered the structure through the west door into the west hallway. These officers were equipped with the following: one with external armor and two with concealable body armor, two rifles, and three pistols. At 11:36:00, four officers entered the south hallway through the south door closest to the suspect. It is not clear what equipment these officers had with them. Four more officers entered the west hallway through the west door at 11:36:03. Three of these officers were from the UPD and one was from the Uvalde Consolidated Independent School District Police Department (UCISD PD). They were equipped with three external body armor carriers and one with concealable body armor and pistols. (ISS)

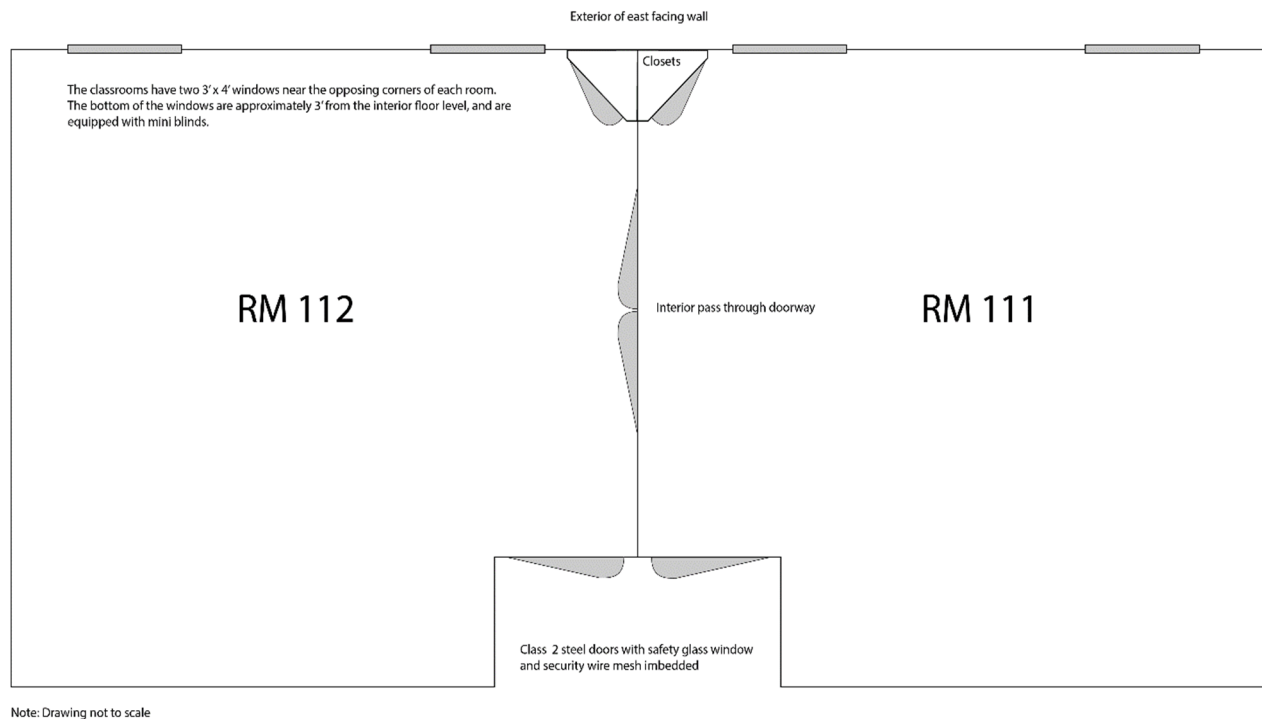
Figure 5. Classroom Layout

The classroom doors were inset just over 36" into a 90-degree inset from the hallway to accommodate the swing of the outward opening classroom doors towards the hall. Each inset had two separate doors, side-by-side, leading into a separate classroom. The door on the left-hand side of the inset opened outward from right to left, and the door on the right-hand side of the inset opened outward from left to right as seen in Figure 5.

We identified three key issues that occurred before the suspect entered rooms 111 and 112 for the last time. First, Uvalde ISD had protocols in place requiring doors to remain locked at all times, and the school was currently on an active lockdown prior to the suspect gaining entry to the school. The suspect was still able to gain access to room 111. We received information from the investigating officer that the lock on room 111 had been reported as damaged multiple times; however, this has not been confirmed through work orders at this time. Regardless, the suspect is seen entering the room, exiting the room, and then reentering the room again prior to officers entering the building at 11:35:55. The only way to engage the lock is to insert a key from the hallway side of the door. At no point is the suspect observed entering the hallway and engaging the locking mechanism. Based upon this, we believe that the lock to room 111 was never engaged.

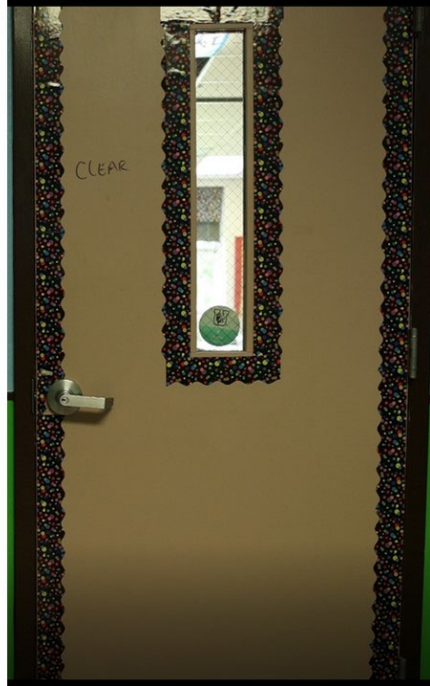
Figure 6. Class 2 Steel Door

The classroom doors were class 2 steel doors. The classroom doors had safety glass with security wire mesh imbedded (see Figure 6). The hardware consisted of a single metal door handle locking latch, three exterior metal hinges, and a door closure device mounted to the top inside portion of the door. The door jambs were composed of steel and set in a metal stud and sheetrock wall.

The door to room 111 had been removed for evidentiary purposes and collection. Once the evidence had been removed the door was left on the floor of the room. The door for room 112 was intact and in place. There was a noticeable concentration of exiting bullet defects in the area of the inset. There were noticeable bullet defects on the door jamb of classroom 111, approximately 5' from floor level. Both rooms 111 and 112 possessed an extraordinary amount of dry blood concentrated on the floor.

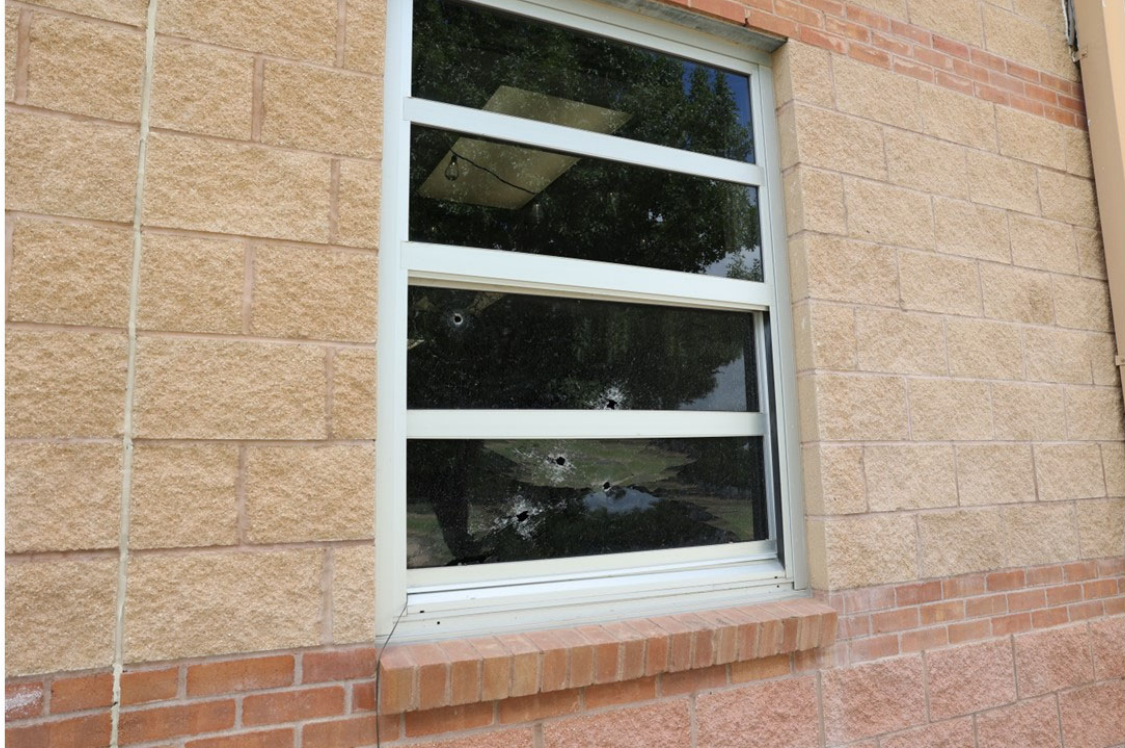
Figure 7. Exterior Classroom Window

An exterior window on the right-hand side as you enter room 111 had a clear bullet defect. Based on the fragmented spiderweb pattern it was evident that the window was composed of safety glass, which fragments into small pieces when it is struck with enough force to break.

- B. If the officers believed that they could not establish control through the doors, they should have found another way to stop the killing and dying. One option would have been to breach the exterior windows of the classrooms. Ideally, this would have involved breaking more than one window simultaneously and then raking the blinds out of the window. It is likely that the suspect would have fired at the officers, but the exterior construction of the building would have provided them with good cover. After the windows were broken (i.e., ported), the officers could have planned to simultaneously stand up in the windows to confront the attacker (i.e., cover). The room would have been substantially darker than the bright exterior conditions at the time. However, breaking the windows and raking the blinds would have increased lighting in the room. Hand-held or weapon-mounted lights could also have been used to increase visibility (see Supplementary information regarding an assessment of breaching options).

It was found that “port and cover” on the window was challenging due to miniblinds obstructing view and unequal lighting conditions.

- Port and cover refers to breaching a window and addressing threats from that opening.
- Miniblinds or obstructions would need to be cleared with a breaching tool for a view into the room,
- The classroom was significantly darkened without artificial lighting while the exterior was relatively sunny and bright. When the exterior window was breached, the unequal lighting conditions resulted in the exterior members having diminished capabilities to see into the dark classroom to acquire a target. Raking the blinds out would increase the lighting in the room, and hand-held or weapon mounted lights could further improve lighting conditions.

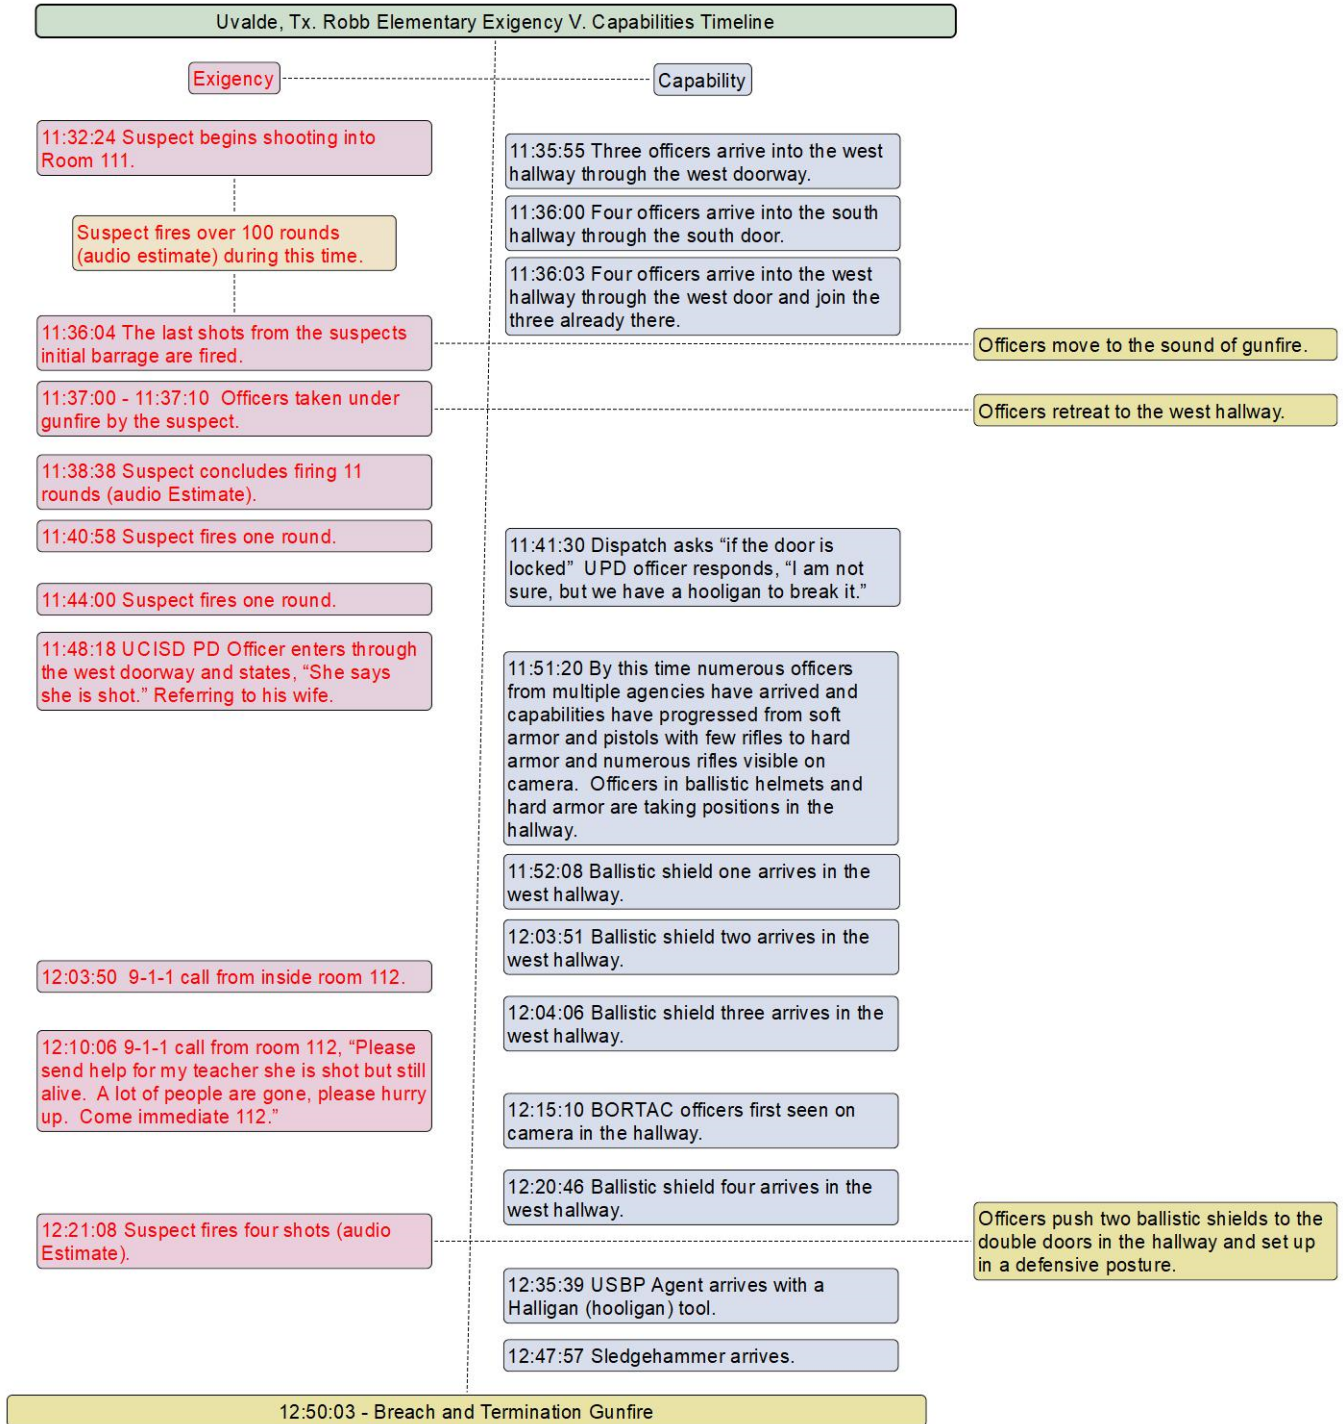
Figure 8. Exigency vs Capability Timeline

Additionally, we have noted in this report that it does not appear that effective incident command was established during this event. The lack of effective command likely impaired both the Stop the Killing and Stop the Dying parts of the response. The final part of this AAR will address incident command issues.

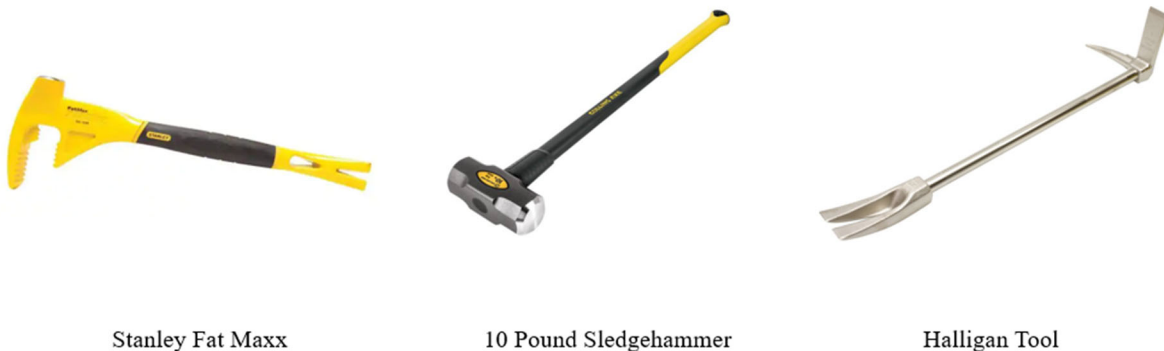
Figure 9. Breaching Tools

ALERRT staff conducted a series of tests at Robb Elementary School incorporating critical thinking and breaching techniques to determine possibilities that may have changed the incident outcome. ALERRT staff used non-traditional tools that can be purchased at most any hardware store or obtained from a firetruck. The tools used were a 10LB sledgehammer, a Stanley Fat Maxx, and a Halligan tool (see Figure 9).
