Joint Meeting with the City of Franklin &  
FCS Board of School Trustees  
Monday, August 24, 2026 6:00 PM Eastern

## Certificate of Substantial Completion

# Site Visit Construction

PROJECT: Franklin Community Preschool  
2022-024.PRE

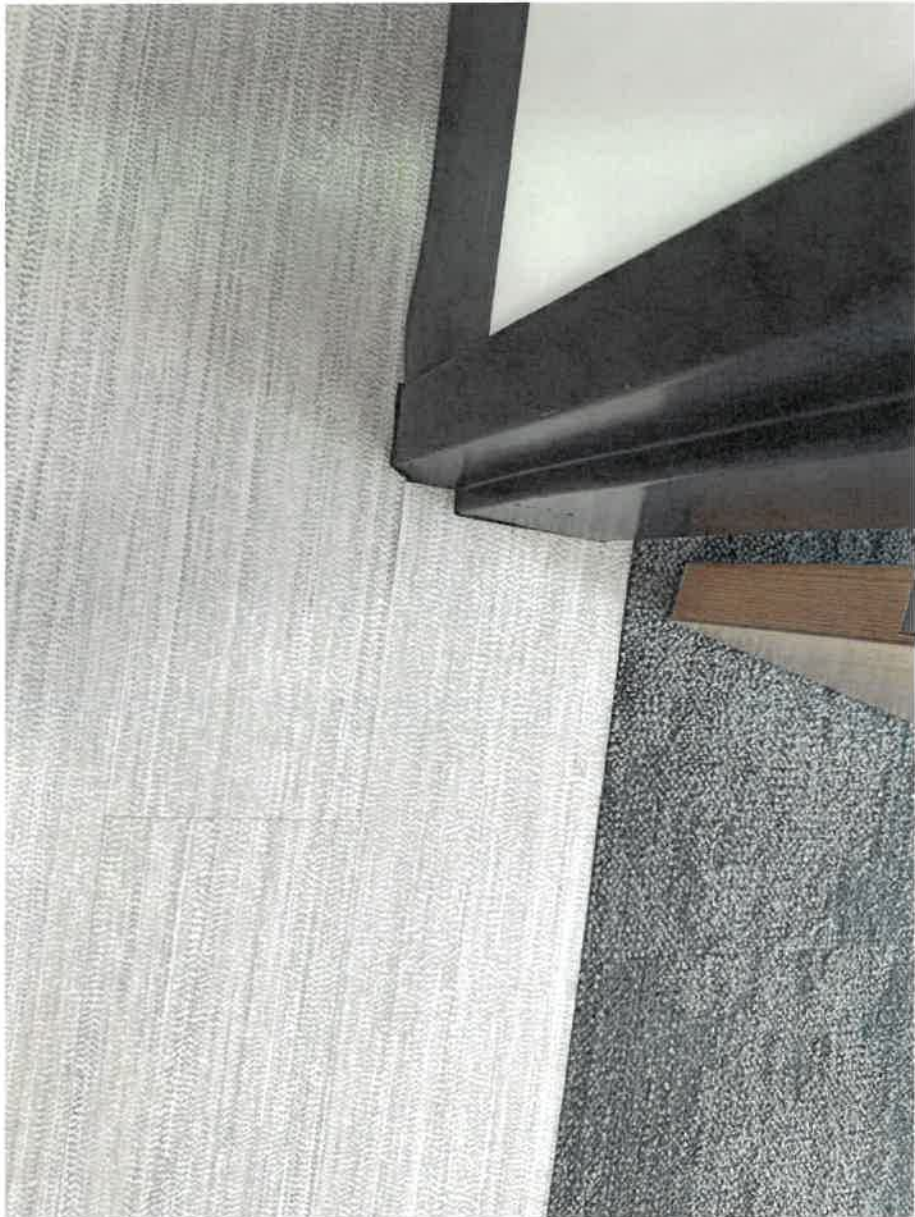
ITEM: 027-016

SUBJECT: Corridor H100  
REMARKS: LVT coming loose outside A104  
CATEGORY: Quality

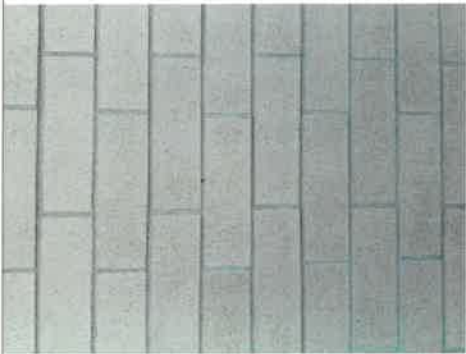
| SPACE NUMBER | SPACE NAME | ELEMENT | LOCATION | DESCRIPTION | STATUS LABEL | ID | SUPPORTING DOCS |
|---|---|---|---|---|---|---|---|
| | N/A | Exterior | | Fill hole on west side | Open | 00009 | |

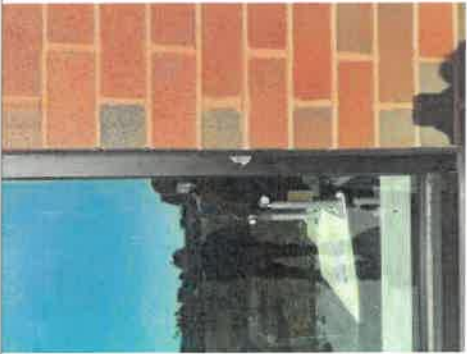
| SPACE NUMBER | SPACE NAME | ELEMENT | LOCATION | DESCRIPTION | STATUS LABEL | ID | SUPPORTING DOCS |
|---|---|---|---|---|---|---|---|
| | N/A | Exterior | | Finish coming off windows SE corner | Open | 00010 | |

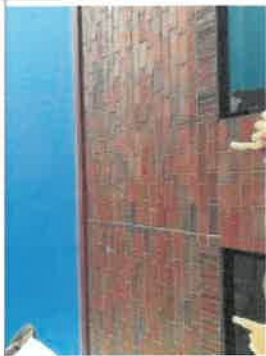
| SPACE NUMBER | SPACE NAME | ELEMENT | LOCATION | DESCRIPTION | STATUS LABEL | ID | SUPPORTING DOCS |
|---|---|---|---|---|---|---|---|
| | N/A | Exterior | | Clean brick and attach coping to cleat | Open | 0001 4 | |

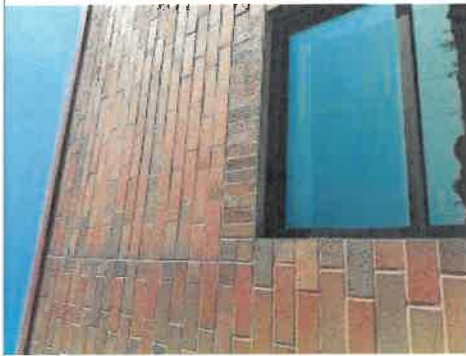
| SPACE NUMBER | SPACE NAME | ELEMENT | LOCATION | DESCRIPTION | STATUS LABEL | ID | SUPPORTING DOCS |
|---|---|---|---|---|---|---|---|
| | N/A | Exterior | | Connect control joints to lentle at multiple locations | Open | 0001 5 | |

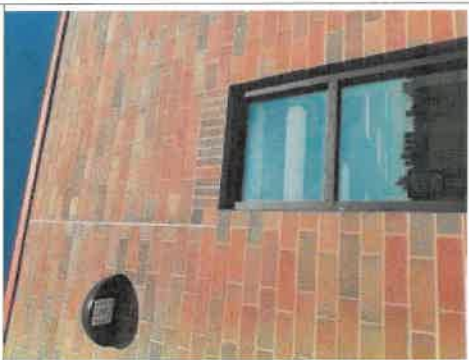
| SPACE NUMBER | SPACE NAME | ELEMENT | LOCATION | DESCRIPTION | STATUS LABEL | ID | SUPPORTING DOCS |
|---|---|---|---|---|---|---|---|
| | N/A | Exterior | | Touch up scratches on window frames | Open | 0001<br>6 | |

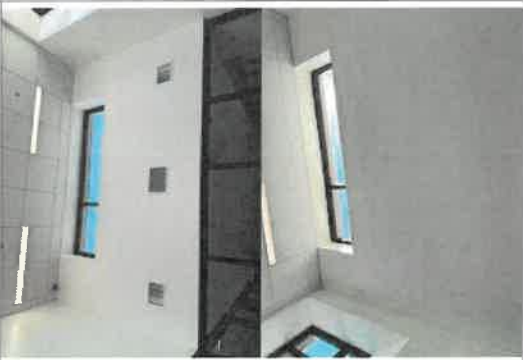
| SPACE NUMBER | SPACE NAME | ELEMENT | LOCATION | DESCRIPTION | STATUS LABEL | ID | SUPPORTING DOCS |
|---|---|---|---|---|---|---|---|
| | N/A | Vestibule V100 | | Sills are not sloped | Open | 0002<br>2 | |

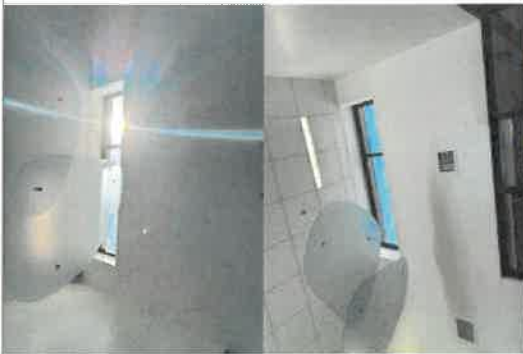
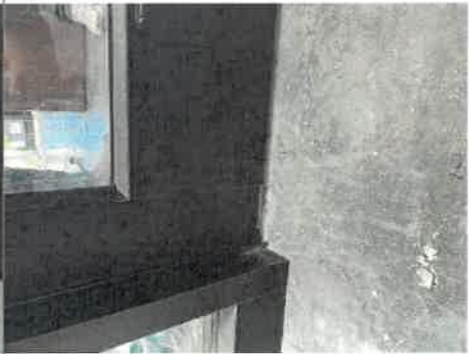
| SPACE NUMBER | SPACE NAME | ELEMENT | LOCATION | DESCRIPTION | STATUS LABEL | ID | SUPPORTING DOCS |
|---|---|---|---|---|---|---|---|
| | N/A | Vestibule V100 | | Door should not have notch at bottom | Open | 0002<br>3 | |

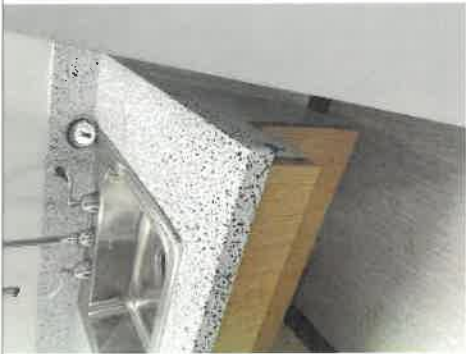
| SPACE NUMBER | SPACE NAME | ELEMENT | LOCATION | DESCRIPTION | STATUS LABEL | ID | SUPPORTING DOCS |
|---|---|---|---|---|---|---|---|
| | N/A | Clinic A111 | | Install end panel on casework | Open | 0002<br>4 | |

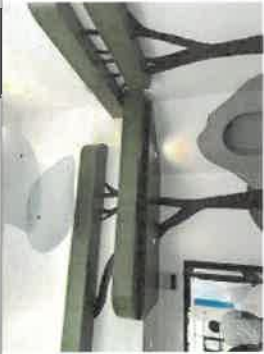
| SPACE NUMBER | SPACE NAME | ELEMENT | LOCATION | DESCRIPTION | STATUS LABEL | ID | SUPPORTING DOCS |
|---|---|---|---|---|---|---|---|
| | N/A | General Office<br>Waiting V101 | | Bulkhead not flush with ceiling | Open | 0002<br>5 | |

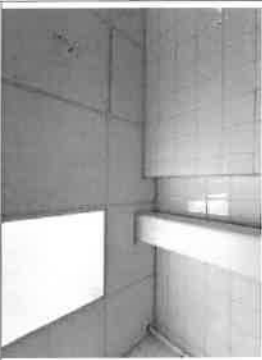
| SPACE NUMBER | SPACE NAME | ELEMENT | LOCATION | DESCRIPTION | STATUS LABEL | ID | SUPPORTING DOCS |
|---|---|---|---|---|---|---|---|
| | N/A | Laundry/Jan C103B | | Replace short tile and install escutcheon at condensate line | Open | 0003 6 | |

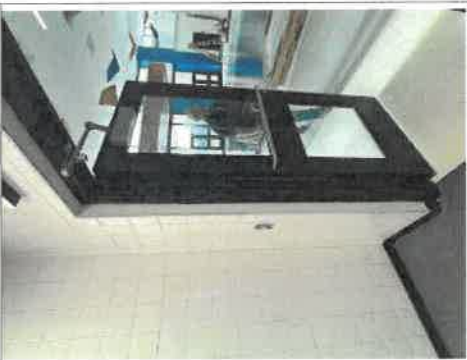
| SPACE NUMBER | SPACE NAME | ELEMENT | LOCATION | DESCRIPTION | STATUS LABEL | ID | SUPPORTING DOCS |
|---|---|---|---|---|---|---|---|
| | N/A | Kitchen C103 | | Caulk tile at ceiling | Open | 00040 | |

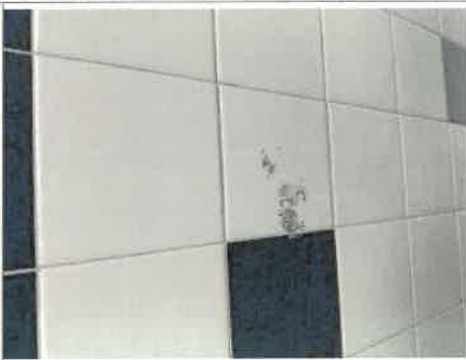
| SPACE NUMBER | SPACE NAME | ELEMENT | LOCATION | DESCRIPTION | STATUS LABEL | ID | SUPPORTING DOCS |
|---|---|---|---|---|---|---|---|
| | N/A | Girls C151 | | Clean tile | Open | 0004<br>3 | |

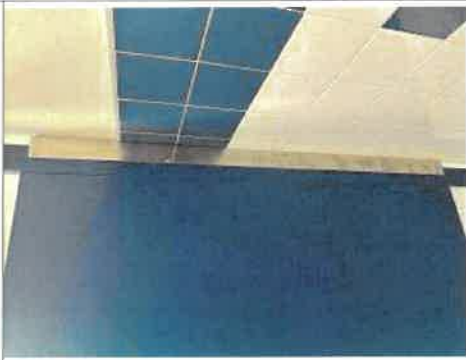
| SPACE NUMBER | SPACE NAME | ELEMENT | LOCATION | DESCRIPTION | STATUS LABEL | ID | SUPPORTING DOCS |
|---|---|---|---|---|---|---|---|
| | N/A | Girls C151 | | Clean residue on partition stainless steel | Open | 0004<br>4 | |

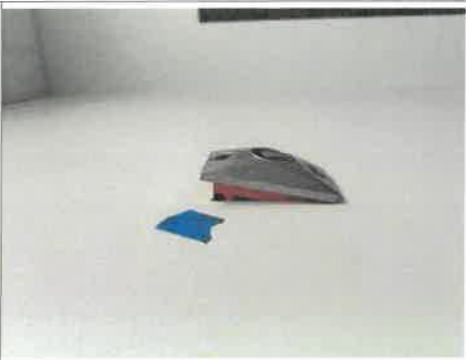
| SPACE NUMBER | SPACE NAME | ELEMENT | LOCATION | DESCRIPTION | STATUS LABEL | ID | SUPPORTING DOCS |
|---|---|---|---|---|---|---|---|
| | N/A | Handwashing C150 | | Mag hold open boxes are not secured with blocking | Open | 00048 | |

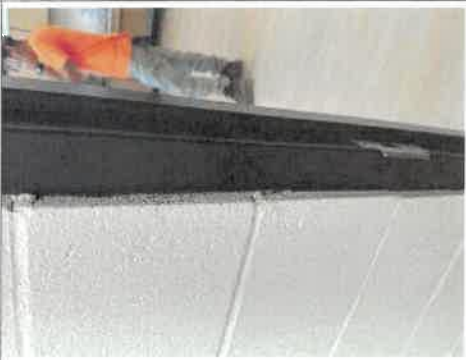
| SPACE NUMBER | SPACE NAME | ELEMENT | LOCATION | DESCRIPTION | STATUS LABEL | ID | SUPPORTING DOCS |
|---|---|---|---|---|---|---|---|
| | N/A | Storage C112A | | Caulk door frame to wall | Open | 00049 | |

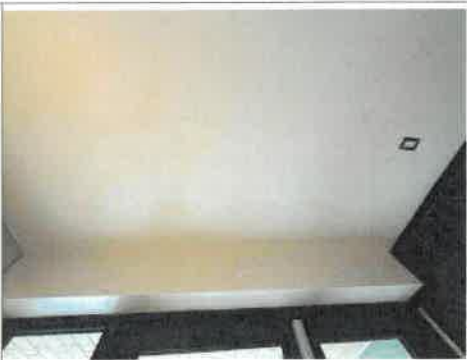
| SPACE NUMBER | SPACE NAME | ELEMENT | LOCATION | DESCRIPTION | STATUS LABEL | ID | SUPPORTING DOCS |
|---|---|---|---|---|---|---|---|
| | N/A | Family Restroom C154 | | Drywall not finish sanded | Open | 0005<br>2 | |

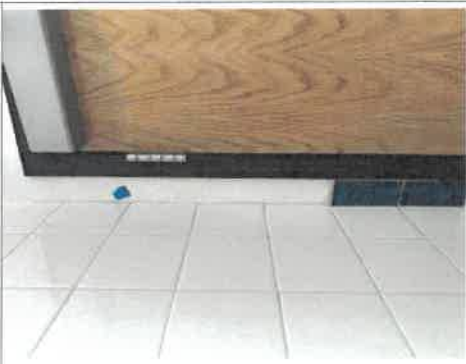
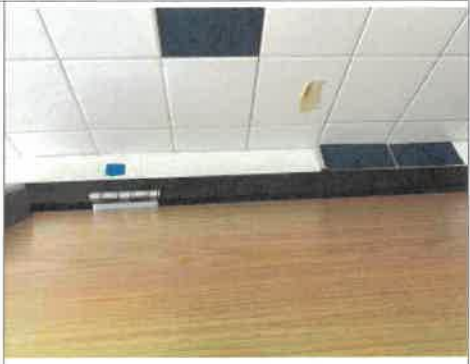
| SPACE NUMBER | SPACE NAME | ELEMENT | LOCATION | DESCRIPTION | STATUS LABEL | ID | SUPPORTING DOCS |
|---|---|---|---|---|---|---|---|
| | N/A | Family Restroom C153 | | Touch up drywall/paint | Open | 0005<br>3 | |

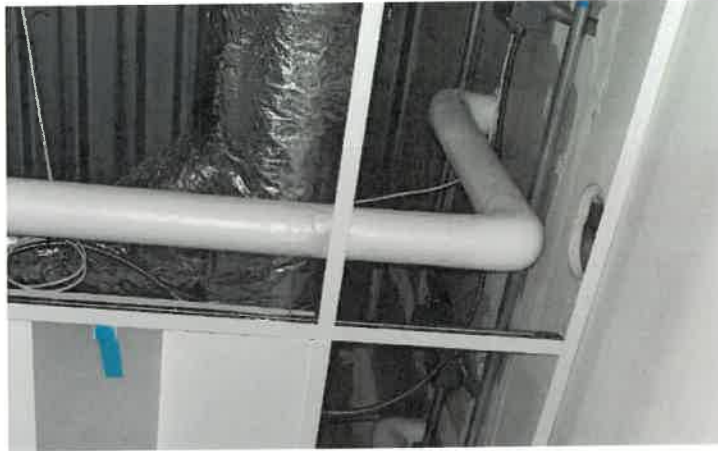
- Overall routing of piping is as indicated on plan, although a handful piping were installed close to ceiling grid. The contractor shall confirm that ceiling tiles can be removed and reinstalled.

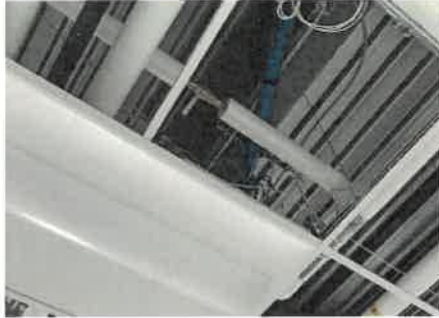
- Need to add isolation valves for future capped connections at the end of unit B. Valves are not on plans.
- Balance stations are missing from all HWR circuits. Typical of all HWR circuits in unit A & B.
- In many areas in unit A & B, valves were far from main branch off. Contractor shall located shut off valves as close as they can (were able) to the main branch off as required in specification.

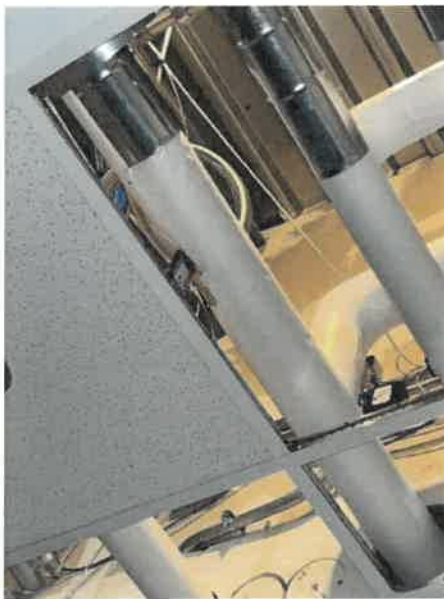
- Insulation torn/squished. Contractors shall replace insulation and ensure ceiling grid/tiles do not damage insulation.
- Unit A A109

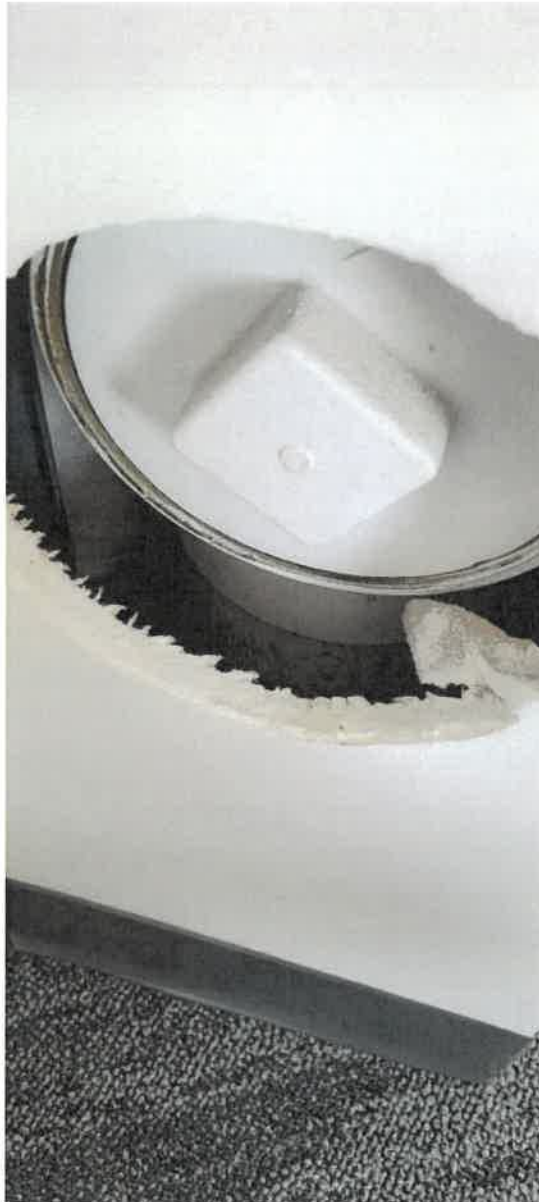
- d. Storm Piping – Storm piping was observed to not be insulated on the vertical drops as required by specifications. Some drops were enclosed within the wall already.

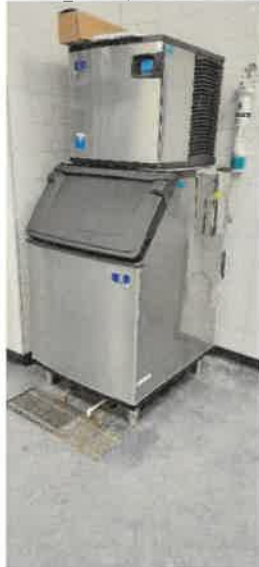
- a. FD-4 near the Ice Maker is missing or covered up that was intended to collect the drain lines instead of being routed to the front of the equipment.
- b. TD-1 did not appear to be properly installed with the flooring and it's flashing/trim around the edge of the drain. The flooring overlapped the drain over the top of the edges.
