May 2, 2024

Mr. Eric Hamilton
Director of Buildings and Grounds
Edina Public Schools
5701 Normandale Road
Edina, MN 55424

RE: 2024 Short-Term & Continuous Radon Monitoring Results
IEA Project #202310883

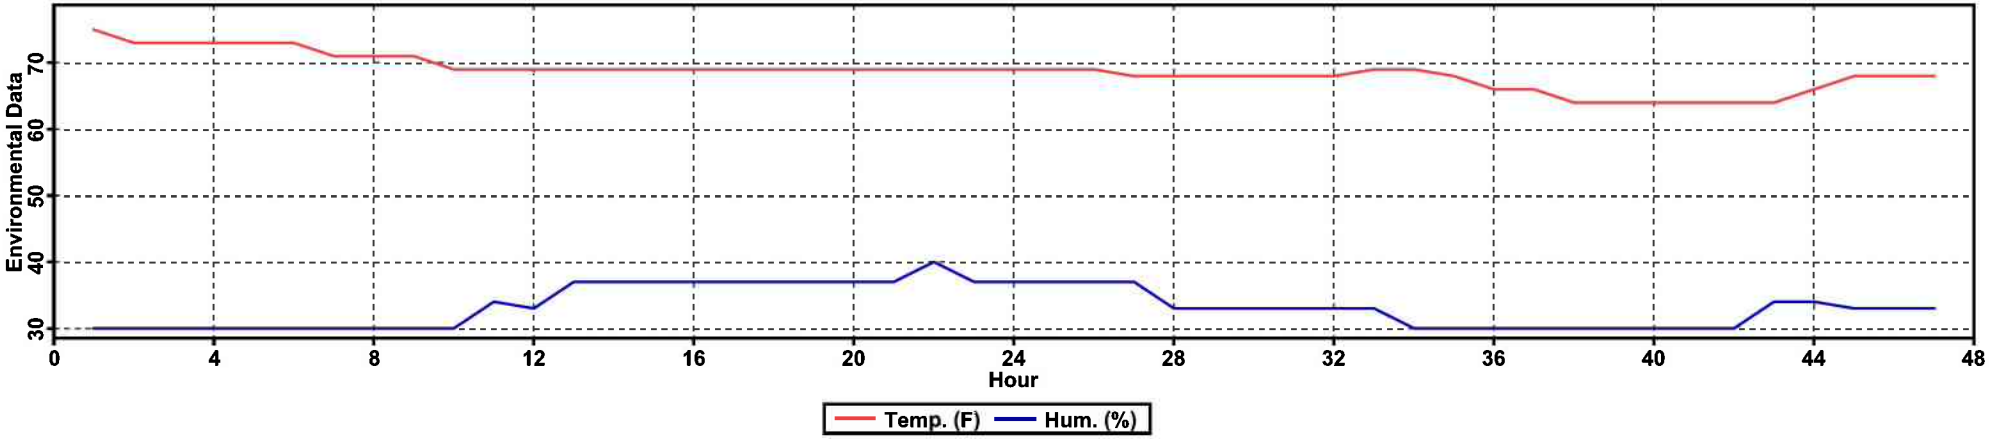
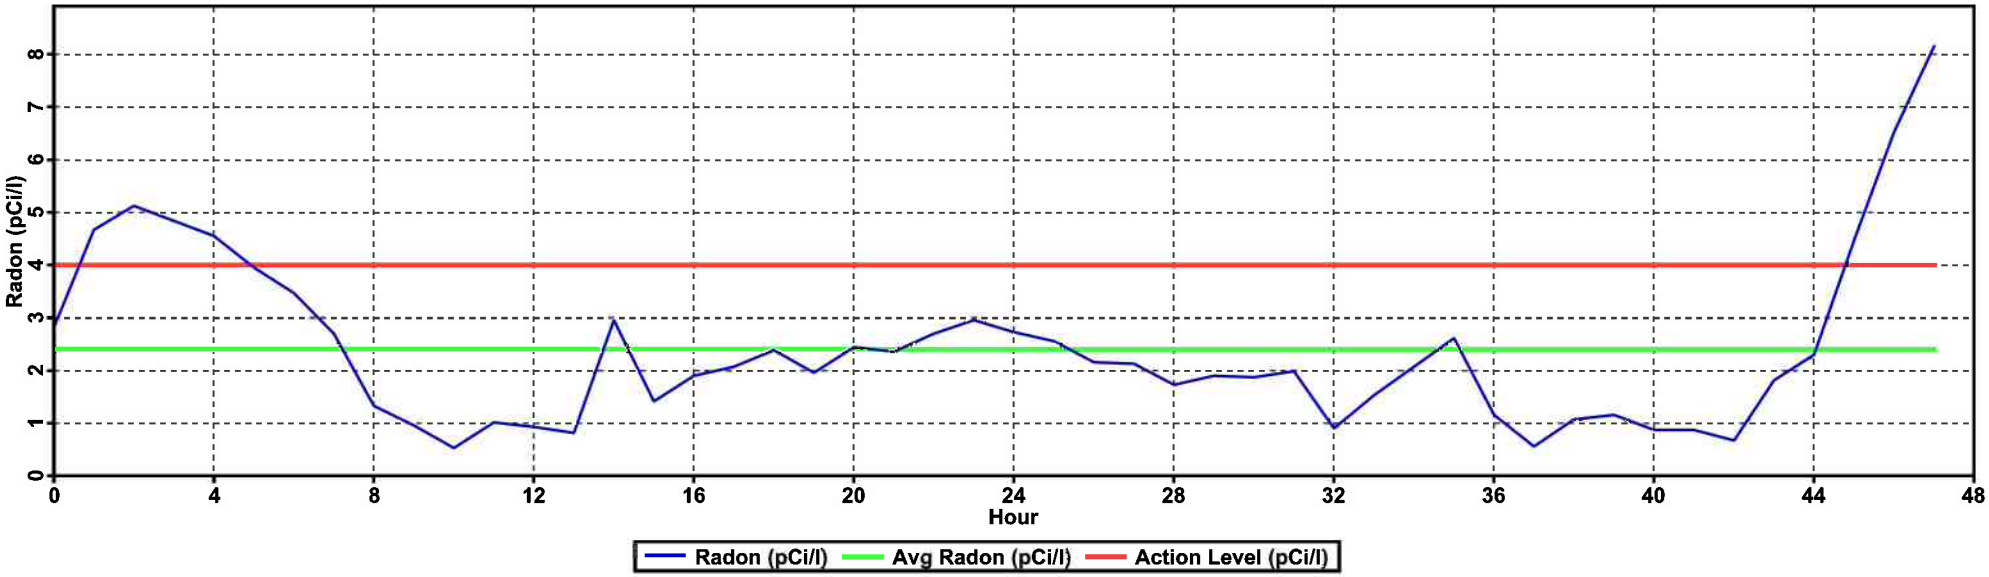
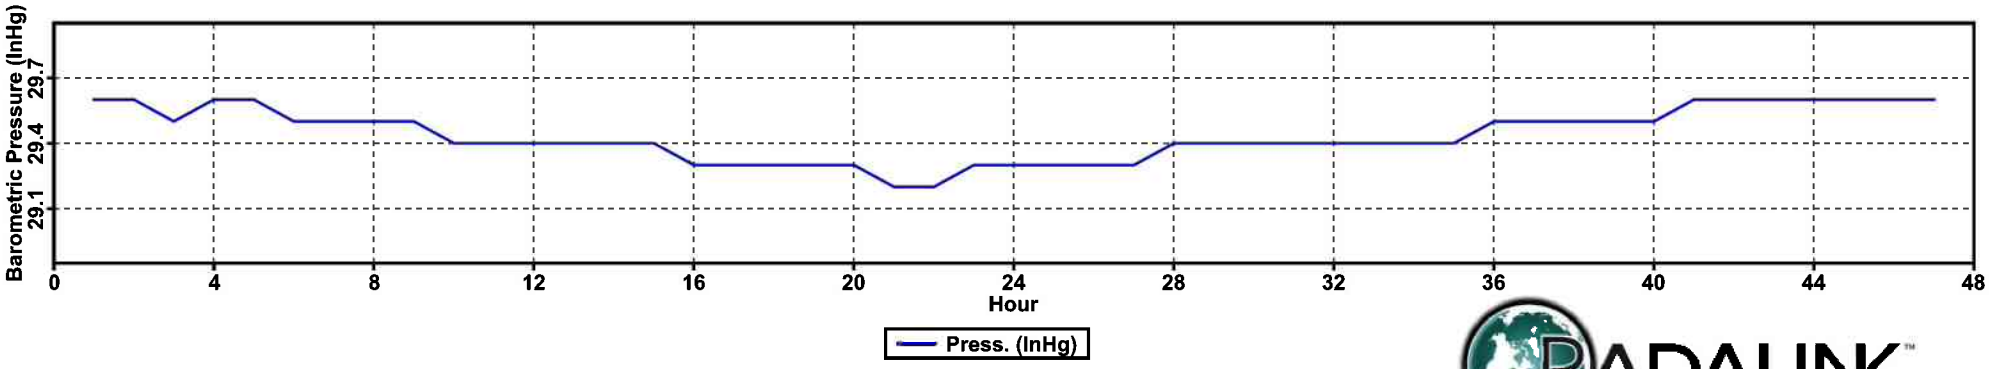
MONITOR-TEST NUMBER: 2245-400

The results of the CRM indicate that radon levels in the S395A Dark Room are below the action level during the workday. The testing was performed during the winter so the testing may be representative of "worst case" conditions.

AVERAGE RADON CONCENTRATION: 2.4 pCi/l

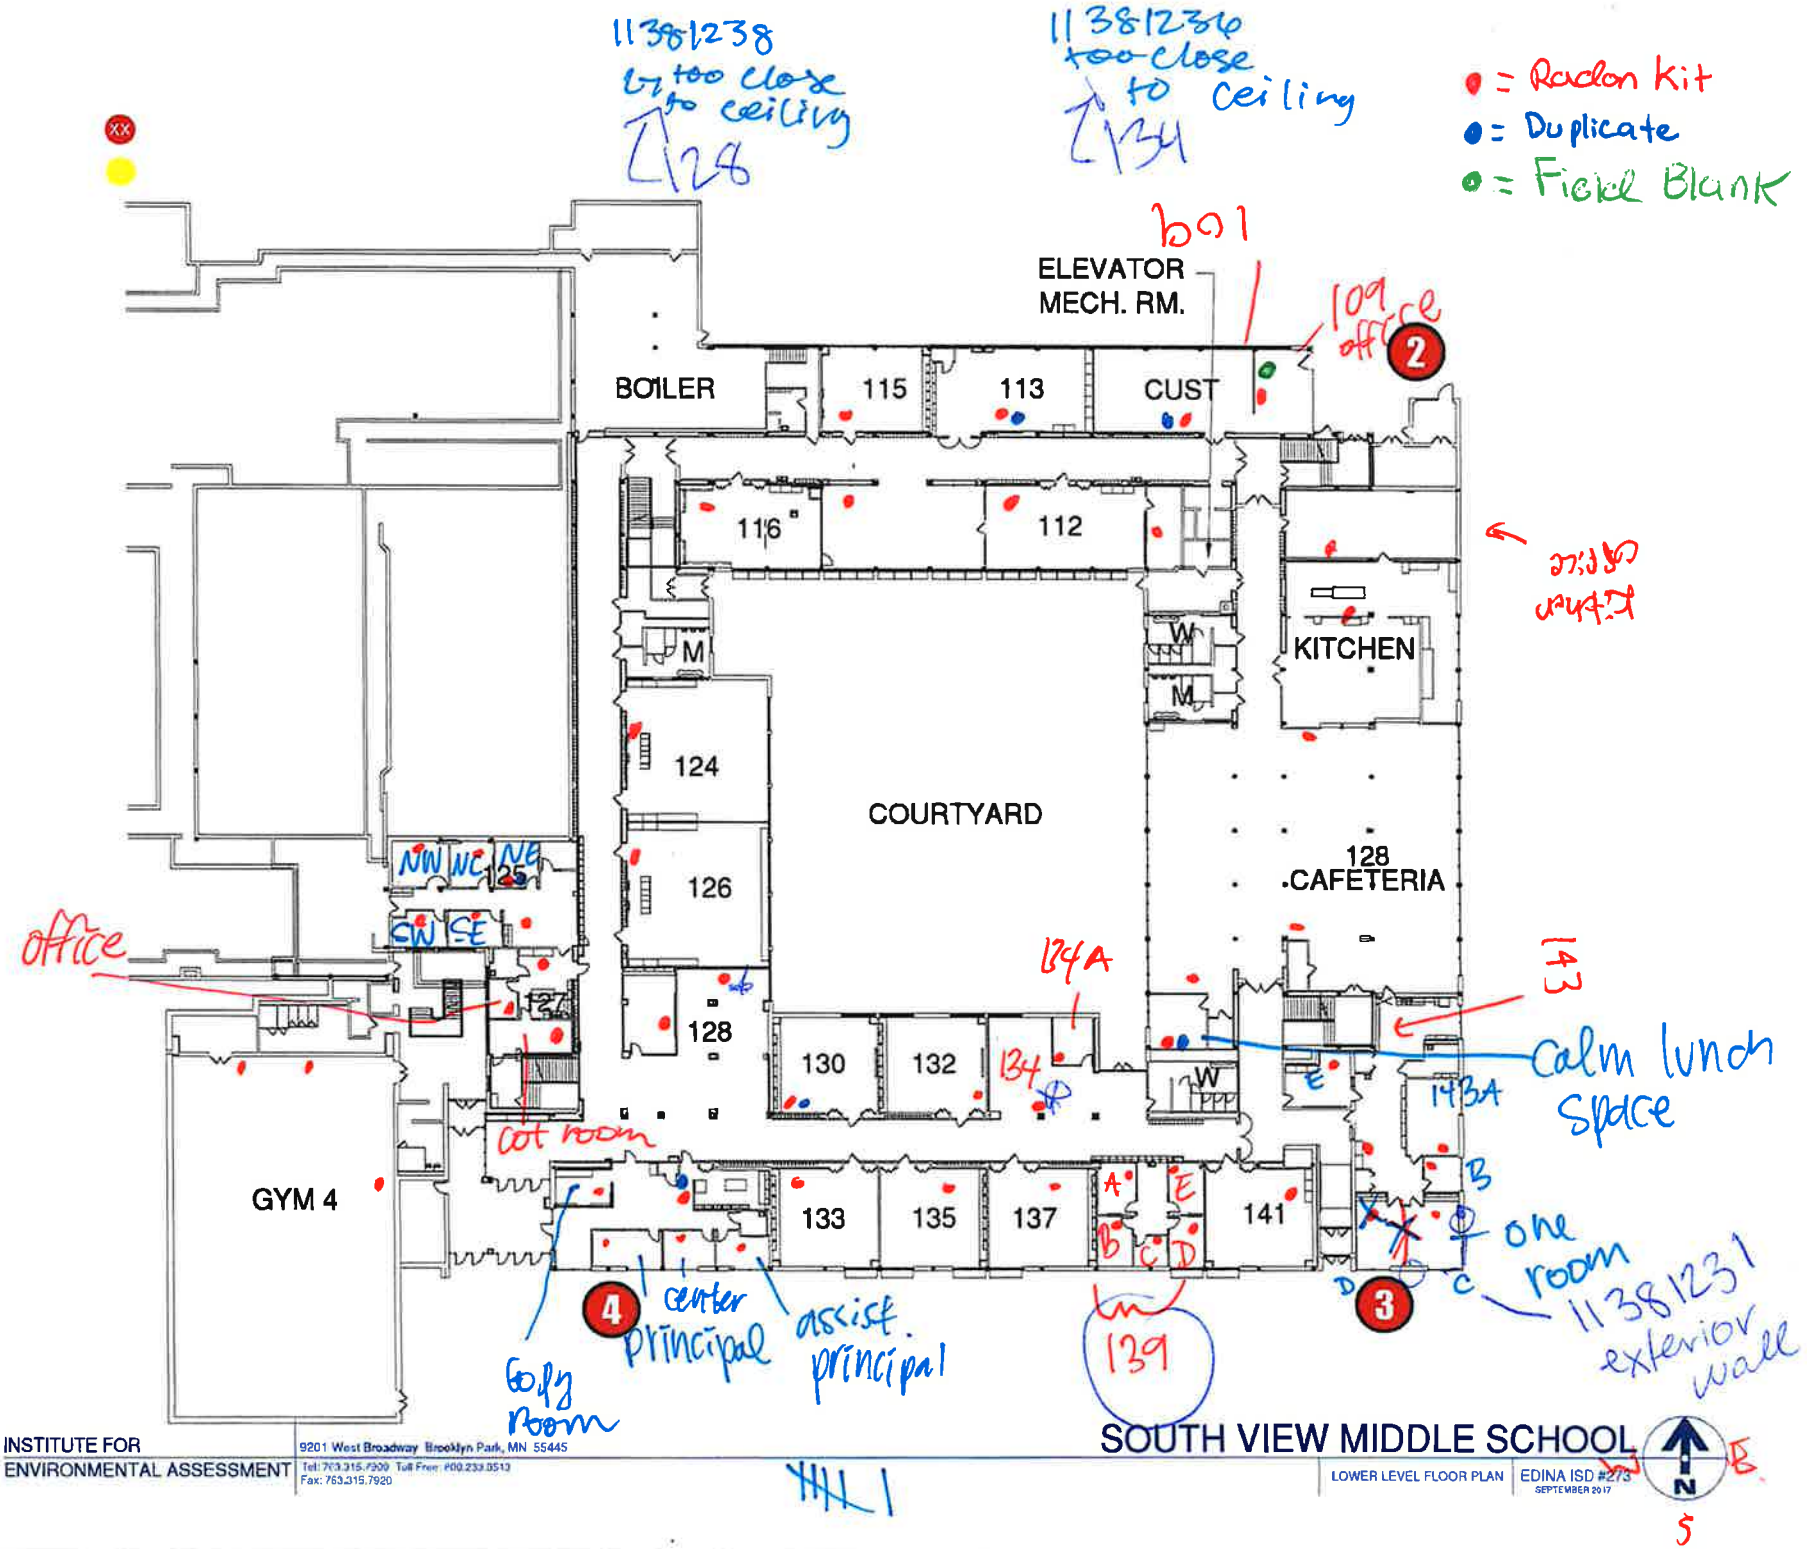
11381238 too close to ceiling
11381236 too close to ceiling
= Radon kit
= Duplicate
= Field Blank
ELEVATOR MECH. RM.
BOILER
115
113
CUST
109 office
116
112
KITCHEN
124
COURTYARD
126
128 CAFETERIA
NW NC NE
SW SE
125
office
127
128
130
132
134
134A
143
143A
Calm lunch space
cot room
GYM 4
133
135
137
141
one room 11381231 exterior wall
4
center principal
assist. principal
139
3
copy room
INSTITUTE FOR ENVIRONMENTAL ASSESSMENT
9201 West Broadway Brooklyn Park, MN 55445
Tel: 763.315.7909 Toll Free: 800.233.0513
Fax: 763.315.7920
SOUTH VIEW MIDDLE SCHOOL
LOWER LEVEL FLOOR PLAN
EDINA ISD #273
SEPTEMBER 2017
N

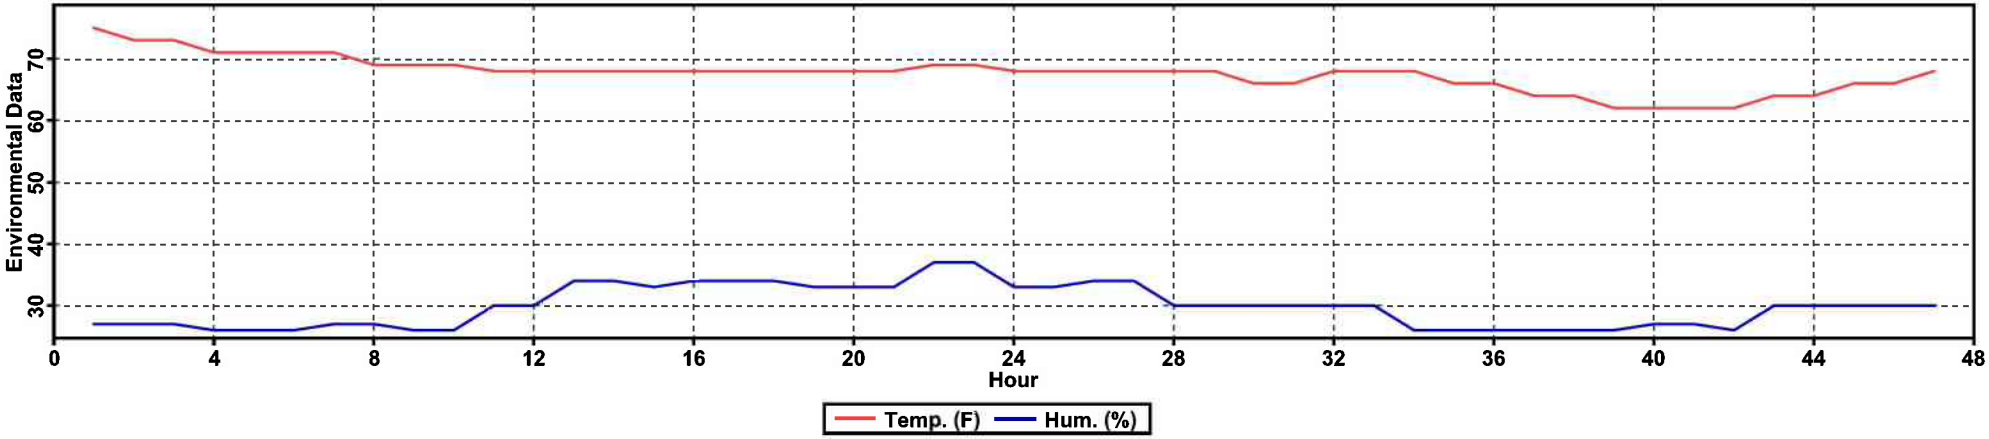
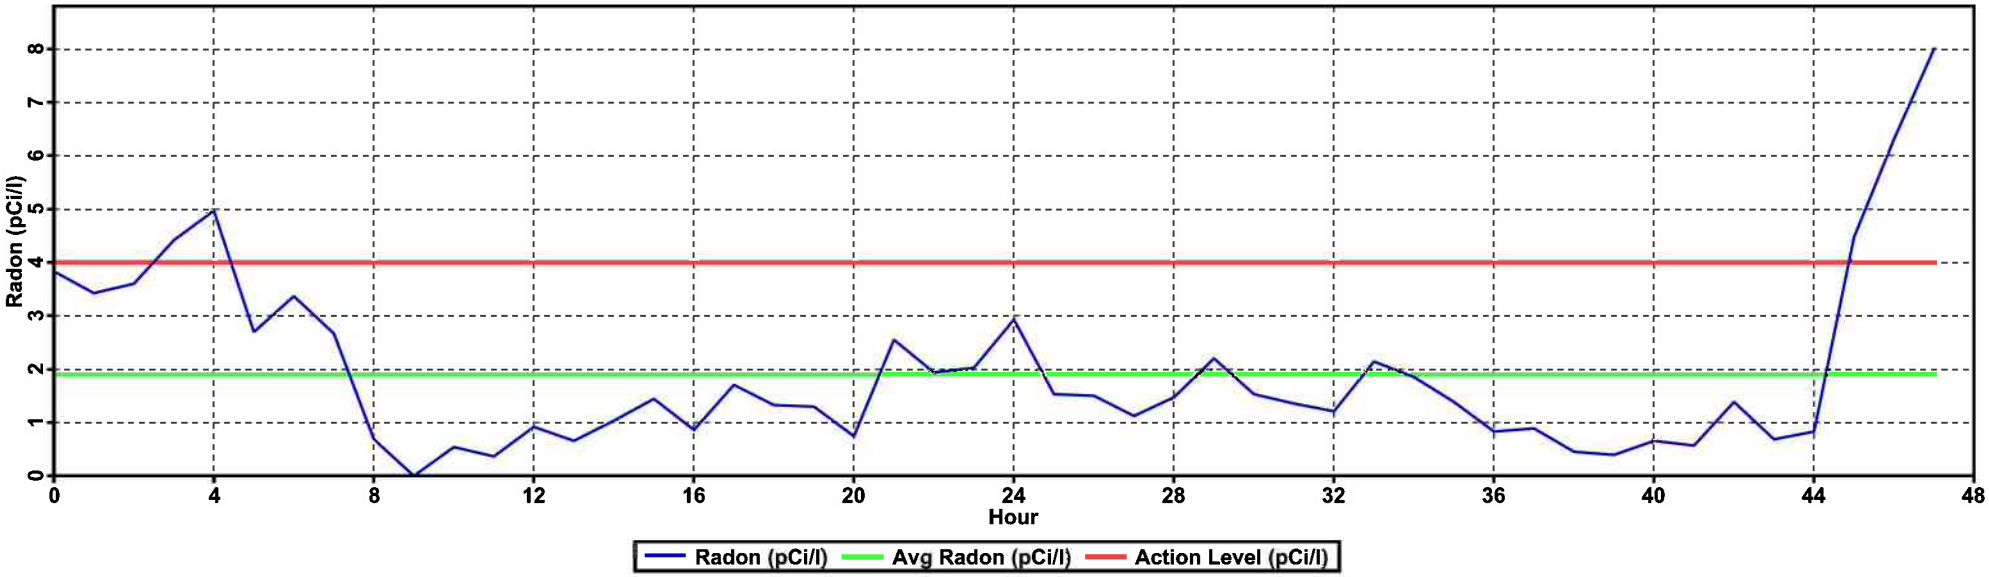
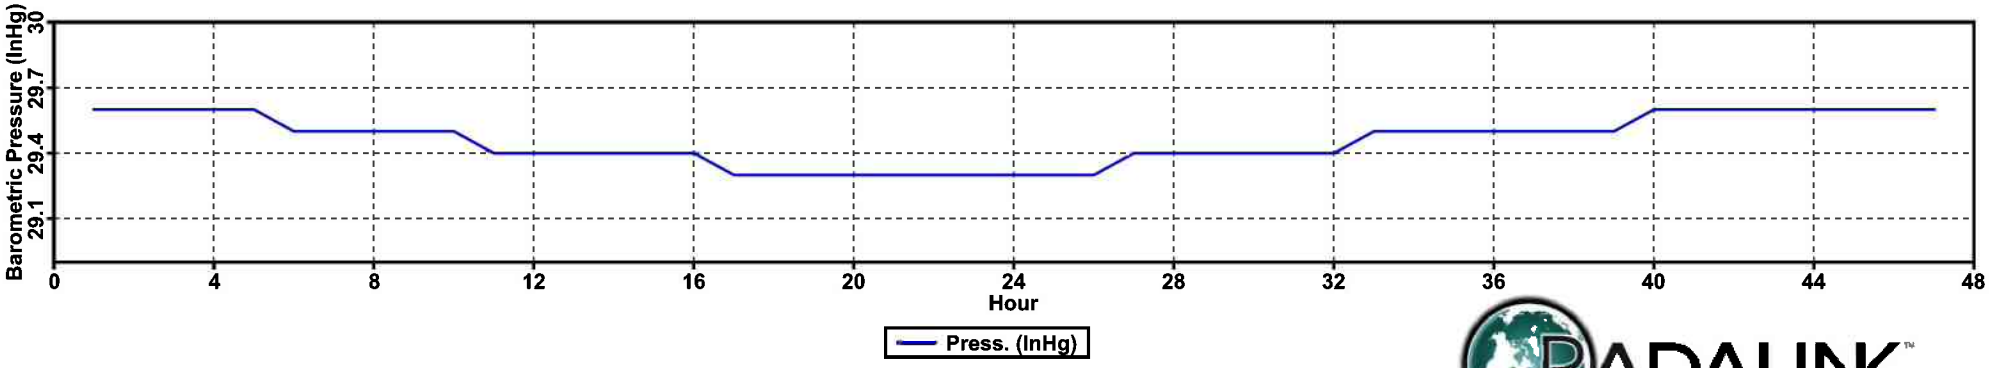
MONITOR-TEST NUMBER: 2368-360

AVERAGE RADON CONCENTRATION: 1.9 pCi/l
