21st January, 2020

**RE: Grouse Creek School Building – Seismic Evaluation** for the existing original portion of the school building located in Grouse Creek, UT.

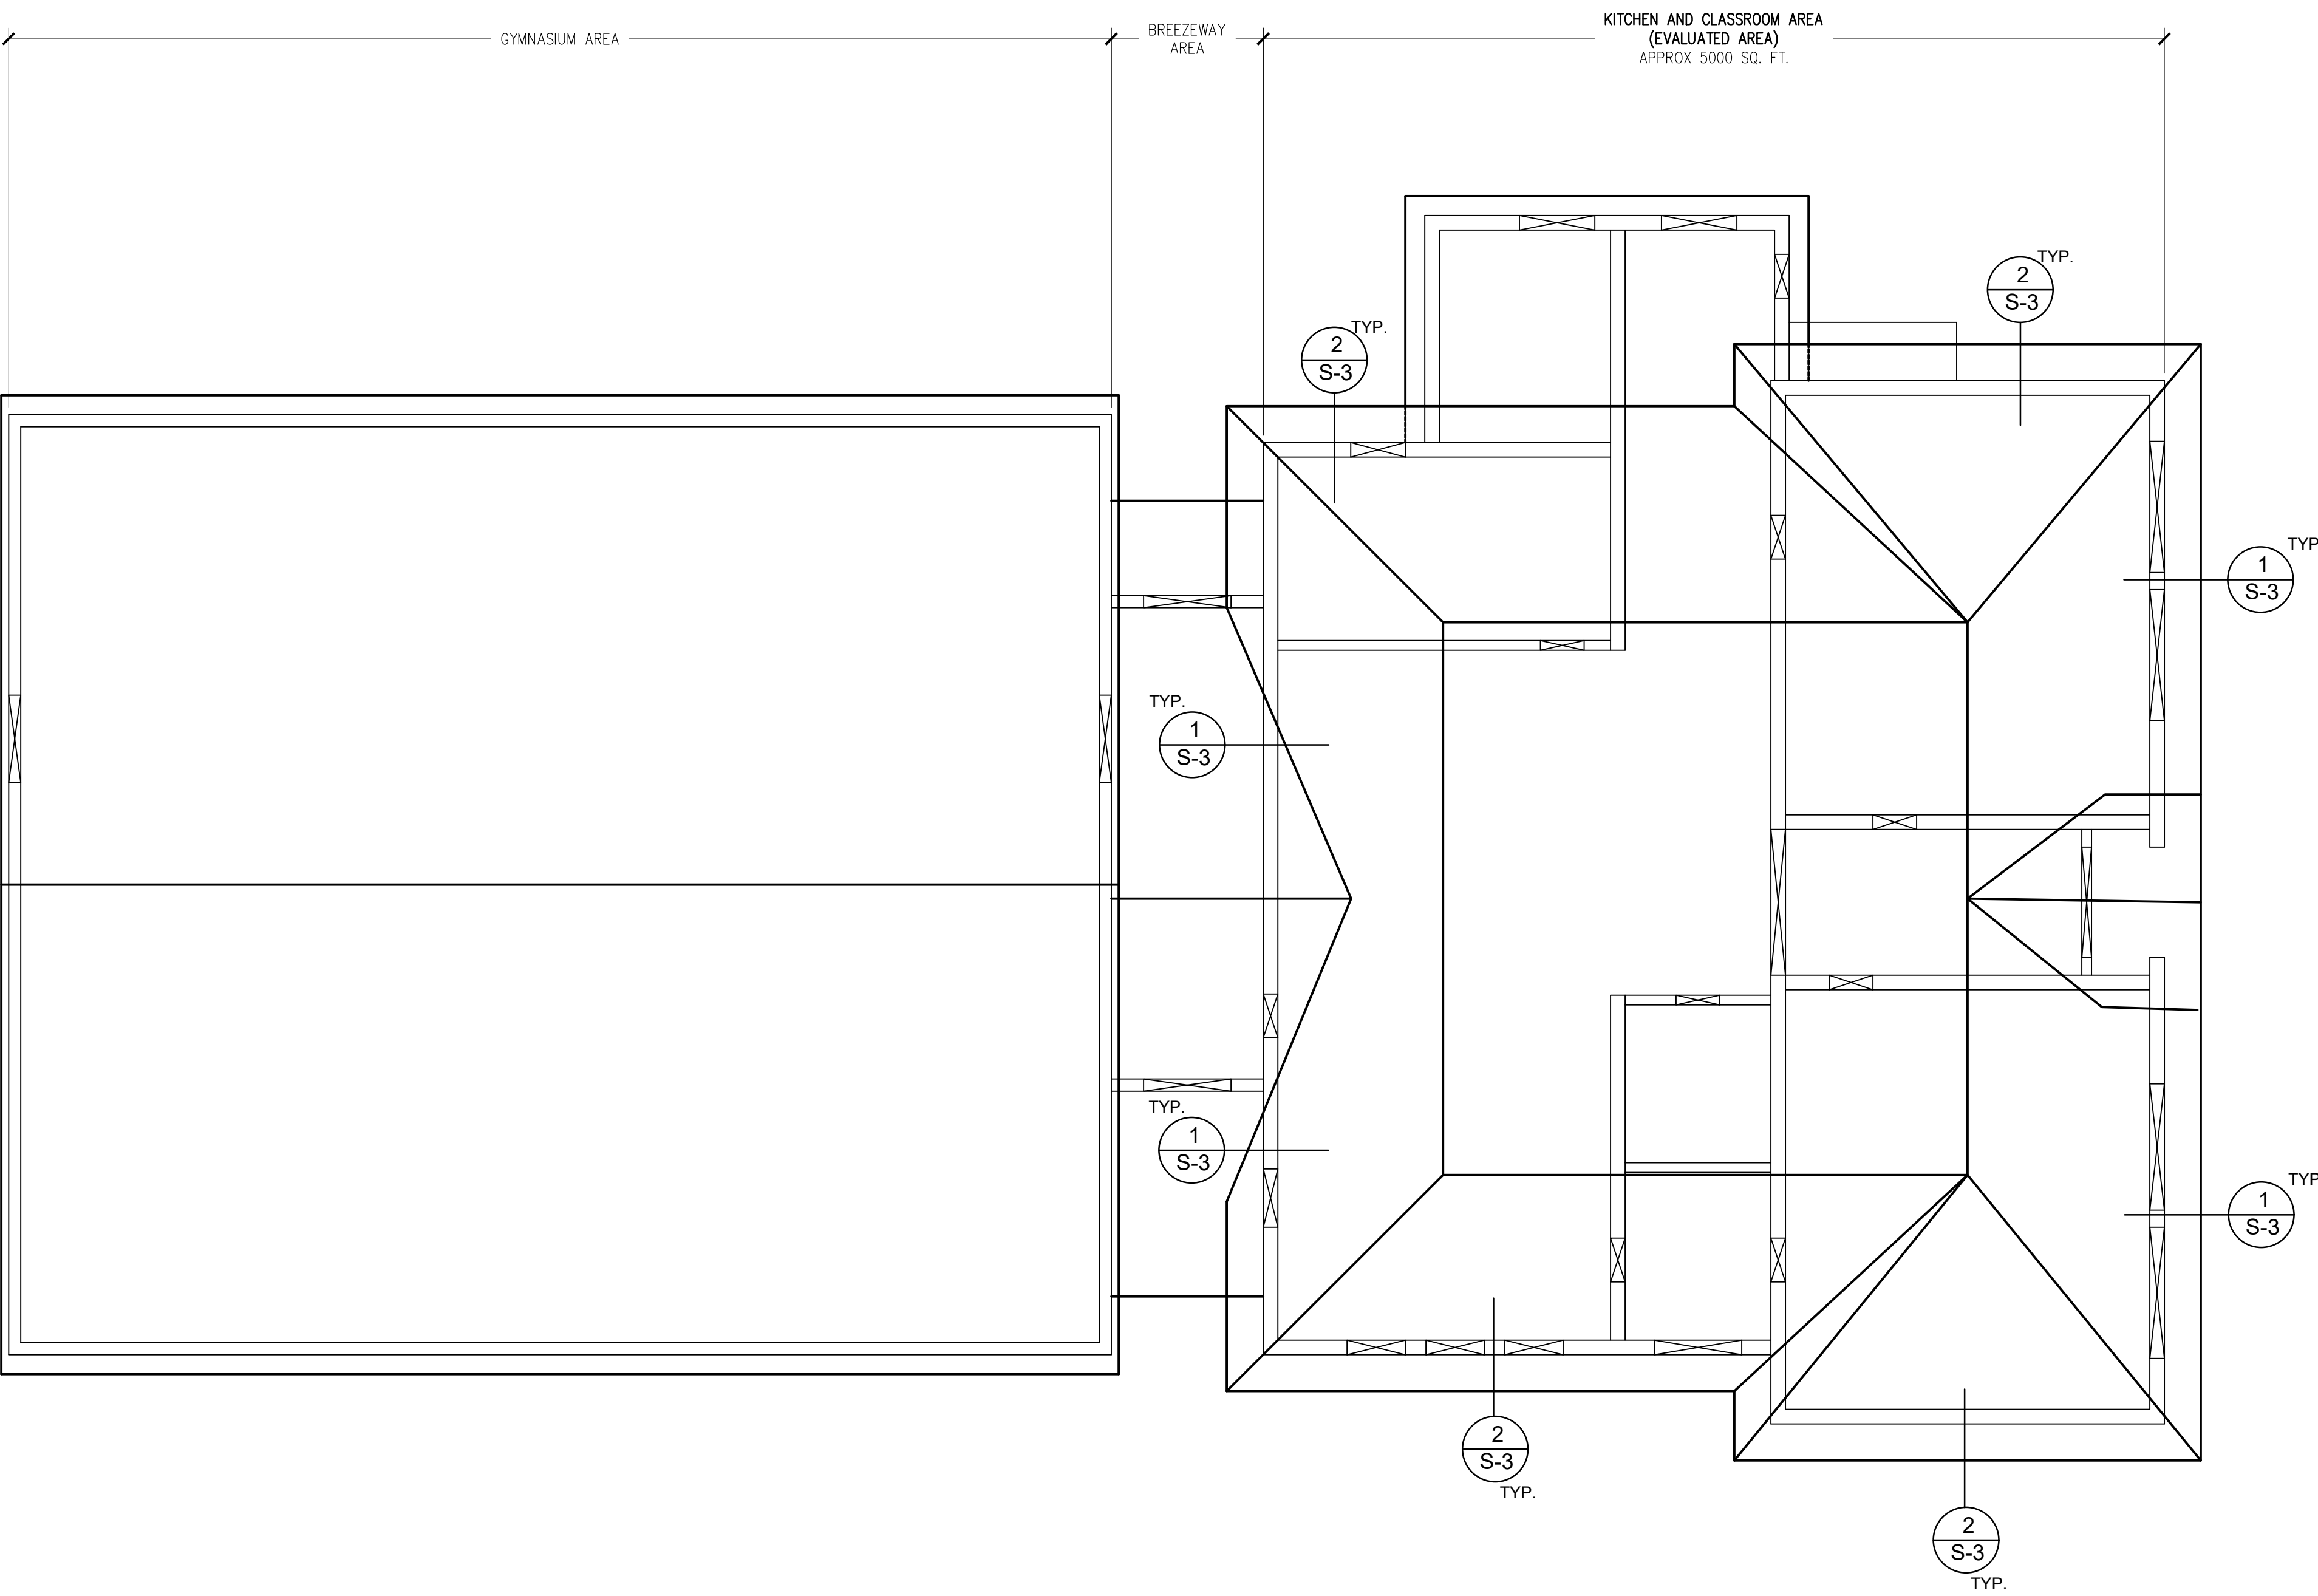
EXISTING BUILDING LAYOUT PLAN  
SCALE: 1/8"

1. **Original School Building** (classrooms & kitchen area) - This portion of the building is a single level, is located on the east end of the building complex, and is constructed of a wood, stick-framed roof, with stick framed ceiling joists (see attached photos). The roof sheathing appears to be 1x wood planking that was sheathed over with Oriented Strand Board (OSB) sheathing in the recent past. The exterior walls, which are also the roof and main floor systems' bearing walls, and two of the main interior walls, are all 12" to 16" thick unreinforced stone walls, which extend down to grade to create stone foundation walls and stone footings. The main floor framing system appears to be 2x wood joists with wood plank decking. We understand this portion of the building was constructed circa 1900. This is the sole area under consideration in this report. See attached "**Existing Building Layout Plan**" sheet.
