**NORTH SLOPE**

**WAINWRIGHT  
AREAWIDE MECHANICAL AND ELECTRICAL  
BUILDING ASSESSMENT AND INVENTORY SURVEY REPORT**

**August 19, 2024**

### ALAK K-12 SCHOOL

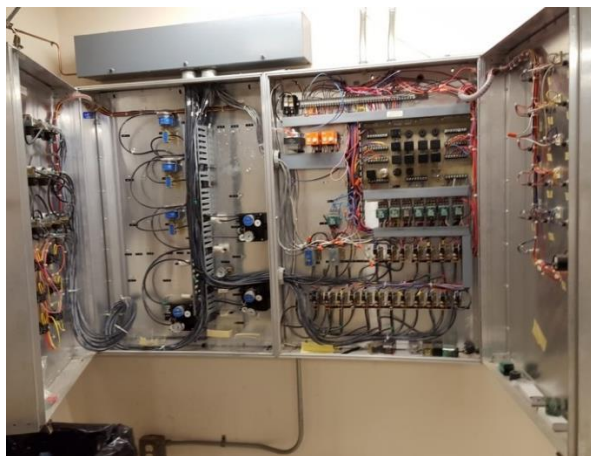
Photo M14 – Typical Pneumatic Control Panel

The control system utilized throughout the building is a combination of pneumatic with some Johnson Controls MetaSys controllers. The pneumatic equipment appears to be in decent condition including tubing and air compressor. The MetaSys controllers are in poor condition. Building control is insufficient. Time clocks are not set correctly. Heating in the building is inconsistent. Many of the space temperature control devices have failed. Given the age of the system the costs of maintaining it will continue to increase due to equipment failure and scarcity of replacement parts. The existing control system should be replaced with a contemporary BACnet based direct digital control (DDC) system for proper environmental control, failure notifications and energy management.

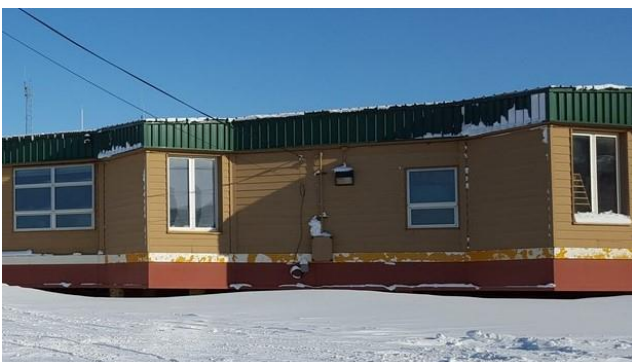
*Photo E1 – Utility Service Entrance*

The school electrical power service is supplied by the utility from a 750kVA pad-mounted transformer located on the Northeast side of the school to the service entrance equipment on the East side (*Photo E2*). The service is fed from below the building to an interior switchgear which houses the 1,200A, 480V, 3p disconnect located in the maintenance building on the east side of School. (*Photo E2*). The main feeder was then routed into a 1,200A, 480V, 4p Automatic Transfer Switch adjacent to the service entrance switch gear. The transfer switch serves a 1,200A, 277/480V, 3p, 4W switchboard 'MDPU' located on the adjacent wall and is fed from a 310kW generator. The 'MDPU' is a Square D QED switchboard. From the 'MDPU' a feeder is routed out of the maintenance building and through the school to an 800A 277/480V, 3p switchboard 'MDPHH' located in the second-floor mechanical room. This panel feeds all 277/480V loads, but also feeds a 300kVA transformer that steps the voltage down to a 1000A, 120/208V, 3p switchboard 'MDPHL'. The distribution section serves all of the normal power panelboards located throughout the facility and has spare capacity for additional breakers.

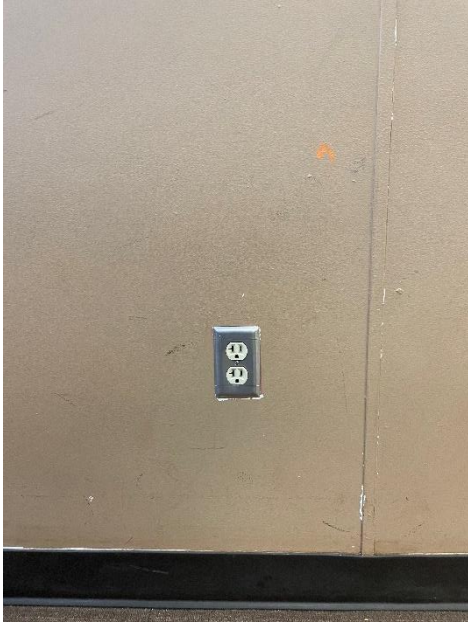
**Photo E4 – Typical Receptacle**

The wiring devices in the facility consisted of ivory Nema 5-20R receptacles and 20A, 120V light switches with stainless steel wallplates (*Photo E4*). In general, the receptacles were in good condition despite the age of the facility. Classrooms have surface raceway, usually above counters, with receptacles, those in general were in OK condition. The kitchen seemed to be lacking receptacles, most of them were taken up by kitchen equipment.

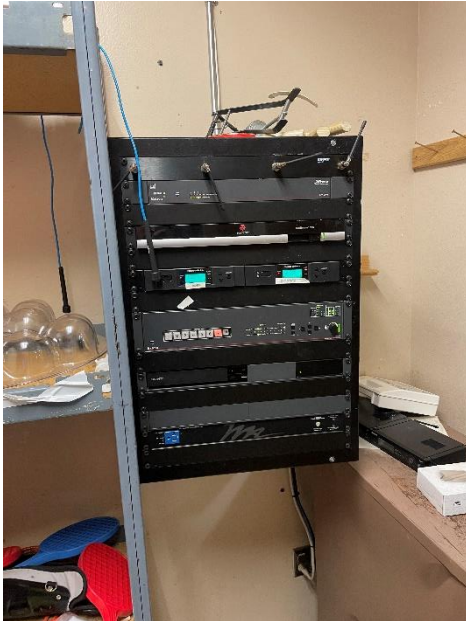
***Photo E12– Gymnasium Sound System***

**The gymnasium sound system was unchanged from the previous inspection. The sound system is in excellent condition and there are no recommendations for this system. (*Photo E12*)**
