Geneva Community Unit School District #304
Operations and Maintenance
7 Year Capital Improvement Plan

January 9, 2017

This report analyzes the existing facilities and their related conditions. It takes a look at the next seven years in which the highest priority needs will be addressed first. These priorities will be based on financial considerations such as cost and efficiencies, condition of existing facilities, code compliance, and the comfort and safety of our buildings. While it is difficult to imagine every possible scenario that our buildings face, I have compiled a comprehensive outlook of the present facilities based on current conditions. This report covers all buildings and grounds the District owns and estimates the funding required to maintain our properties at an optimal teaching and learning environment. Projected costs by building are included in the Appendix. The Seven Year Capital Improvement Plan is intended to provide the information needed to assist the District Board of Education and Administration with the decisions they will face with regard to future financial support of our buildings.

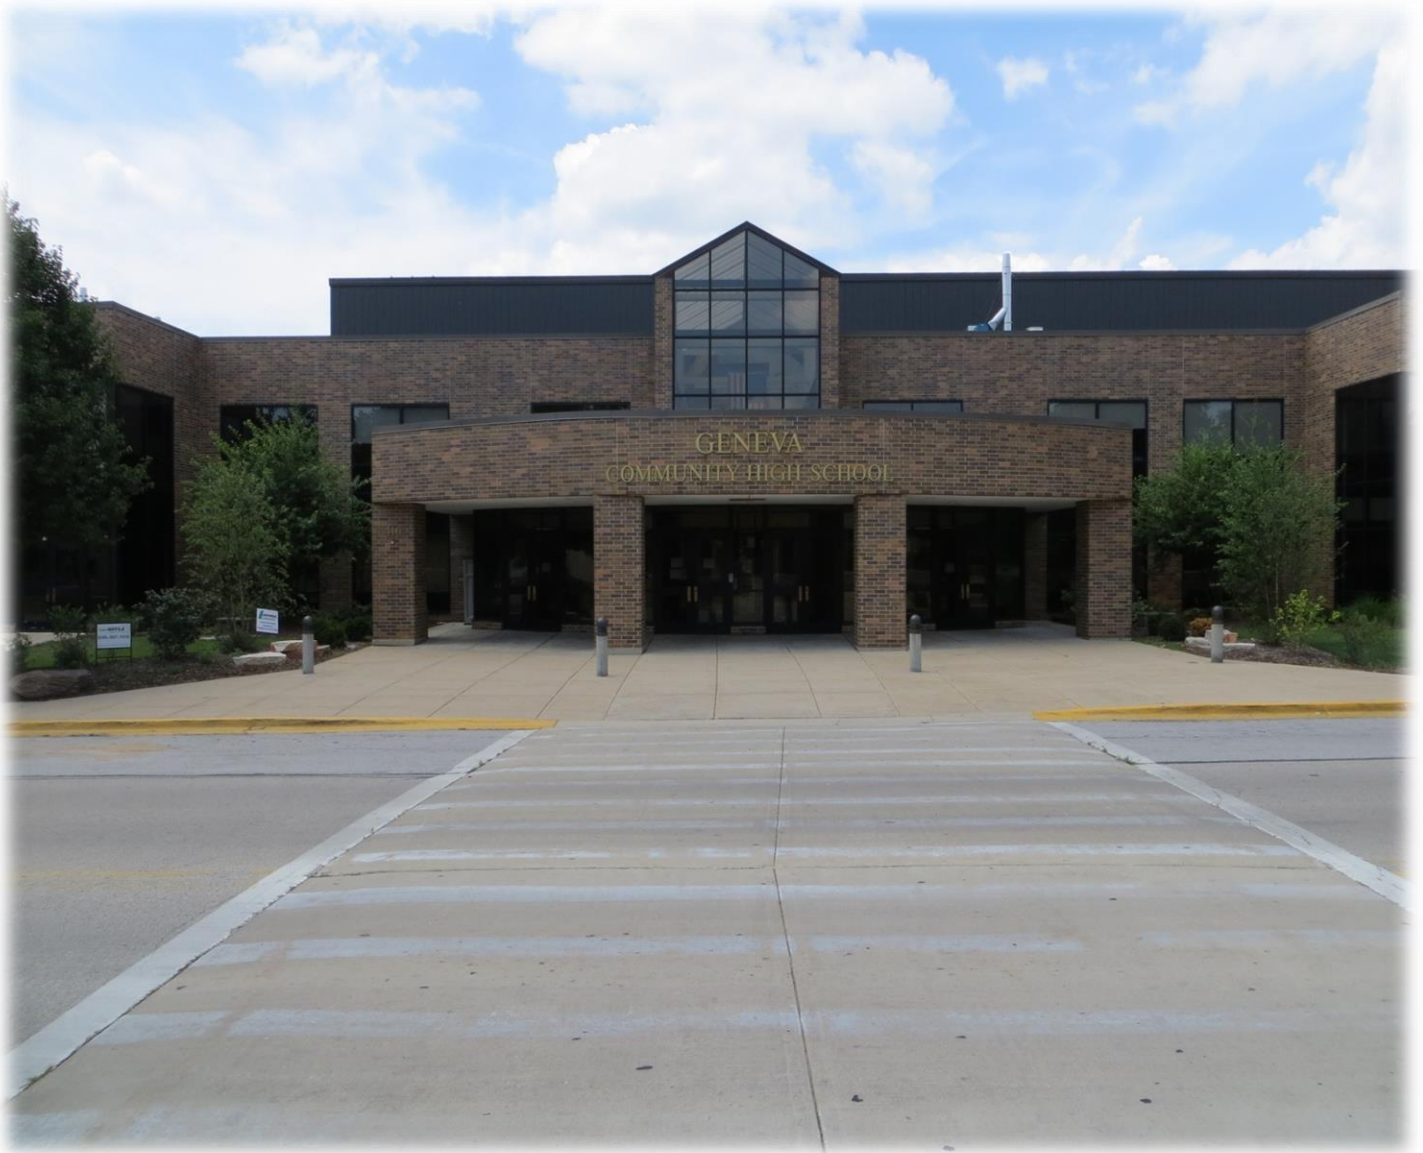
Geneva High School

Several additional capital improvements are needed in the next seven years. The seven **air handlers** that serve the library, Mack Olson Gym, cafeteria, kitchen, auditorium and weight room are all over 42 years old and are in need of updating. Since they all are housed inside the building, the shells of the units are in good condition. We recommend replacing the bearings, shafts and motors to improve reliability and efficiency. Any new equipment will be installed with new **DDC controls** to continue the conversion of the high school from pneumatic controls. The **secondary heating pumps** are nearing the end of their life cycle and need to be replaced. They are in need of upgrading with **variable frequency drives (VFD)** for optimal efficiency. **Flooring** has been an ongoing concern for several years. The existing carpet is at least 17 years old, and in some areas even older. The Fritz quartz tile that was installed in 2000 has not performed well. It is cracking throughout the building and has faded considerably. We are replacing small sections of flooring in phases due to budgeting restrictions. The **stage craft and cafeteria bathrooms** are over 42 years old and showing significant wear. We need to update the bathrooms which would include new flooring, update plumbing, fixtures, sinks and toilets. The **stage and house lighting in the auditorium** is starting to fail and the parts for the lighting panel are becoming obsolete and no longer available. We will need to update the entire lighting system. The **roof on the southwest side** of the building was installed in the 90's and the typical life cycle of a roof is 25 years. The roof will need to be replaced in the next two to three years. The **parking lots** were resurfaced the summer of 2013. Crack filling and seal coating will be needed in the next four to seven years. The **existing galvanized piping** is deteriorating throughout the building and has started leaking in several areas. We will need to replace the old piping with copper piping and provide new ball valves for adequate shut-off. The two **500 gallon PVI hot water heaters** will need to be replaced within the next seven years. The four Kewanee

steam **boilers, installed in 2000, 1967, 2 in 1957**, that supply heat to the high school are inefficient and becoming increasingly costly to maintain. Kewanee stopped manufacturing all boilers and parts in 2001. Over the next several years, there will come a point when we will be unable to locate parts and therefore, we will not be able to repair these boilers. We need to replace the Kewanee boilers with a more efficient boiler system and re-locate this system at the high school. The **heating ventilation and air conditioning (HVAC)** equipment at 301 McKinley maintenance garage is nearing the end of its estimated service life according to ASHRAE. The **tennis courts** are starting to show excessive and deep cracking on the courts. Over the last several years, we have had the courts patched and made suitable for play. We are getting to the point at which patching will no longer be an option and the courts are becoming unsafe. We will need to resurface the tennis courts this year. These costs are shared with the Park District through an Intergovernmental Agreement. **Track resurfacing** will be needed in the next two to five years. The track is starting to show excessive wear and cracking. The estimated life cycle of a track is eight to ten years. An additional **storage shed** will be needed in the athletic area of Burgess Field for gym and athletic storage. The **synthetic turf** has a typical life cycle of eight to twelve years based on usage. We are budgeting over the next several years to have the money available when the renewal maintenance is due.

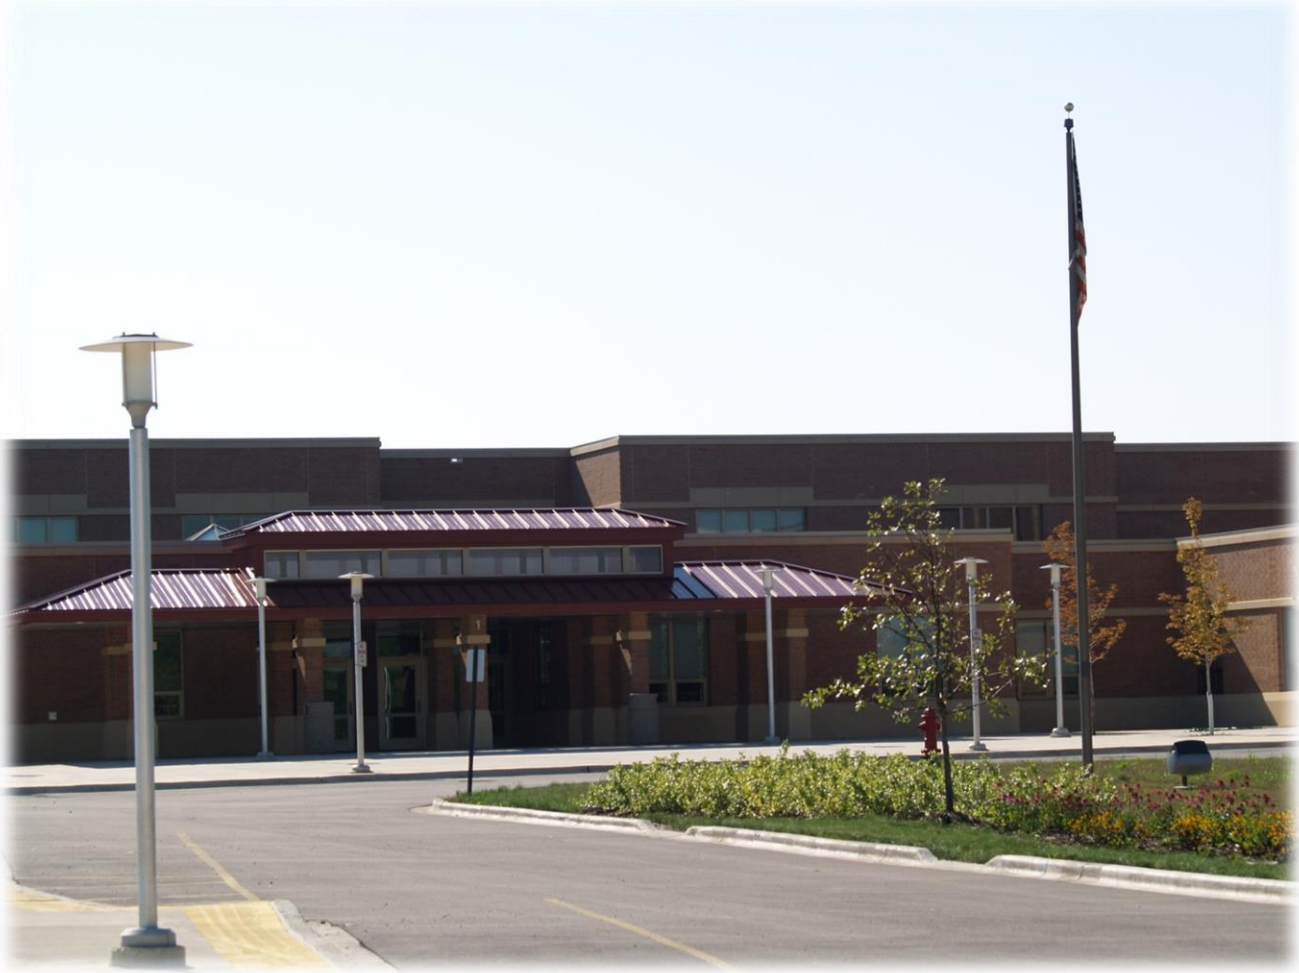
Geneva Middle School North

The existing **Direct Digital Controls** system (Lon) is outdated and costly to repair. It is scheduled to be converted to the ASHRAE standard BACnet control. The **air conditioning system for the IT server room** is oversized for the heat load and continually cycles on and off, causing a condensation issue for that room and premature equipment failure. It is recommended that a smaller tonnage system be installed in conjunction with the current system and if the server size increases as well as the heat load, the existing system will be there to handle the load. Additionally, the **LMC air handling unit** is undersized for cooling when the outside air temperature is above 80 degrees. The airflow needs to be increased and can be done without replacing the entire air handling unit by re-sheaving the pulleys on the shaft, adding four to six more VAV boxes with reheat coils and controls. The typical life cycle of a commercial hot water heater is 12 to 15 years. The two **300 gallon PVI hot water heaters** are original to the building and will need to be replaced within the next seven years. Finally, the **parking lot** will need to be seal coated within the next seven years.

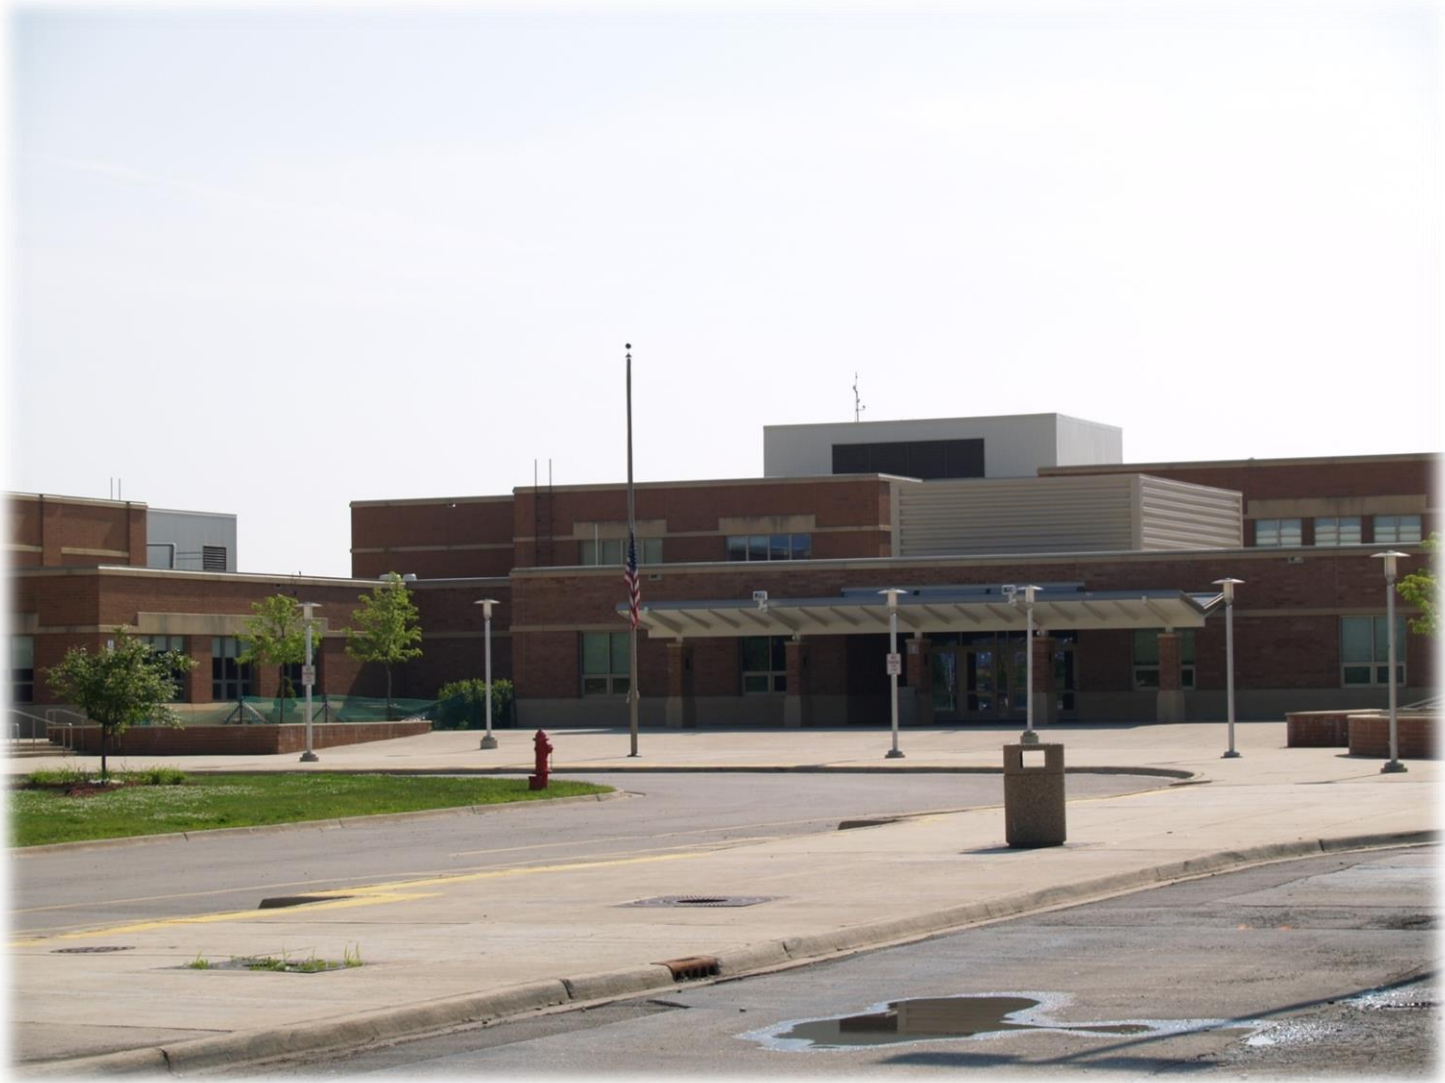
Geneva Middle School South

Additional projects to consider for GMSS. The **contest gym flooring** is showing excessive wear and needs to be resurfaced and sealed. The **stage lighting** in the cafeteria is original to the building, starting to fail and will need to be update within the next three years. The **fire lane** is starting to break down and will need to be resurfaced this year. The **ceiling tile and grid** throughout the building is starting to show signs of wear and discoloration. Replacing the ceiling tile and grid should be completed in sections; we are recommending the first phase to be the main office area, athletic and technology wings. The existing **temperature control** system (Lon) is outdated and costly to repair. It is scheduled to be converted to the ASHRAE standard BACnet control. A new **hot water make-up air unit** needs to replace the gas-fired one for efficiency and freeze protection. Two **air handlers** equipped with **direct expansion (DX) cooling** are in need of cooling upgrades. It is proposed to add a **chiller** for efficiency and reliability, replacing old, inefficient and noisy roof-top DX units. The **Bryan boilers and primary Taco pumps** are original to the building and are nearing the end of their estimated service life according to ASHRAE. They are in need of replacement within the next five to seven years. The **hot water storage tank** is original to the building and will need to be replaced in the next seven years. The **parking lot** was resurfaced the summer of 2013 and will need to be crack filled and seal coated within the next five to seven years.

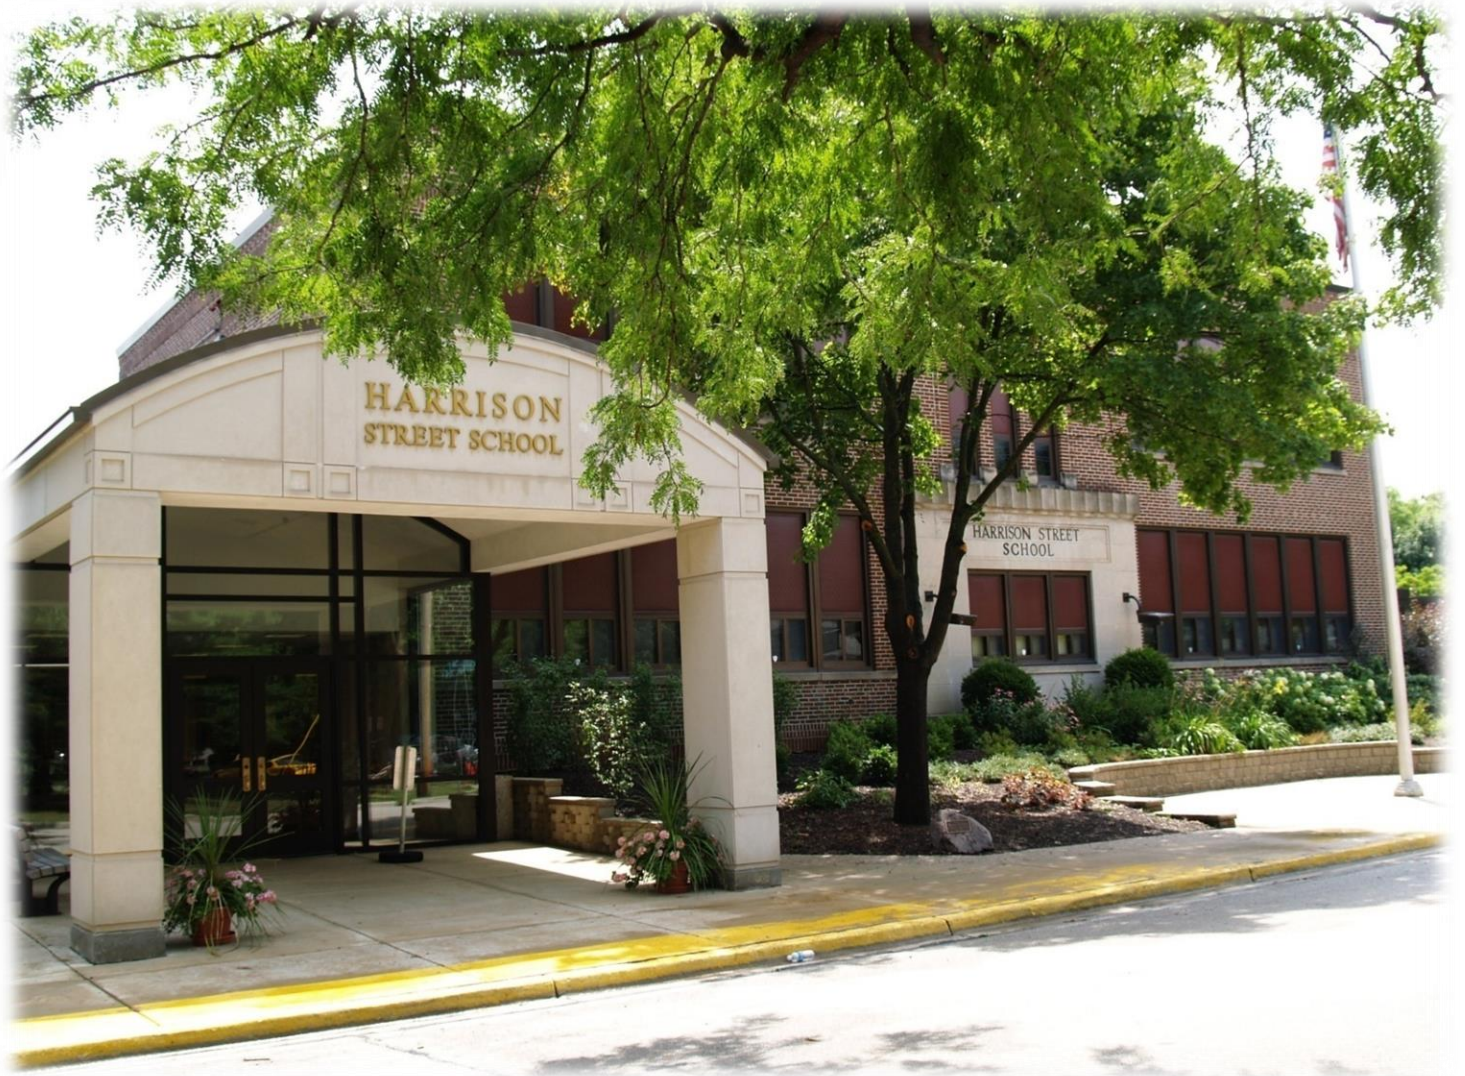
Harrison Street Elementary School

The building is in excellent shape and only in need of a few upgrades. Many of the fifteen **cabinet unit heaters** are older and will need to be replaced as fans fail. Several **air handling units** should either be rebuilt or replaced including the library unit, the art room and the teacher's workroom/conference room area. The **radiant heat** in the glass hallway (kindergarten wing) should be replaced to provide proper heating to that space. The **B&G secondary pumps** were installed in 1999 and are nearing the end of their estimated service life according to ASHRAE. They are in need of replacement for optimal efficiency. The **parking lot** will need to be crack filled and seal coated within the next three to five years.

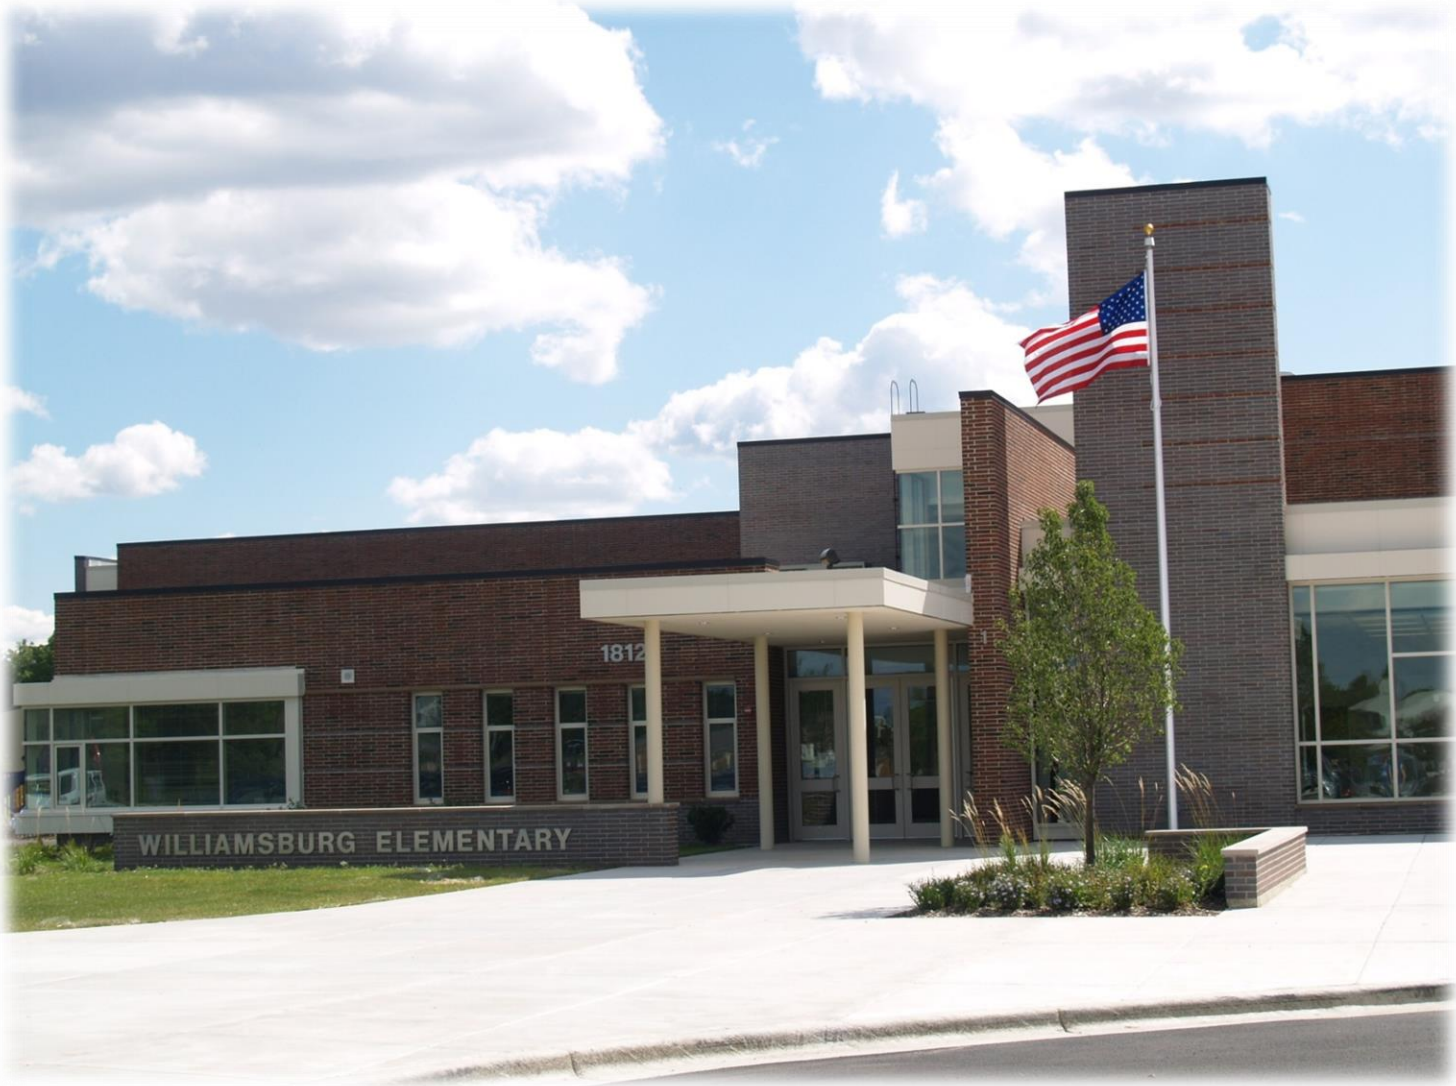
Williamsburg Elementary School

The building is in excellent shape and only the **parking lot** needs to be crack filled and seal coated in the next two to four years.
