## Certificate of Substantial Completion

**PROJECT:** *(name and address)*  
2022-024.PRE - FRANKLIN CUB  
ACADEMY  
1049 Sloan Drive  
Franklin, IN 46131

# Site Visit Construction

## Interior/Exterior Punch List - 7/2/26

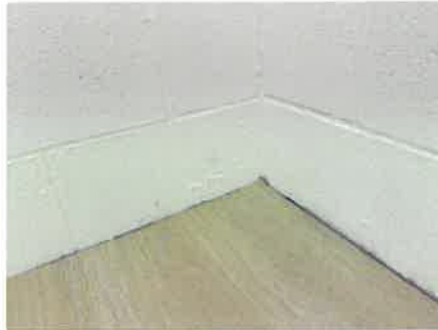
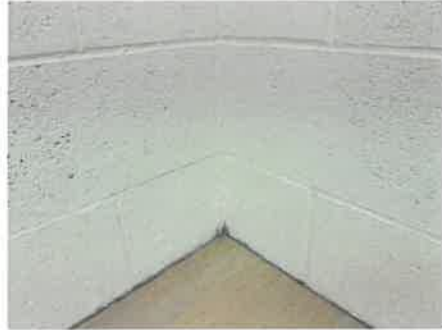
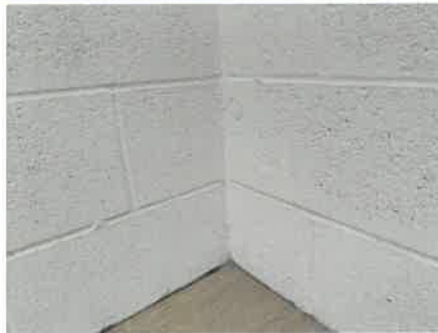
ITEM: 027-008

SUBJECT: General  
REMARKS: Remove concrete splatter on walls in storage rooms  
CATEGORY: Quality

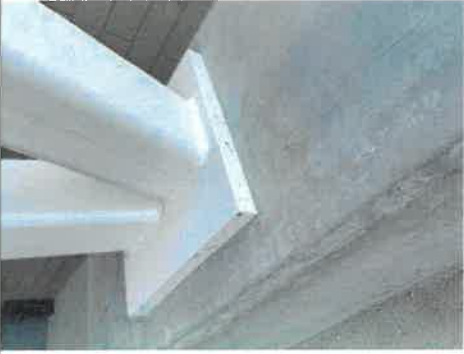
| SPACE NUMBER | SPACE NAME | ELEMENT | LOCATION | DESCRIPTION | STATUS LABEL | ID | SUPPORTING DOCS |
|---|---|---|---|---|---|---|---|
| | N/A | Exterior | | Touch up paint on column | Open | 0000<br>1 | |

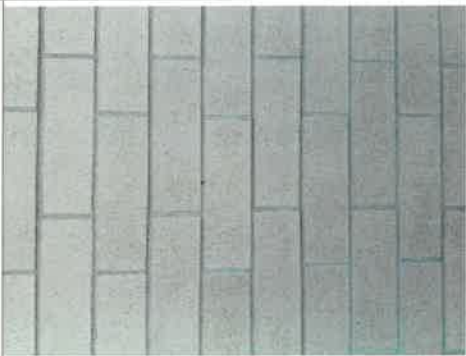
| SPACE NUMBER | SPACE NAME | ELEMENT | LOCATION | DESCRIPTION | STATUS LABEL | ID | SUPPORTING DOCS |
|---|---|---|---|---|---|---|---|
| | N/A | Exterior | | Fill hole on west side | Open | 00009 | |

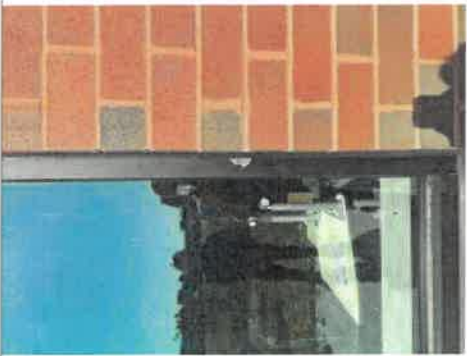
| SPACE NUMBER | SPACE NAME | ELEMENT | LOCATION | DESCRIPTION | STATUS LABEL | ID | SUPPORTING DOCS |
|---|---|---|---|---|---|---|---|
| | N/A | Exterior | | Finish coming off windows SE corner | Open | 00010 | |

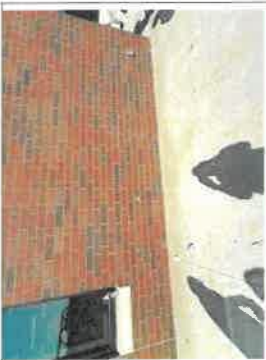
| SPACE NUMBER | SPACE NAME | ELEMENT | LOCATION | DESCRIPTION | STATUS LABEL | ID | SUPPORTING DOCS |
|---|---|---|---|---|---|---|---|
| | N/A | Exterior | | Remove concrete on brick | Open | 0001<br>1 | |

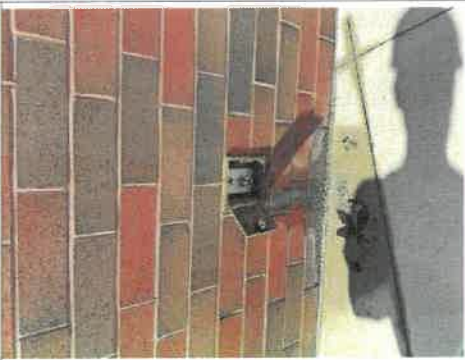
| SPACE NUMBER | SPACE NAME | ELEMENT | LOCATION | DESCRIPTION | STATUS LABEL | ID | SUPPORTING DOCS |
|---|---|---|---|---|---|---|---|
| | N/A | Exterior | | Caulk hose bib | Open | 0001<br>2 | |

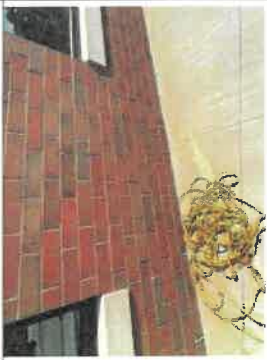
| SPACE NUMBER | SPACE NAME | ELEMENT | LOCATION | DESCRIPTION | STATUS LABEL | ID | SUPPORTING DOCS |
|---|---|---|---|---|---|---|---|
| | N/A | Exterior | | Infill mortar at brick near playground | Open | 0001<br>3 | |

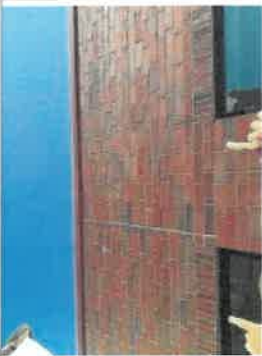
| SPACE NUMBER | SPACE NAME | ELEMENT | LOCATION | DESCRIPTION | STATUS LABEL | ID | SUPPORTING DOCS |
|---|---|---|---|---|---|---|---|
| | N/A | Exterior | | Clean brick and attach coping to cleat | Open | 0001 4 | |

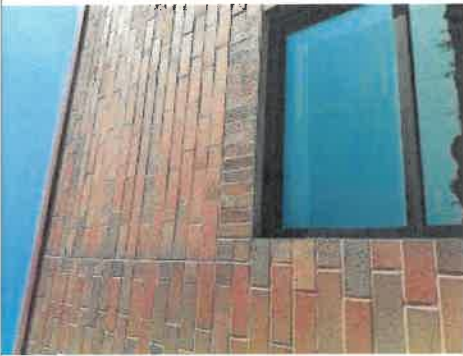
| SPACE NUMBER | SPACE NAME | ELEMENT | LOCATION | DESCRIPTION | STATUS LABEL | ID | SUPPORTING DOCS |
|---|---|---|---|---|---|---|---|
| | N/A | Exterior | | Connect control joints to lentle at multiple locations | Open | 0001 5 | |

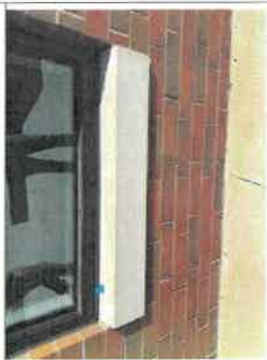
| SPACE NUMBER | SPACE NAME | ELEMENT | LOCATION | DESCRIPTION | STATUS LABEL | ID | SUPPORTING DOCS |
|---|---|---|---|---|---|---|---|
| | N/A | Exterior | | Touch up scratches on window frames | Open | 0001<br>6 | |

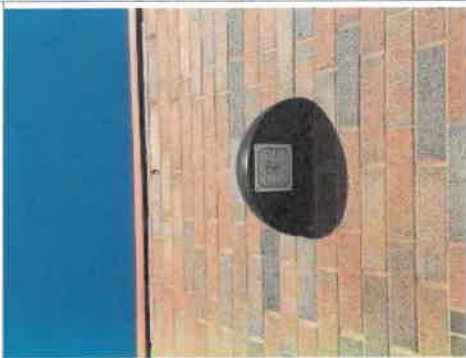
| SPACE NUMBER | SPACE NAME | ELEMENT | LOCATION | DESCRIPTION | STATUS LABEL | ID | SUPPORTING DOCS |
|---|---|---|---|---|---|---|---|
| | N/A | Exterior | | Fix weep at Northeast corner building | Open | 00018 | |

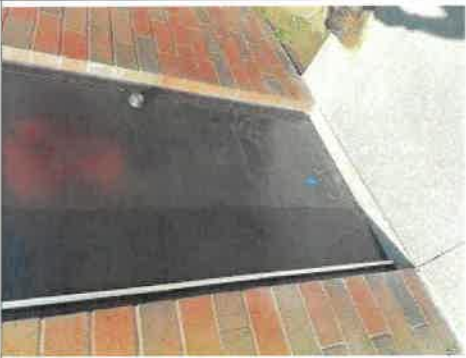
| SPACE NUMBER | SPACE NAME | ELEMENT | LOCATION | DESCRIPTION | STATUS LABEL | ID | SUPPORTING DOCS |
|---|---|---|---|---|---|---|---|
| | N/A | Exterior | | Touchup paint on exterior door Northeast corner building | Open | 00019 | |

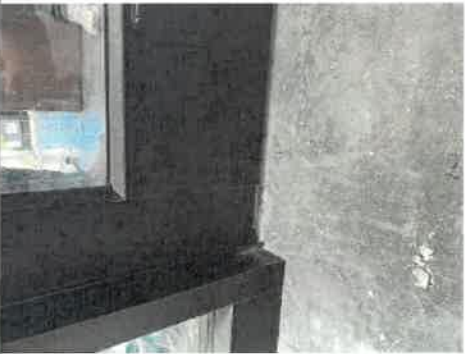
| SPACE NUMBER | SPACE NAME | ELEMENT | LOCATION | DESCRIPTION | STATUS LABEL | ID | SUPPORTING DOCS |
|---|---|---|---|---|---|---|---|
| | N/A | Vestibule V100 | | Door should not have notch at bottom | Open | 0002<br>3 | |

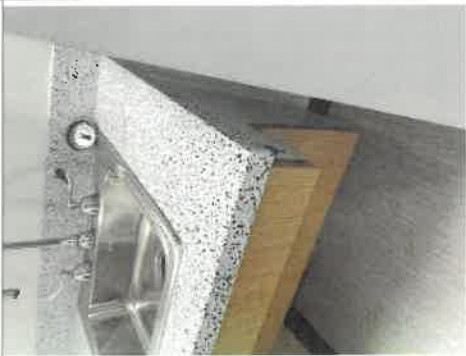
| SPACE NUMBER | SPACE NAME | ELEMENT | LOCATION | DESCRIPTION | STATUS LABEL | ID | SUPPORTING DOCS |
|---|---|---|---|---|---|---|---|
| | N/A | Clinic A111 | | Install end panel on casework | Open | 0002 4 | |

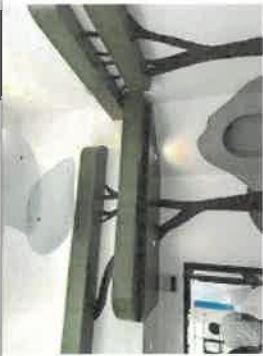
| SPACE NUMBER | SPACE NAME | ELEMENT | LOCATION | DESCRIPTION | STATUS LABEL | ID | SUPPORTING DOCS |
|---|---|---|---|---|---|---|---|
| | N/A | General Office Waiting V101 | | Bulkhead not flush with ceiling | Open | 0002 5 | |

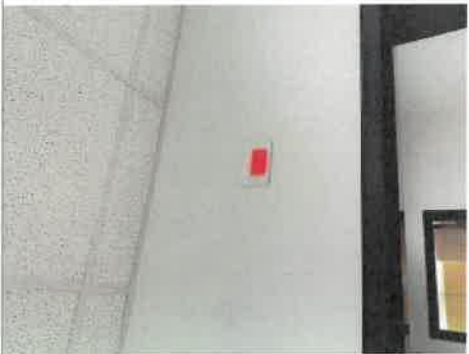
| SPACE NUMBER | SPACE NAME | ELEMENT | LOCATION | DESCRIPTION | STATUS LABEL | ID | SUPPORTING DOCS |
|---|---|---|---|---|---|---|---|
| | N/A | B107 Classroom | | Occupied light doesn't turn off in restroom | Open | 0002<br>6 | |

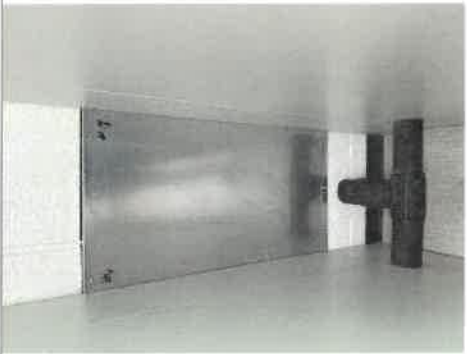
| SPACE NUMBER | SPACE NAME | ELEMENT | LOCATION | DESCRIPTION | STATUS LABEL | ID | SUPPORTING DOCS |
|---|---|---|---|---|---|---|---|
| | N/A | General | | Screws at louvers need to be cut flush | Open | 0002<br>7 | |

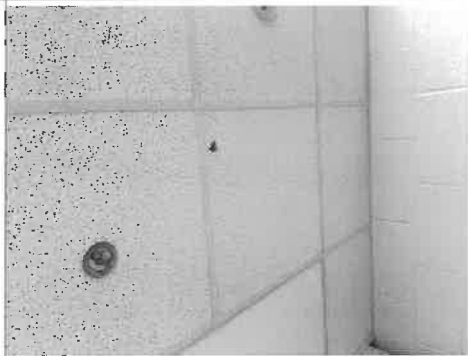
| SPACE NUMBER | SPACE NAME | ELEMENT | LOCATION | DESCRIPTION | STATUS LABEL | ID | SUPPORTING DOCS |
|---|---|---|---|---|---|---|---|
| | N/A | Storage C112A | | Hole in ceiling tile | Open | 0002<br>8 | |

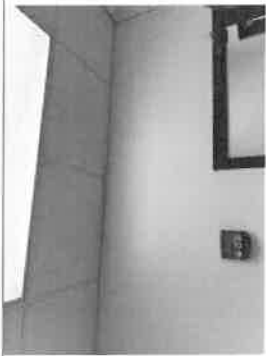
| SPACE NUMBER | SPACE NAME | ELEMENT | LOCATION | DESCRIPTION | STATUS LABEL | ID | SUPPORTING DOCS |
|---|---|---|---|---|---|---|---|
| | N/A | Family Restroom C153 | | Touch up paint and drywall mud | Open | 0002<br>9 | |

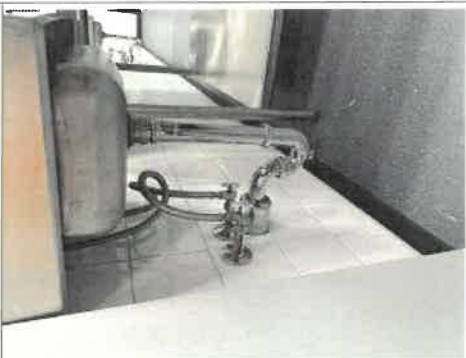
| SPACE NUMBER | SPACE NAME | ELEMENT | LOCATION | DESCRIPTION | STATUS LABEL | ID | SUPPORTING DOCS |
|---|---|---|---|---|---|---|---|
| | N/A | Kitchen C103 | | Install scald guards and pipe insulation | Open | 0003<br>3 | |

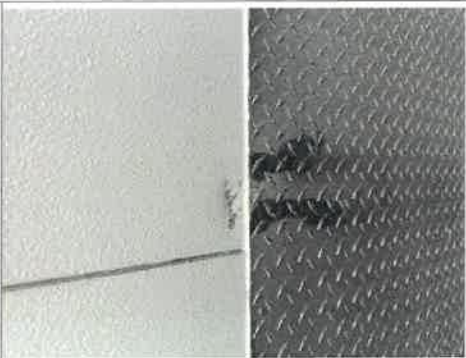
| SPACE NUMBER | SPACE NAME | ELEMENT | LOCATION | DESCRIPTION | STATUS LABEL | ID | SUPPORTING DOCS |
|---|---|---|---|---|---|---|---|
| | N/A | Kitchen C103 | | Dents on freezer/cooler | Open | 0003<br>4 | |

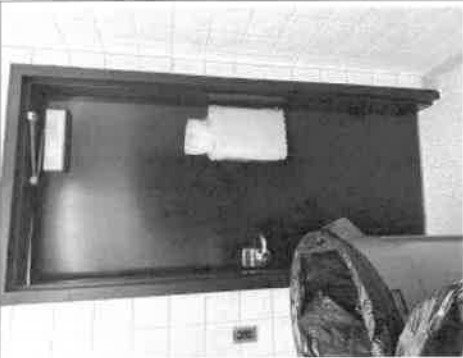
| SPACE NUMBER | SPACE NAME | ELEMENT | LOCATION | DESCRIPTION | STATUS LABEL | ID | SUPPORTING DOCS |
|---|---|---|---|---|---|---|---|
| | N/A | Restroom C103C | | Door needs adjusted and painted | Open | 0003<br>5 | |

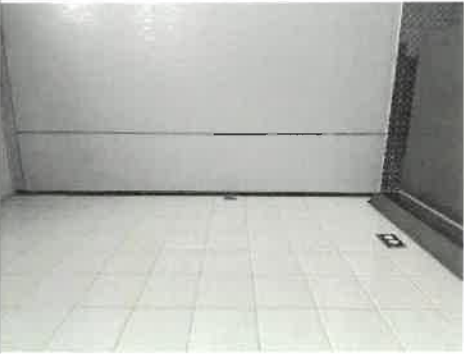
| SPACE NUMBER | SPACE NAME | ELEMENT | LOCATION | DESCRIPTION | STATUS LABEL | ID | SUPPORTING DOCS |
|---|---|---|---|---|---|---|---|
| | N/A | Kitchen C103 | | Caulk joint at freezer/cooler | Open | 0003<br>8 | |

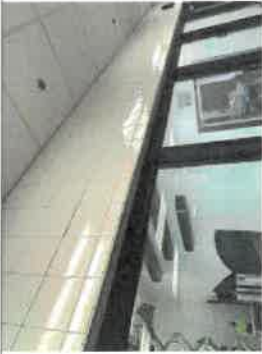
| SPACE NUMBER | SPACE NAME | ELEMENT | LOCATION | DESCRIPTION | STATUS LABEL | ID | SUPPORTING DOCS |
|---|---|---|---|---|---|---|---|
| | N/A | Kitchen C103 | | Touch up and paint drywall at serving line | Open | 0003<br>9 | |

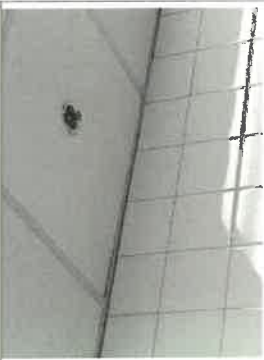
| SPACE NUMBER | SPACE NAME | ELEMENT | LOCATION | DESCRIPTION | STATUS LABEL | ID | SUPPORTING DOCS |
|---|---|---|---|---|---|---|---|
| | N/A | Kitchen C103 | | Caulk tile at ceiling | Open | 00040 | |

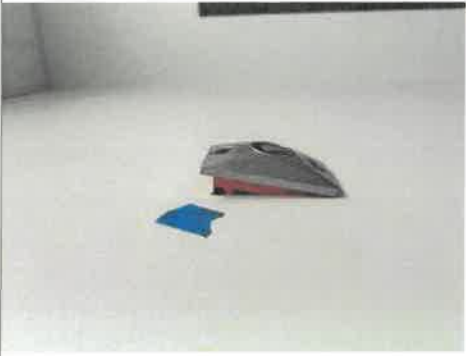
| SPACE NUMBER | SPACE NAME | ELEMENT | LOCATION | DESCRIPTION | STATUS LABEL | ID | SUPPORTING DOCS |
|---|---|---|---|---|---|---|---|
| | N/A | Handwashing C150 | | Mag hold open boxes are not secured with blocking | Open | 00048 | |

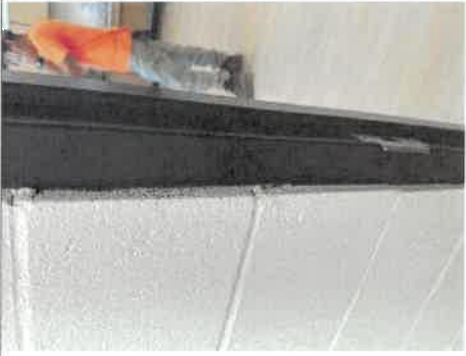
| SPACE NUMBER | SPACE NAME | ELEMENT | LOCATION | DESCRIPTION | STATUS LABEL | ID | SUPPORTING DOCS |
|---|---|---|---|---|---|---|---|
| | N/A | Storage C112A | | Caulk door frame to wall | Open | 00049 | |

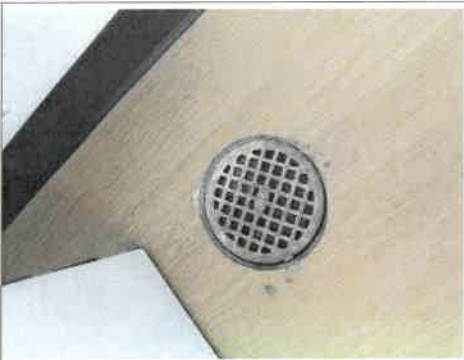
| SPACE NUMBER | SPACE NAME | ELEMENT | LOCATION | DESCRIPTION | STATUS LABEL | ID | SUPPORTING DOCS |
|---|---|---|---|---|---|---|---|
| | N/A | Workroom C112 | | Clean out floor drain | Open | 00050 | |

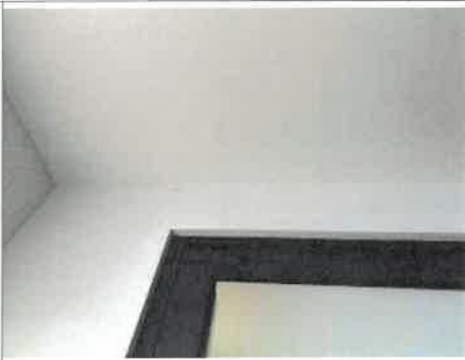
| SPACE NUMBER | SPACE NAME | ELEMENT | LOCATION | DESCRIPTION | STATUS LABEL | ID | SUPPORTING DOCS |
|---|---|---|---|---|---|---|---|
| | N/A | Vestibule V103 | | Drywall not finish sanded | Open | 00051 | |

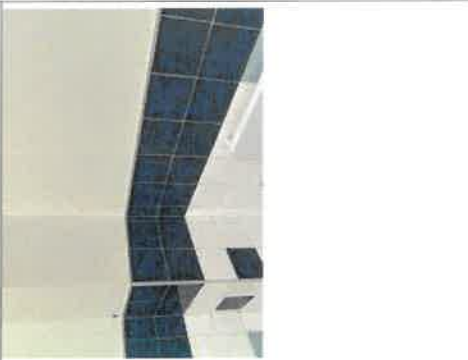
| SPACE NUMBER | SPACE NAME | ELEMENT | LOCATION | DESCRIPTION | STATUS LABEL | ID | SUPPORTING DOCS |
|---|---|---|---|---|---|---|---|
| | N/A | Family Restroom C154 | | Drywall not finish sanded | Open | 0005<br>2 | |

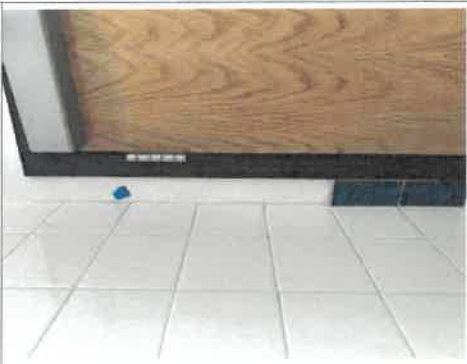
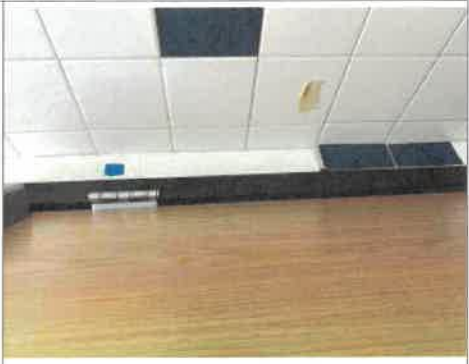
| SPACE NUMBER | SPACE NAME | ELEMENT | LOCATION | DESCRIPTION | STATUS LABEL | ID | SUPPORTING DOCS |
|---|---|---|---|---|---|---|---|
| | N/A | Family Restroom C153 | | Touch up drywall/paint | Open | 0005<br>3 | |

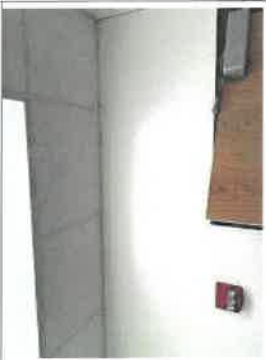
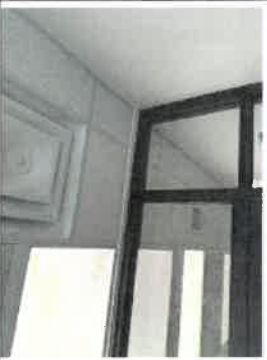
| SPACE NUMBER | SPACE NAME | ELEMENT | LOCATION | DESCRIPTION | STATUS LABEL | ID | SUPPORTING DOCS |
|---|---|---|---|---|---|---|---|
| | N/A | Vestibule V104 | | Touch up drywall/paint | Open | 0005 4 | |

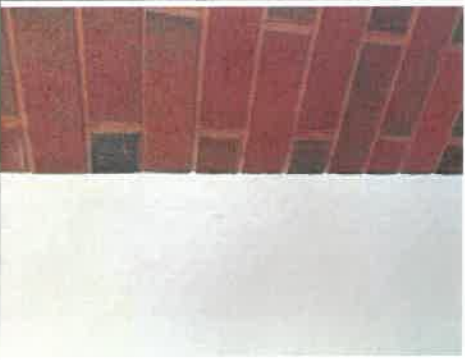
| SPACE NUMBER | SPACE NAME | ELEMENT | LOCATION | DESCRIPTION | STATUS LABEL | ID | SUPPORTING DOCS |
|---|---|---|---|---|---|---|---|
| | N/A | Vestibule V104 | | Drywall should sit back from Face of brick | Open | 0005 5 | |

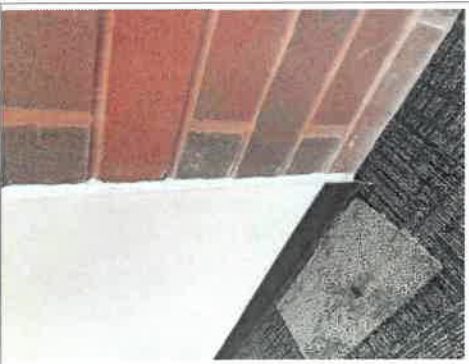
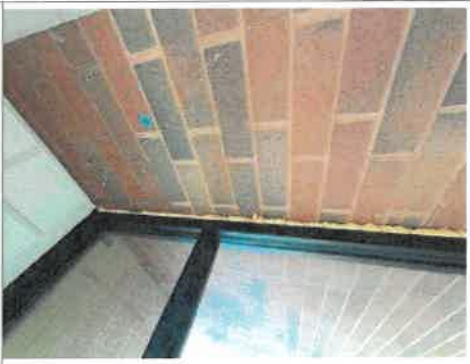
| SPACE NUMBER | SPACE NAME | ELEMENT | LOCATION | DESCRIPTION | STATUS LABEL | ID | SUPPORTING DOCS |
|---|---|---|---|---|---|---|---|
| | N/A | Vestibule V104 | | Cut spray foam back and caulk storefront | Open | 0005<br>6 | |

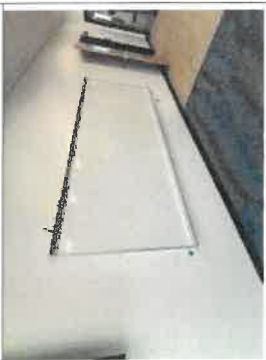
| SPACE NUMBER | SPACE NAME | ELEMENT | LOCATION | DESCRIPTION | STATUS LABEL | ID | SUPPORTING DOCS |
|---|---|---|---|---|---|---|---|
| | N/A | Classroom D105 | | Touch up drywall/paint | Open | 00058 | |

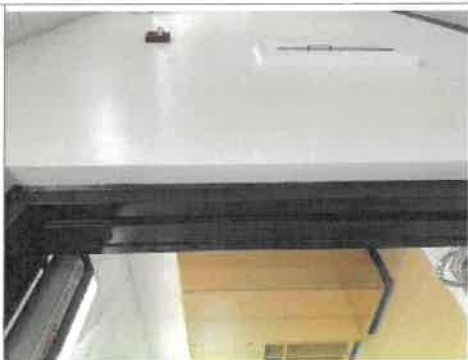
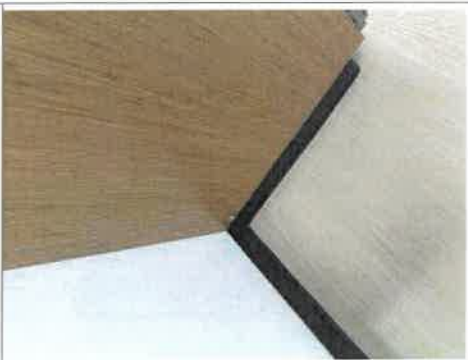
| SPACE NUMBER | SPACE NAME | ELEMENT | LOCATION | DESCRIPTION | STATUS LABEL | ID | SUPPORTING DOCS |
|---|---|---|---|---|---|---|---|
| | N/A | Classroom D104 | | Remove paint on casework | Open | 0006<br>1 | |

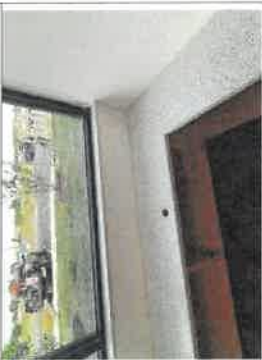
| SPACE NUMBER | SPACE NAME | ELEMENT | LOCATION | DESCRIPTION | STATUS LABEL | ID | SUPPORTING DOCS |
|---|---|---|---|---|---|---|---|
| | N/A | Classroom D104 | | Touch up paint | Open | 0006<br>2 | |

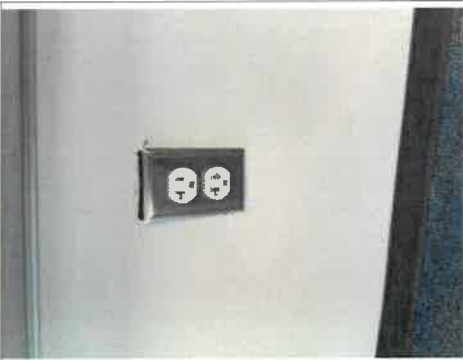
| SPACE NUMBER | SPACE NAME | ELEMENT | LOCATION | DESCRIPTION | STATUS LABEL | ID | SUPPORTING DOCS |
|---|---|---|---|---|---|---|---|
| | N/A | Classroom D104 | | Fix receptacle | Open | 0006<br>3 | |

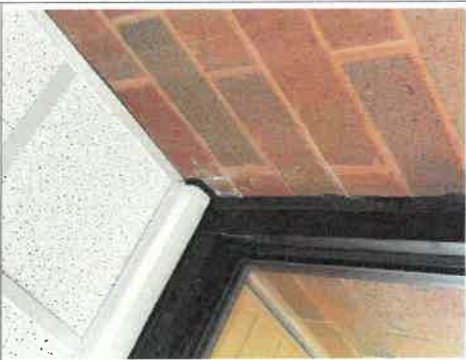
| SPACE NUMBER | SPACE NAME | ELEMENT | LOCATION | DESCRIPTION | STATUS LABEL | ID | SUPPORTING DOCS |
|---|---|---|---|---|---|---|---|
| | N/A | Vestibule V102 | | Touch up caulk | Open | 0006<br>6 | |

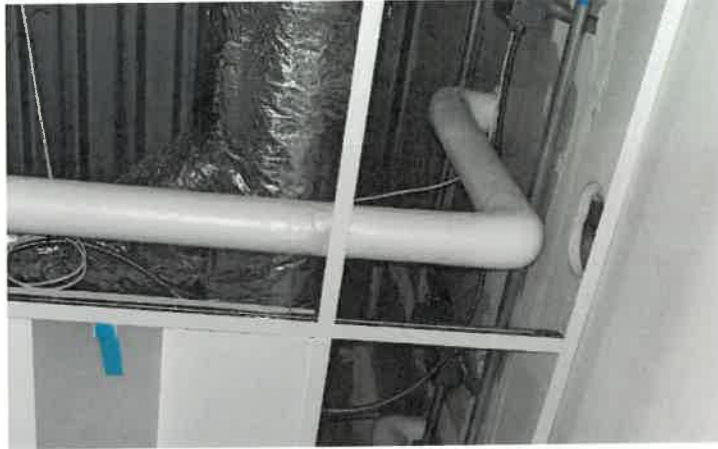
- Overall routing of piping is as indicated on plan, although a handful piping were installed close to ceiling grid. The contractor shall confirm that ceiling tiles can be removed and reinstalled.

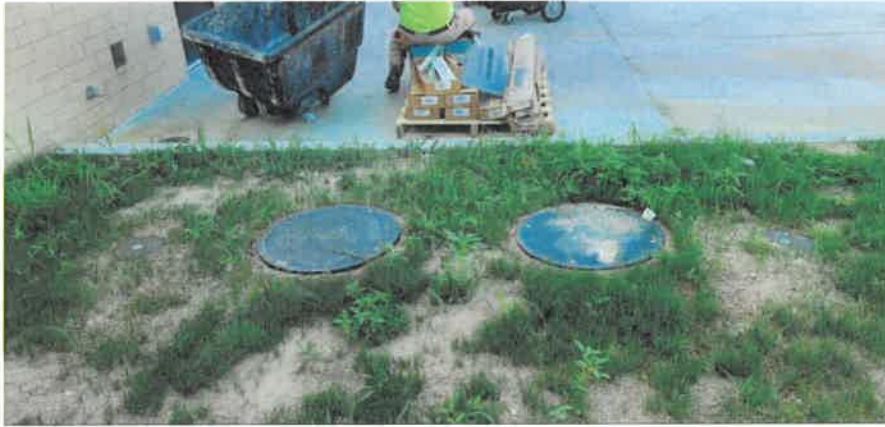
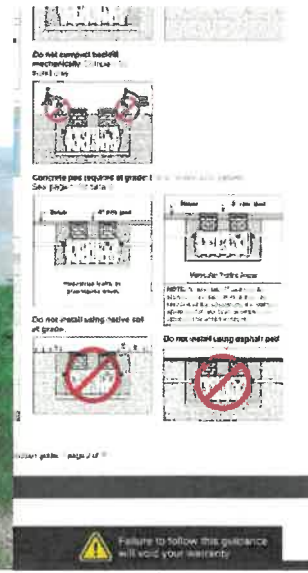
- i.
  - h. Construction debris was observed on multiple fixtures. Contractor shall clear all fixtures of construction debris.
  - i. Throughout – Piping and equipment is missing pipe labeling and equipment tagging as required by specifications.
2. The grease interceptor is not installed as per manufacturers installation requirements and is missing a concrete pad at grade. Install traffic rated lids on grease interceptor manholes.

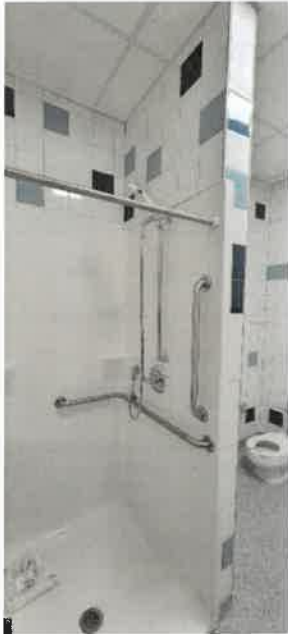
- a.  
10. SH-1 installed is not compliant with specified fixture as scheduled in RFI #004.  
Contractor shall install fixture as scheduled.
