Facilities Management Services

Facility Improvement Measures Wausau - Riverview Elementary School

South Mountain Facility Analysis

Wausau School District - South Mountain ES

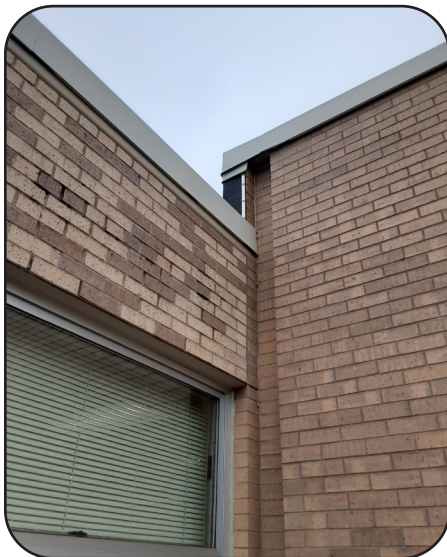
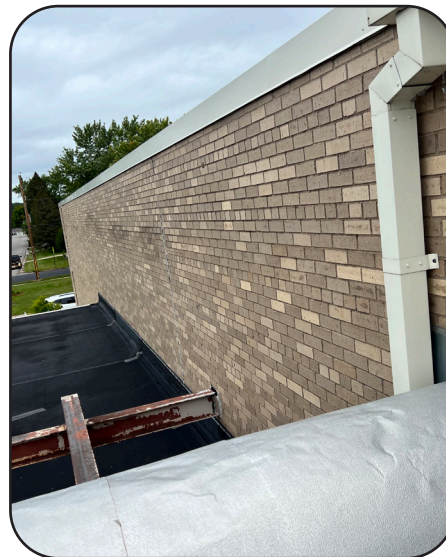
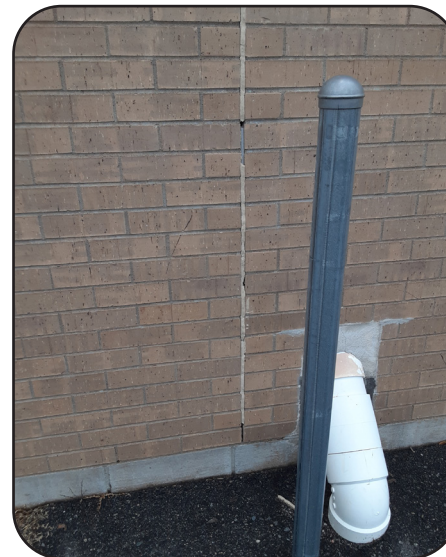
Building System	General Description	Recommendation	Cost Estimate
Exterior Building	Exterior wall bricks mildew stained.	Investigate cause and correct. Clean bricks.	\$14,000
Exterior Building	Exterior gym wall holding water.	Investigate cause and correct.	\$22,000
Exterior Building	Exterior wall control joints failed.	Fill and paint.	\$12,000
Exterior Building	Exterior window caulk failed.	Remove failed caulk and replace.	\$28,000

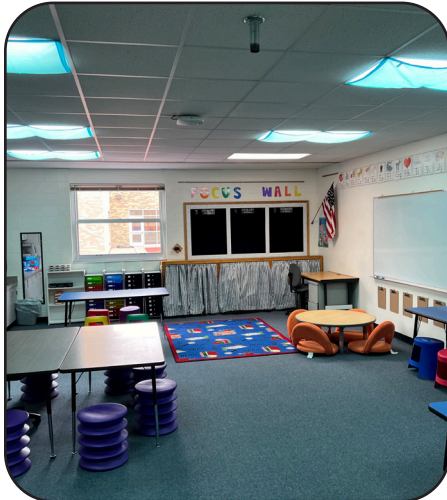
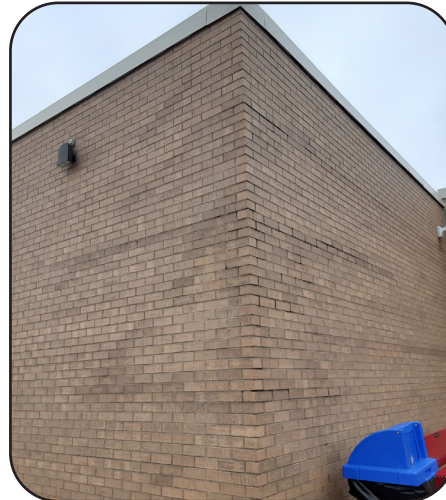
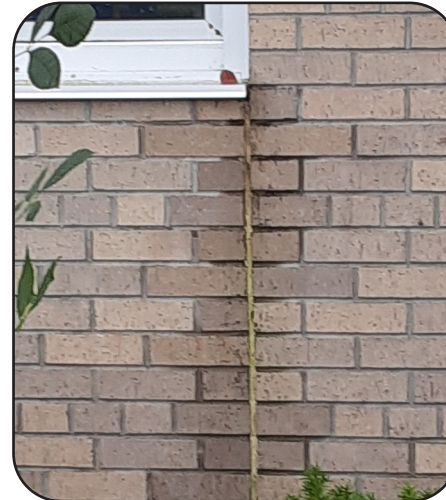
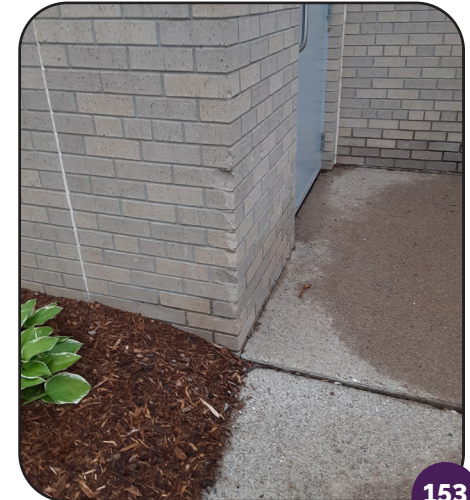
Building System	General Description	Recommendation	Cost Estimate
Electrical - Whole Building Lighting Upgrade	The facility is in need of a whole building lighting upgrade from fluorescent to LED in approx. 2/3 of its square footage. Many classrooms were noted having fabric light filters hung over fixtures due to the harshness and intensity of existing lighting systems. Interior lighting projects provide roughly a 6 year simple payback, along with giving building occupants the ability to adjust light levels to their liking. Additionally, the systems have a 20+ year lifespan, drastically reducing maintenance required to change lamps and ballasts.	Replace classrooms, offices, corridors and common large spaces (gym) with appropriate LED fixtures, occupancy sensors, and dimming controls. Complete this project at the same time of any major HVAC/ceiling work. Pricing given to update 2/3 of the school interior.	\$100,000

Exterior Building	Exterior face brick wall tuck pointing needed.	Re-tuck walls and exterior masonry.	\$65,000
Exterior Building	Exterior window sill drip edges causing wall staining.	Redirect flow to keep water discharge off wall.	\$18,000
Exterior Building	Exterior wall corner bricks chipped.	Replace chipped bricks. Consider replacing as part of larger masonry project.	\$5,500

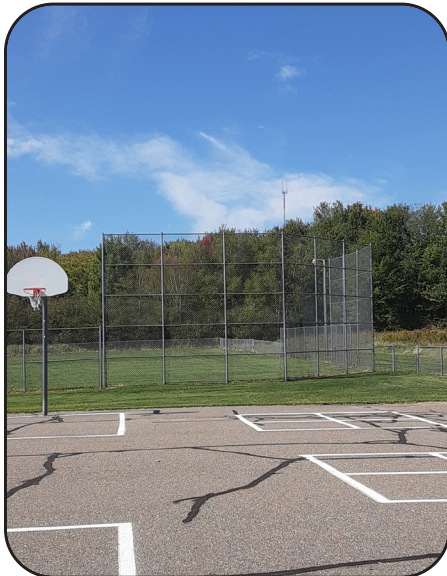
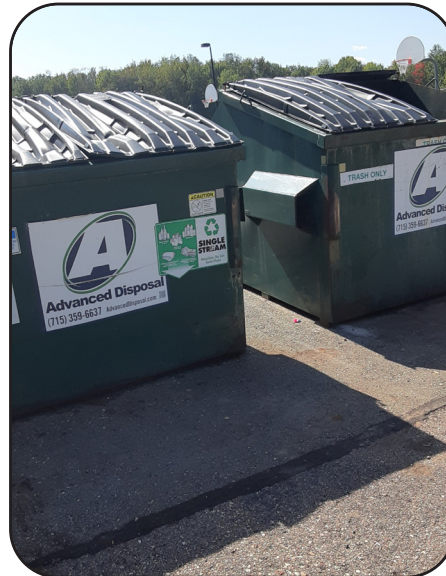
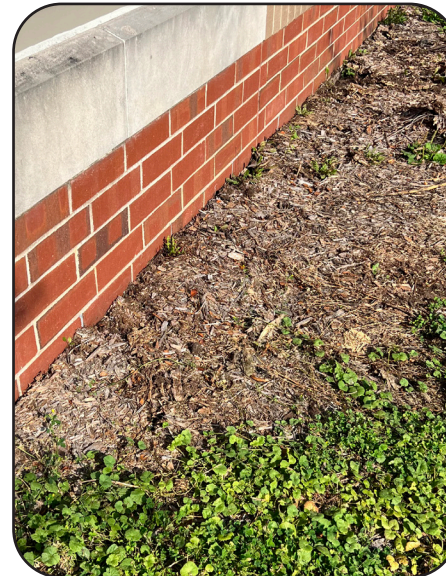
Building System	General Description	Recommendation	Cost Estimate
Site & Landscape	Set routine asphalt maintenance schedule with area rotation.	Continue crack clean and crack fill as needed. Include every 3-5 years seal, and repaint asphalt.	\$5,500
Site & Landscape	Dumpsters on asphalt.	Install concrete pads for dumpsters.	\$6,800
Site & Landscape	Planter mulch above and blocking exterior wall weeps and runoff away from building.	Refresh and retain mulch to an elevation lower than wall weeps, drip edges, border, walk, or turf. Consider crushed gravel in lieu of mulch in planters.	\$2,000
Exterior Building Roofing	Roof sections A-E are 27 years old, out of warranty, and past their expected useful life. Inspection showed peeling seams, failing patches, and evidence of ponding water. Parapet stretching and failures needing patching have occurred.	Replace sections A-E in the next 1-5 years with an adhered 60 mil black EPDM 20 year warranty roof. Recommend completing all roofs at once.	\$437,000

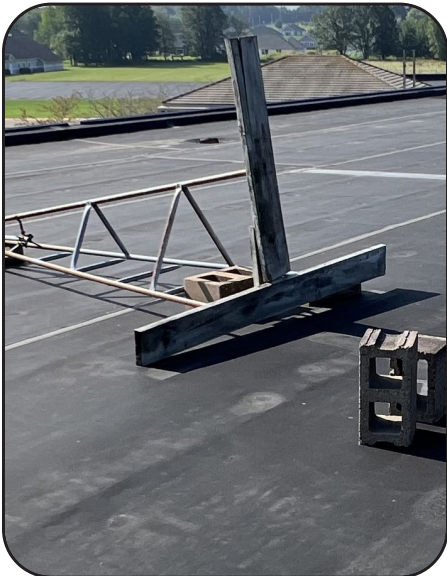
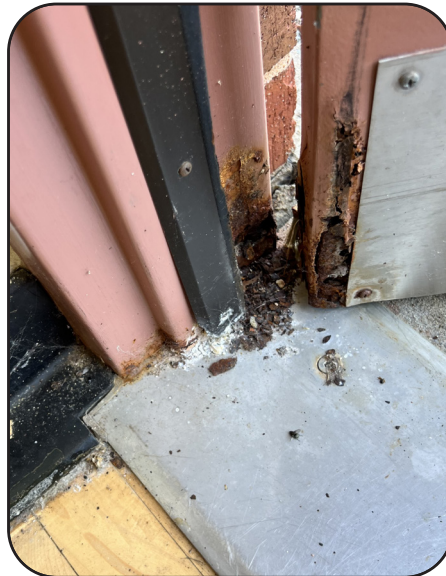
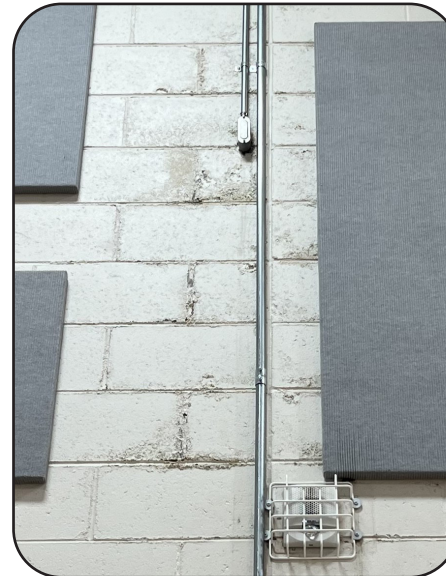
Building System	General Description	Recommendation	Cost Estimate
Exterior Building Roof	Abandoned antennae and CMU blocks on roof. Abandoned equipment and materials will work their way through the roofing membrane causing leaks.	Remove and discard abandoned equipment.	\$500
Exterior - Doors	Although minimal, some sets of exterior steel doors are deteriorating. One set of gym doors has rusted through completely.	Complete a through facility exterior door inventory and replace as necessary. Expect to replace several door sets in the next 1-5 years.	\$20,000
Exterior - Gym EIFS Walls Water Infiltration	The S. Mtn. gym has a significant moisture intrusion problem needing to be addressed quickly. The issue seems to be associated with control joint locations, however the upper exterior of the gym is EIFS, a frequent cause of moisture problems. Drawings of the facility were not available at the time of auditing.	As a first step, replace all gym control joints interior and exterior. This issue has the potential to be costly if existing EIFS needs to be removed to reflash and install new air and moisture barrier. Consider replacing the EIFS with brick veneer masonry cavity wall if existing construction conditions permit.	\$150,000

Exterior Building	Exterior wall face brick effervescence.	Identify and eliminate cause. Clean brick and mortar.	\$14,000

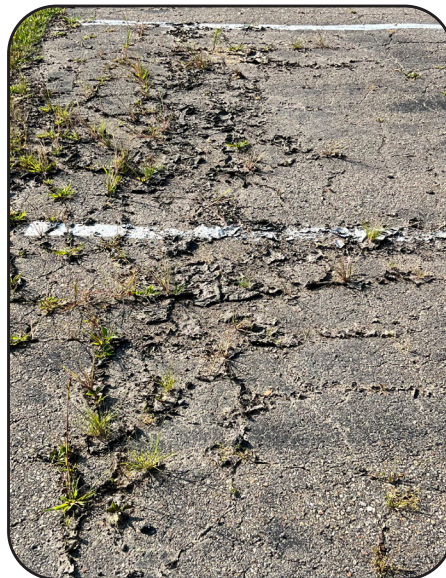
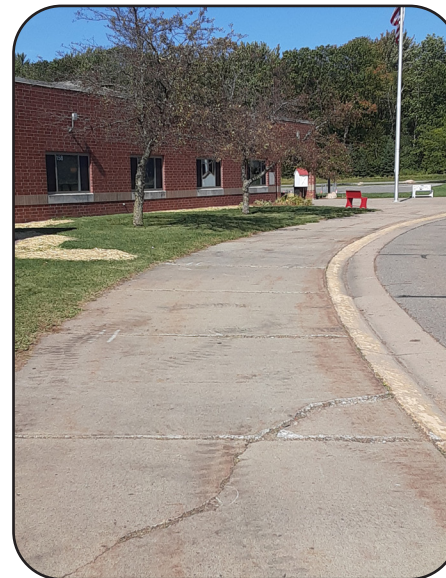
Building System	General Description	Recommendation	Cost Estimate
Exterior Building	Exterior upper library wall just under roof edge severely stained. Immediate observation for visitors to site.	Identify and eliminate cause. Clean stained wall areas.	\$35,000
Site & Landscape	Asphalt parking area has failed.	Replace parking lot. Ensure adequate below grade base fill is added. (Especially around edges of lot area and drive entries).	\$92,000
Site & Landscape	Concrete walk slabs cracked.	Replace cracked concrete walk slabs.	\$18,000
Site & Landscape	Many concrete walk slabs joints have deteriorated.	Replace concrete walk concrete slabs with deteriorated joints.	\$35,000

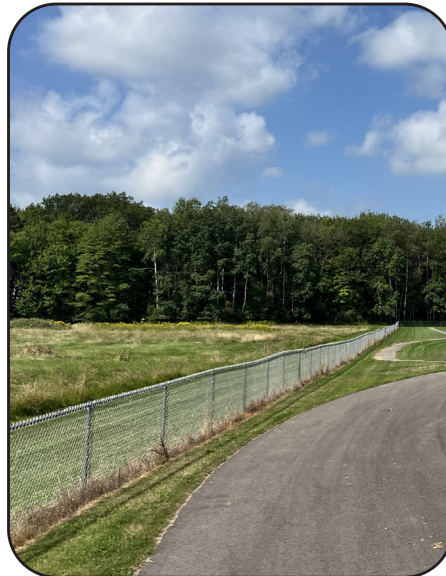
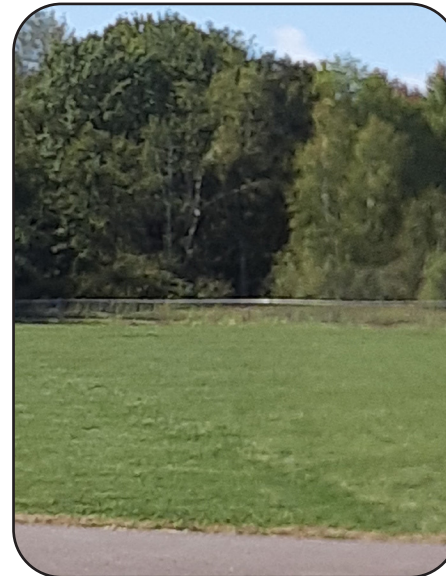
Building System	General Description	Recommendation	Cost Estimate
Site & Landscape	Outbuilding storage door frames damaged (Overhead & pass through).	Repair both overhead and pass through door frames.	\$1,000
Site & Landscape	Existing perimeter fencing is too low.	Replace 4' fence with 6' fence.	\$24,000
Site & Landscape	Standing water between two building sections.	Add yard rains under service drive to site runoff area.	\$18,000
Exterior Building	Exterior metal doors faded and frames rusted.	Prepare, paint, and repair frames. Replace if frame bases are not repairable.	\$25,000

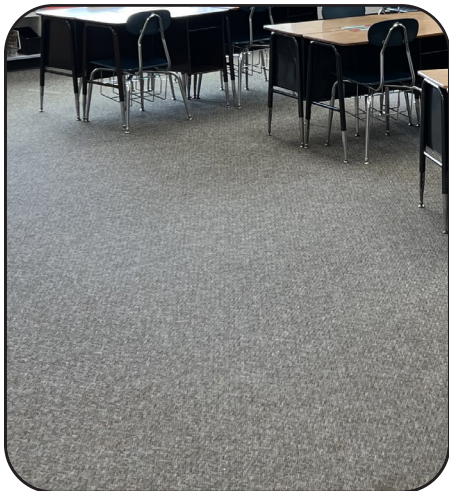
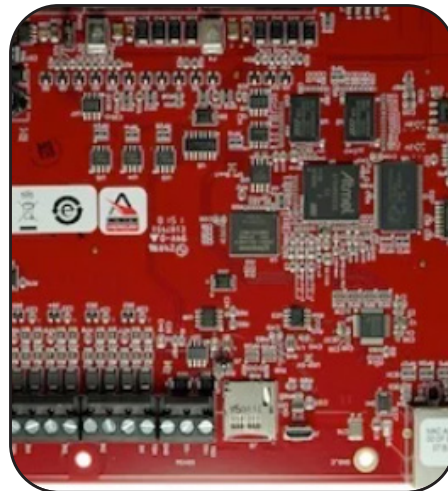
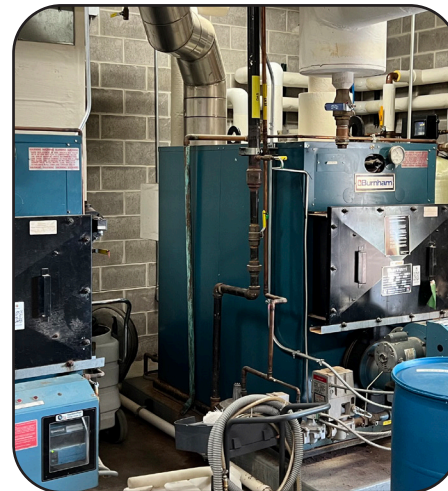
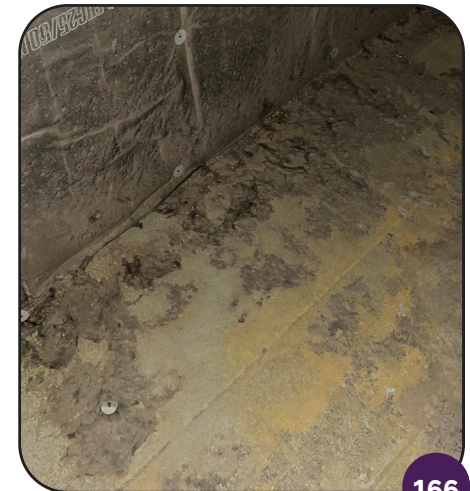
Building System	General Description	Recommendation	Cost Estimate
Interior - Flooring	Although minimal, several classrooms were noted having stained and dated carpeting.	Replace carpeting as needed, pricing given for three classrooms.	\$20,000
Electrical - Door Access	Card Access systems across the district are in need of upgrade to their board controllers. Information was compiled through district IT interviews and recommended per school individual need.	Replace HID Vertx boards to Mercury LP1502's.	\$12,000
Mechanical - Boilers	South Mountain is heated by two 27 year old 1500MBH boilers. Although the boilers have been running well, and are known to be a robust design, they are inefficient by today's standards, have antiquated controls, and are at their expected useful life.	Replace the boilers with high efficiency condensing boilers in the next 3-6 years, along wit their corresponding building heating pumps.	\$300,000

Mechanical - HVAC	The HVAC system is in overall good condition. 1997 vintage AHU's and VAV's serve the original building section. This equipment is approaching 30 years old and reaching the end of it's expected useful life. Remaining equipment is modern and in excellent condition. Some AHU's were found in need of cleaning with air filters dated four years old.	Aggressive maintenance to extend the life of the 1997 equipment 10+ years. Inspect VAV duct systems for leaks. Perform coil cleaning on all 1997 AHU's and VAV's. Recommission the equipment with your controls provider and a testing & balancing contractor.	\$40,000

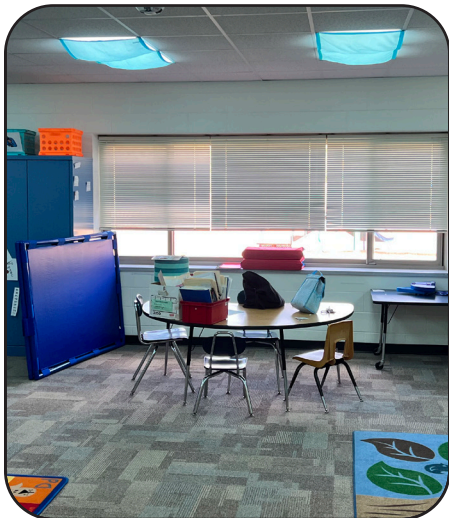
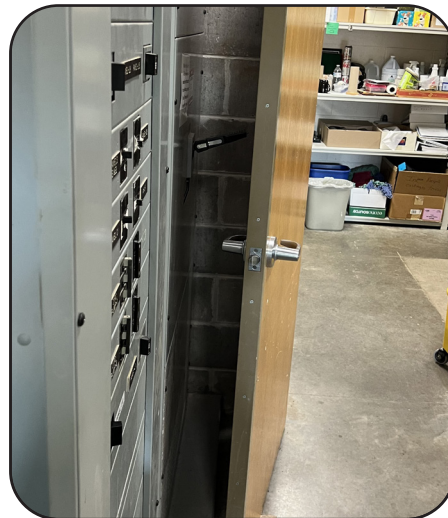
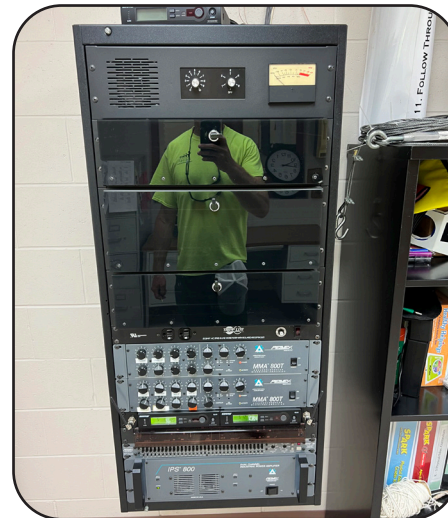
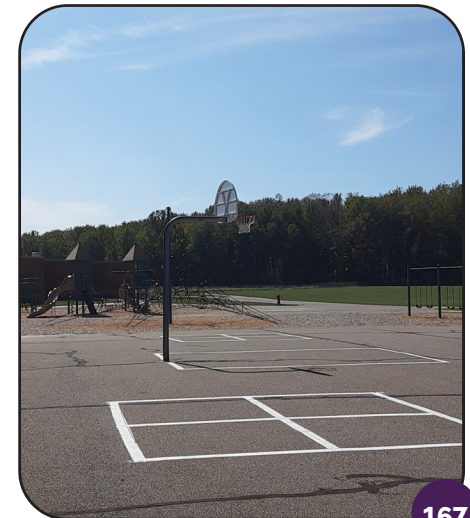
Building System	General Description	Recommendation	Cost Estimate
Electrical - Whole Building Lighting Upgrade	The original facility is in need of a whole building lighting upgrade from fluorescent to LED. Classrooms were noted having fabric light filters hung over fixtures due to the harshness and intensity of existing lighting systems. Interior lighting projects provide roughly a 6 year simple payback, along with giving building occupants the ability to adjust light levels to their liking. Additionally, the systems have a 20+ year lifespan, drastically reducing maintenance required to change lamps and ballasts.	Replace original building classrooms, offices, and corridors with appropriate LED fixtures, occupancy sensors, and dimming controls. Estimate given for older portion of the facility not converted to LED. Gym lighting controls should be replaced along with lighting controls of newer LED fixtures.	\$90,000

Electrical - Code Violation	Door to boiler room swings in front of main electrical switchgear, an inch from the main breaker. Clearance is required in front of all electrical panels.	Consider remounting the boiler room doors and swinging into the maintenance receiving room if egress code allows. Boiler room doors could be relocated to the north.	\$7,500
Electrical - Bell/PA & Communication	PA/Bell/Clock/mass communication systems due for upgrade. Existing system is obsolete using decades old technology.	Replacement recommended to Single-wire standard.	\$240,000
Site & Landscape	No security area lighting on back play lot areas.	Add LED area lighting for security and safety (site opening during inclement weather)	\$18,000

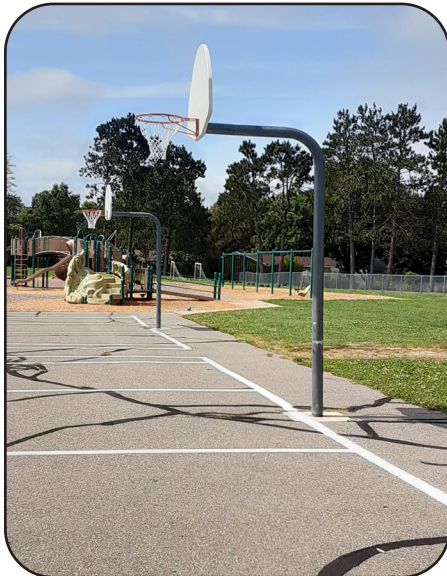
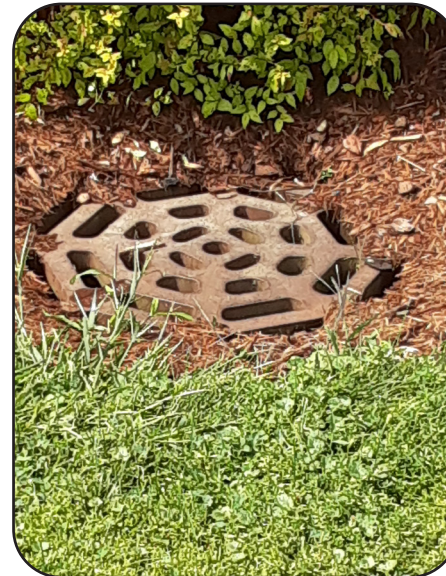
Building System	General Description	Recommendation	Cost Estimate
Site & Landscape	Set routine asphalt maintenance schedule with area rotation.	Continue crack clean and crack fill as needed. Include every 3-5 years seal, and repaint asphalt.	\$5,500
Site & Landscape	Mulch washing out on to walks.	Annually or more often if needed refresh and retain mulch to an elevation lower than border, walk, or turf. Consider crushed gravel in lieu of mulch planters along walks and buildings.	\$3,500
Site & Landscape	Mulch filling storm drain basin inside of planters.	Add screen between drain cover and basin. Clean screen seasonally.	\$1,000
Site & Landscape	Increase routine planters landscaping maintenance.	Annually or more often if needed prune, thin, and remove invasive vegetation in planters and around building perimeters, fencing, hardscape surface edges, utility supply areas.	\$5,000

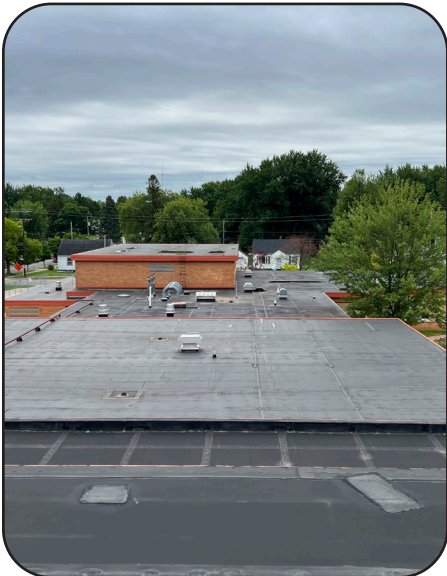
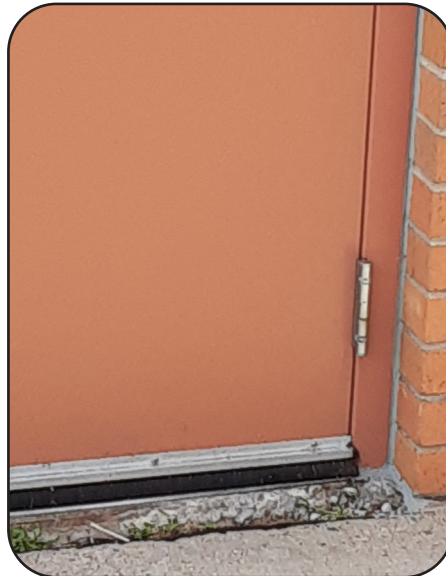
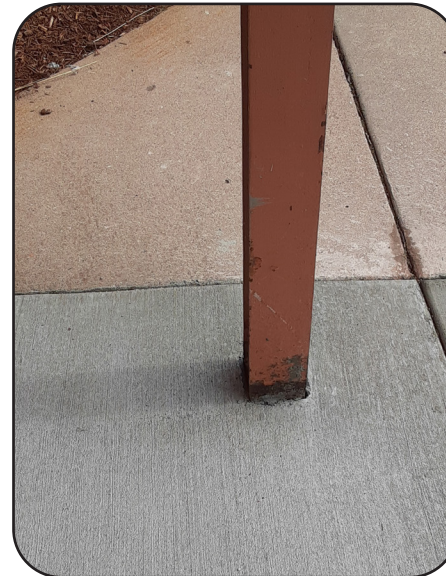
Building System	General Description	Recommendation	Cost Estimate
Exterior Building Roofing	Roof sections A-M are all between 22-27 years old. All sections are out of warranty and have been problematic. Some sections appear in worse condition than others. Some sections are holding water, others with fastener backout, stretching the membrane significantly. Many of these roofs are also .045 mil, a substandard thickness prone to issues.	Replace sections A-M in the next 1-5 years with an adhered 60 mil black EPDM 20 year warranty roof. Recommend completing all roofs at once.	\$622,000
Exterior Building	Exterior door threshold concrete gap.	Fill, caulk, and seal gap to make a smooth transition to landing.	\$2,500
Exterior Building	Entrance metal beam rusty and paint missing.	Prepare and apply durable weather/salt proof coating.	\$1,000
Exterior Building	Exposed foundation wall insulation and waterproofing.	Re-adhere and waterproof foundation wall insulation below exposed grade. Back fill with traffic bond (sharp edged crushed gravel) to lock up water resistant protection along wall and above insulation.	\$13,500

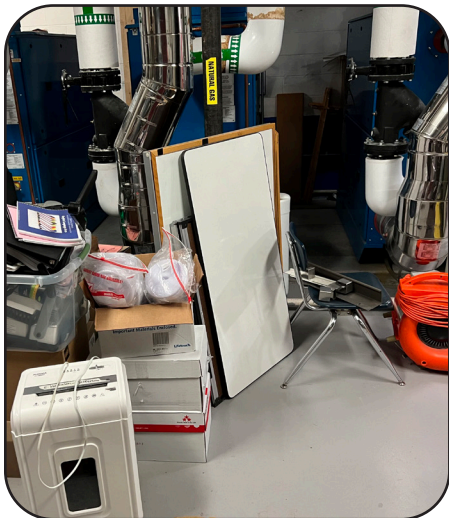
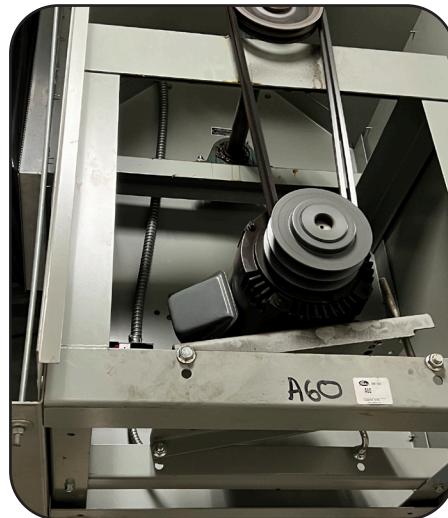
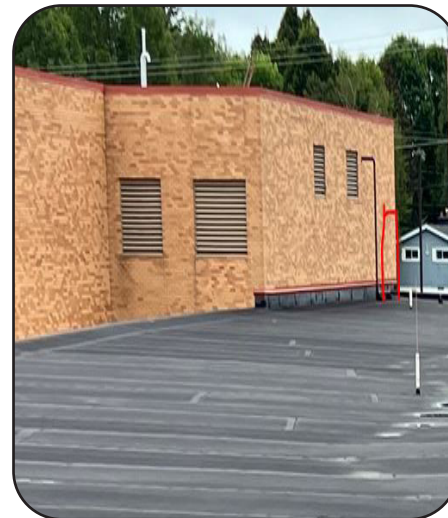
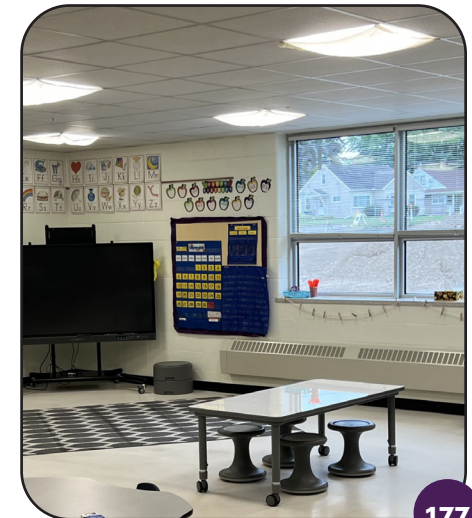
Building System	General Description	Recommendation	Cost Estimate
Interior - Storage Safety	Storage of miscellaneous combustible materials were noted being stored along side the boilers. Along with freeing up maintenance space and setting best practice for facilities personnel, cluttered spaces such as this create a fire hazard.	Clean, organize, and purge. Keep mechanical and electrical room spaces used only for their intended purpose.	\$500
Mechanical - HVAC Safety	One exhaust fan on the upper mezzanine mechanical room was observed operating with a missing safety shroud. Unguarded rotating equipment is a life safety hazard.	Reinstall or purchase and replace a new belt shroud.	\$500
Mechanical - Life Safety	Access to the upper mezzanine mechanical room is unsafe and not conducive to performing routine maintenance. The only access is up a two-story wall ladder with no cage and no tie-off system, the top of the ladder gives choice to either step across to the mezzanine platform, or open a vertical man door to access the roof.	Reroute piping in the mezzanine and install a man door on the south side of the mezzanine wall, accessible by walking the roof from the western penthouse. Install exterior signage at the existing door so users know they're opening a door to a ladder. Install proper fall protection on the existing ladder.	\$30,000

Electrical - Lighting Controls	The 2016 addition installed standard on/off switching vs infinite slider dimming switches on new LED fixtures. The new lighting is too bright, teachers are forced to cover new LED lighting fixtures with fabric light filters.	Replace switches with slider dimmer control.	\$15,000

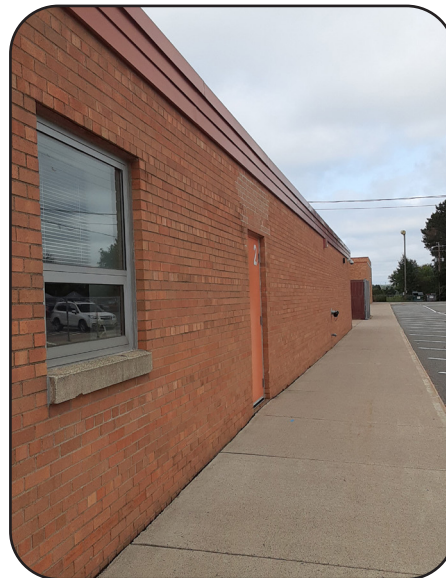
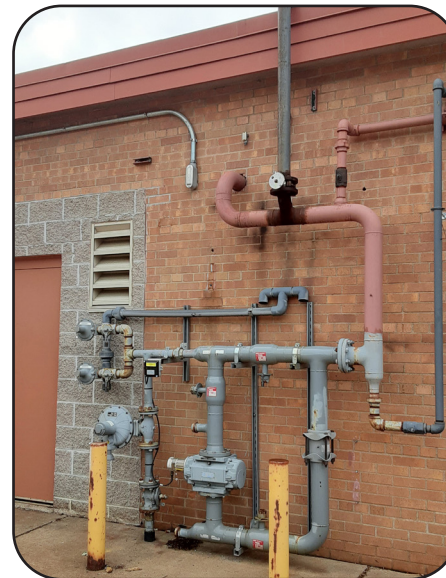
Building System	General Description	Recommendation	Cost Estimate
Site & Landscape	Uneven transition between concrete door landing and walk.	Replace, patch, cut, grind and/or mud jacking as needed.	\$17,500
Site & Landscape	Building perimeter and hardscape gaps.	Back fill gaps with sand and backer rod. Caulk and seal with appropriate joint filler. Heat melt in place material recommended for smooth, clean appearance.	\$3,500
Site Utilities	Gas valve on side of building not secured inside of fencing and potential climbing assistance to roof.	Enclose, secure valve access, and eliminate potential climbing assistance.	\$4,500
Site Utilities	Failed front sign base.	Replace base and upgrade sign. Consider complete upgrade replacement for sign.	\$35,000

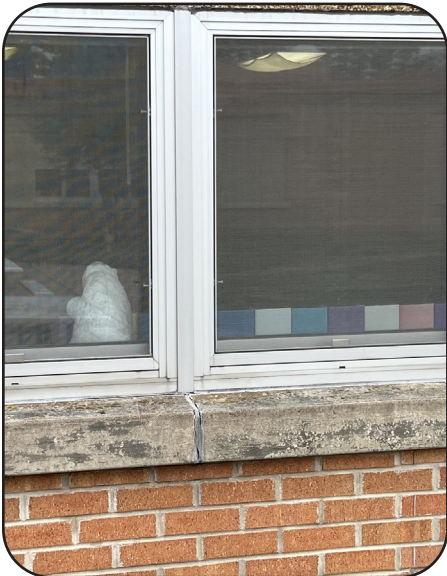
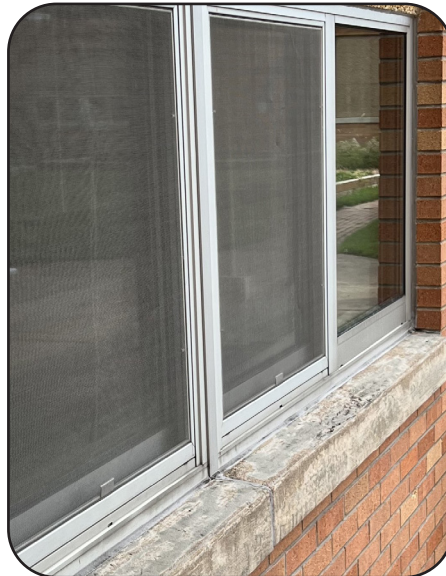
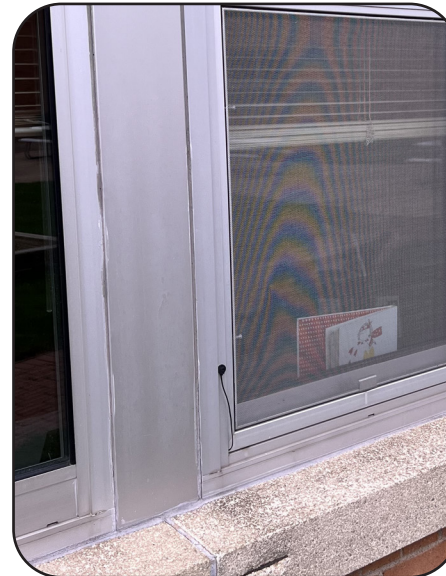
Building System	General Description	Recommendation	Cost Estimate
Exterior Building	Failed and missing window caulk, joint compound, and sealant.	Remove failed and around areas of missing caulk. Re-caulk without blocking or sealing weeps.	\$15,000
Exterior Building	Stone window sills deteriorating.	Patch and seal, or replace. Consider completion with major sill restoration project.	\$45,000
Exterior Building	Window sills internal reinforcing steel exposed.	Patch and seal or replace. Consider completion with major sill restoration project.	\$15,000
Exterior Building	Window steel lintels rusty.	Prepare and paint with weather resistant coatings. Consider completion with major sill restoration project.	\$28,000

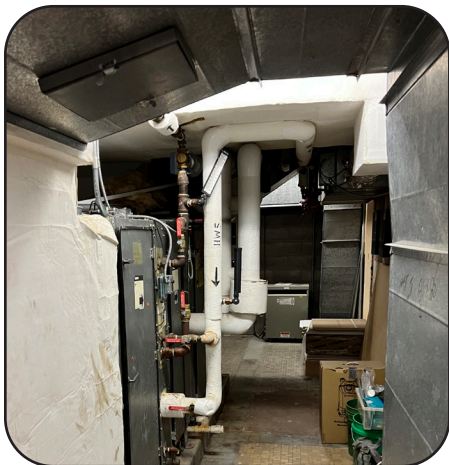
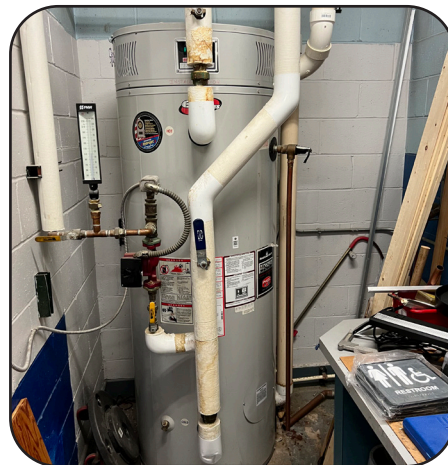
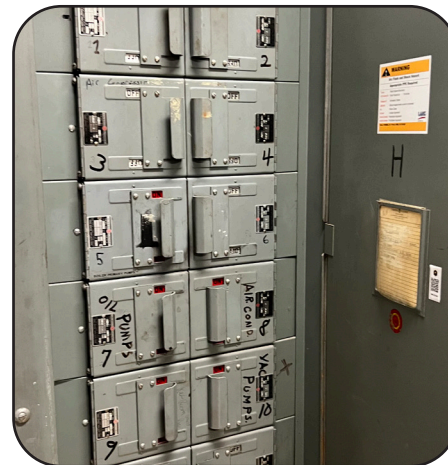
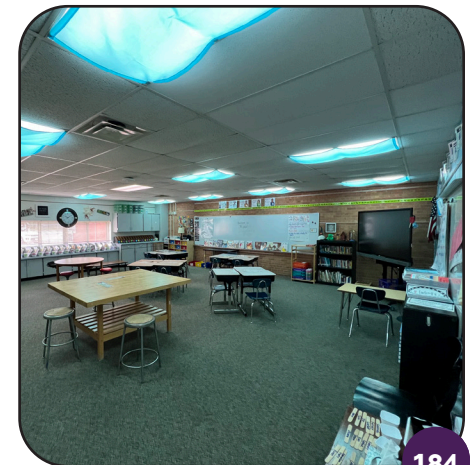
Building System	General Description	Recommendation	Cost Estimate
Mechanical - HVAC	The HVAC system in Jefferson is in overall good condition. 1997 vintage AHU's and VAV's serve the original building section. This equipment is approaching 30 years old and reaching the end of it's expected useful life. Remaining equipment is modern and in excellent condition.	Aggressive maintenance to extend the life of the 1997 equipment 10+ years. Inspect VAV duct systems for leaks. Perform coil cleaning on all 1997 AHU's and VAV's. Recommission the equipment with your controls provider and a testing & balancing contractor.	\$60,000
Plumbing - Domestic Hot Water	The two (60 & 100 gallon) gas fired water heaters are both 16 years old, at their expected useful life.	To determine the priority of each unit, consider what being without hot water for a few days in the areas they serve would mean for operations. Recommend to replace in the next 1-3 years.	\$20,000

Electrical	Several original 1955 vintage electrical panels with fused disconnects are still active in the facility. These panels are obsolete and long past their expected useful service life.	Replace panels in the next 1-3 years. Parts will be difficult or impossible to obtain upon a failure or trip.	\$60,000
Electrical - Whole Building Lighting Upgrade	The facility is in need of a whole building lighting upgrade from fluorescent to LED. Many classrooms were noted having fabric light filters hung over fixtures due to the harshness and intensity of existing lighting systems. Interior lighting projects provide roughly a 6 year simple payback, along with giving building occupants the ability to adjust light levels to their liking. Additionally, the systems have a 20+ year lifespan, drastically reducing maintenance required to change lamps and ballasts.	Replace classrooms, offices, corridors and common large spaces (gym) with appropriate LED fixtures, occupancy sensors, and dimming controls. Estimate given for older 2/3 of the facility not converted to LED.	\$113,000

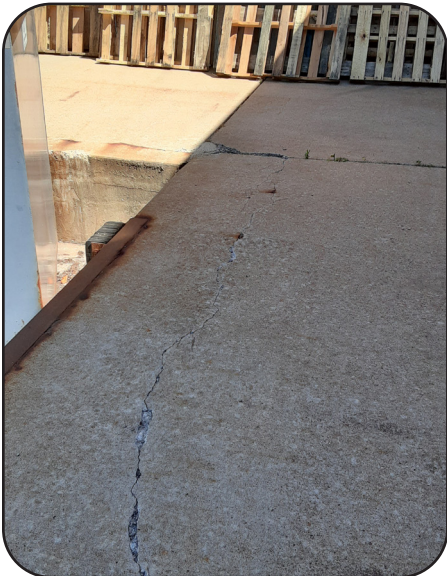
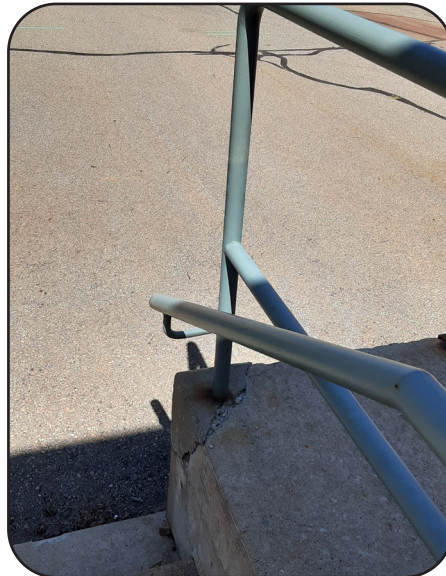
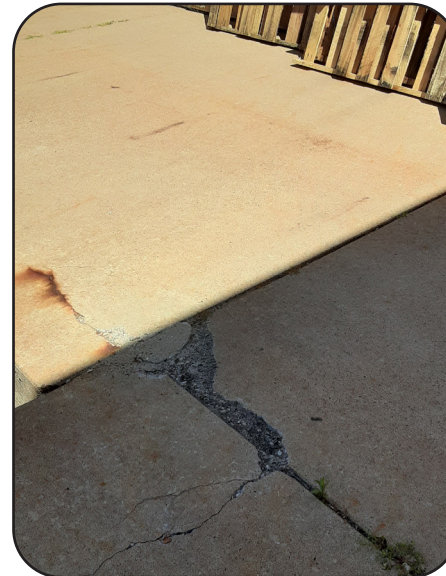
Building System	General Description	Recommendation	Cost Estimate
Site & Landscape	Concrete dock slabs cracked.	Replace cracked concrete slabs. Consider replacement with comprehensive dock upgrade/replacement project.	\$27,000
Site & Landscape	Concrete dock stairs post base open and cracked.	Cut and repair. Consider complete stair replacement along with comprehensive dock upgrade/replacement project.	\$7,500
Site & Landscape	Deteriorated concrete joints between dock and dock walk ramp.	Replace slabs with open or deteriorated joints. Consider replacement with comprehensive dock upgrade/replacement project.	\$12,500
Site & Landscape	Concrete dock walk ramp rebar exposed.	Replace slabs with exposed repair and cracks to underlying rebar. Consider replacement with comprehensive dock upgrade/replacement project.	\$27,000

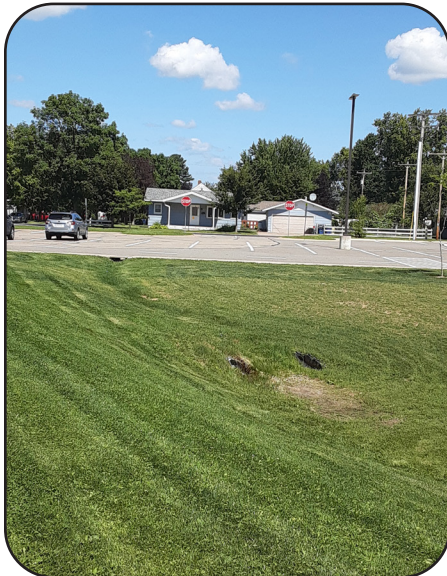
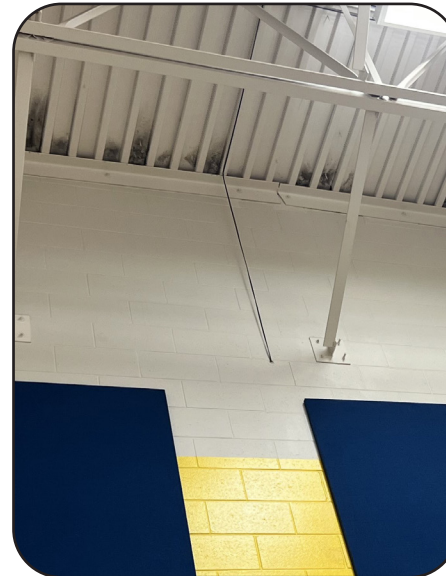
Building System	General Description	Recommendation	Cost Estimate
Site & Landscape	Storm water culvert open.	Add guard and large debris grates on culvert inlets and outlets.	\$1,000
Exterior Building Roofing	Roof sections A-E are 27 years old, out of warranty, and past their expected useful life. Inspection showed peeling seams, failing patches, and evidence of ponding water. Scupper outlets appear to be improperly pitched, draining water on the building under normal circumstances.	Replace sections A-E in the next 1-5 years with an adhered 60 mil black EPDM 20 year warranty roof. Recommend completing all roofs at once.	\$430,000
Exterior - Upper Gym	Upper gym roof/ceiling edge stained per air and moisture infiltration. Observed areas around gym block windows with similar conditions.	Investigate and eliminate cause. Clean and remove stains. .	\$14,500
Mechanical	The GD Jones chiller has had a major failure and is in need of replacement.	As of the writing of this audit, the unit was budgeted for and scheduled for replacement prior to next cooling season. Cost estimate provided as a placeholder.	\$1,000

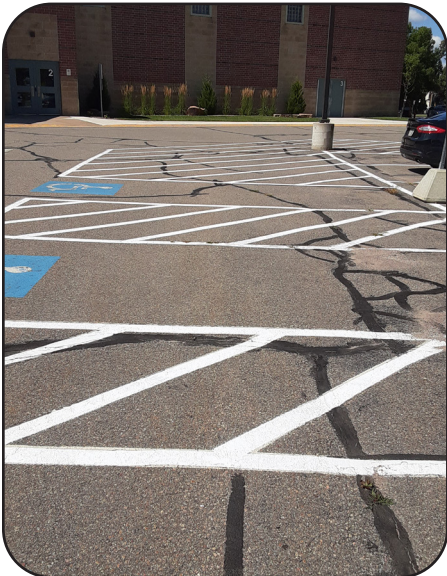
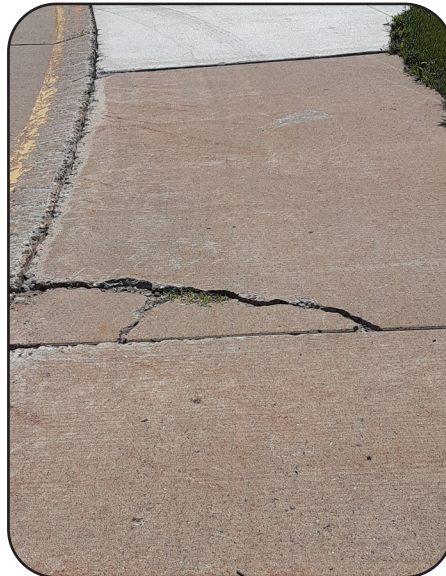
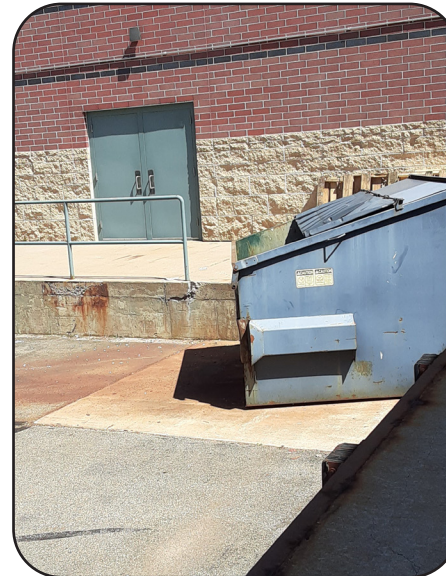
Building System	General Description	Recommendation	Cost Estimate
Site & Landscape	Set routine asphalt maintenance schedule with area rotation.	Continue crack clean and crack fill as needed. Include every 3-5 years seal, and repaint asphalt.	\$6,500
Site & Landscape	Multiple walk concrete slabs with transitional and divided cracks.	Replace cracked concrete walk slabs.	\$16,000
Site & Landscape	Dumpsters concrete slab stained.	Professional clean to remove rust stains.	\$4,500
Exterior - Doors	Although minimal, some sets of exterior steel doors are deteriorating. One set of gym doors is rusting through.	Complete a through facility exterior door inventory and replace as necessary. Expect to replace several door sets in the next 1-5 years.	\$20,000

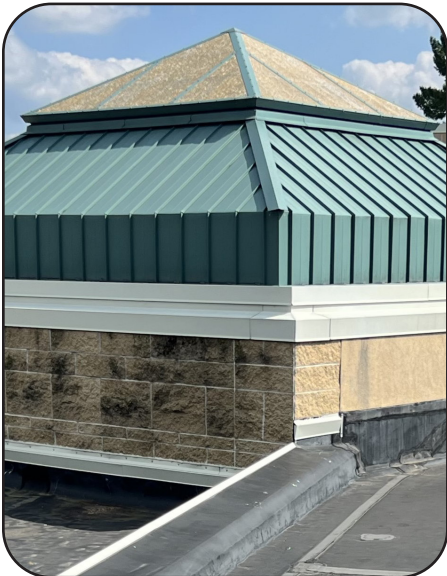
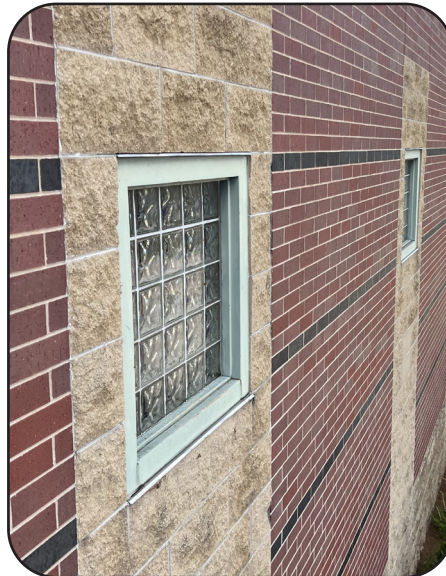
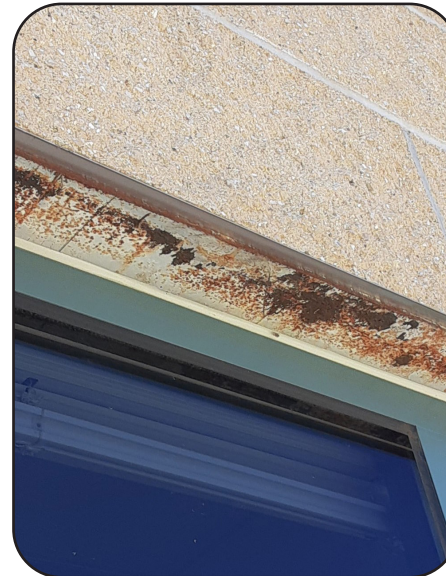
Building System	General Description	Recommendation	Cost Estimate
Exterior - Entry structure	The high-ceiling pyramid roof structure is in need of maintenance. Mildew, EIFS, flashings, caulk, paint, and skylight all have deficiencies. Roofing appears to overlap the bottom EIFS joint which would trap water below the roof membrane.	Perform general maintenance on the structure. Properly terminate roof below EIFS when re-roofing the facility. Replace aged inefficient skylight with glass or opaque panel. Pressure wash, caulk, paint, and reflash metals. Consider replacing EIFS with masonry.	\$50,000
Exterior - Gym Block Window	Area around gym block windows stained per air and moisture infiltration. Observed areas around gym roof edge with similar conditions.	Investigate and eliminate cause. Clean and remove stains. .	\$8,500
Exterior Building	Exterior window lintels rusting.	Prepare and paint with durable weatherproof coating.	\$20,000

Exterior Building	Stained exterior window sills.	Verify cause and remedy. Professionally clean wall sills and decorative stone. Consider completion as more extensive exterior wall corrective project.	\$12,500

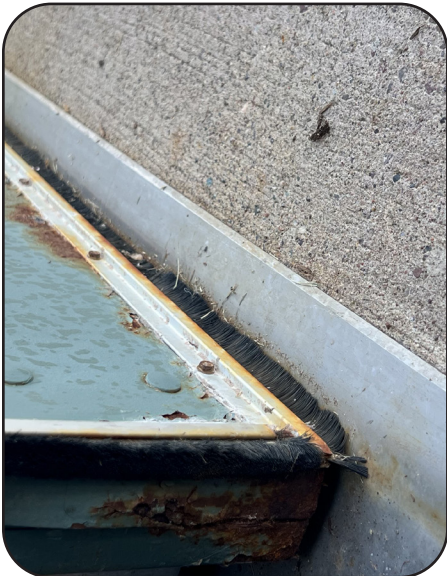
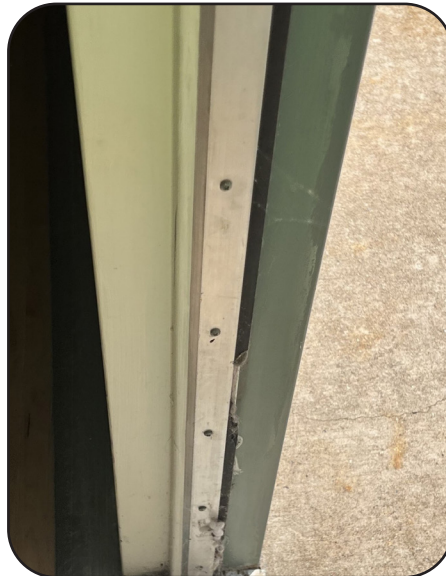
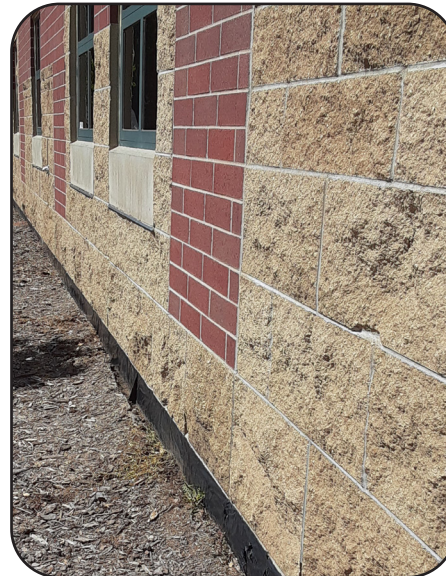
Building System	General Description	Recommendation	Cost Estimate
Exterior Building	Failing exit metal doors and frames .	Replace doors and frames.	\$15,000
Exterior Building	Damaged exit door seals.	Replace damaged seals.	\$1,000
Exterior Building	Exterior wall base waterproof membrane exposed.	Verify integrity of waterproof membrane. Re-adhere and patch if open or torn.	\$1,000
Exterior Building	Exterior wall joint fabric exposed.	Verify integrity of waterproof membrane. Re-adhere and patch if open or torn.	\$1,000

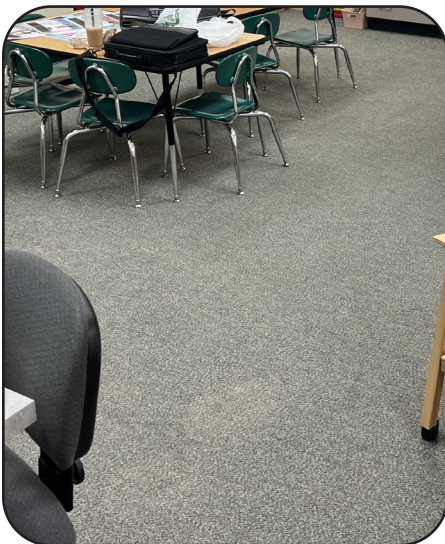
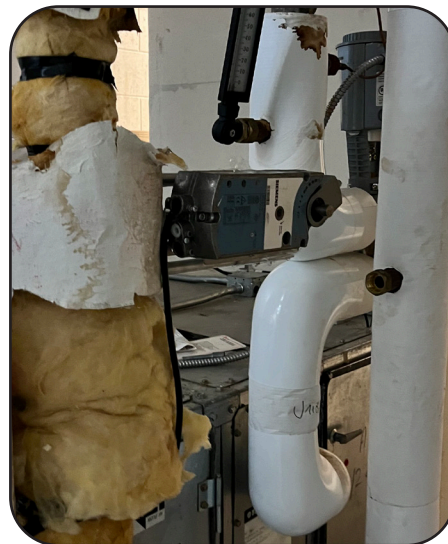
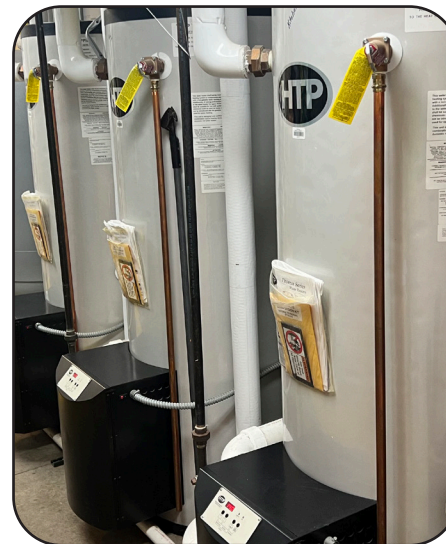
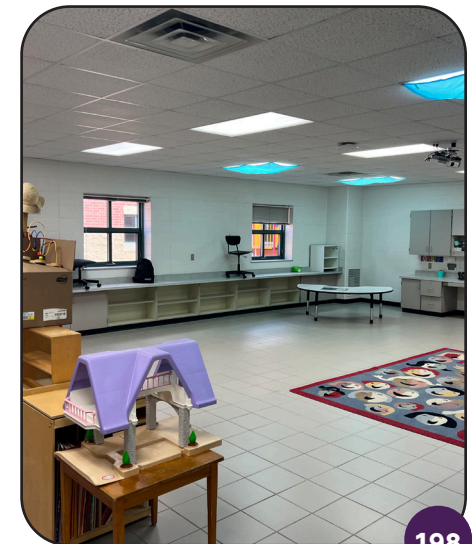
Building System	General Description	Recommendation	Cost Estimate
Interior - Flooring	Although minimal, several classrooms were noted having stained and dated carpeting.	Replace carpeting as needed, pricing given for five classrooms.	\$30,000
Mechanical - Pipe Insulation	Missing and or damaged pipe insulation was noted.	Replace damaged and missing pipe insulation. Pricing given for minimal work noted in mechanical rooms.	\$5,000
Plumbing - Domestic Hot Water	The three 120 gallon gas fired water heaters are all 9 years old. These high efficiency units are in good condition, however expect to need to replace at least one in the next 5-10 years. The system appears oversized for the load, consider downsizing if replacing all at once.	Expect failure of at least one unit in the next 5-10 years. Estimate given for one unit replacement.	\$15,000
Electrical - Whole Building Lighting Upgrade	The original facility is in need of a whole building lighting upgrade from fluorescent to LED. Classrooms were noted having fabric light filters hung over fixtures due to the harshness and intensity of existing lighting systems. Interior lighting projects provide roughly a 6 year simple payback, along with giving building occupants the ability to adjust light levels to their liking. Additionally, the systems have a 20+ year lifespan, drastically reducing maintenance required to change lamps and ballasts.	Replace original building classrooms, offices, corridors with appropriate LED fixtures, occupancy sensors, and dimming controls. Estimate given for older 2/3 of the facility not converted to LED. Gym lighting controls should be replaced along with lighting controls of newer LED fixtures.	\$130,000

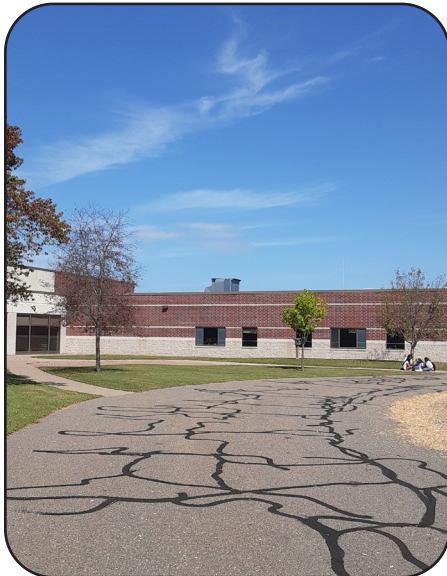
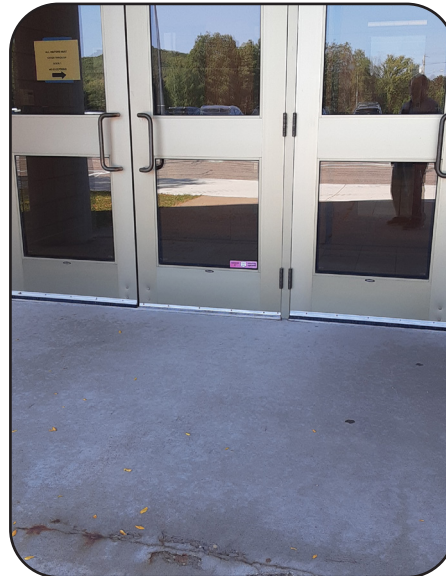
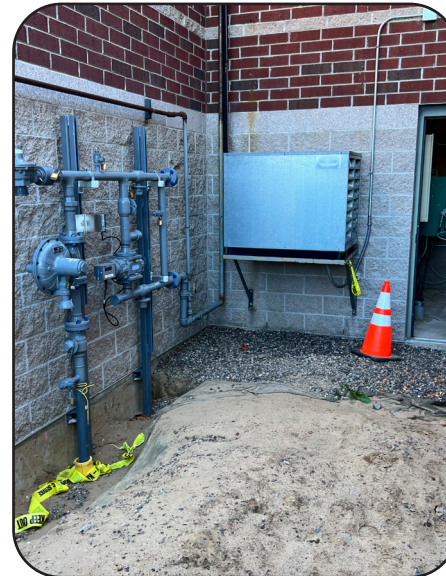
Building System	General Description	Recommendation	Cost Estimate
Site & Landscape	Set routine asphalt maintenance schedule with area rotation.	Continue crack clean and crack fill as needed. Include every 3-5 years seal, and repaint asphalt.	\$8,800
Site & Landscape	Concrete door landing deteriorating	Replace concrete door landing.	\$8,500
Site & Landscape	Utility hardscape area open.	Close exposed hardscape areas.	\$12,500
Exterior Building	Exterior wall block and mortar stained.	Professionally clean walls. Consider completion as more extensive exterior wall cleaning project.	\$5,000
