Facilities Management Services

Facility Improvement Measures Wausau - Riverview Elementary School

South Mountain Facility Analysis

Wausau School District - South Mountain ES

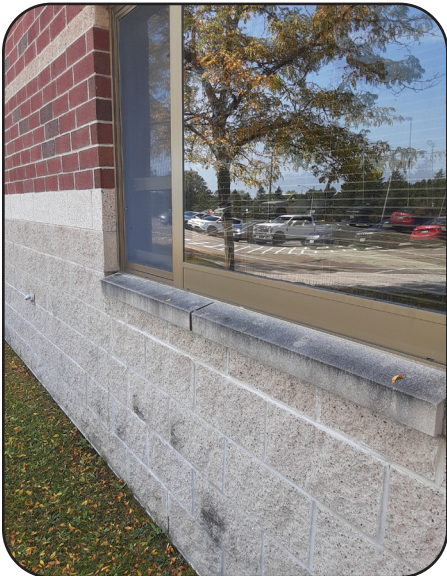
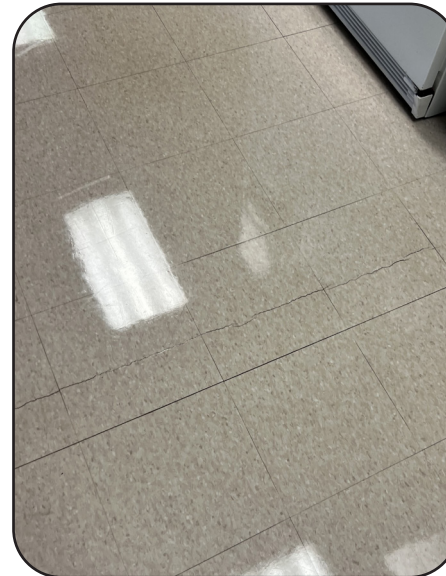
Building System	General Description	Recommendation	Cost Estimate
Exterior Building	Stained exterior window sills.	Professionally clean wall sills. Consider completion as more extensive exterior wall corrective project.	\$9,500
Exterior Doors	Although doors are in good condition, several door sets with no center mullion were noted with large air gaps between.	Inspect all exterior doors and perform a whole building door weather stripping and door sweep replacement as necessary.	\$5,000
Interior - Flooring	Although minimal, several areas were noted having cracked and gapped VCT. Area shown in staff lounge.	Repair damaged VCT tile, consider replacement with a superior product. Floor tile patches will likely stand out unless full surface is replaced.	\$5,000
Mechanical - Pipe Insulation	Missing and or damaged pipe insulation was noted in various locations around the building.	Insulate DHW piping up to water heaters. Missing insulation was also noted near the boilers. Replace any damaged or missing pipe insulation found elsewhere. Pricing given for minimal work noted in mechanical rooms.	\$5,000

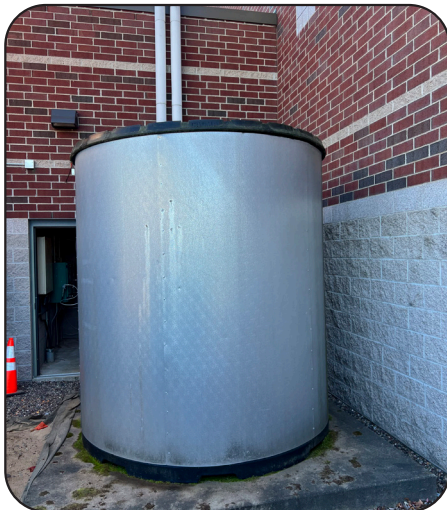
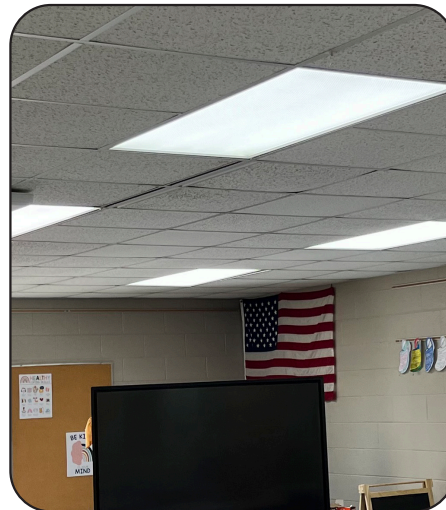
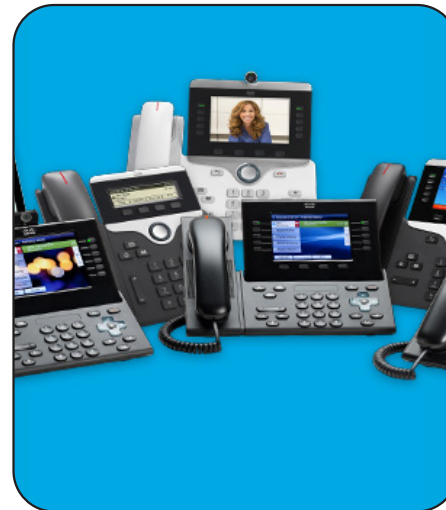
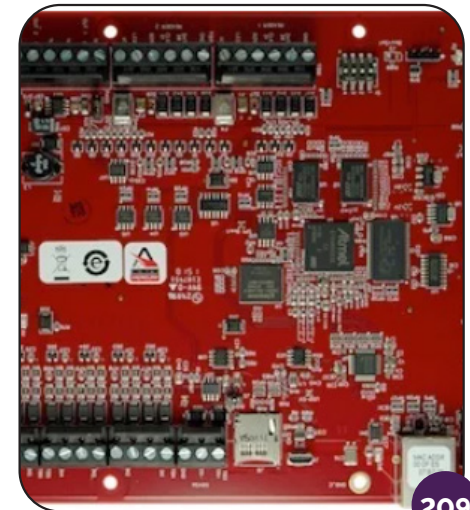
Building System	General Description	Recommendation	Cost Estimate
Mechanical - Cooling Capacity	The Stettin cooling system utilizes ice storage to allow the energy intensive chiller to be run during off-peak hours, reducing operating costs. The ice bank system however is undersized, on hot days the building uses all the ice and is unable to cool.	Several options are available to review with a mechanical design engineer. Consider adding additional ice storage capacity and corresponding higher chiller capacity. Consider removing certain spaces from the cooling load, or cooling certain spaces with DX cooling to remove them from the ice load. Pricing given as a FIM placeholder.	\$500
Electrical - Whole Building Lighting Upgrade	The facility is in need of a whole building lighting upgrade from fluorescent to LED. Interior lighting projects provide roughly a 6 year simple payback, along with giving building occupants the ability to adjust light levels to their liking. Additionally, the systems have a 20+ year lifespan, drastically reducing maintenance required to change lamps and ballasts.	Replace classrooms, offices, corridors and common large spaces (gym) with appropriate LED fixtures, occupancy sensors, and dimming controls.	\$94,000

Electrical - Bell/PA & Communication	PA/Bell/Clock/mass communication systems due for upgrade. Existing system is obsolete using decades old technology.	Replacement recommended to Single-wire standard.	\$240,000
Electrical - Door Access	Card Access systems across the district are in need of upgrade to their board controllers. Information was compiled through district IT interviews and recommended per school individual need.	Replace HID Vertx boards to Mercury LP1502's.	\$6,000

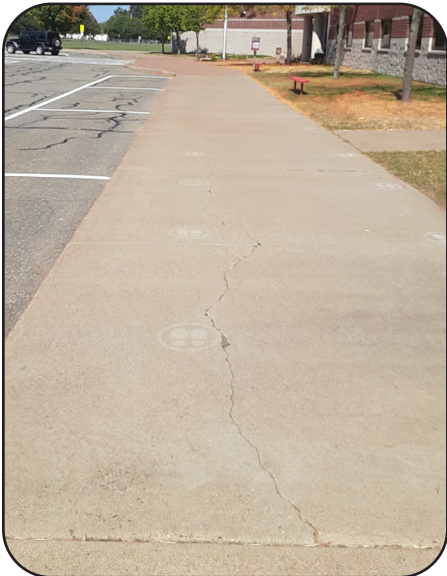
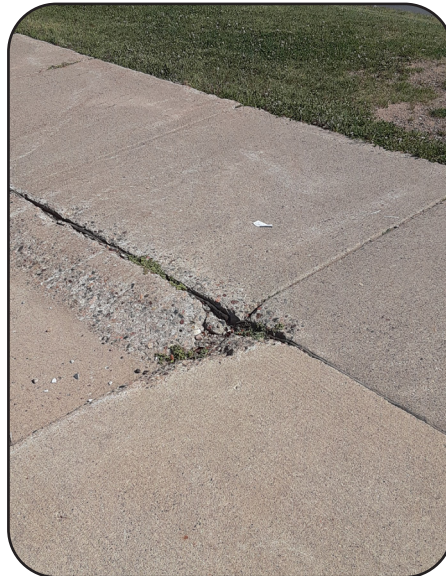
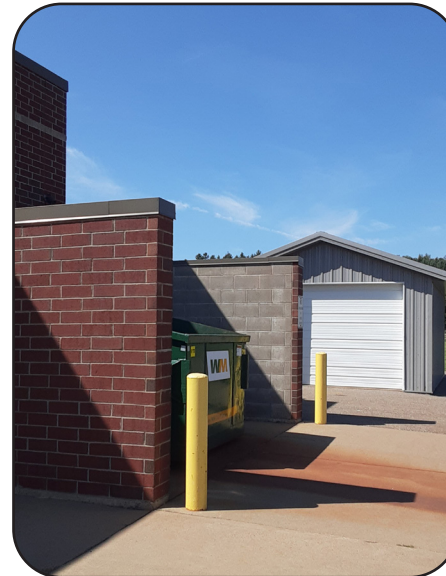
Building System	General Description	Recommendation	Cost Estimate
Site & Landscape	Multiple walk concrete slabs with transitional and divided cracks.	Replace cracked concrete walk slabs.	\$12,000
Site & Landscape	Concrete roll over curb deteriorating	Replace concrete curb.	\$7,500
Site & Landscape	Dumpsters concrete slab stained.	Professional clean to remove rust stains.	\$4,500
Exterior Building	Exterior window caulk missing and failing.	Remove failed and missing caulk. Re-caulk without blocking or sealing weeps.	\$18,000

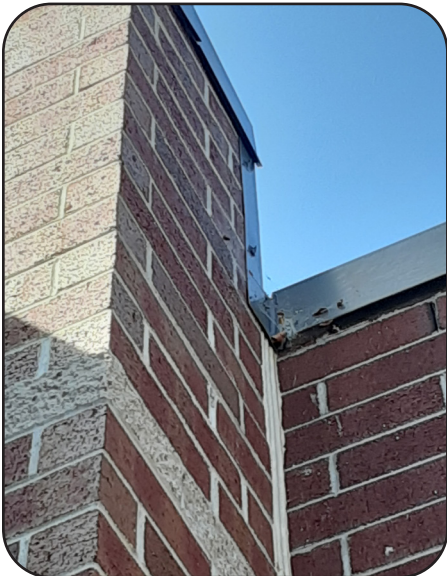
Building System	General Description	Recommendation	Cost Estimate
Exterior Building	Roof corner flashing damaged.	Waterproof and replace flashing.	\$2,500
Interior - Gym Flooring	The Stettin gym floor is in good condition but in need of maintenance. Surface finishing is de-laminating and larger cracks are forming between wood floor boards.	Perform a full refinishing and restriping in the next 1-2 years. Maintain a wood floor refinishing cycle, recommended every 5-10 years dependent on use and condition.	\$25,000
