Geneva Community Unit School District #304  
Operations and Maintenance  
7 Year Capital Improvement Plan

February 25, 2019

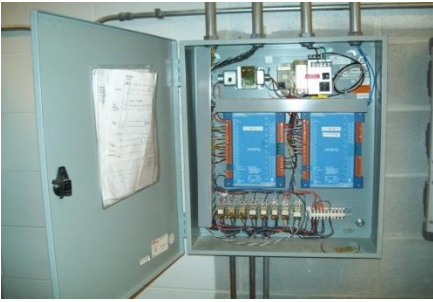
## Lon Controller

Lon controls throughout the building.

Outdated and costly to repair.

Replace Lon to BACnet.

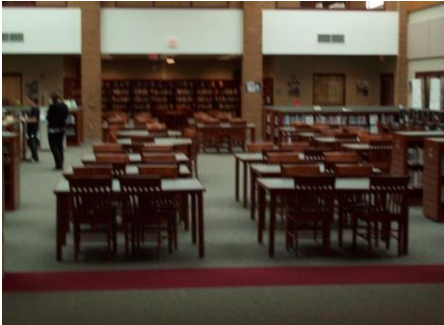
## LMC

AHU is undersized for space.

Recommend increasing the capacity of the AHU and adding four to six VAV boxes with controls to increase comfort and control humidity.

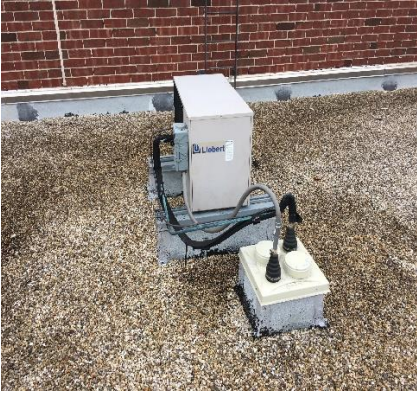
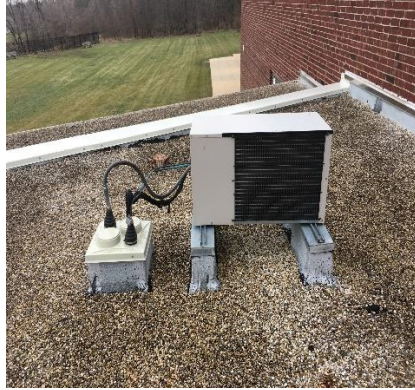
### **Air Handling Unit**

Air handling unit is nearing the end of its life cycle.

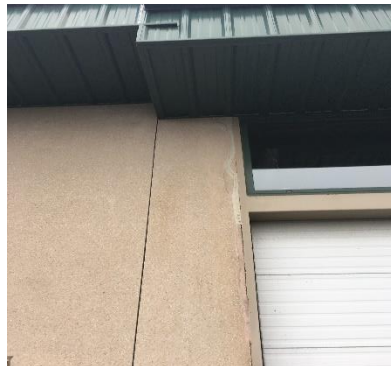
## Architectural Precast Wall Panel

The exterior architectural precast wall panel has cracked and will need to be replaced.
