TIKIGAQ

**POINT HOPE SCHOOL
MECHANICAL AND ELECTRICAL
BUILDING ASSESSMENT AND INVENTORY SURVEY REPORT**

August 19, 2024

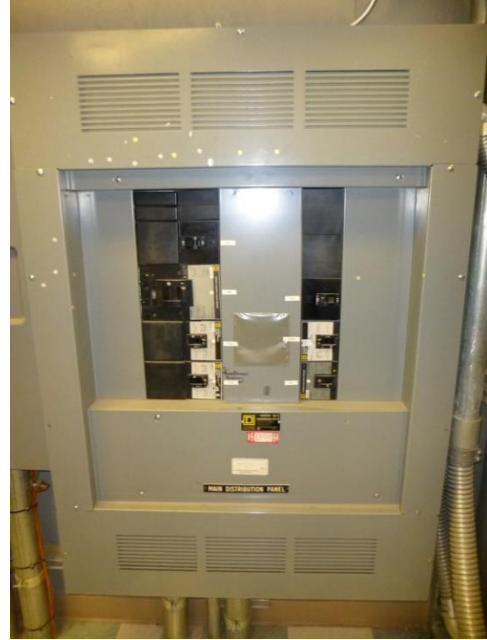
Photo E4 – Panel 'MDP'

The older portion of the school is distributed power via Panel 'MDP' (*Photo E4*) which is located on the 2nd Floor of the Voc-Ed area. This 'MDP' then feeds Panels 'ES', 'WS', 'VE', 'RE', 'NG', 'T', 'T1', and Sub-Distribution Panel 'SDP' (*Photo E5*). 'SDP' is located in the 2nd Floor Fan Room above the old Gymnasium and feeds Panels 'NF1', 'FS', 'NM', 'NC', 'NC2', 'K1', 'K2', 'GS1', 'GS2', 'G', 'F', 'H', 'NA1' and 'NA2'. All panels were in fair to good condition and replacement breakers are readily available.

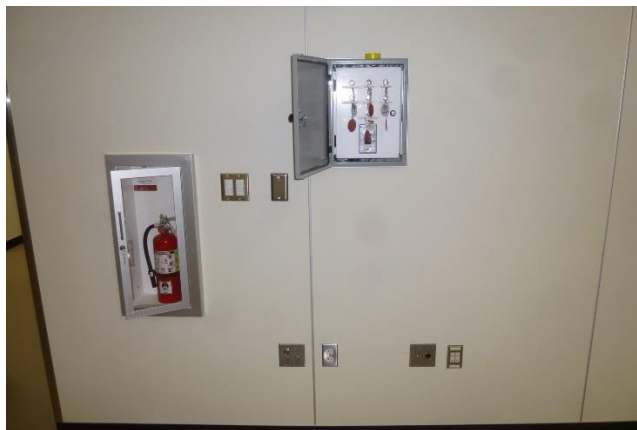
Photo E7 – Devices in new Gymnasium Addition

stainless steel and ivory in the older portion of the school. The new Gymnasium addition utilized entirely stainless steel faceplates (*Photo E7*).

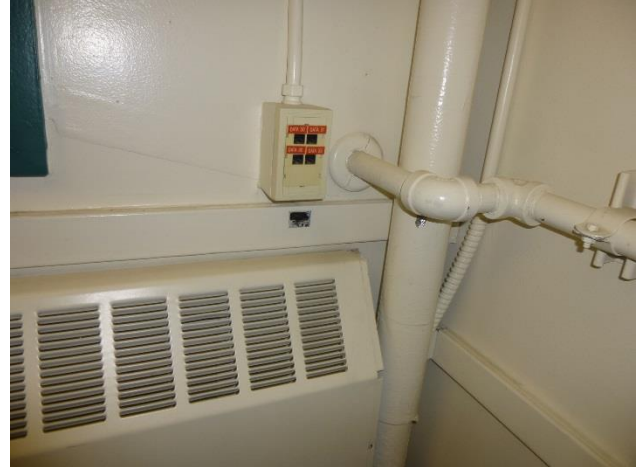
Photo E15 – Typical Older School Data Installation

The new telecommunications system cabling consists of Category 6 wiring. All of the older portion of the school is routed in Category 5 and 5e wiring, however, that is all being replaced in the Phase IV project with new Cat 6. The wiring is routed above the accessible ceiling in J-Hooks and/or cable tray, and conduit drops from these locations to the jacks. The new Gym addition wiring is all concealed with flush mounted jacks and stainless steel faceplates. Numerous wireless access points are located throughout the addition for full wireless coverage. The wiring within the older portion of the school is generally surface mounted from the ceiling to 4-port jacks within surface raceway and/or conduit (*Photo E15*). The majority of the surface mounted installations are being replaced with recessed mounted in the Phase IV project.

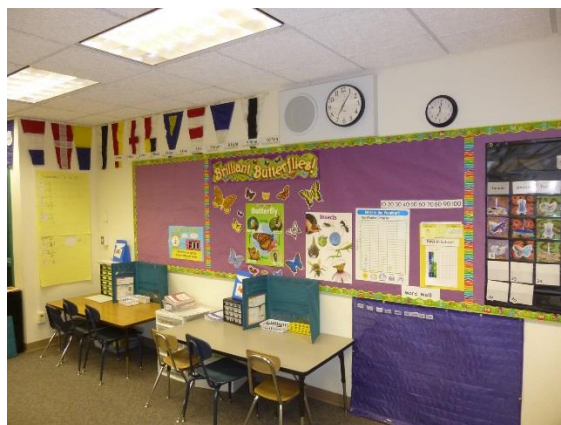
Photo E18 – Old Speakers/Clocks

The older intercom/bell system within the remaining portion of the school is no longer in use and will be replaced, as previously mentioned. The existing Primex Wireless clock system will also be replaced with the new Atlas IP clock system (*Photo E18*).
