NORTH STAR
CONTRACTING

Inspection Report

Menahga Public School
Menahga Public School - 216 Aspen Ave S
216 Aspen Ave S
Menahga, MN 56464

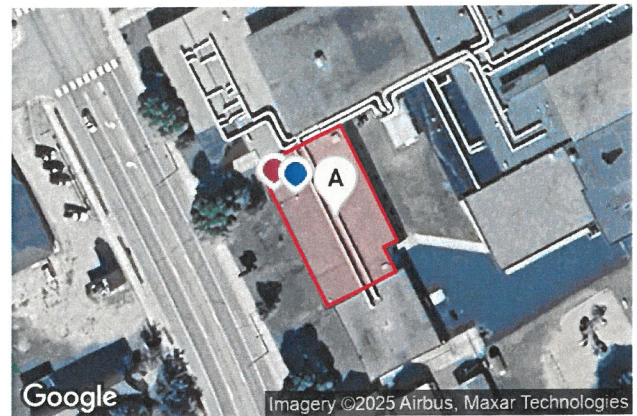
Curb - Exhaust fan curb (Emergency)

Need to reflash in existing curb due to damaged membrane flashing.

Flash in curb with appropriate materials per manufacturer's installation recommendation's.

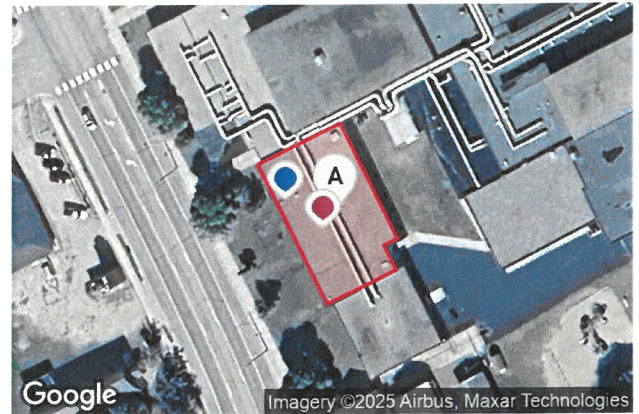
3

Base Flashing Lap (Emergency)

Open lap in base flashing.

We will clean and prime lap then install new patch to ensure water tightness.

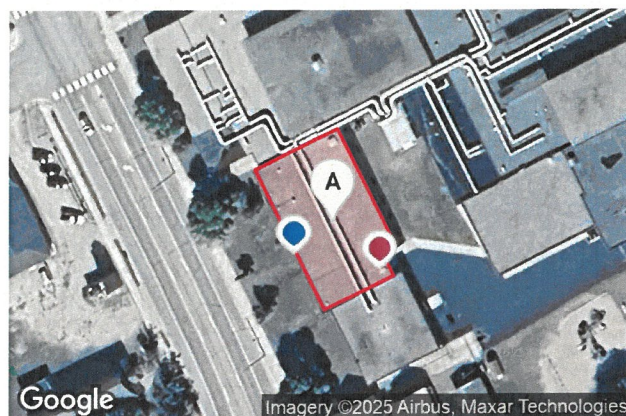
5

Membrane - Bridging

Membrane has come loose and is bridging at an angle change in the roof system.

Cut membrane at angle change. Secure roof membrane to deck or wall. Reflash wall or curb flashing.

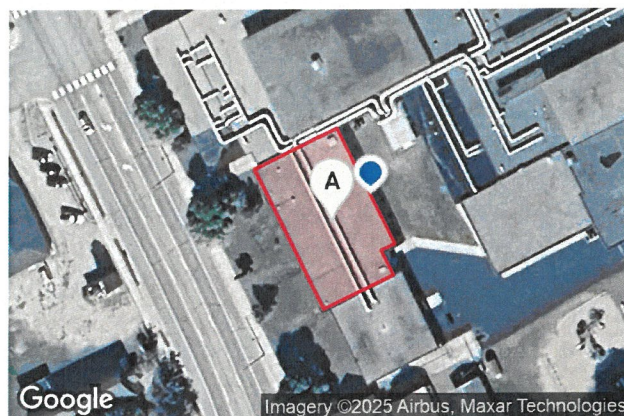
Membrane - Bridging

Membrane has come loose and is bridging at an angle change in the roof system.

Cut membrane at angle change. Secure roof membrane to deck or wall. Reflash wall or curb flashing.

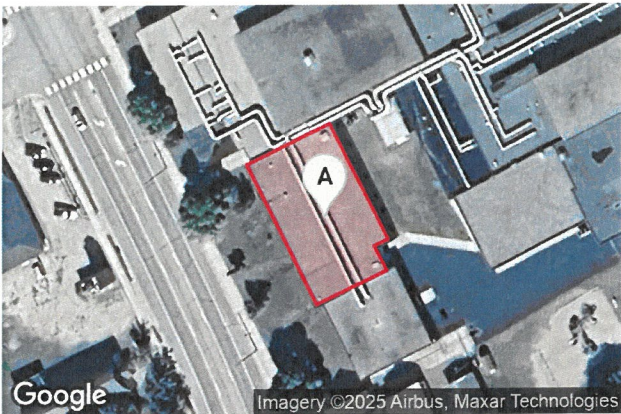
Membrane:	C-
Flashings:	D
Sheet Metal:	C-
<hr/>	
Overall:	D
<hr/>	
Estimated Replace:	2028

Recommendations:
We recommend repairs to further extend the life of this roof section.

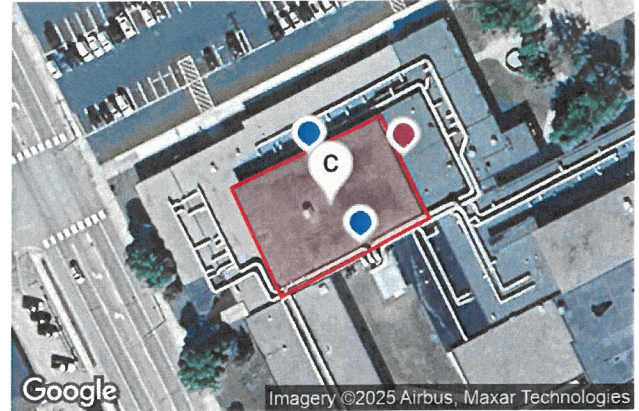
1

Perimeter - Metal Edge - Strip In (Emergency)

Roof membrane has separated from metal edge. If the metal edge strip in is failing it can allow water to infiltrate and damage the roof system, deck and building interior.

Remove the loose membrane, secure metal edge joint, clean and prime metal and install new material that extends 3-12" onto roof to ensure water tightness.

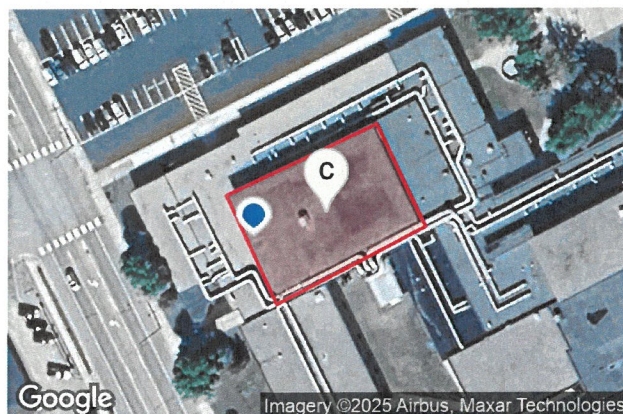
Perimeter - Metal Edge - Strip In (Emergency)

Roof membrane has separated from metal edge. If the metal edge strip in is failing it can allow water to infiltrate and damage the roof system, deck and building interior.

Remove the loose membrane, secure metal edge joint, clean and prime metal and install new material that extends 3-12" onto roof to ensure water tightness.

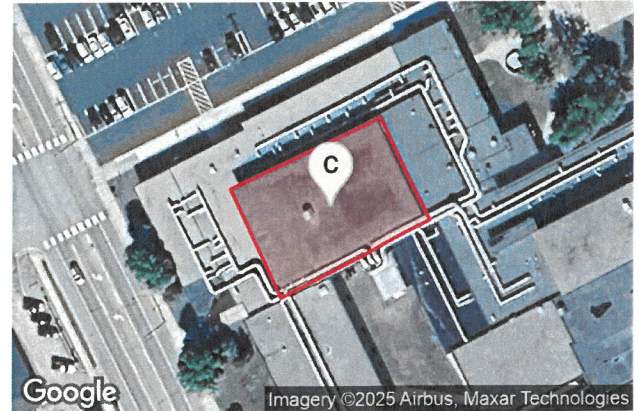
Membrane:	D-
Flashings:	D-
Sheet Metal:	C-
<hr/>	
Overall:	D-

Estimated Replace: 2027

We recommend replacement due to outstanding repair items.

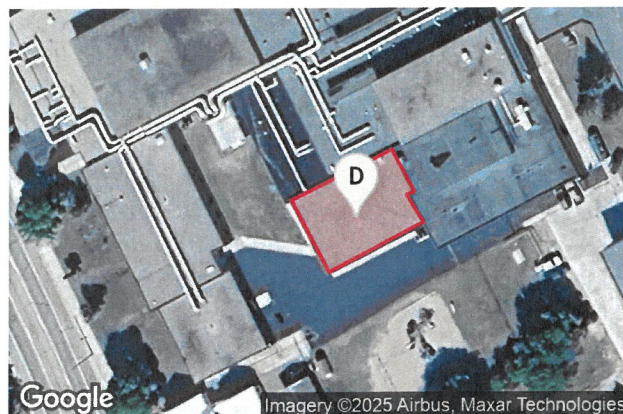
Drainage - Drains/Scupper Open Membrane (Emergency)
