NORTH SLOPE

**ANAKTUVUK PASS
AREAWIDE MECHANICAL AND ELECTRICAL
BUILDING ASSESSMENT AND INVENTORY SURVEY REPORT**

August 19, 2024

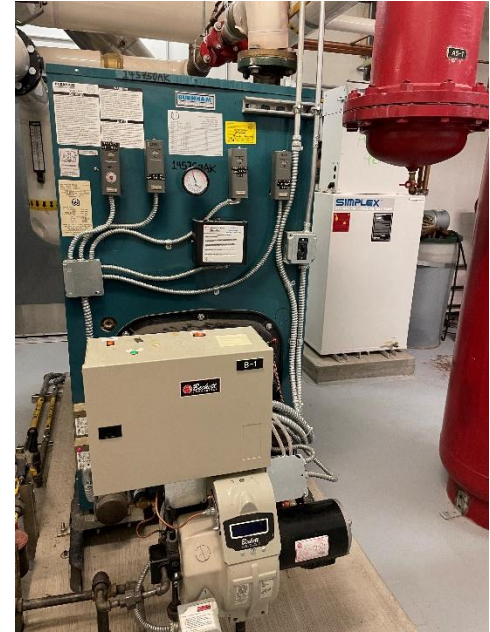
Photo M8 - Boiler and Burner

The heating system consists of two fuel oil cast iron sectional boilers. The boilers are rated at 1,100,000 BTU/hr gross output each. The boilers were installed in the 2012 renovation project. The boilers are in good condition. The boilers are piped in a primary/secondary with a circulation pump per boiler and seven pumps serving the building. The building heating pumps CP-5A/5B and CP-3A/3B have variable frequency drives; the rest of the pumps are constant volume. CP-3A/3b, CP-4A/4B and CP-5A/B operate in a lead/lag configuration. The pumps powered by VFDs will not automatically start after a power outage or when switching back to normal power after being on the generator. CP-3A/B and CP-5A/B are critical to the schools heating system and must be manually restarted. There were signs of leaks at the pump seals in multiple locations. The piping in the boiler room consists of steel and copper piping. The piping outside of the boiler room is nearing the end of its useful life expectancy. The piping in the fan rooms was in poor condition.

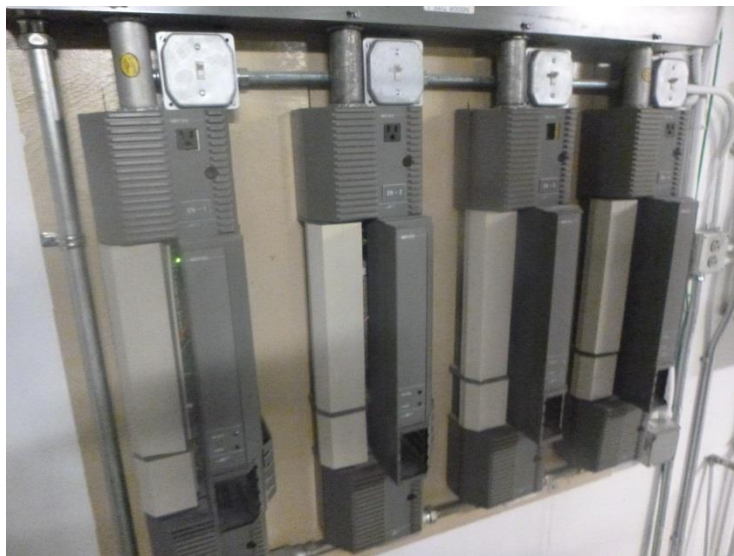
Photo M13 – Metasys Control Panels

The control system utilized throughout the building is a Johnson Control Metasys system. The system was originally installed around 1997 to control the central mechanical equipment. The classroom temperature controls were upgraded to the Johnson system during the 2012 renovation. The main controllers utilized throughout the school in the fan rooms are at the end of their useful life expectancy. The controls were not operating correctly while we were on-site the building was overheating. The main controls should be upgraded to modern DDC controls. The controls installed during the 2012 renovation should be retro-commissioned to verify operation and address issues with overheating of spaces.

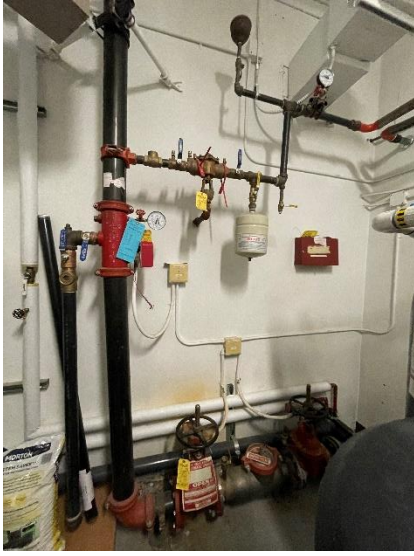
Photo M17– Fire Protection Sprinkler Riser

The fire protection system is a wet sprinkler system and is supplied from the city water utility. The system is in fair condition. No issues were reported with the system. The sprinkler heads are not quick response required by IBC for use in school occupancies. The sprinkler heads should be replaced with quick response heads. The cold storage room adjacent is protected by a glycol sprinkler system. Glycol sprinkler systems with the concentration required for freeze protection in Northern Alaska are no longer allowed by NFPA 13. The sprinkler system should be replaced with a dry pipe sprinkler system.

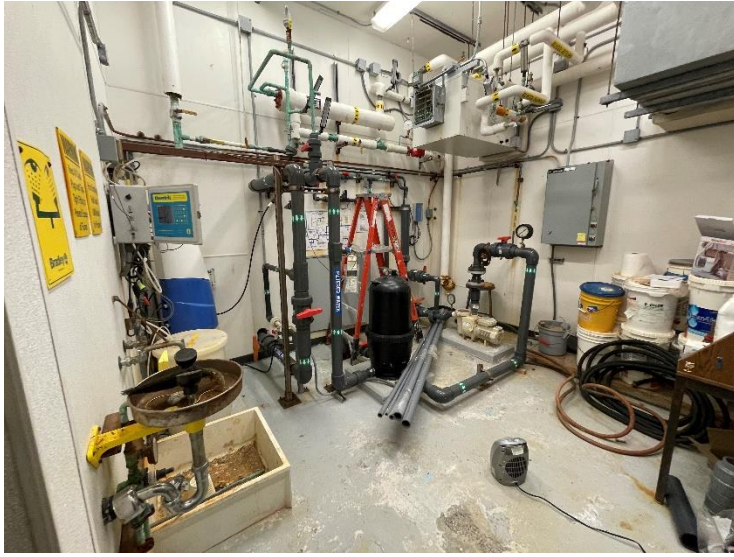
Photo M19 – Pool Mechanical Room

The pool equipment room was upgraded during the 2012 renovation project. The pool equipment is in good condition. The chemical feed controller was not working according to on-site maintenance staff.

The pool was drained and out of commission during our site visit. Work was in progress to repair the pool equipment.

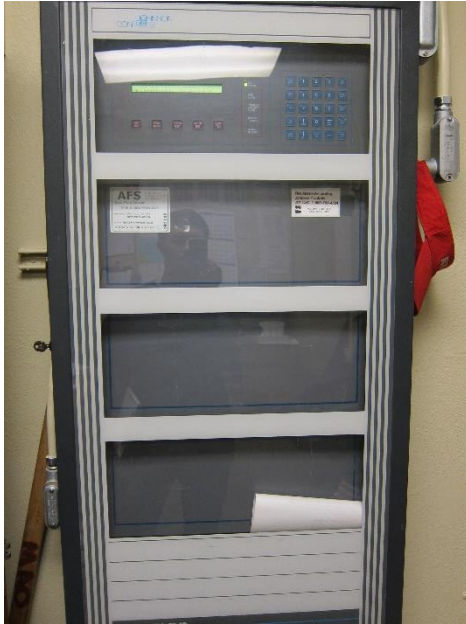
Photo E8 – Fire Alarm Control Panel

Arctic Fire and Safety has recently updated the FACP with a new Notifier system, in the existing Metasys enclosure, along with annunciation devices. Original smoke detectors remain which are compatible with the new system controller. The new FACP is ready to be upgraded to the new code required voice evacuation system. New system is using the old Metasys enclosure. (Photo E8a).

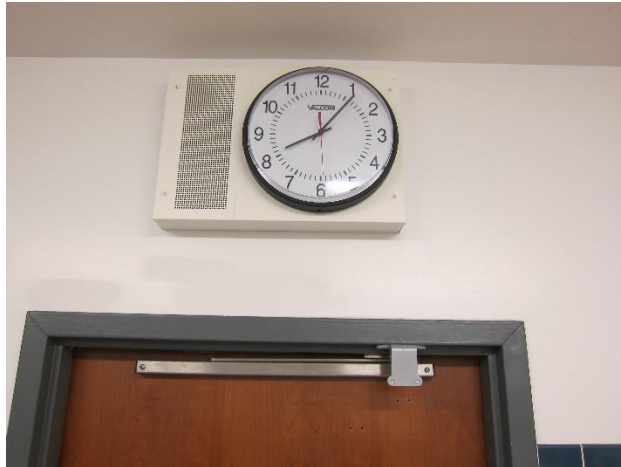
Photo E10 – Typical Combo Clock/Speaker

The clock system appears to be repaired with only a couple of clocks in classrooms having issues.

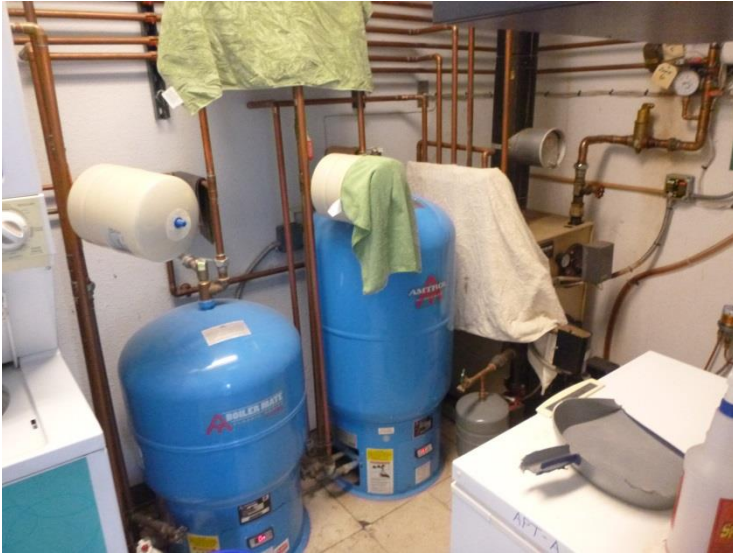
Photo M1 – Mechanical Room
Ventilation

Ventilation is provided by three HRVs, one Venmar HRV is installed to serve each unit. The HRVs do not have preheat coils and have limited capacity for operation in the winter. The HRVs were not operating when we were on-site.
