FACILITY AUDIT BOYCEVILLE COMMUNITY SCHOOL DISTRICT APRIL 2023

PREPARED BY: CESA 10 Facilities Management 725 W Park Avenue Chippewa Falls, WI 54729 888-947-4701 http://facilities.cesa10.org

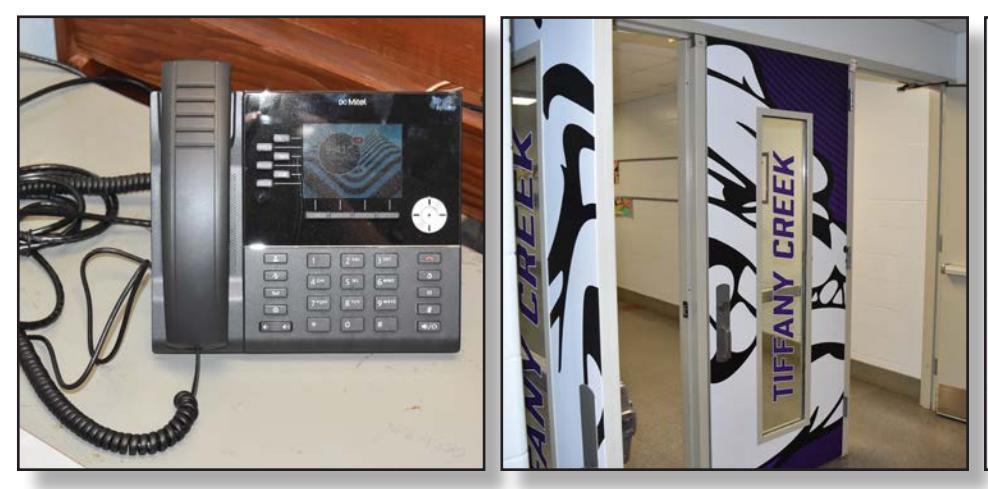
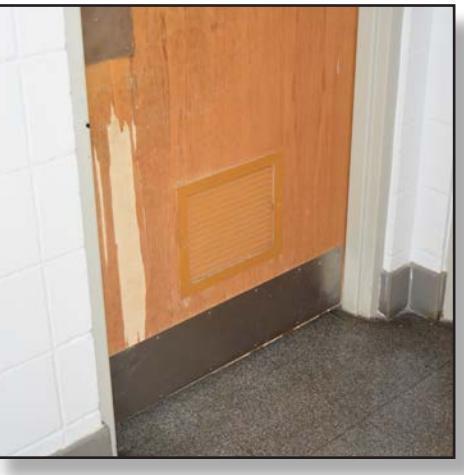
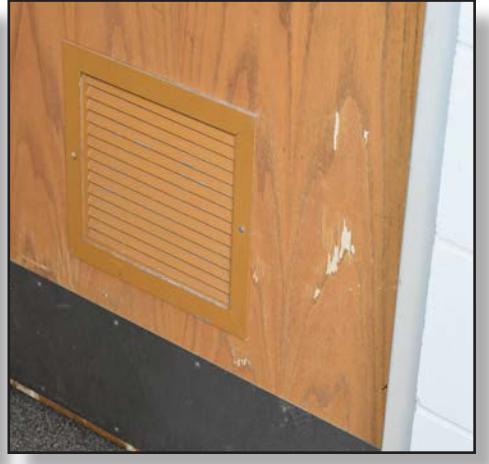
Interior Doors/ Walls	The District has started branding efforts by installing Bulldog contact paper on windows. However, the existing floor and wall colors must also be updated in school colors for a cohesive look.	The District can expand on branding efforts by painting interior walls in school colors to promote school spirit and make the building interior more aesthetically pleasing.	7	7	7	6	27	2	\$47,000		
Interior Doors	Several wooden interior doors were missing kick plates. Additionally, some hallway door sets were not working correctly and needed updated components.	The District should set a replacement standard for interior door replacements. New classroom doors should have kick plates but no windows for safety purposes. The cost includes 42 new interior classrooms and office doors.	8	8	6	5	27	3	\$165,000

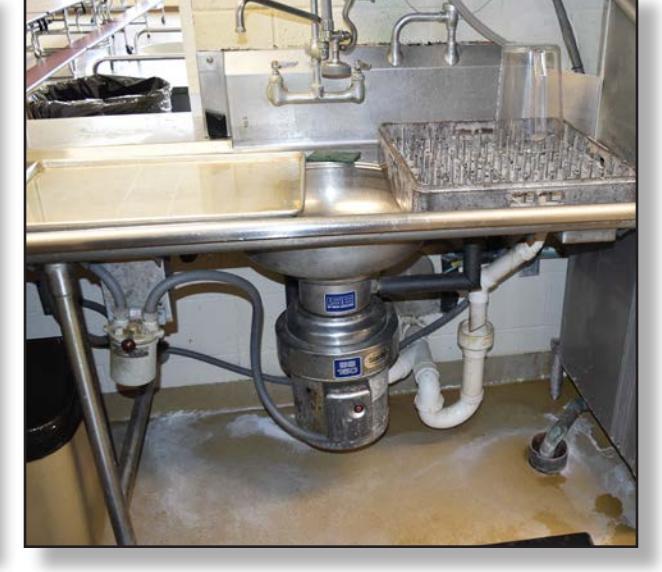
Kitchen Equipment	The kitchen equipment is lacking and should be updated, including replacing the exhaust fan, installing an acid neutralizer on the water heater, adding a walk-in freezer and cooler, establishing storage space, moving the dishwasher next to the three-compartment sink, updating the steamtable and adding a water hookup. The District should also consider adding a server line, so there are two people to help with flow issues.	The District currently prepares most of the food in the Middle/High School and transports it to the Elementary School. This requires temperature checks and staff time. By updating kitchen equipment and storage options, the District can increase the safety and efficiency of this operation.	7	6	6	7	26	2	\$85,500

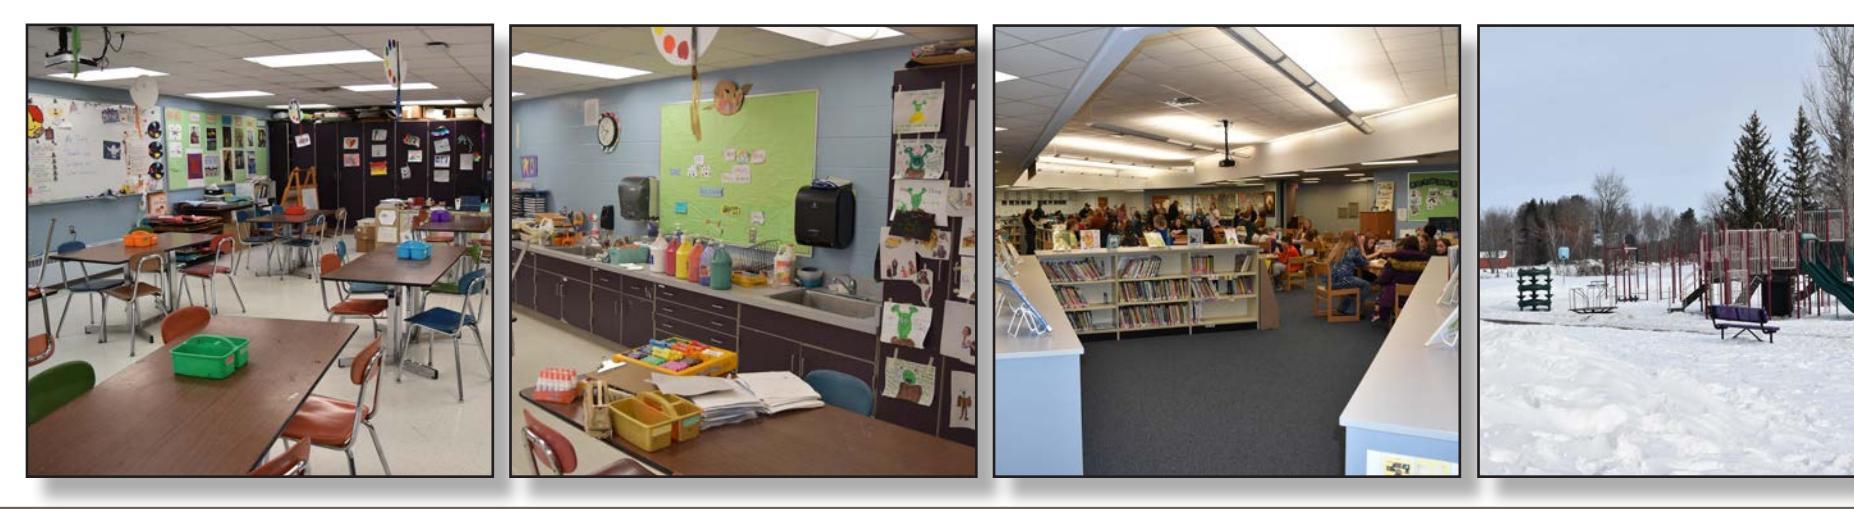
Playground Equipment	Some of the playground equipment appeared to be outdated and deteriorating. Surface materials are wood chips brought in annually to maintain sufficient depth.	The District should begin a replacement schedule for the playground equipment. The price includes the lower elementary playground equipment. CESA 10 also recommends adding edging around equipment to keep woodchips in place.	7	7	6	6	26	2	\$95,000

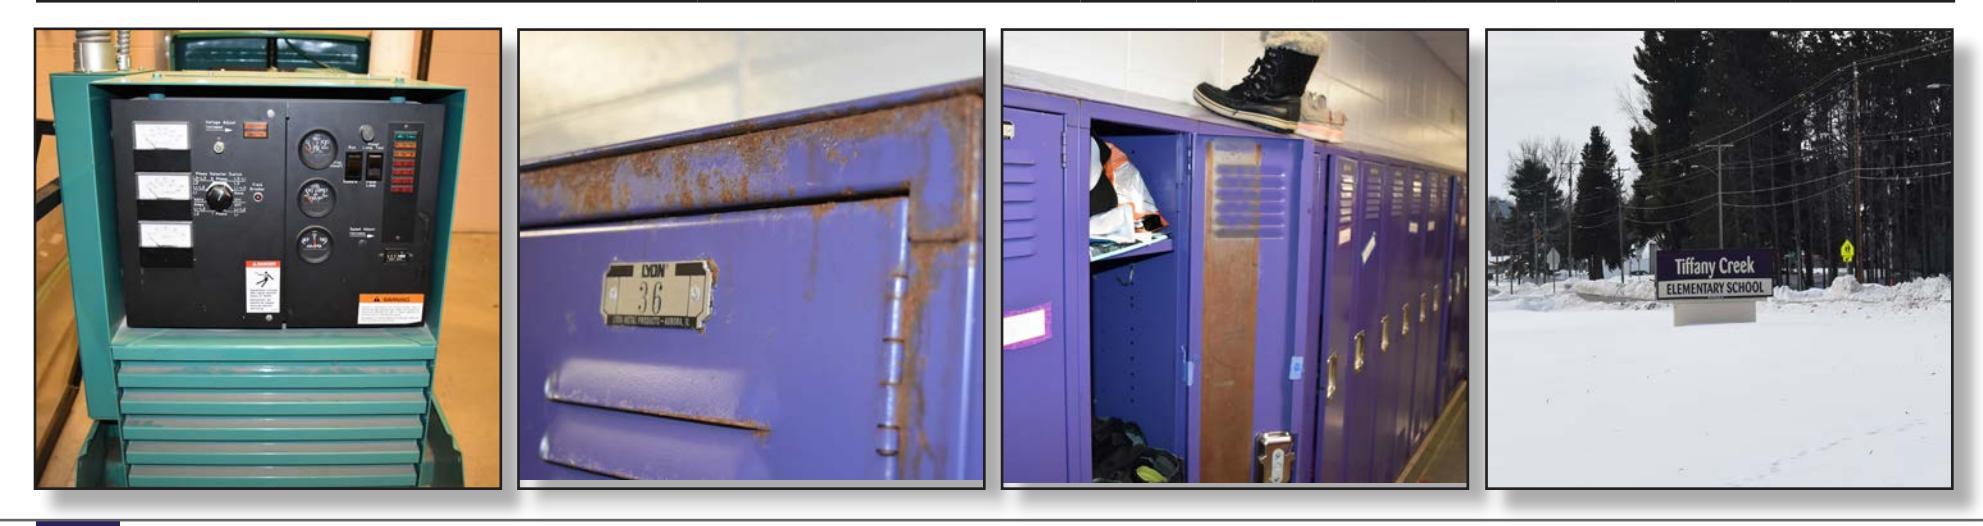
Main Office	The main office area is outdated and would benefit from new paint, carpeting, and casework.	If the office location is moved, this space should be updated at that time. If the office isn't moved, this area could use a facelift.	6	6	6	5	23	2	\$18,000		
Exterior Signage	The elementary school would benefit from an electronic marquee for its front sign.	The District should invest in a light- up marquee sign.	6	6	6	5	23	2	\$22,000

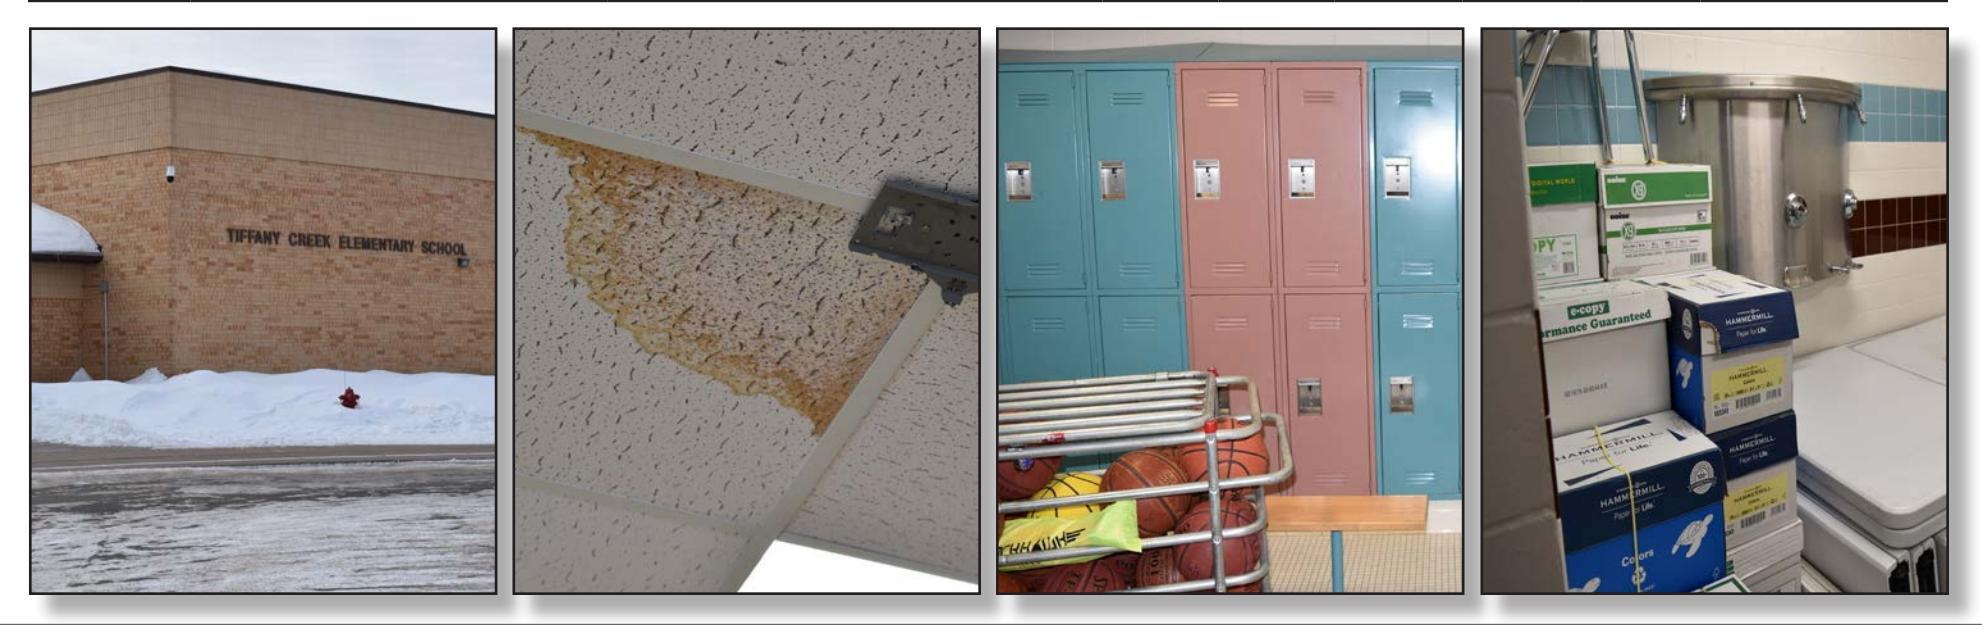
Locker Rooms	The gymnasium locker rooms are currently only being used for storage.	The District should investigate a better use of these spaces. If storage is the best use, invest in racking for improved organization.	6	6	5	4	21	-	-

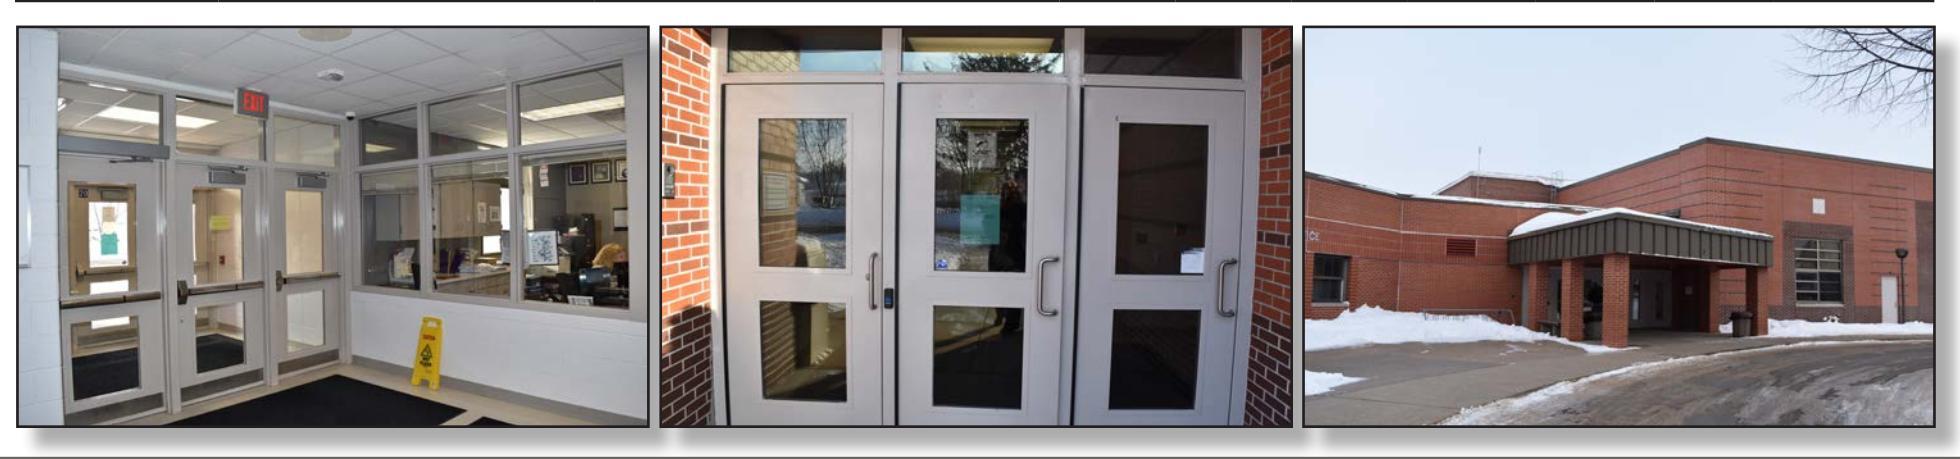
District Office Secure Entrance	The District office entrance is similar to the MS/HS entrance. Visitors are buzzed in by the main office and have free reign of the school.	The District should explore updating the vestibule area and installing a window from the District office storage room to allow office staff to greet guests coming into the building. CESA 10 recommends updating signage to push visitors to the MS/HS entrance.	9	9	8	8	34	3	\$115,000

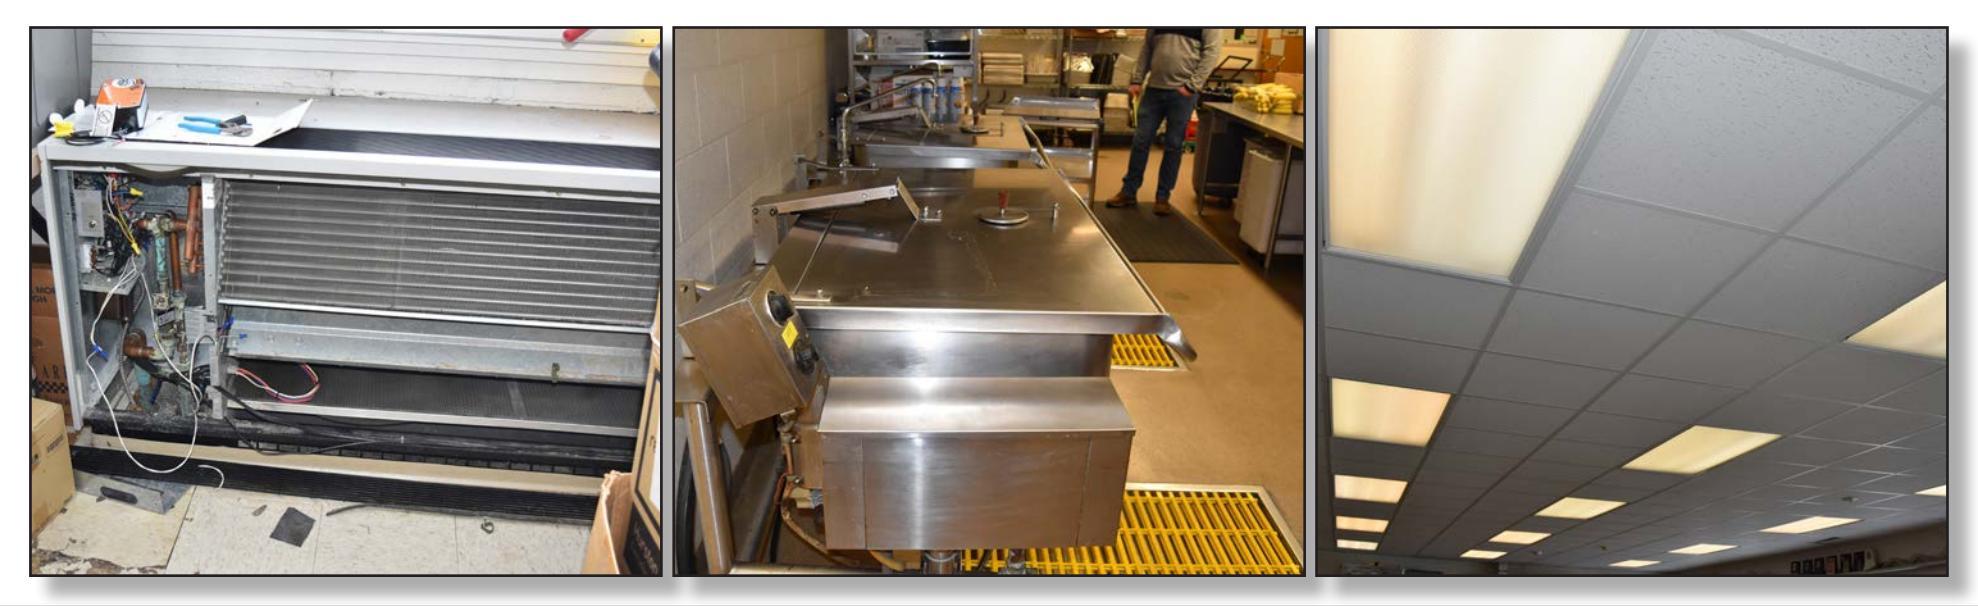
Lighting Interior	The entire school utilizes fluorescent technology lighting. The District should invest in LED lighting for all interior fixtures.	The District will benefit from light level upgrades, dimming capability, energy efficiency, and cost reductions through a building-wide LED conversion.	9	7	7	7	30	3	\$525,000

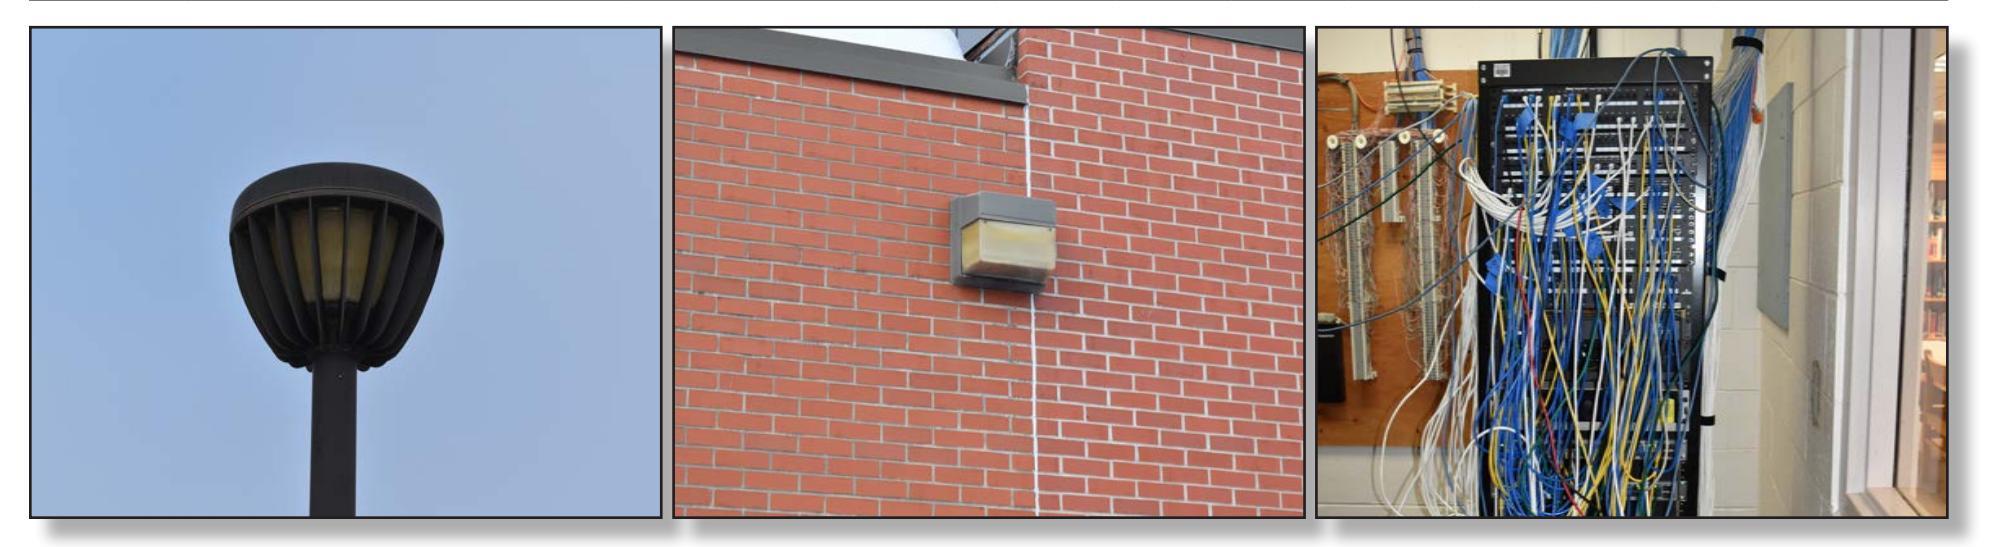
IT Cooling	The Mitsibushi unit in the IMC closet is leaking freon and needs to be replaced.	The District should replace the unit.	7	8	7	8	30	1	\$8,000

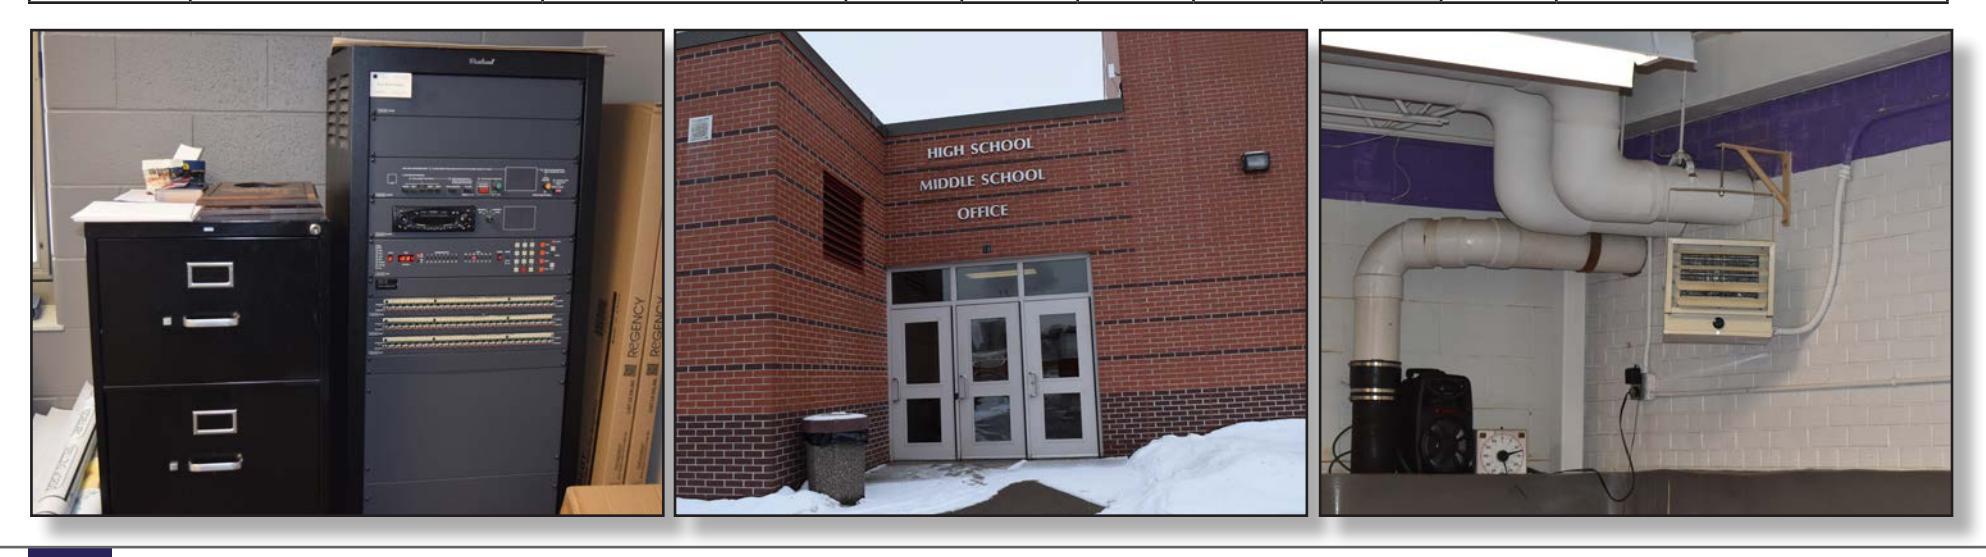
Exterior Signage	Exterior signage for the Middle/ High School office should be updated to make things more clear for building visitors.	Exterior signage will need to be updated to reflect entry procedures if the District installs a secure entrance at the Middle/High School.	7	7	8	7	29	1	\$550	
MS Wrestling Room	The Middle School wrestling room needs new lighting and a hydronic unit heater.	CESA 10 recommends updating the space heater to a hydronic unit heater.	7	7	7	8	29	2	\$18,000

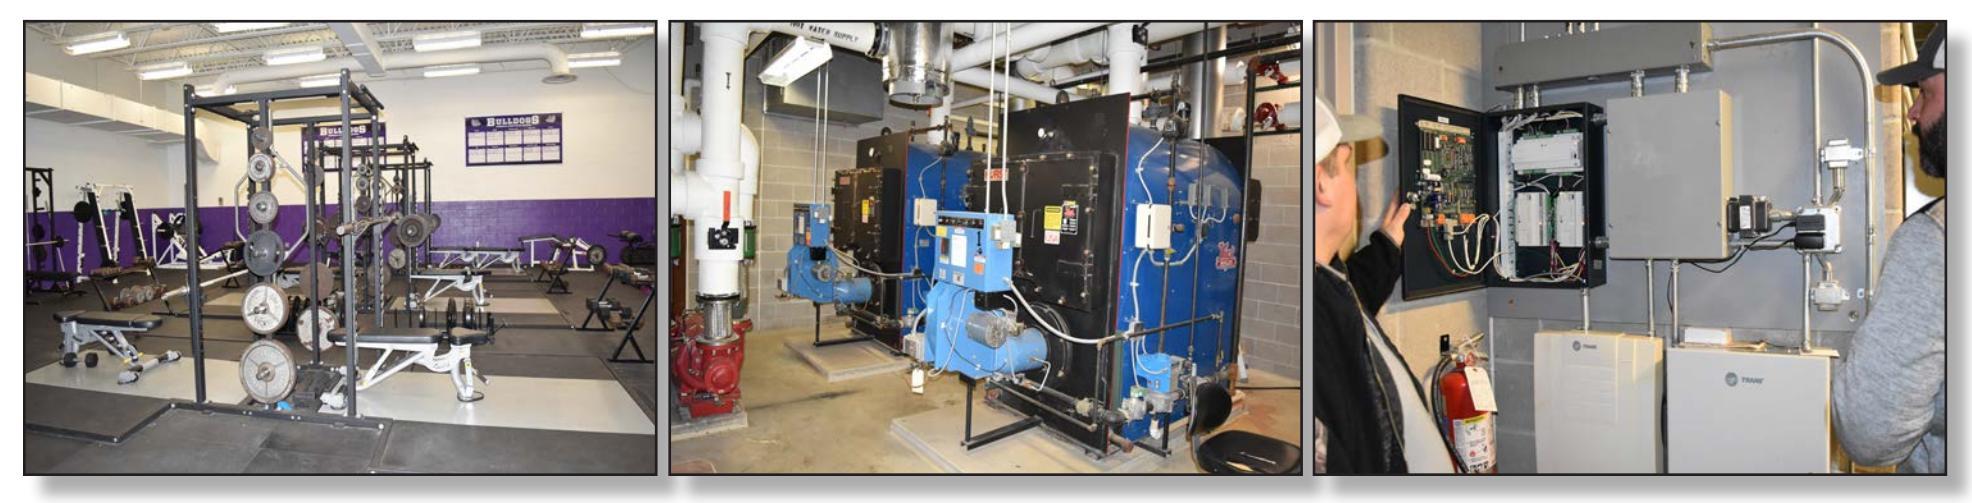
HVAC Controls	The school has two building automation systems (Trane Tracer/Gene Al). The staff mentioned it is difficult to control certain areas of the buildings, and the systems don't communicate with each other.	The District should replace the existing systems with one that serves the entire building and pick up uncontrolled areas. CESA 10 recommends adding Co2 censors to the AHUs for better control. This will save the District energy and help control building comfort.	8	6	8	6	28	3	\$425,000

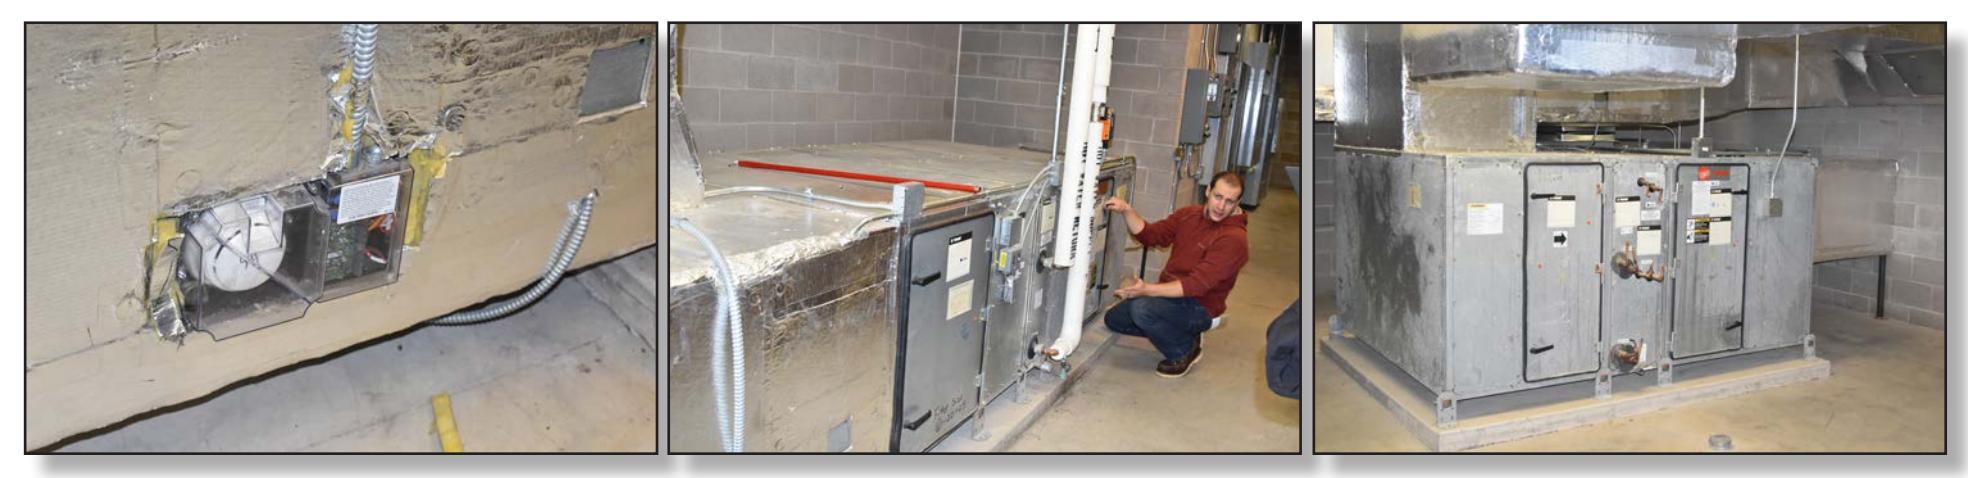
•••	Facility Improve	ement Measures			Project	Recommer	dation Pri	ority Order	
	C • E • S • A ¹⁰ Boyceville Community School District Facilities Management Services Middle/High School			High=10 Med=5 Low=0	Poor =10 Ave =5 Great =0	<2 yr=10 5 yr= 5 10 yr= 2 20 yr= 0	Priority	<\$10K=1 <\$100K=2 >100K=3	
Building System	General Description	Recommendation	Useful Life	EHS Concern	Func. Cond.	ROI	Total Points	Proj. Cost	Cost Est.
Commissioning	The school has completed several mechanical projects over the years. If the District pursues the HVAC projects recommended in this report, it would be good to commission the building afterward.	Commissioning is recommended when HVAC projects are completed. Commissioning effectively keeps energy costs low, minimizes system problems, and improves building operations.	7	7	7	7	28	2	\$65,000
Air Handling Systems	The building has several different ventilation systems, with numerous air handling units at the end of their useful life. These units should be updated to avoid ventilation-related concerns. The school has humidity issues in several areas due to this, which can cause odors and environmental problems.	The High School wrestling and locker room unit should be replaced. The AHU-2E that serves the classroom addition is noisy, and interior components should be updated. There is currently no ventilation in the Middle School wrestling room, and a new system should be installed. Some of the units updated in 2000 need controls with VFDs installed.	7	7	7	7	28	3	\$185,000

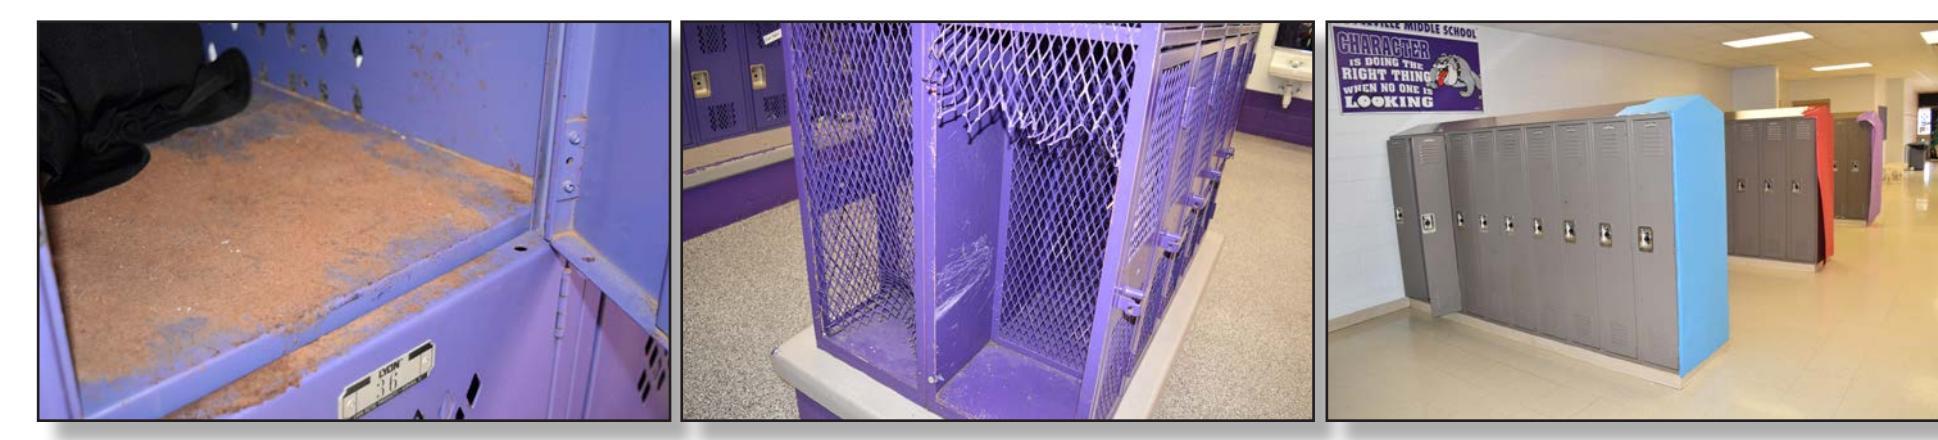
Student Lockers	The Middle School houses a bank of lockers in an open area, which raised a safety concern. While multiple cameras were trained on this area, students can still hide behind the rows of lockers. Plus, it leads to increased maintenance time to clean between each row.	The District should update all Middle School lockers with new ones. The lockers on the southwest side of the building should be flush with the wall to open up the space for safety.	8	7	7	6	28	3	\$135,000

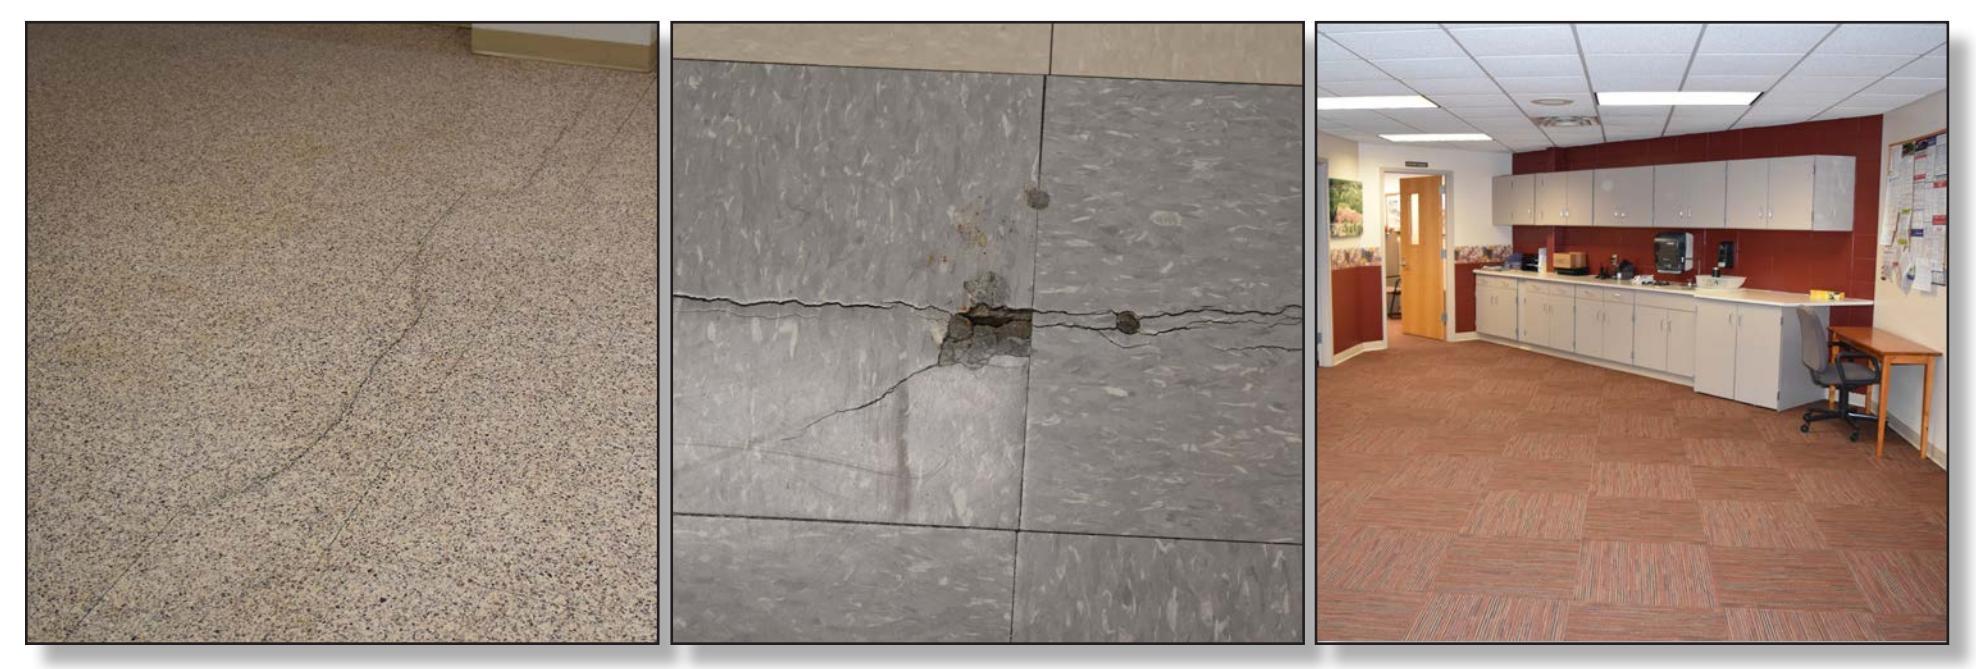
Facility Improvement Measures			Project Recommendation Priority Order								
	G • E • S • A ¹⁰ Boyceville Community School District Facilities Management Services Middle/High School			High=10 Med=5 Low=0	Poor =10 Ave =5 Great =0	<2 yr=10 5 yr= 5 10 yr= 2 20 yr= 0	Priority	<\$10K=1 <\$100K=2 >100K=3				
Building System	General Description	Recommendation	Useful Life	EHS Concern	Func. Cond.	ROI	Total Points	Proj. Cost	Cost Est.			
Rooftop Units	Two existing rooftop units are at the end of their useful life. All roof-mounted condensing units are nearing or past their useful life cycle.	The rooftop units and roof-mounted condensing units should be replaced.	7	6	7	7	27	3	\$175,000			
Flooring	The flooring throughout the school is a mix of VCT and carpeting that is aged and deteriorating. Pockmarks can be seen in the tile in many classrooms, and several cracks are apparent throughout the hallways and cafeteria. The current flooring isn't maintenance friendly and is difficult to keep clean. Significant tile perimeter discoloring was noted during the audit.	The District should replace the flooring with a more maintenance- free epoxy that is easier to clean. Carpet squares in certain areas, like the IMC and office areas, will keep noise levels down and be easy to switch out. Cost estimates are for approximately 220,000 square feet of flooring.	8	7	6	6	27	3	\$430,000

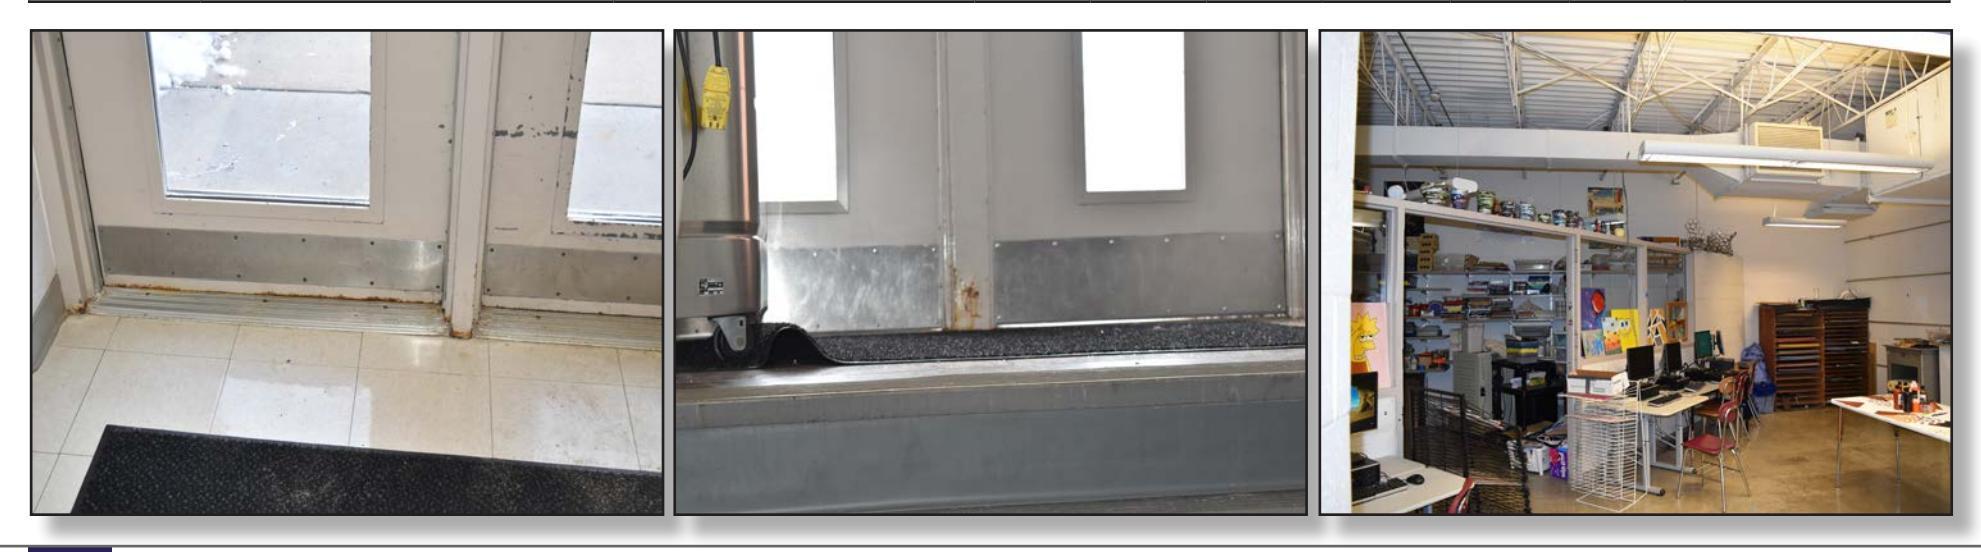
Art Room Mechanical	The air handling unit is loud and distracting in the art room. The noise echoes in the room.	The District should update the air handling unit and install a drop ceiling to help with acoustics.	7	7	8	5	27	2	\$78,000

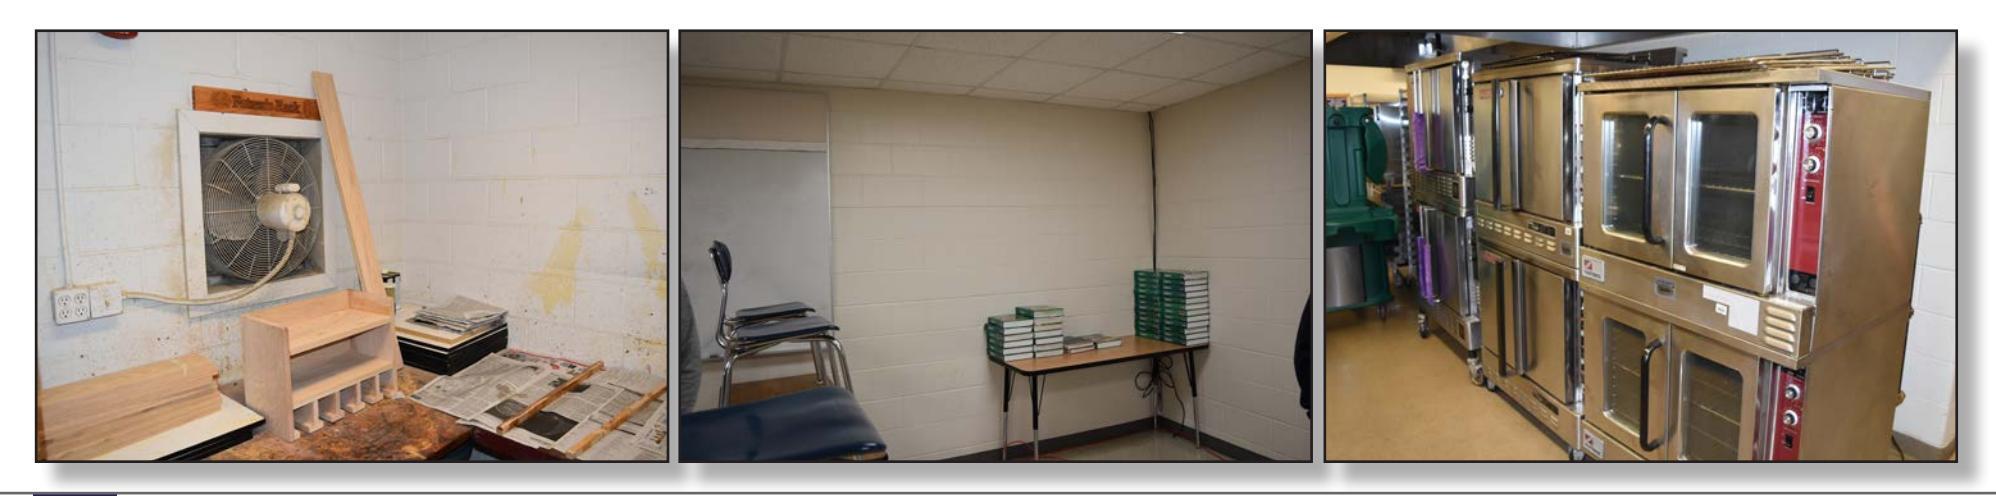
Kitchen	The kitchen equipment is functional but nearing the end of its expected useful life. There are maintenance issues with water pressure and the condensing units for the refrigerator and freezer. Two double-convection ovens should be replaced.	The District should update the condensing units and two double convection ovens and fix the plumbing issues with the water pressure.	7	7	6	6	26	2	\$75,000

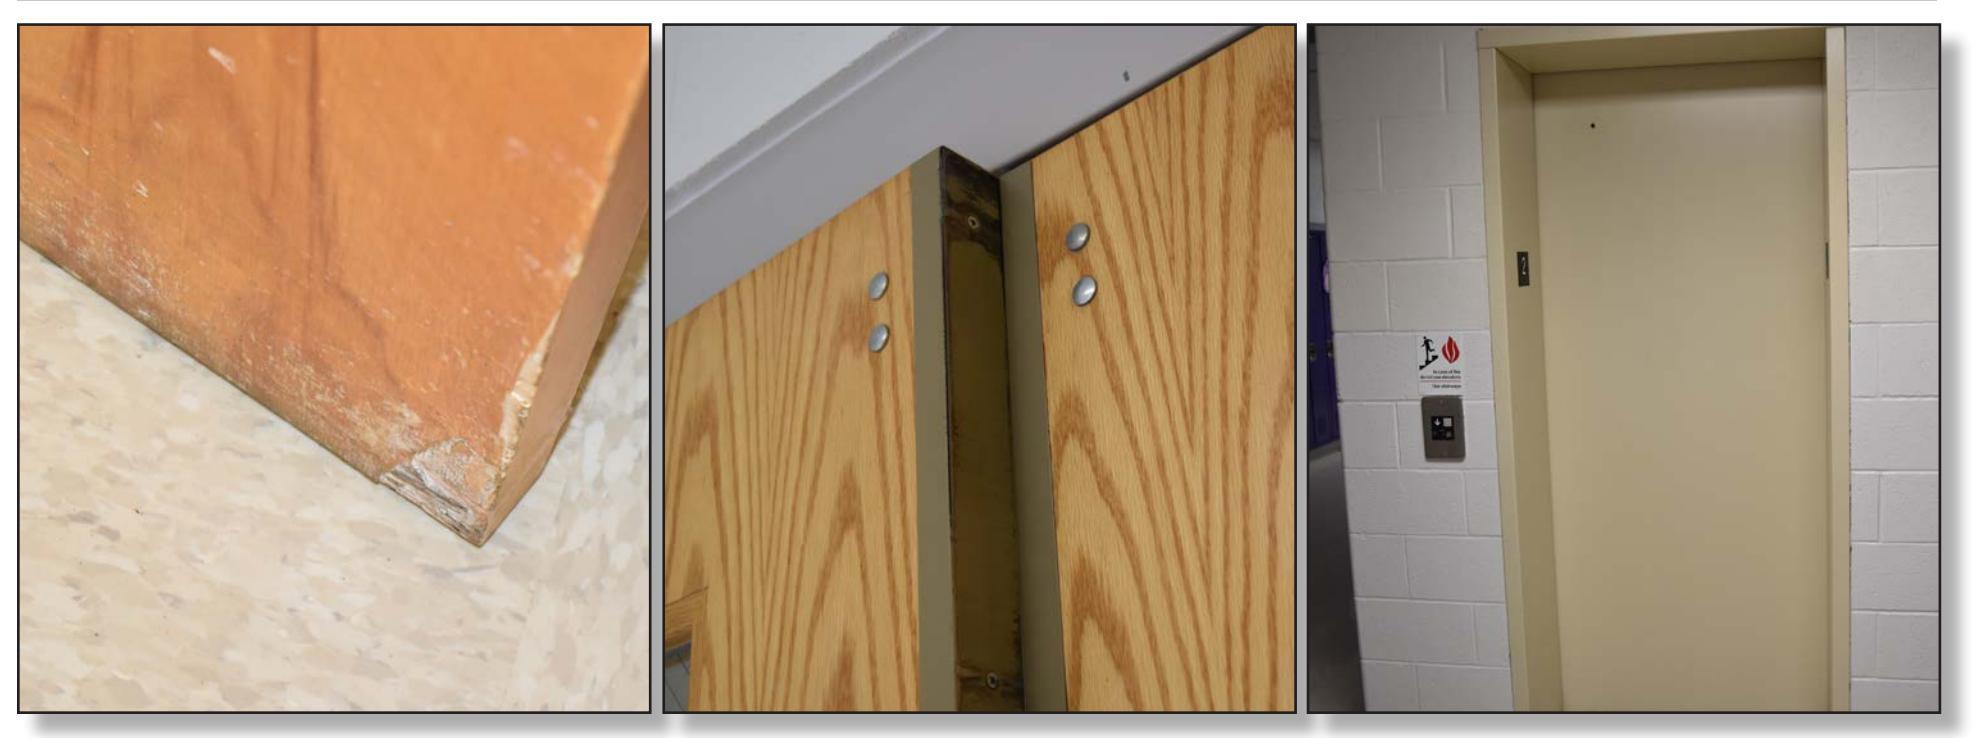
Facility Improvement Measures				Project Recommendation Priority Order								
C • E • S • A ¹⁰ Boyceville Community School District Facilities Management Services Middle/High School		<2 yr=10 3-5 yr= 7 5-10 yr= 3 10+ yr= 0	High=10 Med=5 Low=0	Poor =10 Ave =5 Great =0	<2 yr=10 5 yr= 5 10 yr= 2 20 yr= 0	Priority	<\$10K=1 <\$100K=2 >100K=3						
Building System	General Description	Recommendation	Useful Life	EHS Concern	Func. Cond.	ROI	Total Points	Proj. Cost	Cost Est.				
Interior Doors	Several wooden interior doors were chipped, scratched, broken, or missing locks.	The District should set a standard for interior door replacements and consider moving from a physical lock to a key fob system to enhance security and ease of use. Also, look at solid doors with no windows for safety purposes.	8	8	8	2	26	3	\$101,000				
Elevator	The one working elevator appeared in good condition and had recently passed inspection. The Middle School elevator was inoperable at the time of the audit.	The District should repair or replace the Middle School elevator, depending on its condition. The estimated cost listed is to repair it.	7	7	7	5	26	2	\$42,000

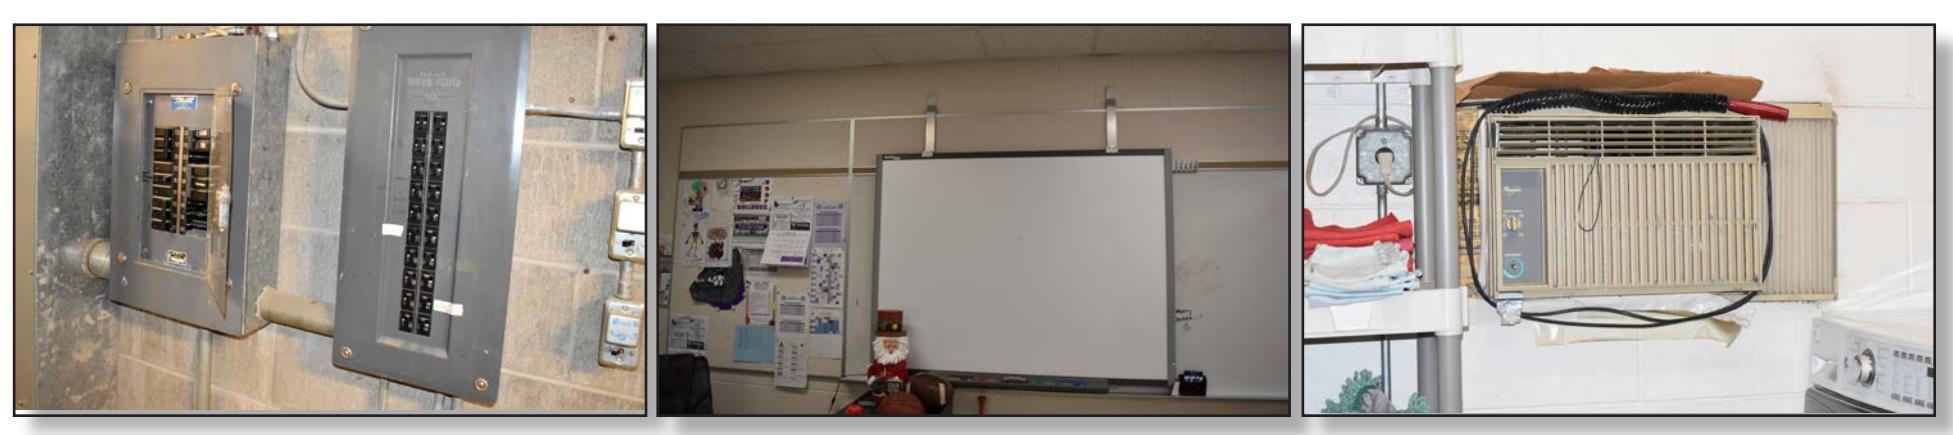
Dehumidification	There is cooling in certain areas but not the entire building. Current locations with cooling are the District office, High School offices, and kitchen. Neither gymnasium has cooling. The District runs dehumidifiers in the summer months. CESA 10 noted some water damage on the edge of the Middle School gym that could be due to humidity issues.	The District should add a chiller to include the entire building for cooling and dehumidification. The chilled water would be piped to central air handling stations for cooling and dehumidification. This will improve the learning environment and prevent humidity issues.	7	7	7	4	25	3	\$1,750,500

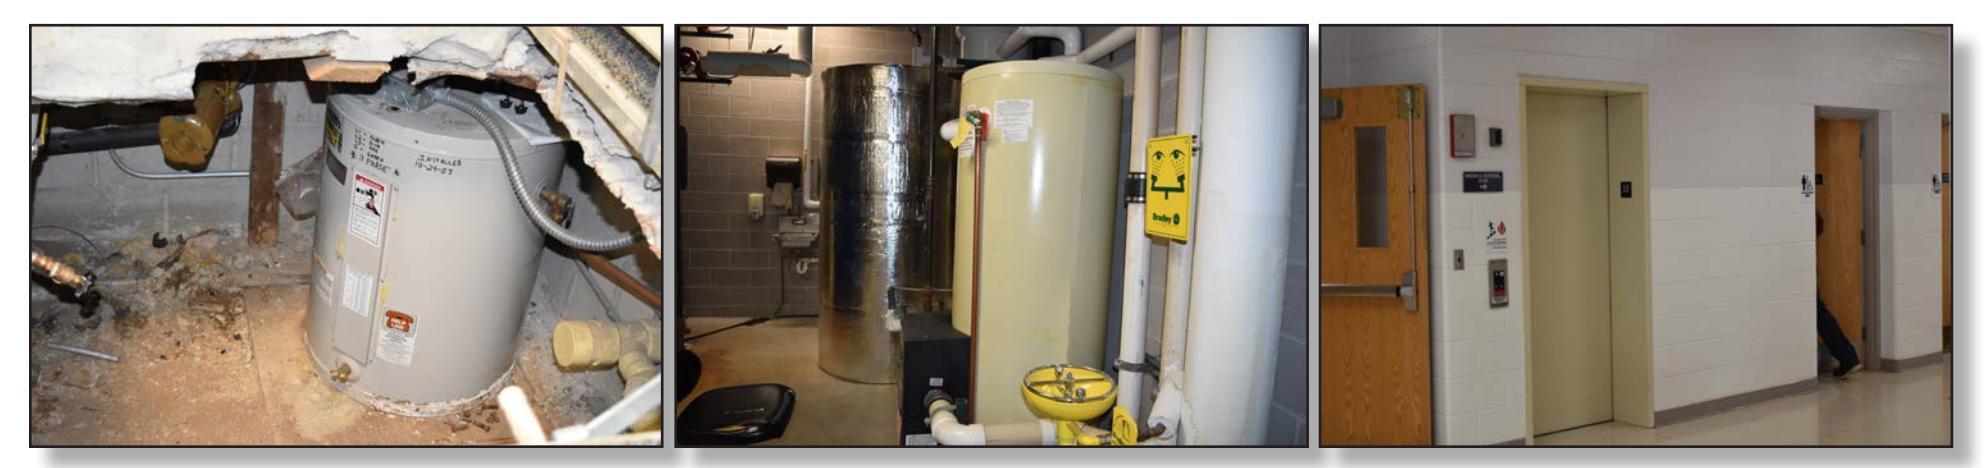
ADA	Several ADA-compliance issues were noted during the audit. The Middle School locker rooms needed ADA- compliant bathrooms, the restroom by the gym had only a 31.5-inch passage, not large enough for a wheelchair to access the stall, and the Middle School elevator leading to the wrestling room was broken.	When updating the locker room areas, the bathrooms should be updated to achieve ADA-compliance, this includes renovating the existing walls, fixtures, and partitions.	7	7	5	5	24	3	\$185,000

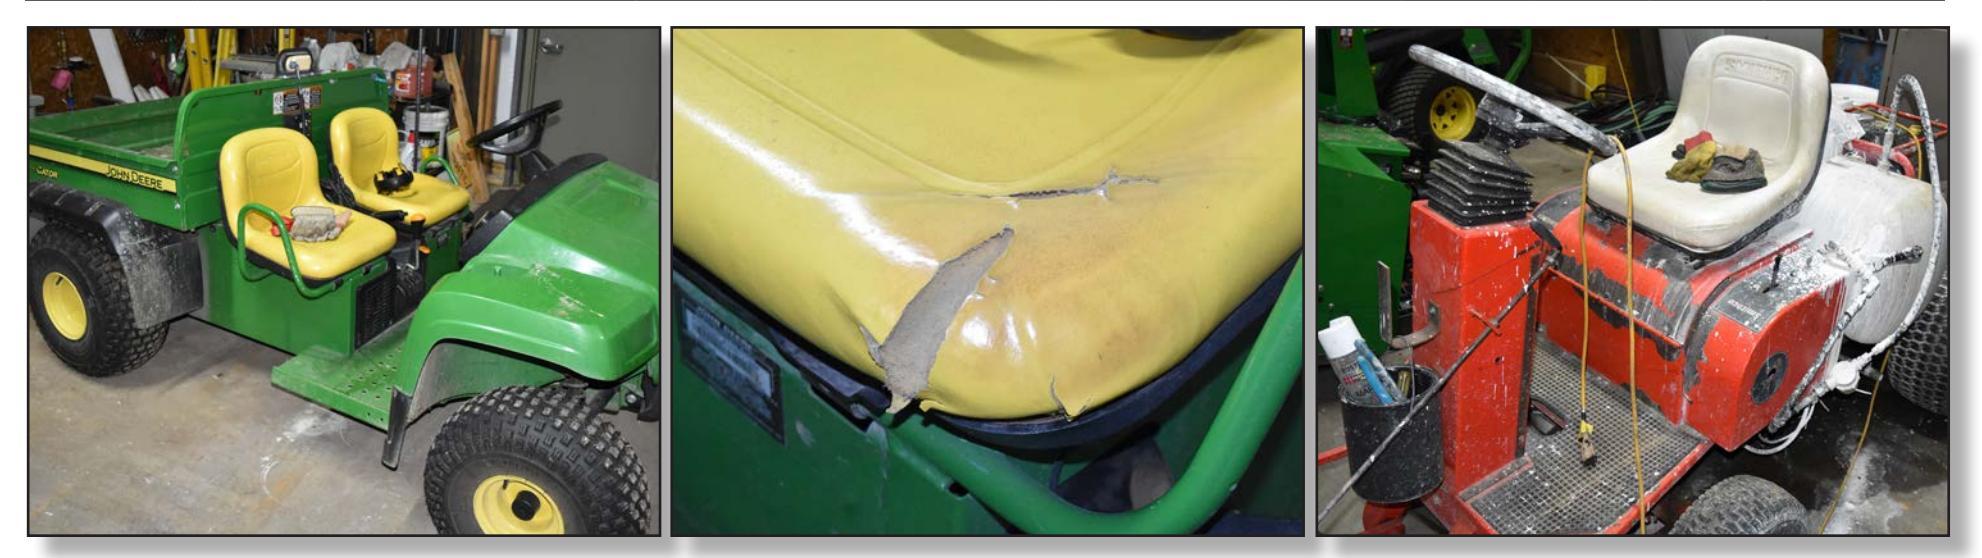
Grounds	Staff members noted several pieces of equipment that need updating, including the paint sprayer, floor scrubber, 1565 mower, and gator. Staff Another ATV is needed with a plow.	The costs estimated are \$15,000 for a paint sprayer, \$25,000 for a floor scrubber, \$35,000 for a 1565 mower, and \$48,000 for a gator with a plow.	7	6	6	5	24	2	\$245,000		
Electrical	Minimal electrical outlets were noted in classrooms. The District should add additional electrical outlets.	The computer lab and IMC would be good areas to add electrical outlets as the spaces are renovated for small groups.	5	7	6	4	22	1	\$7,500
