FACILITY AUDIT BOYCEVILLE COMMUNITY SCHOOL DISTRICT APRIL 2023

PREPARED BY: CESA 10 Facilities Management 725 W Park Avenue Chippewa Falls, WI 54729 888-947-4701 http://facilities.cesa10.org

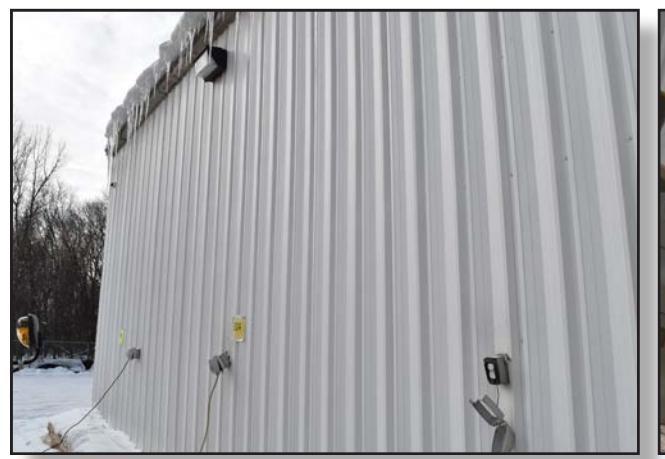
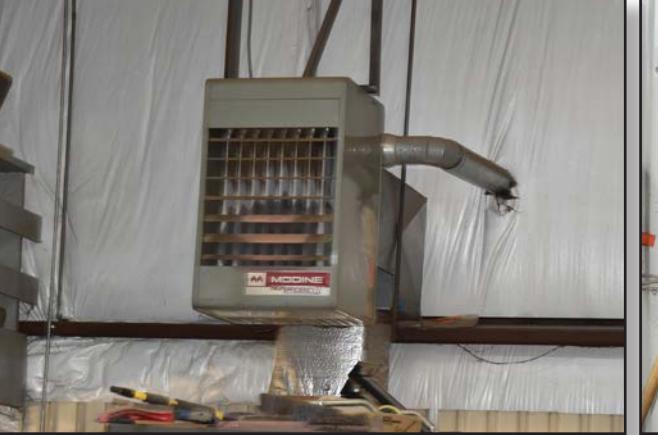
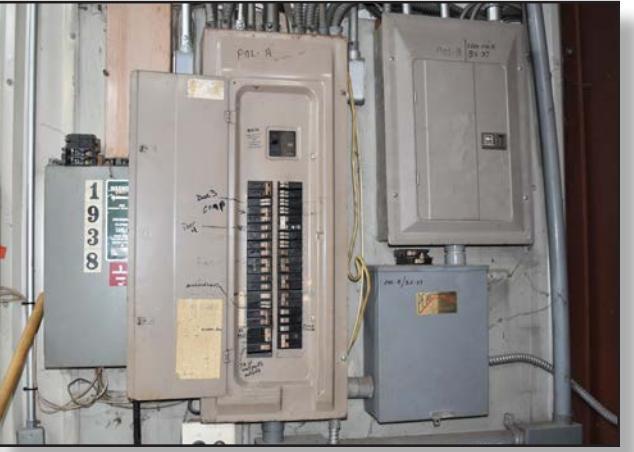
Ventilation	The bus garage smelled heavily of exhaust. While the buses only come inside for maintenance, the District should ensure adequate air quality for staff.	The District should upgrade to a direct gas-fired makeup air unit and monitor ongoing air quality.	8	8	7	6	29	2	\$38,000		
Electrical	The bus garage has a 100-amp 120/208v 3-phase service at full capacity. With this current services, it can not add any additional equipment or electrical load to the building.	The District should upsize the transformer to a 200-amp 120/208v 3-phase service. The main building panel and associated feeder must be upsized to accommodate a larger service. Existing circuits can be reused as needed.	7	7	7	7	28	2	\$75,000
