Site Findings for Daniel Wright

Site Findings for Sprague

Site Findings for Half Day

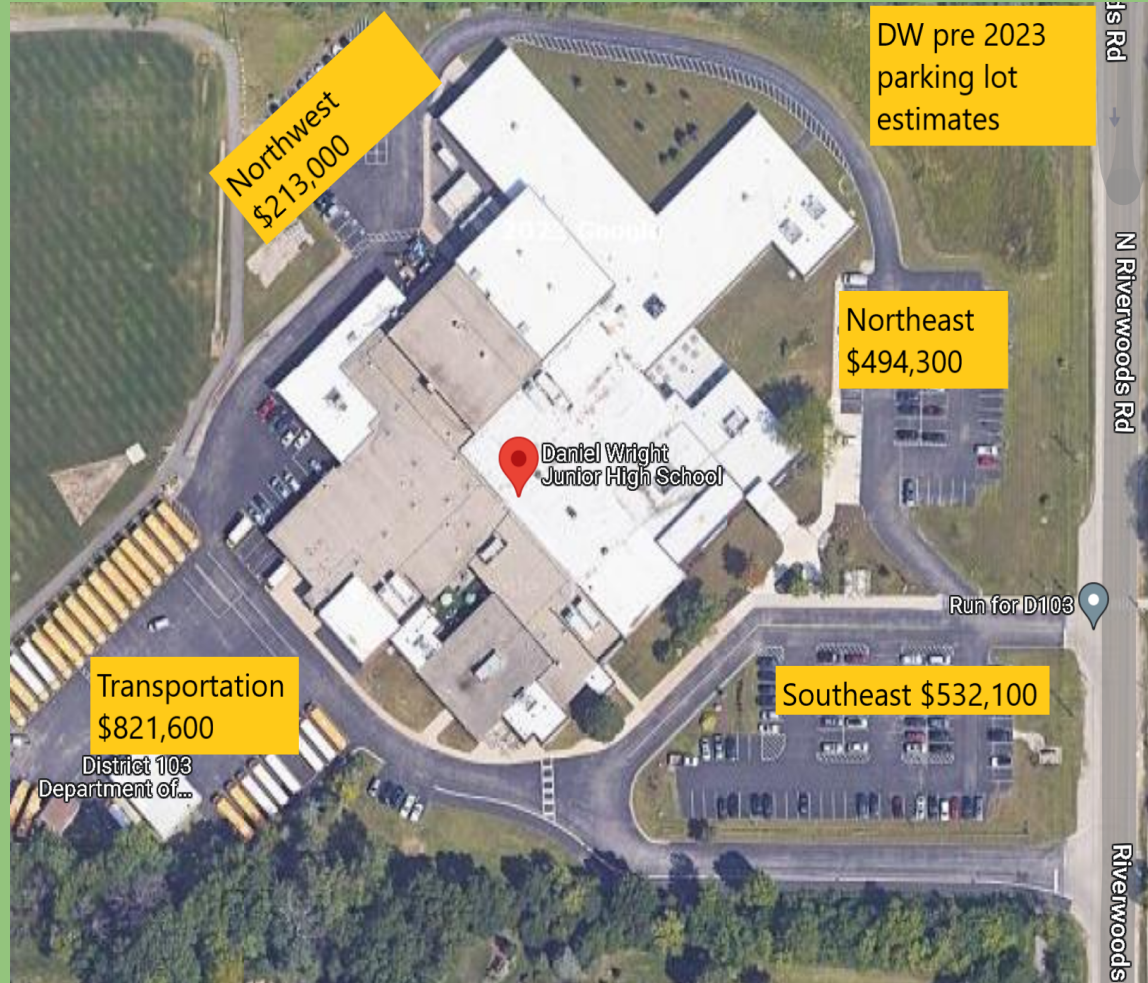
This winter has revealed that the deterioration of the parking areas at Daniel Wright has worsened exponentially.

The parking lots and sidewalks are showing signs of severe disrepair and are in need of replacement.

The current condition of these lots indicate that a complete reconstruction will be needed. Less invasive methods would not be effective at this point.

Upon review with multiple civil engineers, we feel the budget numbers represented on this plan are fair estimates for the work needed at this time.

The higher cost for the Transportation area reflect the use of concrete rather than asphalt. Concrete will withstand the vehicle weight and traffic volume of the buses for a longer duration before failure.

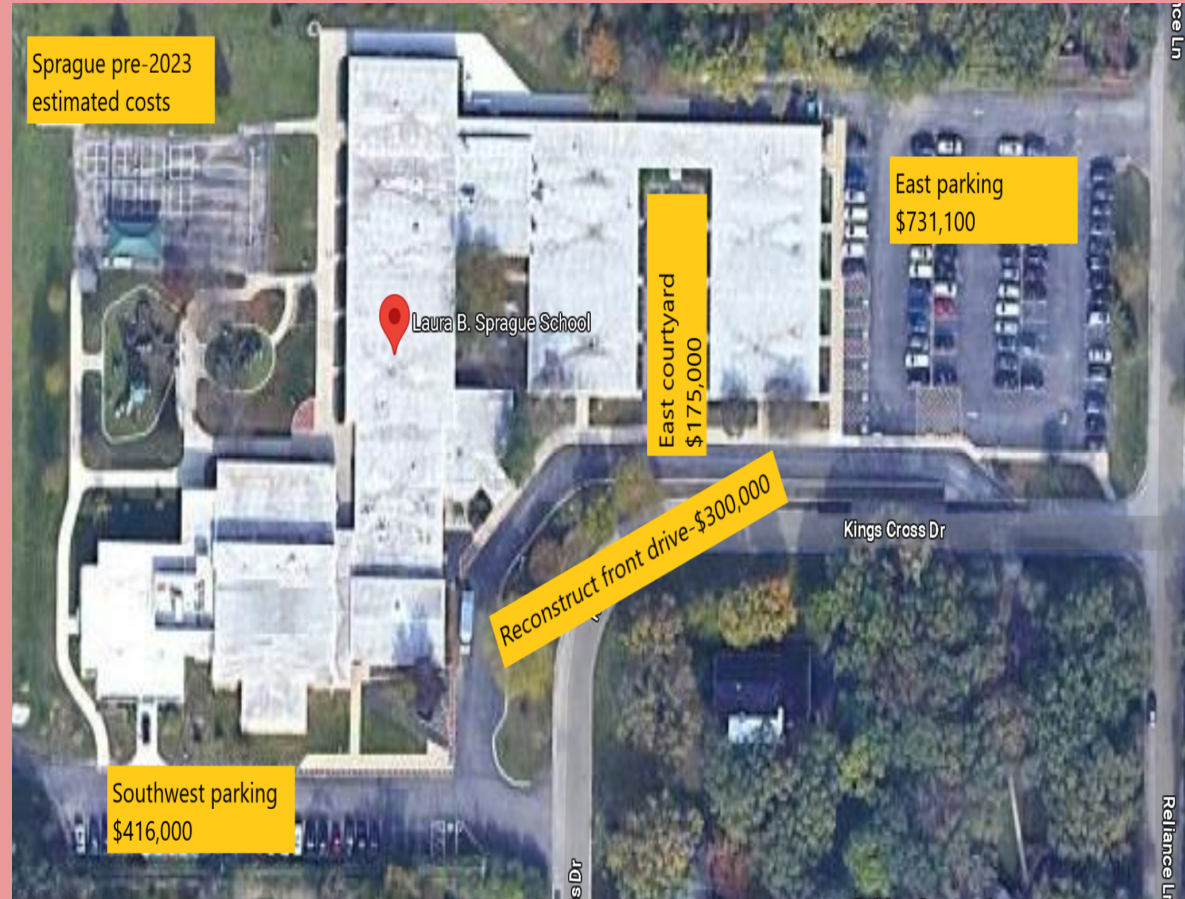
The parking areas at Sprague continue to endure challenges. All parking areas show signs of excessive wear and indicate replacement is necessary.

The pricing on the included map represents replacing the parking lots “as is”. We know that this would not necessarily meet our needs.

Exploration for reconstruction would involve design fees through civil engineers to study the traffic patterns and assess storm water retention needs on this property to ensure the end product suits our long term facility needs.
