Menahga Public School
Menahga Public School - 216 Aspen Ave S
216 Aspen Ave S
Menahga, MN 56464

Summary

Section: Section D

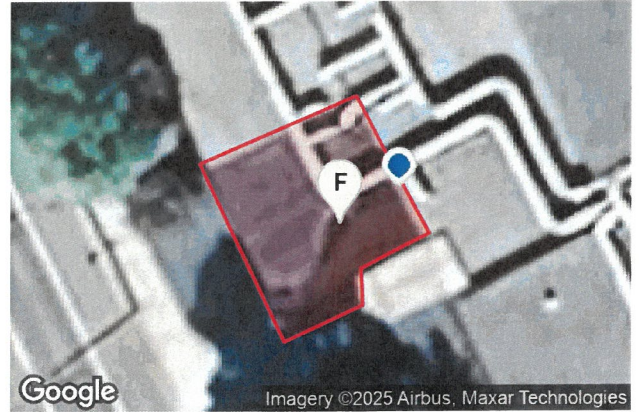
Base Flashing - Damaged (Emergency)

Quantity: 25 LF

Deficiency:

Damaged, missing, or faulty flashing is allowing water to infiltrate.

Corrective Action:

Install new flashing according to industry standards.

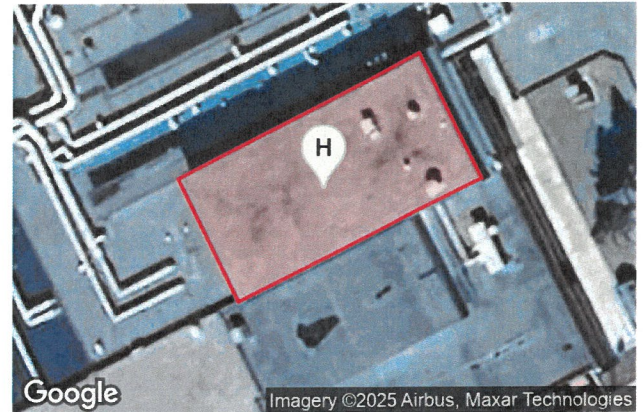
Bird Droppings-Contaminating Roof area

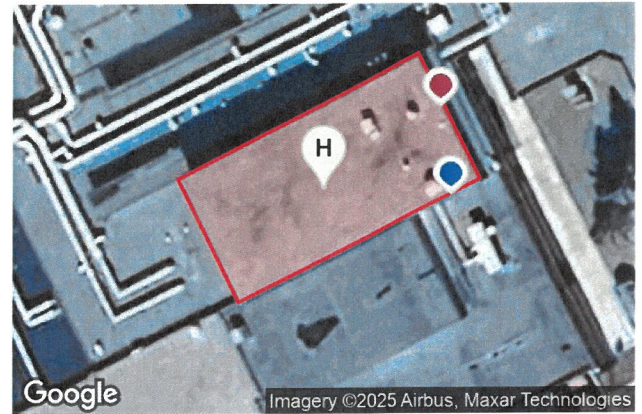
1

Perimeter - Metal Edge - Strip In (Emergency)

Roof membrane has separated from metal edge. If the metal edge strip in is failing it can allow water to infiltrate and damage the roof system, deck and building interior.

Remove the loose membrane, secure metal edge joint, clean and prime metal and install new material that extends 3-12" onto roof to ensure water tightness.

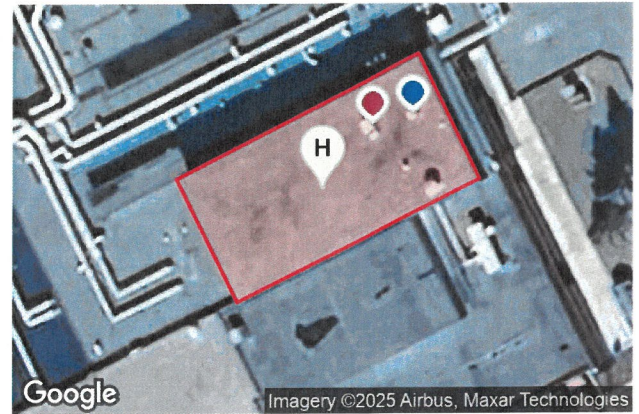
Curb - Exhaust fan curb

Quantity: 1 EA

Need to reflash damaged/bridging membrane at existing curb.

Flash in curb with appropriate materials per manufacturer's installation recommendation's.

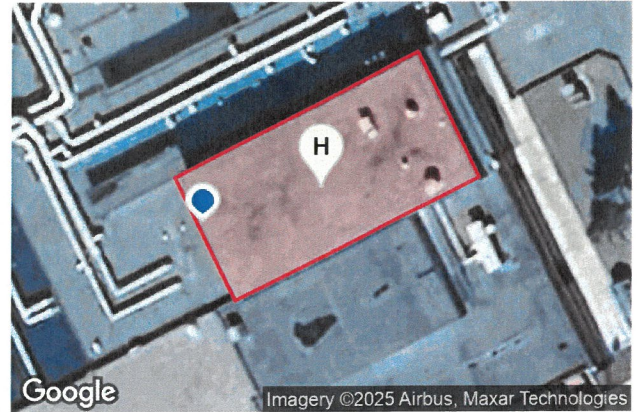
Fastener: Backed Out

Quantity: 1 EA

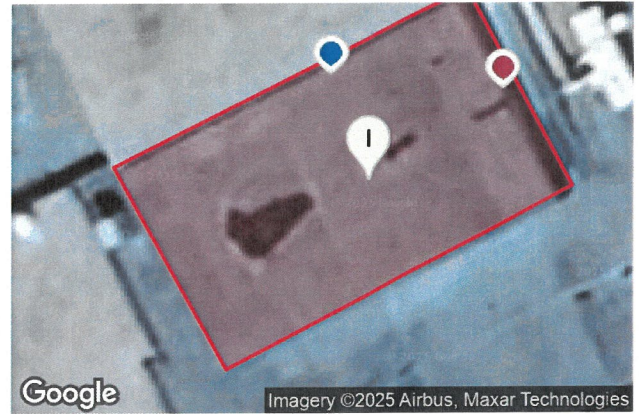
Membrane - Contamination (Excessive bird droppings)

Quantity: 70 LF

Install Bird spikes to prevent further damage.
