Wausau School District

Facility Assessment

September 2024

CESA 10 Facilities Management

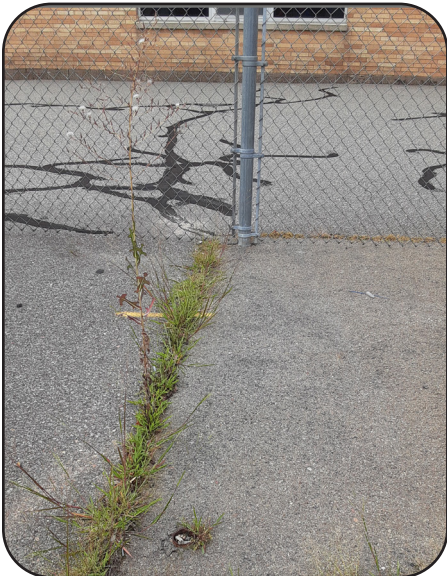
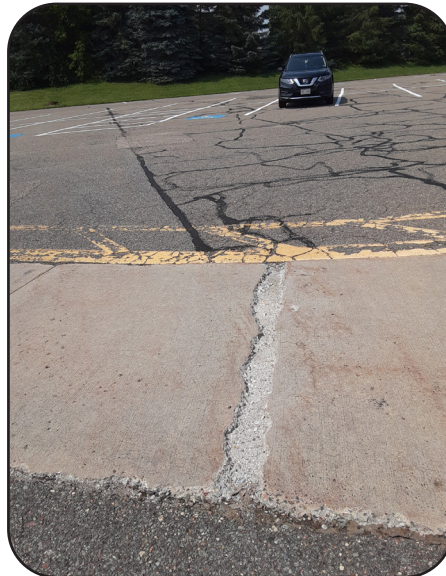
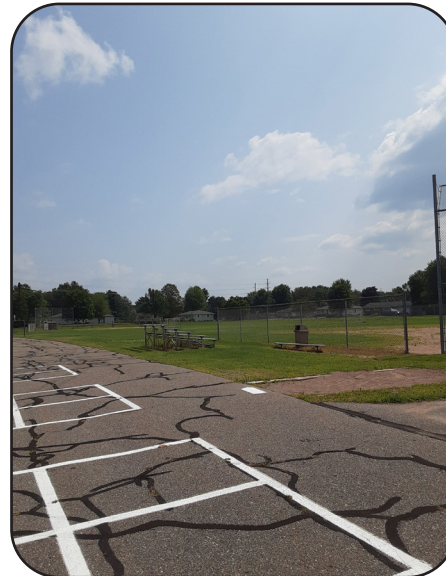
Building System	General Description	Recommendation	Cost Estimate
Site & Landscape	Invasive vegetation in asphalt cracks.	Remove vegetation, crack clean, and crack fill as per common practice in district.	\$1,000
Site & Landscape	Open gaps and deteriorated joints between several concrete slabs.	Replace slabs with open or deteriorated joints.	\$8,500
Site & Landscape	Substantial crack-filled areas without top sealing.	Continue to crack clean and crack fill as needed. Approximately every 3-5 years additionally seal and repaint asphalt.	\$7,500
Site & Landscape	Increase routine planters and mulch landscaping maintenance.	Annually or more often if needed remove vegetation around building perimeters, fencing, hardscape surface edges, utility supply areas, and planters. Refresh and retain mulch to an elevation lower than border, walk, or turf. Consider crushed gravel in lieu of mulch in planters.	\$5,000

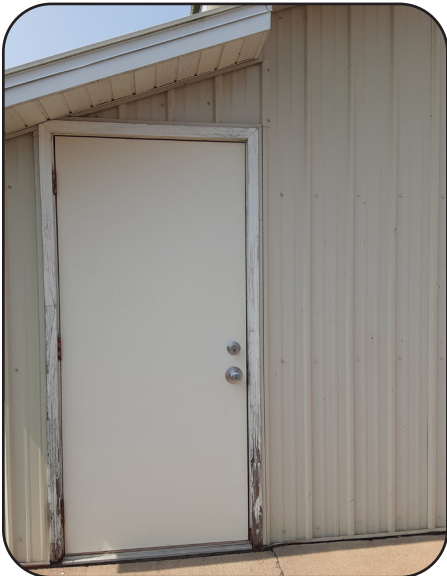
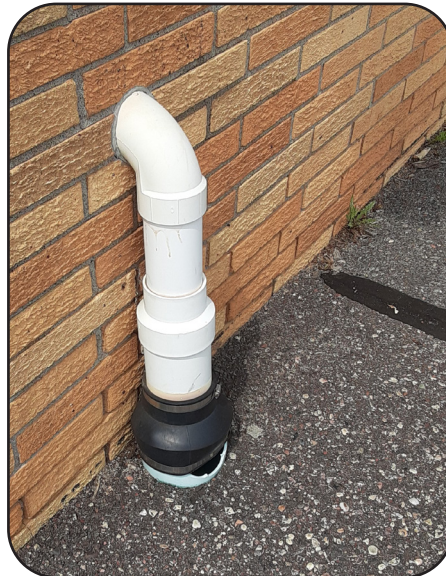
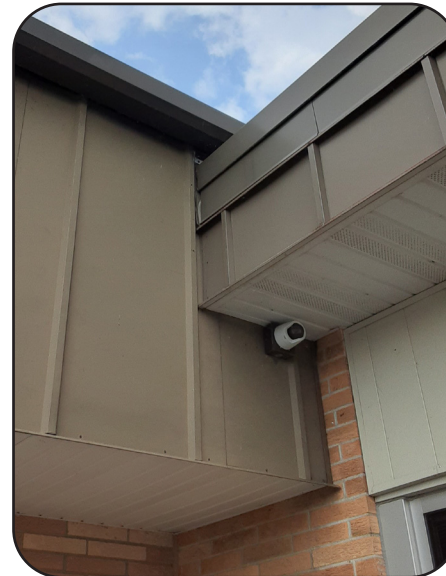
Building System	General Description	Recommendation	Cost Estimate
Site & Landscape	Outbuilding shed painted wood trim and door frames paint peeling.	Prepare and repaint. Consider replacing with metal or cladding where possible.	\$2,500
Exterior Building	Open ground level roof drain pipe connector.	Refit and repair connection.	\$1,000
Exterior Building	Open roof edge fascia flashing joint.	Refit, repair, and seal flashing joint.	\$1,000
Exterior Building	Exterior exit soffit and fascia paint peeling.	Prepare and paint. Consider cladding.	\$1,800

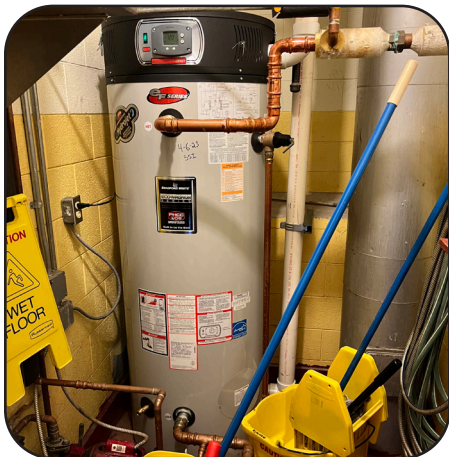
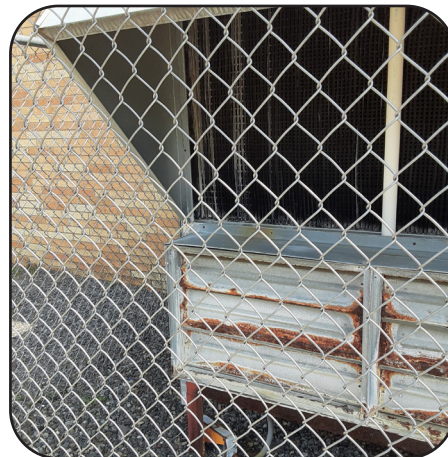
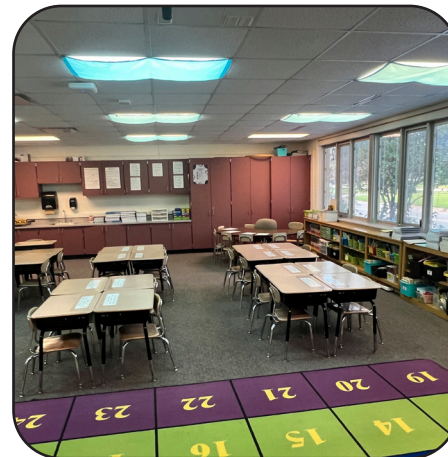
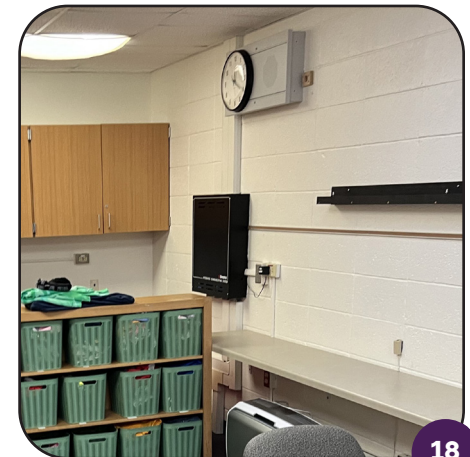
Building System	General Description	Recommendation	Cost Estimate
Mechanical - Pipe Insulation	Missing and/or damaged pipe insulation was noted in various locations around the building.	Insulate DHW piping up to water heaters. Replace damaged and missing pipe insulation. Presence of asbestos and abatement needed can drastically change pricing. Pricing given for minimal work noted in mechanical rooms, not potential tunnel abatement.	\$5,000
Mechanical - HVAC	Exterior condenser unit rusting.	Clean, prep for coating, and protect with rust resistant coating or paint. Verify planned unit replacement schedule prior to new coating.	\$5,000
Electrical - Whole Building Upgrade	The facility is in need of a whole building lighting upgrade from fluorescent to LED. Many classrooms were noted having fabric light filters hung over fixtures due to the harshness and intensity of existing lighting systems. Interior lighting projects provide roughly a 6 year simple payback, along with giving building occupants the ability to adjust light levels to their liking. Additionally, the systems have a 20+ year lifespan, drastically reducing maintenance required to change lamps and ballasts.	Replace classrooms, offices, corridors and common large spaces (gym) with appropriate LED fixtures, occupancy sensors, and dimming controls.	\$90,000

Electrical - Bell/PA & Communication	PA/Bell/Clock/mass communication systems due for upgrade. Existing system is obsolete using decades old technology.	Replacement recommended with the district's Single wire system standard.	\$139,200

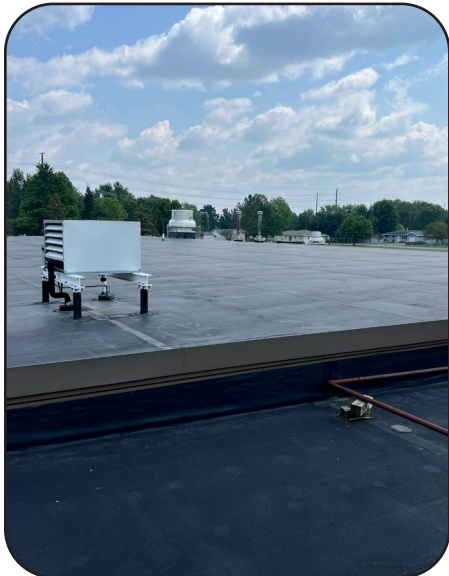
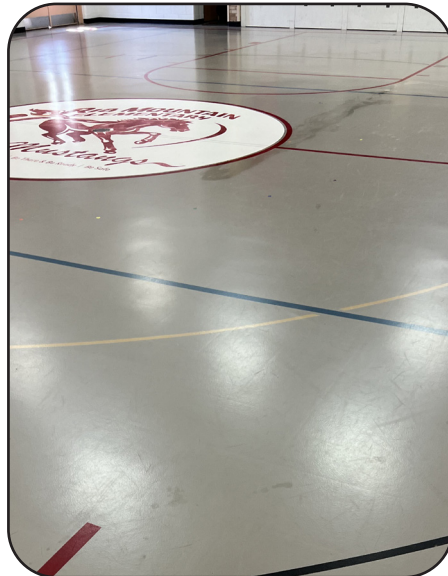
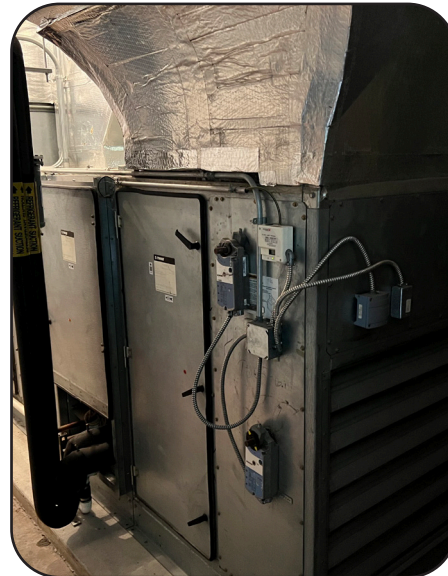
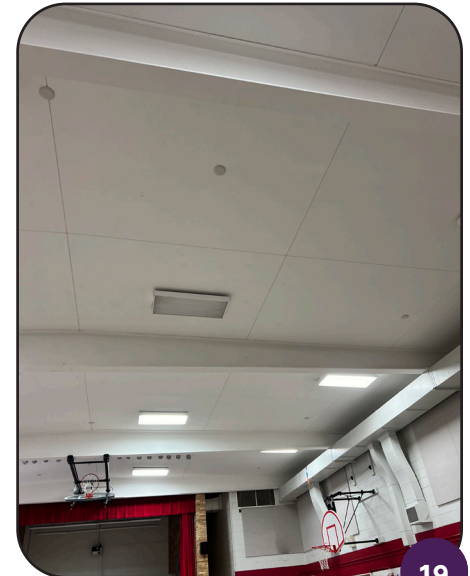
Building System	General Description	Recommendation	Cost Estimate
Exterior Building - Roofing	Roof section C is 13 years old and under warranty until 2026. This roofing is holding up well and appears in good condition.	Replace roof section C in the next 5-8 years with an adhered 60 mil black EPDM 20 year warranty roof.	\$155,000
Interior - Gym Floor	The gymnasium synthetic floor is holding up well, but scratches and gouges are evident due to lunchroom activities taking place in the space.	Budget to replace the gym floor in the next 5-10 years.	\$100,000
Mechanical - HVAC	The existing mechanical system at Rib Mountain is functioning adequately but it is 25 years old and obsolete to today's standards. Heating is accomplished through large gas fired duct furnaces, there are no boilers in the school. The school is largely heated and cooled with a ducted system through the tunnels, with individual volume dampers for the spaces.	If the district expects Rib Mountain to be a long-term 10+ year part of the elementary portfolio, a major mechanical project should be undertaken in the next five years. This should include, at a minimum, a hot water system running throughout the building. Existing space dampers could be swapped with VAV boxes with reheat, conventional AHU's exchanged with the furnaces. The large DX units have good life remaining, chilled water is not recommended unless the district chooses for further temperature control and efficiency.	\$975,000

Mechanical - Gym Fans	No gym destratification fans are present.	Install gym destrat fans. Include schedulable control through the DDC system so fans can automatically turn on and off as desired.	\$15,000

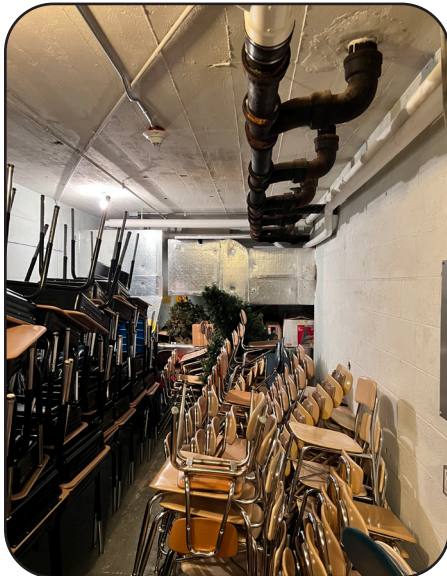
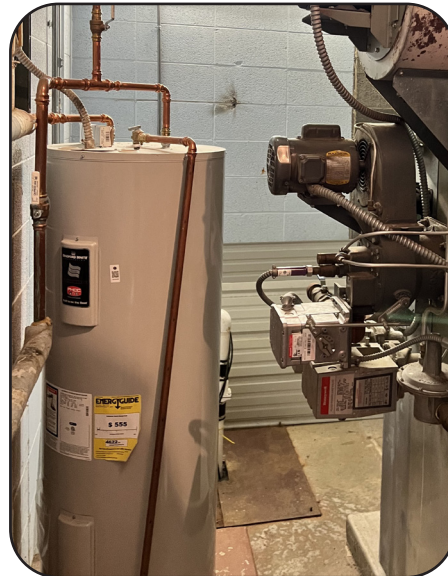
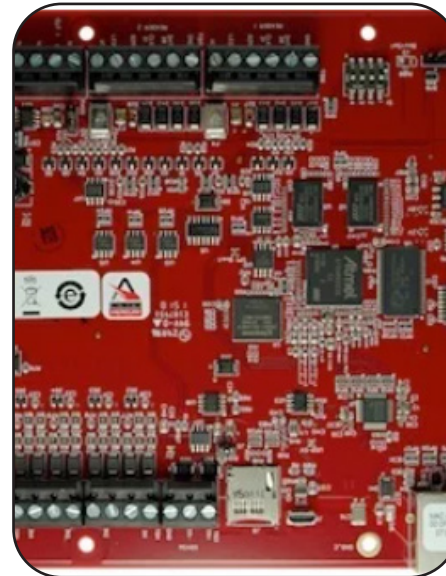
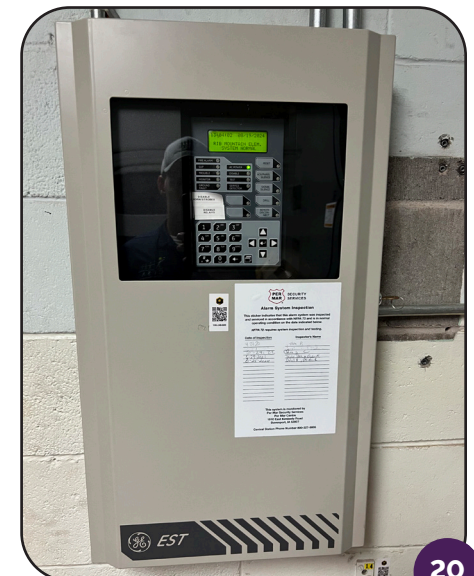
Building System	General Description	Recommendation	Cost Estimate
Plumbing - Cast Sanitary Pipe	Cast iron sanitary piping was noted below grade level. Piping observed was in fair condition however PVC connections have been made, suggesting past issues.	Estimating costs and predicted life of cast pipe is a difficult endeavor. Typically once failures begin they will continue over time. Addressing this issue can be costly since the piping is often buried in concrete. Estimates given are for a maintenance plan over the next 5-10 years.	\$40,000
Plumbing - Domestic Hot Water	An 8 year old electric 50 gallon domestic hot water heater is in place in the south mechanical room serving the southern bathrooms. The unit likely has 2-5 years of life remaining. Nearby piping to the unit was not insulated.	Consider replacing the electric unit with a gas fired unit to reduce operating costs. Gas is readily available in the room. Insulate all DHW piping in the vicinity and replace damaged insulation. Relocate unit to allow more clearance to the nearby HVAC.	\$4,500

Electrical - Door Access	Card Access systems across the district are in need of upgrade to their board controllers. Information was compiled through district IT interviews and recommended per school individual need.	Replace HID Vertx boards to Mercury LP1502's.	\$8,000
Electrical - Fire Panel	Fire panel at end of expected usable life.	Replace or upgrade to Edwards standard.	\$118,750

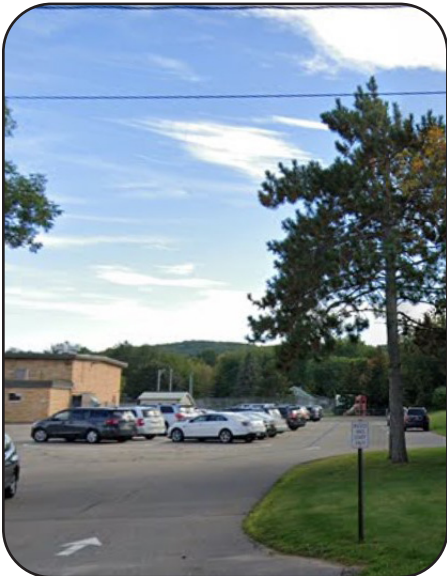
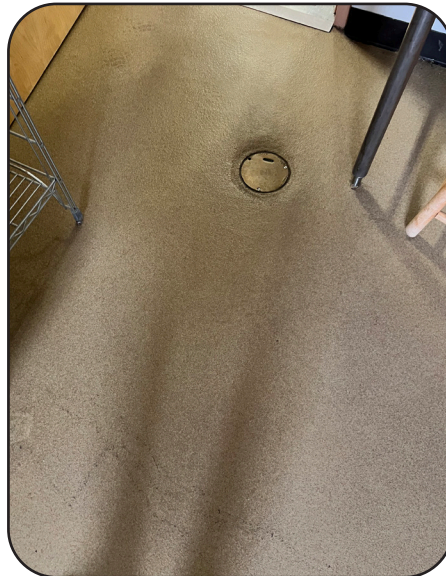
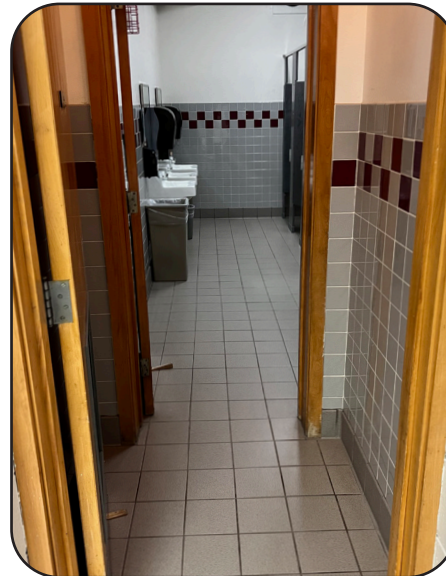
Building System	General Description	Recommendation	Cost Estimate
Site & Landscape	Front parking area asphalt surface failing.	Mill and resurface parking lot.	\$75,000
Plumbing	Frequently re-occurring grease trap back up associated with detergent/soap use.	Investigate proper installation of grease trap and use of chemical dispensing. Consider running lines with a camera. Correct deficiencies.	\$3,500
Interior - Bathrooms	Rib Mountain is lacking adequate bathroom space. The main original bathroom is undersized and not ADA compliant, secondary bathrooms are also undersized.	Add restrooms if additional students are added to school. Complete this project in conjunction with a cafeteria addition.	\$600,000

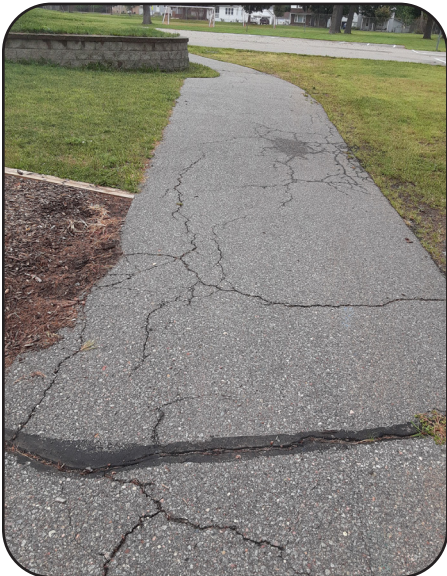
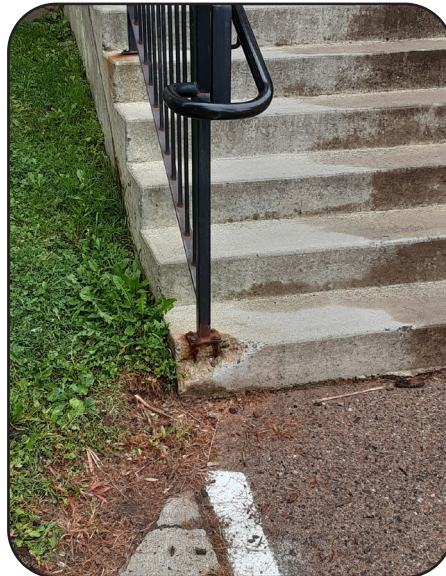
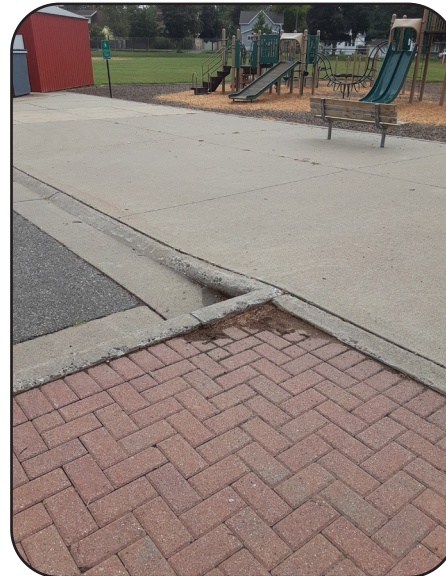
Building System	General Description	Recommendation	Cost Estimate
Site & Landscape	Cracks across asphalt walking path areas.	Clean and fill cracks. Schedule every 3-5 years crack clean, seal, and repaint asphalt.	\$3,500
Site & Landscape	Concrete stairs post base open and cracked.	Cut and repair. Consider stair replacement.	\$2,500
Site & Landscape	Uneven hardscape transitions.	Realign, replace, patch, cut, grind and/or mud jacking as needed.	\$12,000
Site & Landscape	Mulch filled above exterior brick wall drip edge.	Refresh and retain mulch to an elevation lower than wall weeps, drip edges, border, walk, or turf. Consider crushed gravel in lieu of mulch in planters.	\$1,500

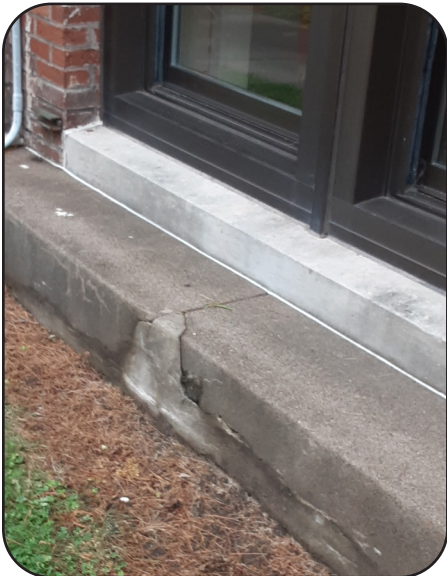
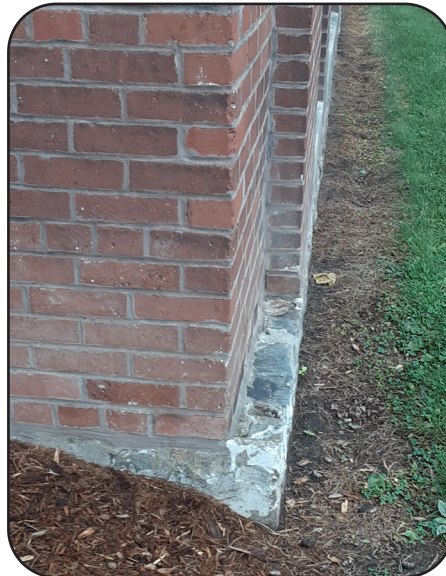
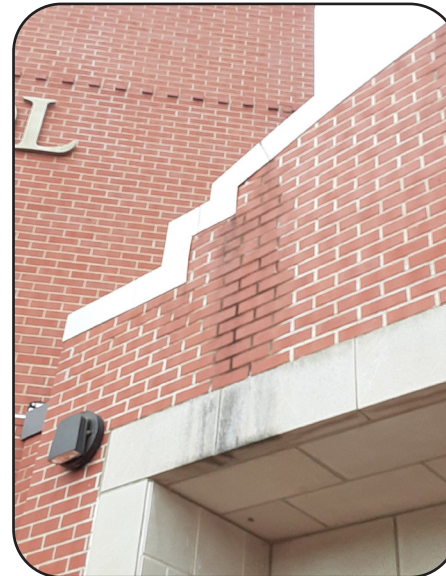
Building System	General Description	Recommendation	Cost Estimate
Exterior Building	Building perimeter wall base concrete and stone curbs cracked.	Fill, patch, and seal cracks. Consider completion as more extensive exterior wall corrective project.	\$18,000
Exterior Building	Exterior wall base open mortar.	Fill, patch, and seal openings. Consider completion as more extensive exterior wall corrective project.	\$18,000
Exterior Building	Wall mildew stains above covered exits.	Verify cause and remedy. Remove stains. Consider completion as more extensive exterior wall corrective project.	\$3,700
Exterior Building	Missing masonry drip edge bricks.	Replace missing bricks, caulk, and seal top surfaces. Consider completion as more extensive exterior wall corrective project.	\$5,000

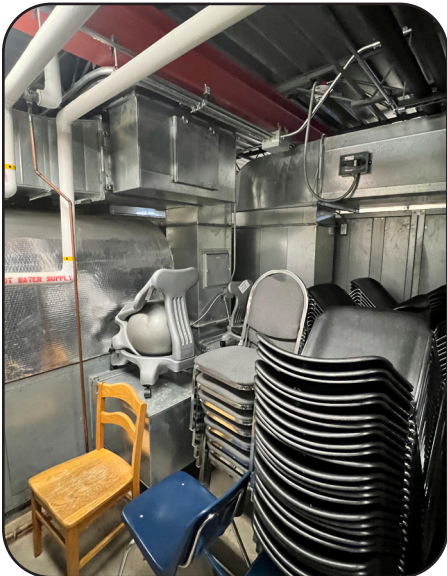
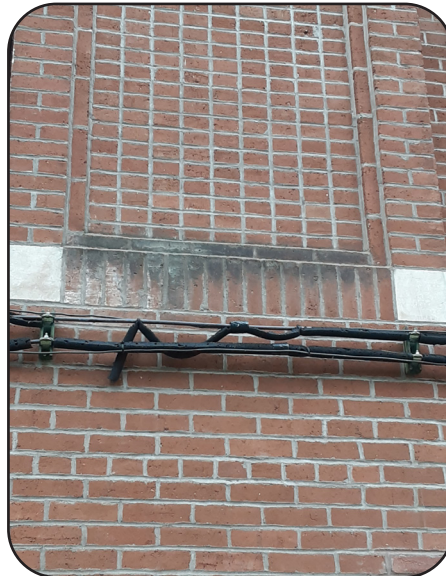
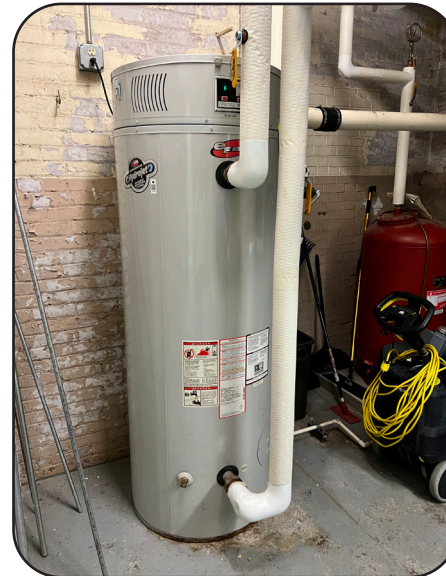
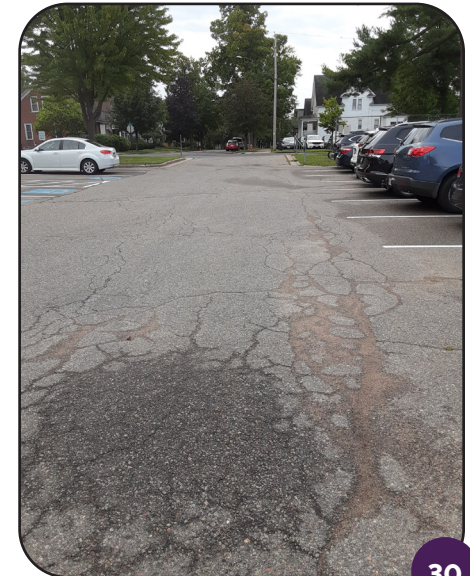
Building System	General Description	Recommendation	Cost Estimate
Interior - Storage Safety	Storage of excess furniture was noted in mechanical rooms. Along with freeing up maintenance space and setting best practice for facilities personnel, clutter spaces such as this create a fire hazard.	Clean, organize, and purge. Keep mechanical and electrical room spaces used only for their intended purpose.	\$500
Mechanical - Pipe Insulation	Missing and/or damaged pipe insulation was noted in various locations around the building.	Replace damaged and missing pipe insulation. Presence of asbestos and abatement needed can drastically change pricing. Pricing given for minimal work noted in mechanical rooms.	\$5,000
Plumbing - Domestic Hot Water	The 100-gallon gas-fired water heater in the boiler room is 18 years old and beyond its expected useful life.	Replace water heater with a high efficiency unit within the next 1-3 years.	\$7,500

Site & Landscape	Excessive cracks (alligator) on asphalt drive and parking area. Failed top asphalt layer in several areas.	Mill and resurface poor asphalt surface areas.	\$45,000

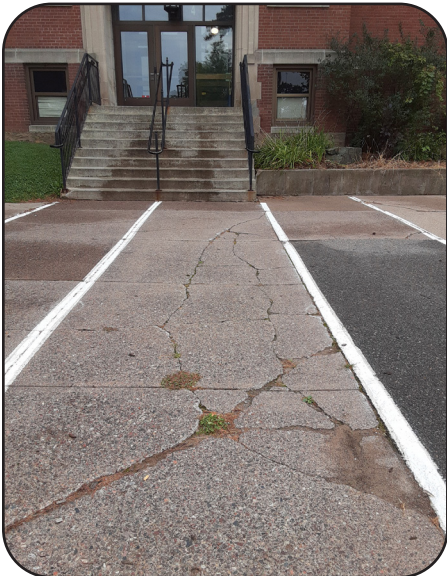
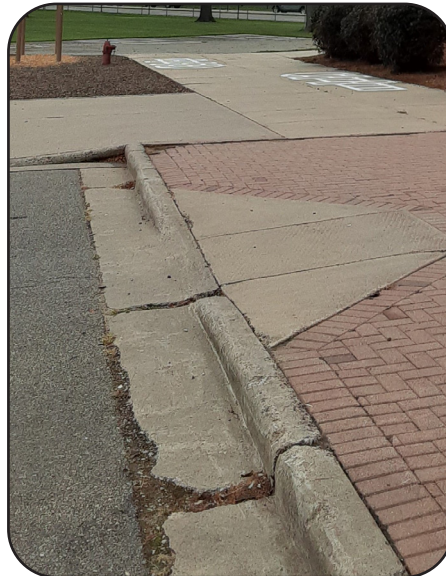
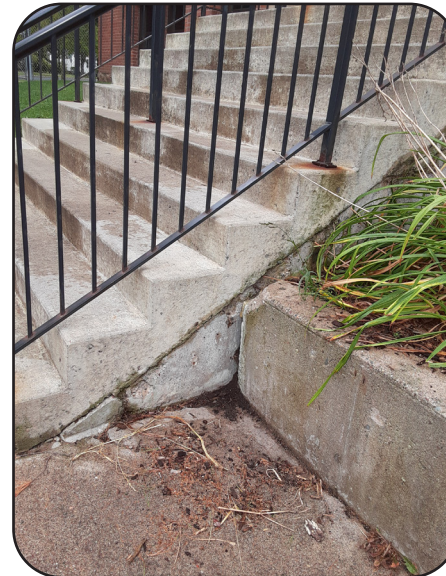
Building System	General Description	Recommendation	Cost Estimate
Site & Landscape	Multiple walk concrete slabs with transitional and divided cracks.	Replace cracked concrete walk slabs.	\$25,000
Site & Landscape	Drive concrete curbs cracked and open.	Replace, patch, cut, grind and/or mud jacking as needed.	\$17,500
Site & Landscape	Open concrete planter curb and stair base.	Patch and seal curb and base. Consider replacement with stairs replacement.	\$1,500
Site & Landscape	Open gaps between hardscapes and exterior wall perimeters.	Back fill gaps with sand and backer rod. Caulk and seal with appropriate joint filler. Heat melt in place material recommended for smooth, clean appearance.	\$7,500

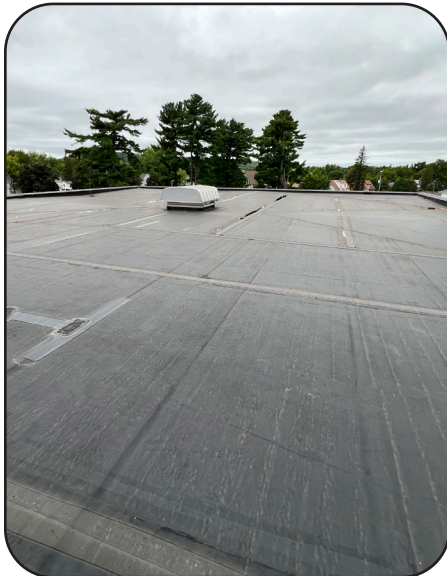
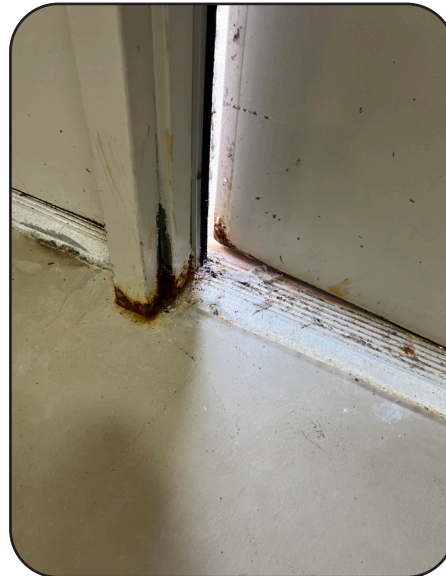
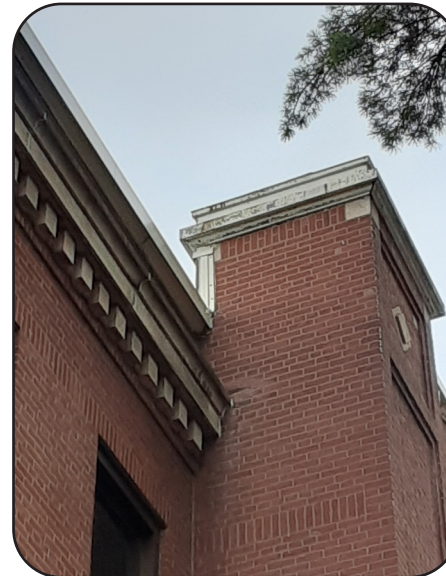
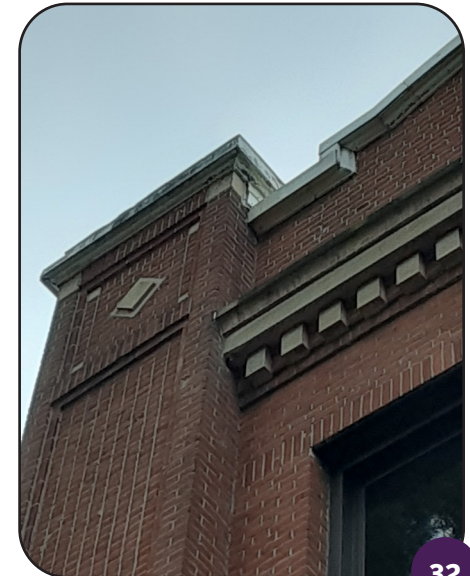
Building System	General Description	Recommendation	Cost Estimate
Exterior - Roofing	Roof sections A-C are 23 years old and holding in good condition, however are at their expected useful life and out of warranty. Some areas of sections A & B are ponding water. Roof section D is in excellent condition with 20 years of warranty remaining.	Replace roof sections A-C in the next 2-5 years with an adhered 60 mil black EPDM 20 year warranty roof. The small elevator shaft roof within Roof B is severely holding water and should be closely monitored for leaks prior to re-roofing this section.	\$95,000
Exterior - Doors	Although minimal, some sets of exterior street doors are deteriorating. One set of gym doors is rusting through.	Complete a thorough facility exterior door inventory and replace as necessary. Expect to replace several doors in the next 1-5 years.	\$15,000
Exterior Building	Roof edge cornice paint peeling.	Prepare and paint. Consider completion as more extensive exterior wall corrective project.	\$3,000

Exterior Building	Roof edge cornice masonry deteriorating.	Replace edge masonry. Consider completion as more extensive exterior wall corrective project.	\$12,000

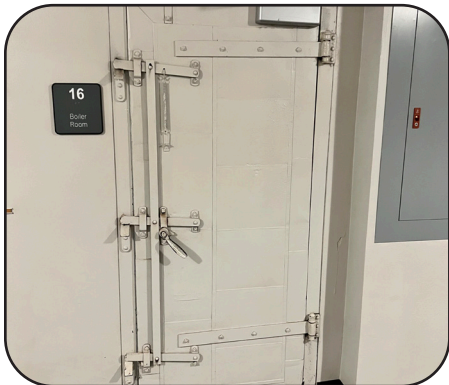
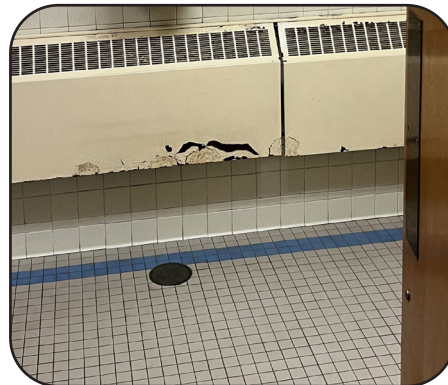
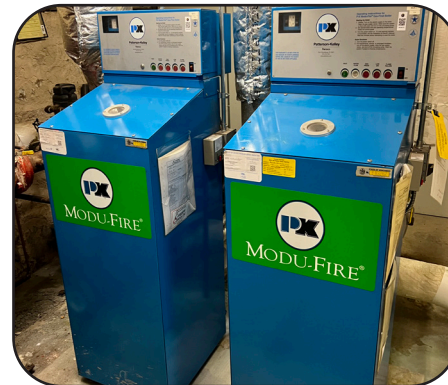
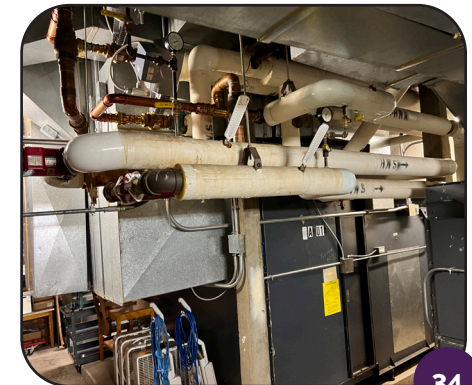
Building System	General Description	Recommendation	Cost Estimate
Interior - Door Safety	The original boiler blast door is still in place to the main student ground floor corridor. This door is unsecured giving students or intruders access to the boiler and electrical rooms, where they could harm themselves, and/or shut down or damage equipment.	Replace the door with a hollow metal steel door with lockset.	\$7,500
Interior - Paint & Plaster	Minor scratches, wall damage, and needed painting was noted throughout the building, indicative of its age. Mainly in drywall and plaster, occasionally on wood doors and street shrouds.	Address plaster and drywall issues, paint.	\$7,500
Mechanical - Boilers	Grant Elementary is heated by two 18 year old standard efficiency boilers, each 1MBTU. The boilers are holding up well, however approaching their expected useful life, and inefficient to today's standards. The boiler system seems to be undersized for the facility, however maintenance staff reported no issues.	Replace the boilers and pumps in the next 5-10 years with high efficiency condensing boilers.	\$275,000

Mechanical - HVAC	Grant Elementary is provided HVAC through the older section of the facility with 1987 vintage multizone units, along with radiant wall fin heat. The gym and music areas are served by 2000 vintage mechanical. The 2000 era equipment was originally installed with evaporative cooling units which have since been disconnected, along with supplemental mechanical cooling. The 1987 equipment is beyond it's expected service life, the 2000 vintage equipment should have 5-10 years of life remaining, however is no longer operating as originally designed.	Undergo a full facility HVAC renovation in the next 3-7 years replacing all air handlers. If full facility air conditioning is not required, mechanically cool the gym and AHU4 served spaces as cooling these areas is more feasible given existing conditions. Add a dedicated office staff AHU with DX cooling.	\$1,550,000

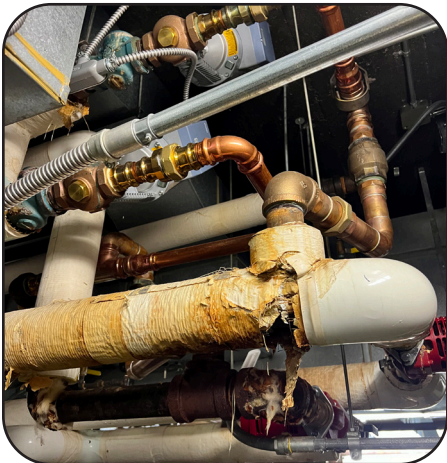
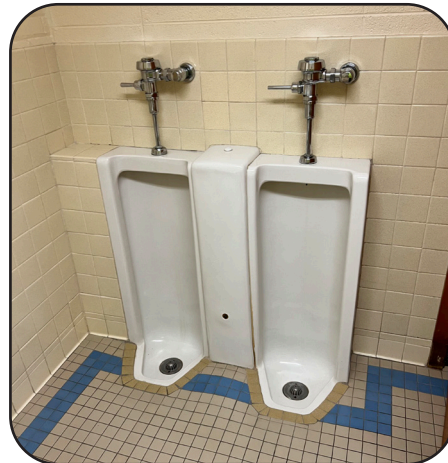
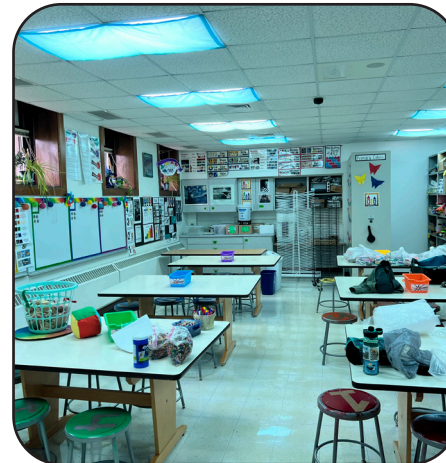
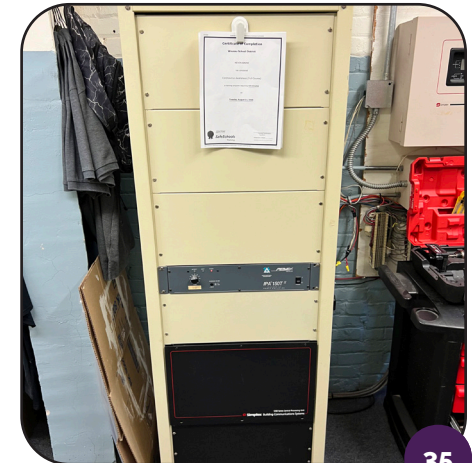
Building System	General Description	Recommendation	Cost Estimate
Mechanical - Pipe Insulation	Missing and/or damaged pipe insulation was noted in various locations around the building.	Replace damaged and missing pipe insulation. Presence of asbestos and abatement needed can drastically change pricing. Pricing given for minimal work noted in mechanical rooms.	\$5,000
Plumbing	Some bathrooms currently have no isolation valves necessary to perform maintenance when problems occur.	Install missing isolation valves for bathroom fixtures.	\$10,000
Electrical - Whole Building Lighting Upgrade	The facility is in need of a whole building lighting upgrade from fluorescent to LED. Many classrooms were noted having fabric light filters hung over fixtures due to the harshness and intensity of existing lighting systems. Interior lighting projects provide roughly a 6 year simple payback, along with giving building occupants the ability to adjust light levels to their liking. Additionally, the systems have a 20+ year lifespan, drastically reducing maintenance required to change lamps and ballasts.	Replace classrooms, offices, corridors and common large spaces (gym) with appropriate LED fixtures, occupancy sensors, and dimming controls.	\$105,000

Electrical - Bell/PA & Communication	PA/Bell/Clock/mass communication systems due for upgrade. Existing system is obsolete using decades old technology.	Replacement recommended with the district's Single-wire system standard.	\$132,000

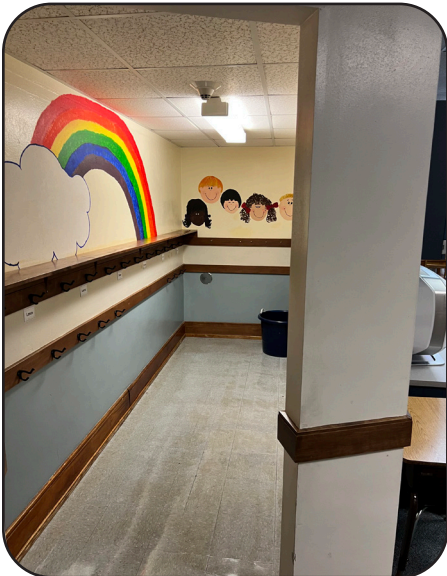
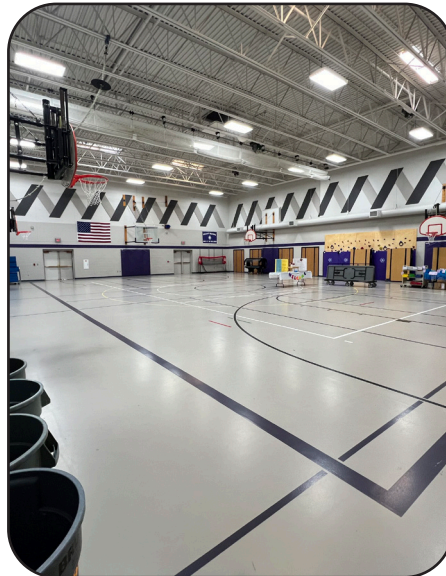
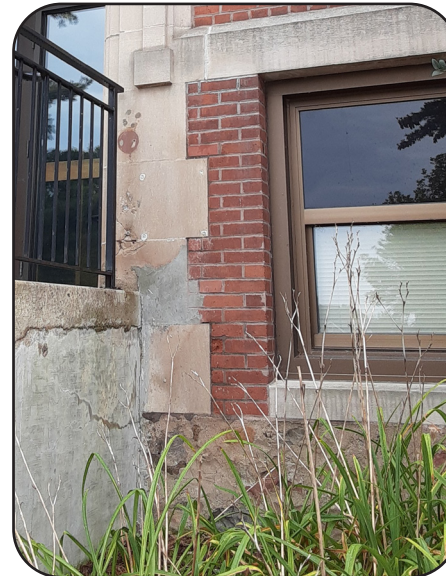
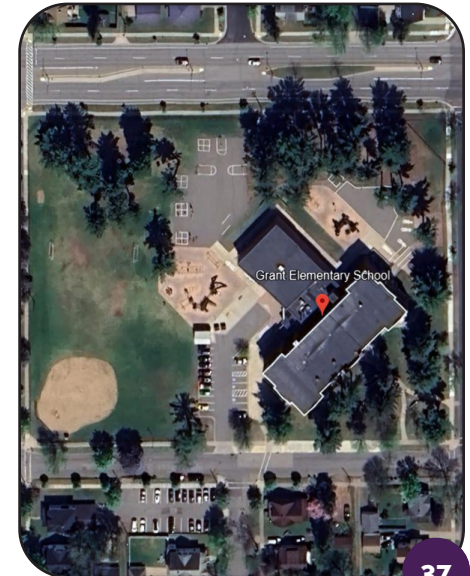
Building System	General Description	Recommendation	Cost Estimate
Interior - Flooring	Although most of the facility flooring is in good condition, spot areas of aged VCT and traffic-worn carpeting are evident.	Replace older VCT with surfaces of district choice. Some VCT appeared of a vintage where asbestos mastic was likely. Replace stained and foot traffic worn carpeting as desired. Pricing given to address 5,000 sq ft of carpet/VCT, not including abatement.	\$40,000
Mechanical - Gym Ceiling Fans	No gym destratification fans are present. Ceiling fans in high ceiling spaces help distribute heat from the ceiling to the occupants in winter, and can help maintain comfort in spring/fall.	Install gym destrat fans. Include schedulable control through the DDC system so fans can automatically turn on and off as desired.	\$25,000
Exterior Building	Exterior wall decorative corner stones damaged.	Replace stones. Consider completion as more extensive exterior wall corrective project.	\$18,500

Site & Landscape	Poor traffic flow for pick up and drop off. Tight urban site with minimal traffic options.	Reroute and modify perimeter street traffic between school and ancillary parking lot.	\$85,000

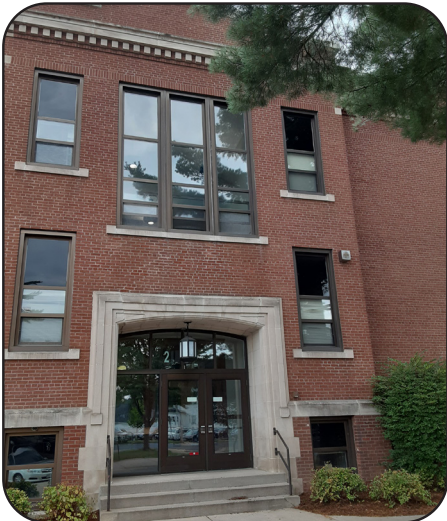
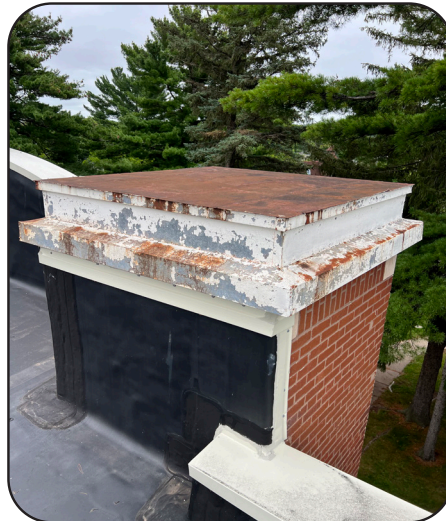
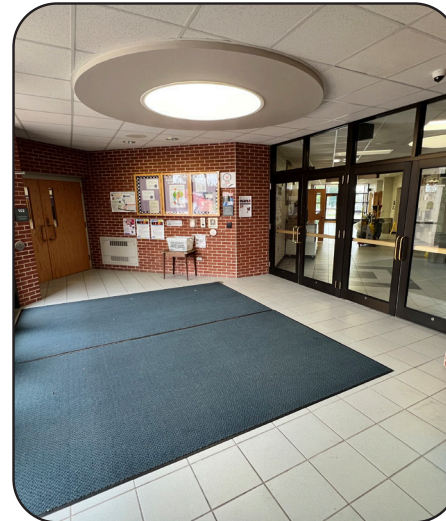
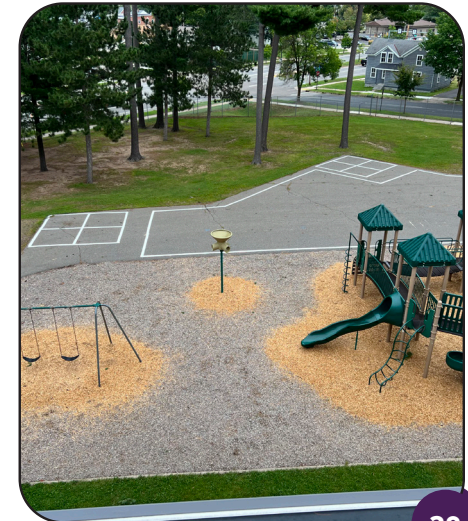
Building System	General Description	Recommendation	Cost Estimate
Exterior Building	Exterior door do not close and latch.	Adjust or replace door closures. Consider replacement of all rusty and failed metal doors and door frames.	\$35,000
Exterior Building	Exterior or abandoned chimney deteriorating.	Prepare, seal and paint chimney top and vertical perimeter.	\$12,000
Interior - Entrance Security	Although the main entrance is "secure", with a second set of vestibule locked doors, there is a great distance and elevation change between the entrance and the main office. Other sets of doors to the gym and receiving are present within the vestibule, creating additional hiding areas and security challenges.	Given existing conditions, creating a true secure entrance on ground floor to this facility will be challenging without a build out of additional new square footage. As an immediate step we recommend investment in additional cameras and electronic vetting. Upgrade camera quality and move to an IP based system where visitors can be viewed on any PC with main door control. Estimate given for increasing electronic capabilities. Assume a \$1M project for a main office build out near the existing entrance.	\$50,000

Electrical	Minimal area lighting in fenced in play areas.	Install additional LED area lighting to improve security and safety inside of play areas.	\$18,000

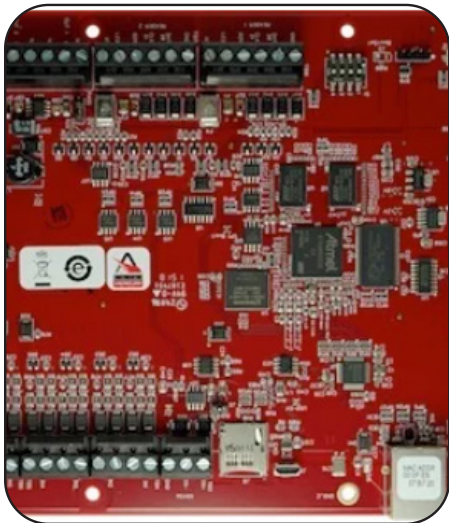
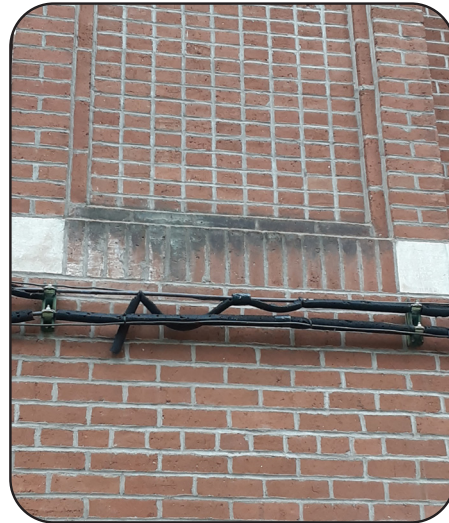
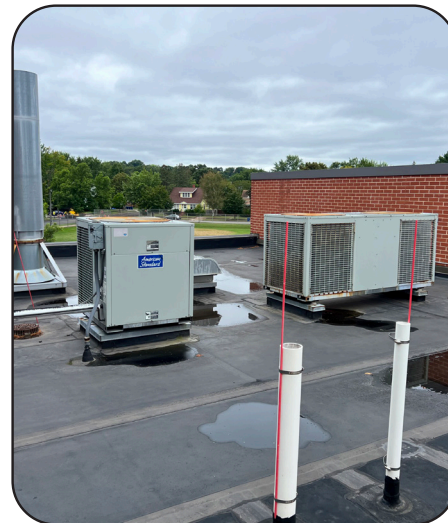
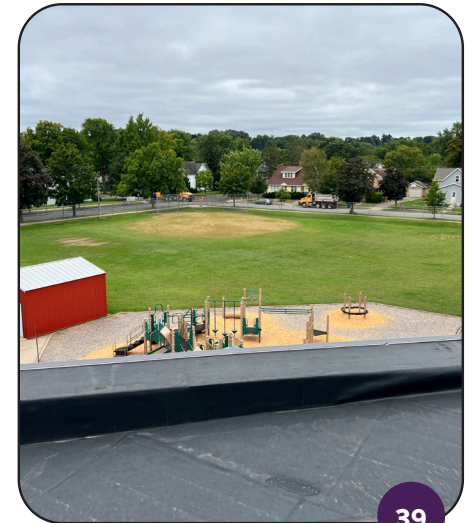
Building System	General Description	Recommendation	Cost Estimate
Electrical - Door Access	Card Access systems across the district are in need of upgrade to their board controllers. Information was compiled through district IT interviews and recommended per school individual need.	Replace HID Vertx boards to Mercury LP1502's.	\$4,000
Mechanical - Pipe Insulation	Missing and or damaged pipe insulation was noted in various locations around the building.	Replace damaged and missing pipe insulation. Presence of asbestos and abatement needed can drastically change pricing. Pricing given for minimal work noted in mechanical rooms.	\$3,000
Mechanical - Chilled Water	The facility is largely non-airconditioned. Given the age and construction of this facility, 2nd and 3rd floors are commonly very hot in the cooling season, creating an environment not conducive to teaching and learning.	Install chilled water based mechanical cooling to the entire facility.	\$850,000

Site- Pickup/Drop-Off Lane	The 5 acre Grant block is confined on three sides by residential housing and Bridge St on the other. This creates an unsafe situation for pickup/drop-off and pedestrians crossing traffic areas.	Design and install a student pickup/drop-off area running through the West side of the school lot, eliminating the baseball and soccer activities. This would allow for a safer transfer of bussed and vehicle transferred students.	\$950,000

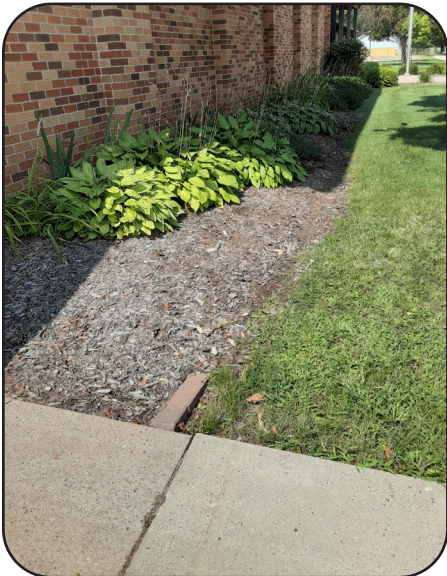
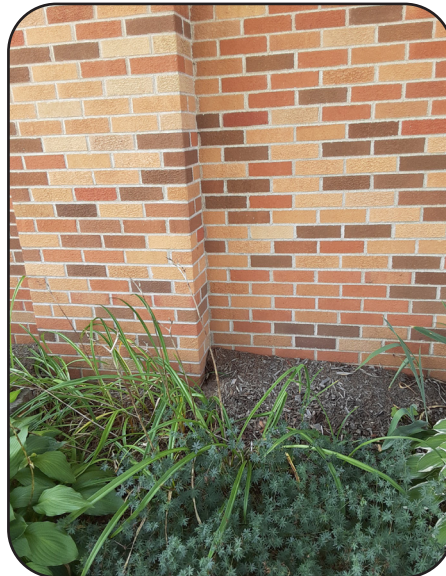
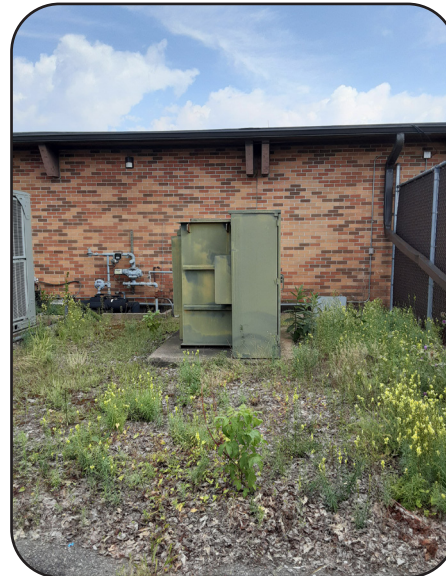
Building System	General Description	Recommendation	Cost Estimate
Site & Landscape	Mulch pouring over border and on to turf.	Annually or more often if needed remove vegetation around building perimeters, fencing, hardscape surface edges, utility supply areas, and planters. Refresh and retain mulch to an elevation lower than border, walk, or turf. Consider crushed gravel in lieu of mulch in planters.	\$3,500
Site & Landscape	Mulch filled above exterior brick wall drip edge.	Refresh and retain mulch to an elevation lower than wall weeps, drip edges, border, walk, or turf. Consider crushed gravel in lieu of mulch in planters.	\$1,000
Site & Landscape	Invasive vegetation inside mechanical area isolation fence.	Annually or more often if needed remove vegetation around building perimeters, fencing, hardscape surface edges, mechanical equipment areas, utility supply areas, and planters.	\$1,000
Site & Landscape	Outbuilding metal door and frame faded and paint peeling.	Prepare and paint.	\$1,000

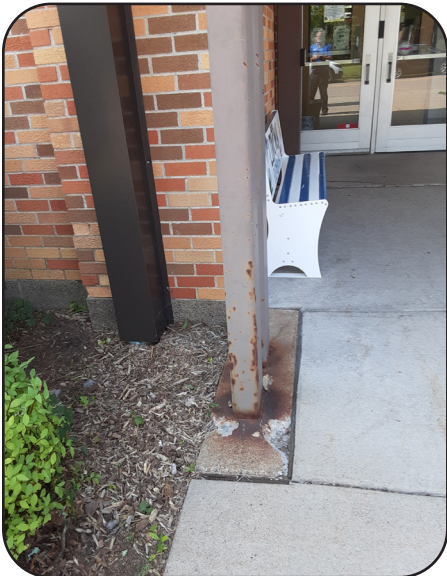
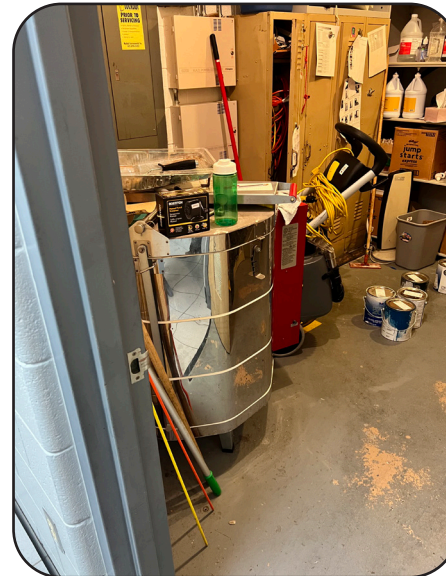
Building System	General Description	Recommendation	Cost Estimate
Exterior Building	Entrance metal beam rusty and paint missing.	Prepare and apply durable weather/salt proof coating.	\$1,000
Exterior Building	Exterior wall base brick and foundation cracked and open.	Fill, patch, and seal openings.	\$2,500
Interior - Kiln Safety	Art kiln is located within a janitorial closet with materials stacked on and around the kiln. Exhaust measures taken for the kiln are in poor condition and mismatched duct size.	If the kiln is to remain in the janitorial closet, clean and organize the space. Refurbish exhaust ductwork.	\$2,000
Site & Landscape	Open gaps between hardscapes and exterior wall perimeters.	Back fill gaps with sand and backer rod. Caulk and seal with appropriate joint filler. Heat melt in place with material recommended for smooth, clean appearance.	\$5,500

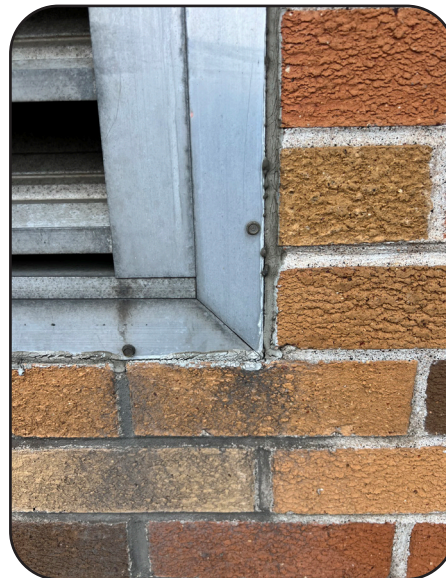
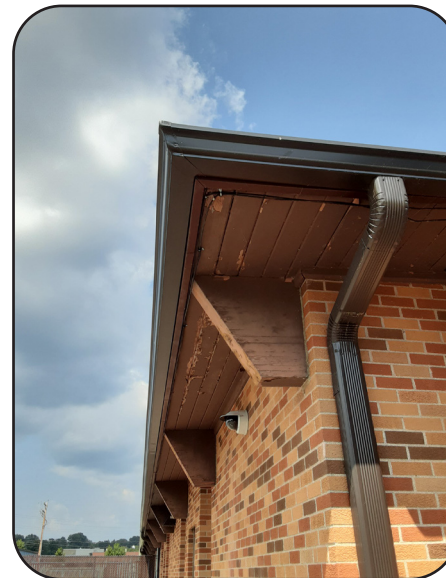
Building System	General Description	Recommendation	Cost Estimate
Exterior Building - Exposed Wood	Exposed wood beam roof outlookers across the facility are deteriorating.	Minimal examination shows little evasive rot. No rot was known to have transferred across into the building. Have an exterior professional examine each outlooker. Likely remedy is to clean, prep, and paint. Follow up by roofing contractor encapsulating the outlookers in metal flashing and caulk.	\$60,000
Exterior Building - Caulk	Although not rampant across the facility, some building exterior caulk at soffit joints and mechanical louvers is well past its life.	Perform a thorough examination of all exterior caulking and replace where necessary.	\$20,000
Exterior Building	Wood soffit paint peeling.	Prepare and paint. Consider cladding soffits with metal to extend life and reduce maintenance.	\$12,000
Exterior Building	Exterior wall base foundation blocks mortar open.	Patch, caulk, and seal.	\$1,500

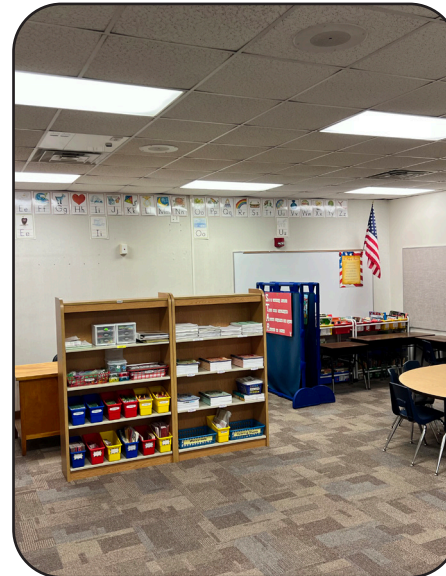
Building System	General Description	Recommendation	Cost Estimate
Exterior Building	Debris in pipe well/chase.	Remove debris. Seasonally clean well. Consider cover panel or filling with permeable and easy to remove material (clean sand or pea gravel).	\$1,000
Exterior Building	Exit metal door and frame faded and paint peeling.	Prepare and paint.	\$5,000
Interior - Ceilings	Several classrooms were noted to have stained and pillowed/curling ceiling tile, this was not the condition in the majority of the school. However, with the overhead HVAC renovation measure being recommended, all ceiling tile in the facility will need to be replaced, along with tile added where there is none.	Complete a full facility new acoustical ceiling tile project, paired with an HVAC renovation. If the HVAC project does not occur, budget to replace three classrooms in the next 2 years.	\$90,000
Interior - Flooring	The majority of the flooring throughout the school is in very good condition. One corridor was noted to have carpet tile not holding well with raised seams.	Budget to replace minimal carpeting in the school in the next 2-5 years.	\$15,000
