Wausau School District

Facility Assessment

September 2024

CESA 10 Facilities Management

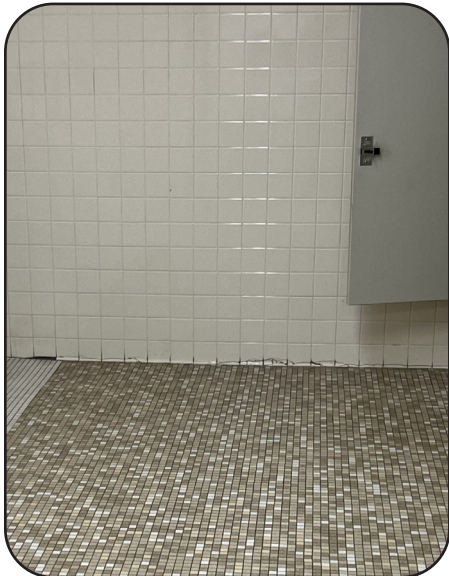
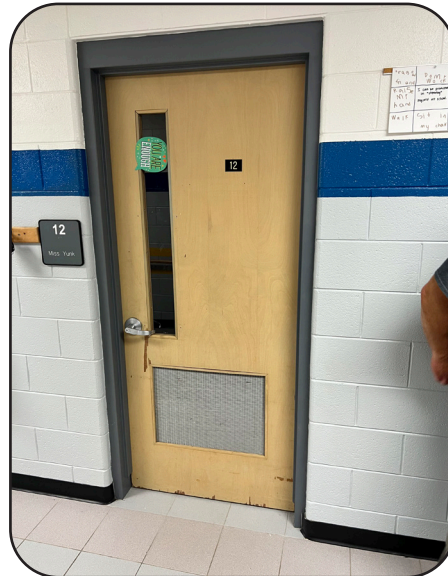
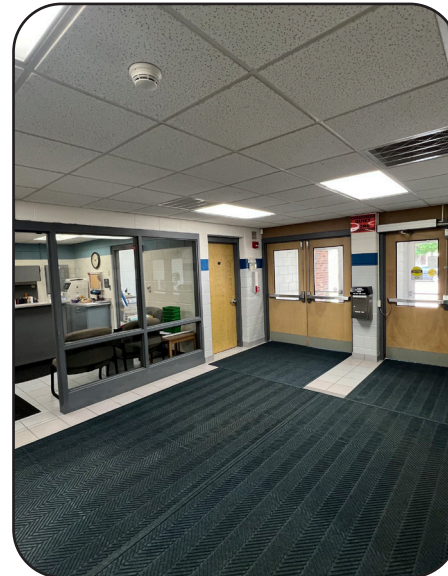
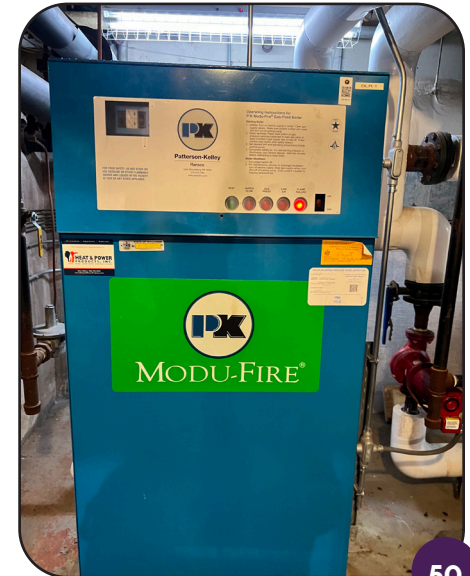
Building System	General Description	Recommendation	Cost Estimate
Interior - Bathrooms	In general bathrooms in the facility were in aged, but good, condition. Floor patching has taken place over the years. The main boys bathroom is in need of wall tile repair.	Complete a thorough inspection of all bathroom tile. Repair tile as necessary.	\$15,000
Interior - Wood Doors	Several older wood doors throughout the facility are in poor condition; de-laminating, stained, and chipped.	Replace aged and damaged interior wood doors. Estimate given for 10 doors.	\$15,000
Interior - Secure Entrance	Although the entrance is secure with a vestibule and electronic vetting area, visitors are not directly routed through the office prior to being given access to the building. This can be accomplished cost effectively at Lincoln ES with the addition of a wall or storefront glass and door modifications.	Install secure entrance measures routing visitors through the office prior to being given access to the full school.	\$100,000

Mechanical - Boilers	Lincoln ES is heated by two boilers of varying age, one 21 years old and one 14, each 1.5MBTU. The boilers are holding up well, however are approaching their expected useful life and inefficient to today's standards.	Expect to replace the older boiler in the next 2-5 years, and the newer boiler in 7-12 years. High efficiency condensing boilers are recommended. Estimate given for replacing one boiler.	\$100,000

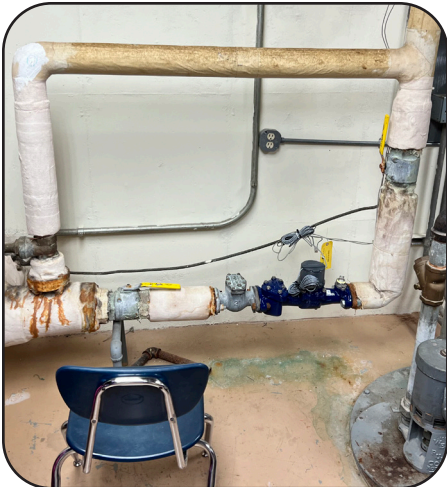
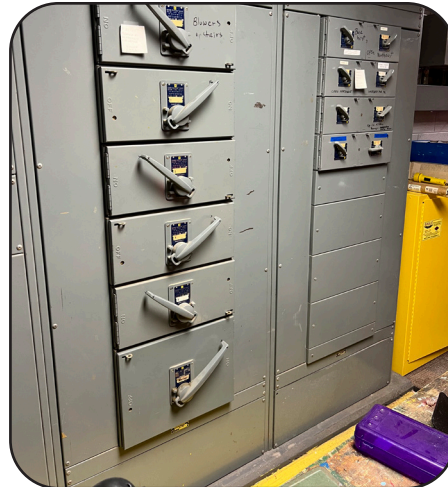
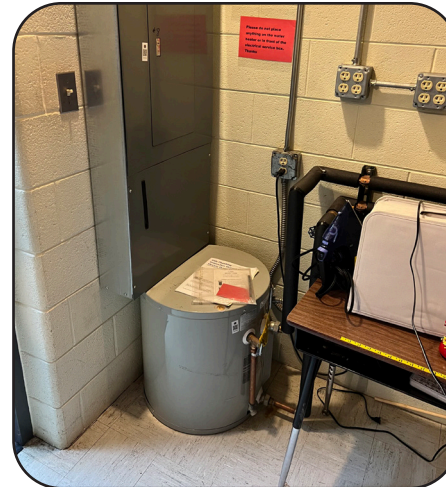
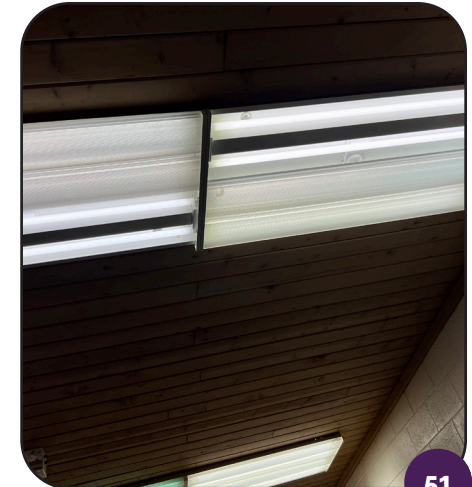
Building System	General Description	Recommendation	Cost Estimate
Mechanical - Pipe Insulation	Missing and/or damaged pipe insulation was noted in various locations around the building. Hard pipe fittings were evident, suggesting the presence of asbestos.	Replace damaged and missing pipe insulation, abate where necessary. Presence of asbestos and needed abatement can drastically change pricing. Pricing given for minimal work noted in mechanical rooms.	\$25,000
Electrical - Main Service	Original 1967 main and distribution subpanels are beyond expected service life and no longer supported. Used and refurbished breakers must be found when problems arise.	Replace main electrical service and all original subpanels and disconnects downstream.	\$450,000
Electrical - Code	A small electric water heater was installed in a janitorial closet off the IMC which is not installed to code. An electrical panel is on top of the water heater.	Relocate the water heater.	\$3,500

Electrical - Whole Building Lighting Upgrade	The facility is in need of a whole building lighting upgrade from fluorescent to LED. Many classrooms were noted having fabric light filters hung over fixtures due to the harshness and intensity of existing lighting systems. Interior lighting projects provide roughly a 6 year simple payback, along with giving building occupants the ability to adjust light levels to their liking. Additionally, the systems have a 20+ year lifespan, drastically reducing maintenance required to change lamps and ballasts.	Replace classrooms, offices, corridors and common large spaces (gym) with appropriate LED fixtures, occupancy sensors, and dimming controls. Complete this project at the same time of any major HVAC/ceiling work.	\$81,000

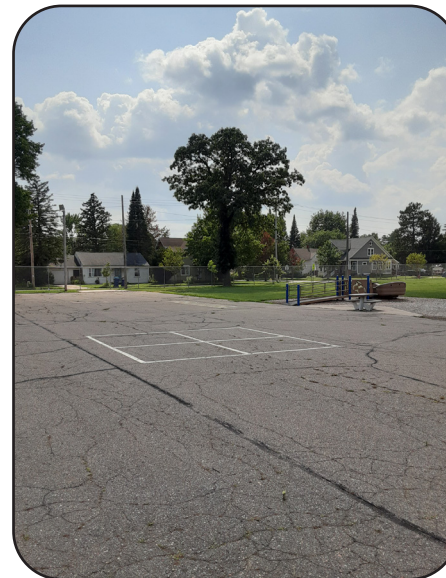
Building System	General Description	Recommendation	Cost Estimate
Site & Landscape	Cracked concrete slab corner.	Cut and patch.	\$1,000
Site & Landscape	Raised fence post concrete base.	Resent fence post. Consider raising elevation inside of fence to back fill around base and set slope away from inside of fence.	\$1,000
Site & Landscape	Significant cracks (alligator) on asphalt drive and parking area. Predecessor to failed top asphalt layers.	Mill and resurface poor asphalt surface areas.	\$25,000
Site & Landscape	Multiple drive concrete slabs with transitional and divided cracks.	Replace cracked concrete drive slabs. Ensure below grade fill and slab thickness is appropriate for larger trucks (garbage & food delivery).	\$20,000

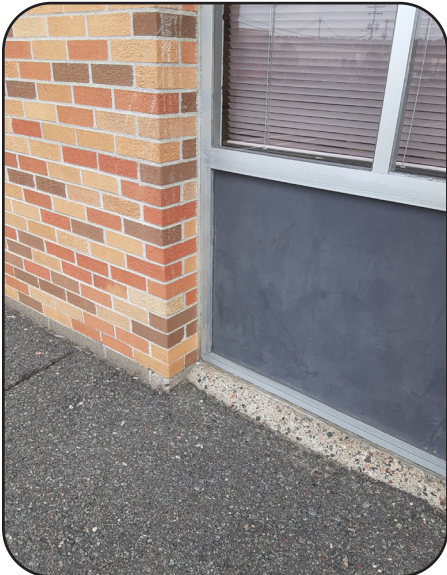
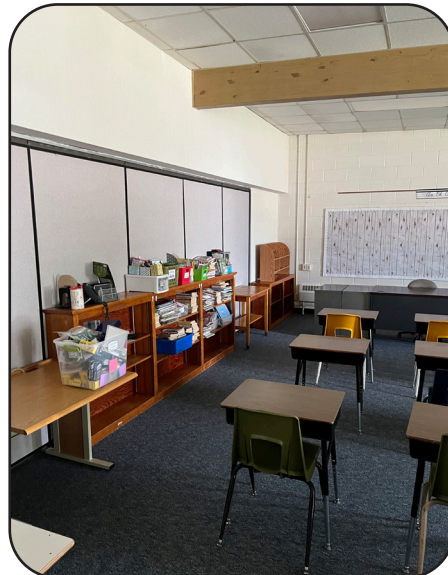
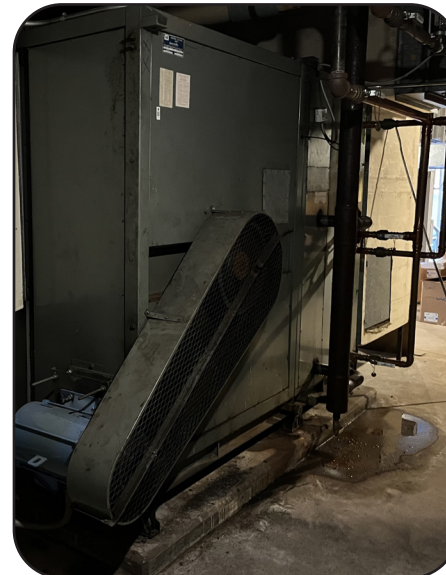
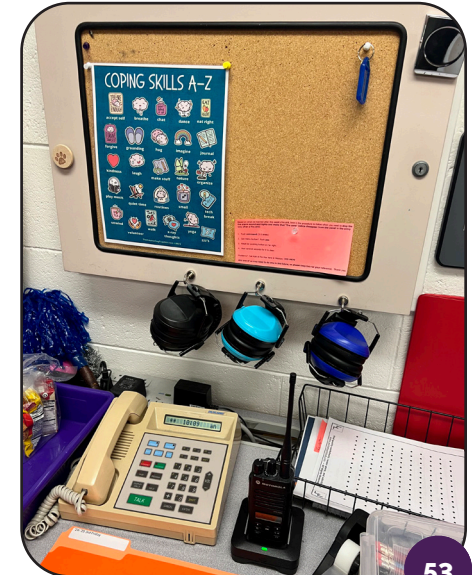
Building System	General Description	Recommendation	Cost Estimate
Exterior Building	Faded metal window/spandrel panels.	Paint or replace.	\$18,000
Interior - Partition Walls	One movable partition wall was noted between rooms 111 and 112, likely no longer of use. Building a solid stud wall in this location will block noise between the classrooms and allow for electric and data in the wall.	Replace partition wall with solid stud wall. Include sound batts and electrical/IT.	\$10,000
Mechanical - HVAC	Air-side HVAC in Lincoln is provided by original 1967 air handlers. This equipment is 25 years past its expected service life and obsolete. Air is provided to perimeter classrooms directly through the tunnel systems unducted. Asbestos is present in the tunnels, however the tunnels themselves appear to be dry and in very good condition. Chilled water is provided by a 2016 40 Ton air cooled chiller with 10+ years of service life remaining.	Complete HVAC replacement moving to overhead air distribution. Although the chiller has much life remaining, it is likely not adequately sized to cool the entire facility. If partial cooling is acceptable, the chiller may be reused, or supplemented with additional DX cooling.	\$1,680,000

Electrical - Bell/PA & Communication	PA/Bell/Clock/mass communication systems due for upgrade. Existing system is obsolete using decades old technology.	Replacement recommended with the district's Single-wire system standard.	\$144,000

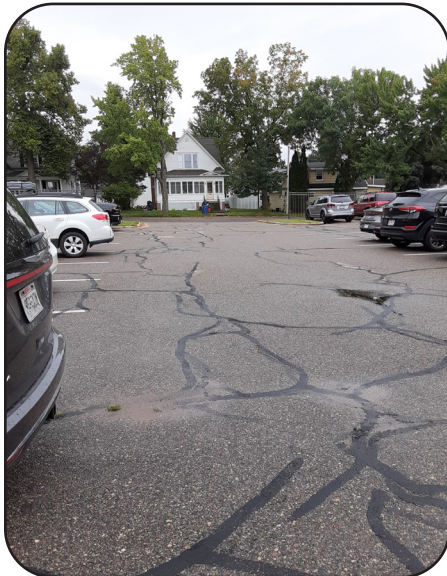
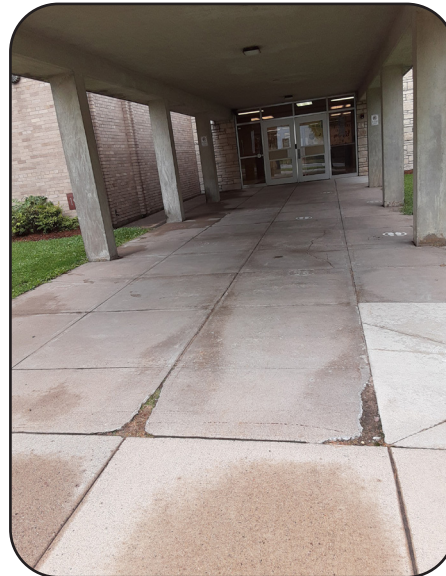
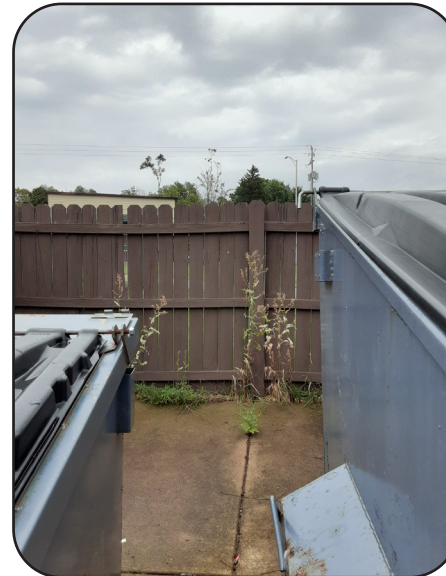
Building System	General Description	Recommendation	Cost Estimate
Site & Landscape	Substantial crack-filled areas without top sealing.	Continue to crack clean and crack fill as needed. Approximately every 3-5 years additionally seal and repaint asphalt.	\$7,500
Site & Landscape	Open gaps and deteriorated joints between several concrete slabs.	Replace slabs with open or deteriorated joints.	\$18,500
Site & Landscape	Invasive vegetation inside of dumpster fence.	Annually, or more often if needed, remove vegetation around building perimeters, fencing, hardscape surface edges, utility supply areas, and planters.	\$1,400
Site & Landscape	Sand covering path pavers.	Clear and remove sand seasonally.	\$1,000

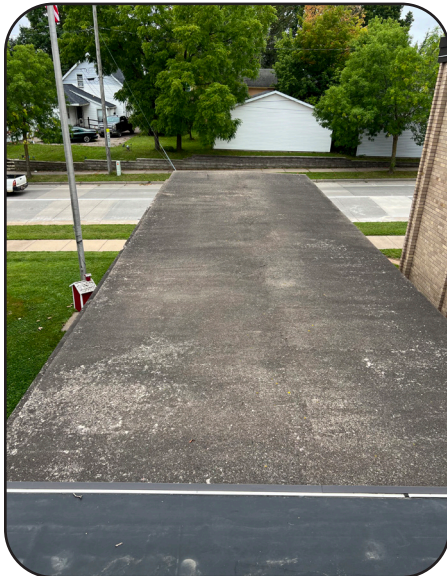
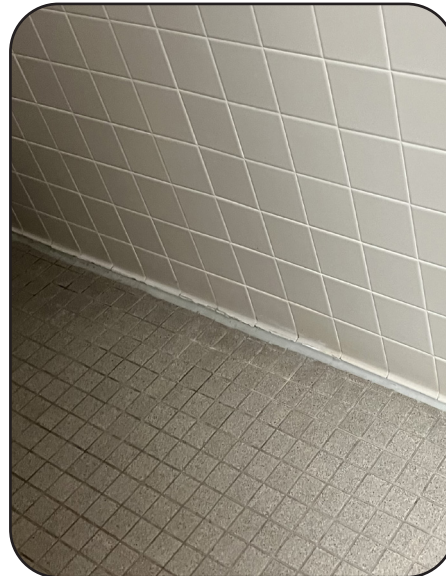
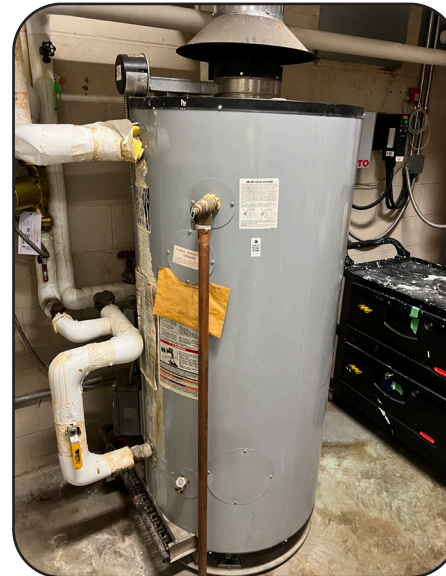
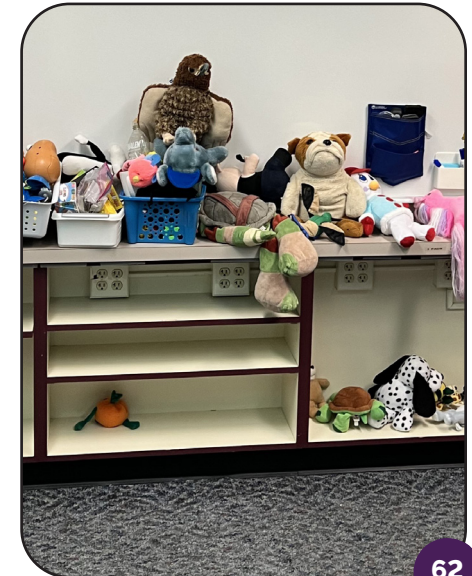
Building System	General Description	Recommendation	Cost Estimate
Exterior Building - Roofing	Two small roof sections on Franklin are in poor condition. Roof G is 24 years old, out of warranty, and leaking. Also, the exposed concrete canopy, currently with no membrane roof, is deteriorating.	Replace roof section G next summer. Insulation replacement is likely. Install a membrane roof and metal flashing over the concrete canopy roof to extend its life. Minor masonry repair will be necessary prior.	\$22,500
Interior - Structural	Minor structural settling has occurred in room 102/the bathroom area. It does not appear to have gotten worse in recent years.	Mark walls and monitor semi-annually to ensure no further settling.	\$500
Plumbing - Domestic Hot Water	The atmospheric gas fired water heater in the boiler room is 27 years old and far beyond its expected useful life.	Replace water heater with a high efficiency power vent unit withing the next year.	\$7,500

Electrical Availability	Throughout some portions of the building, extra power sources were noted to run in external raceway on block walls feeding outlets. Some were observed in special ed areas creating a safety hazard.	Rerun power internally in block wall cavities, if possible. The circuit pictured appears to be overloaded and not to code. As an immediate step, install tamper proof outlet protectors.	\$15,000

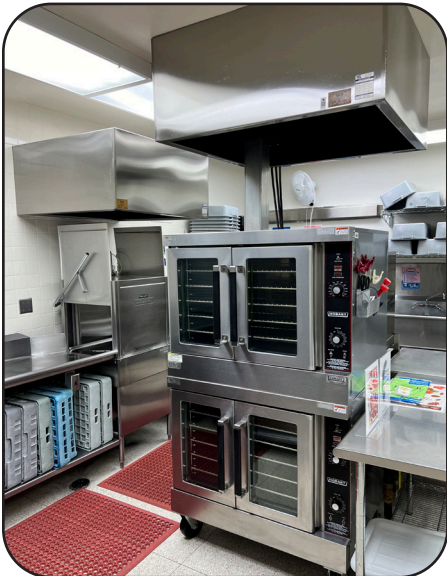
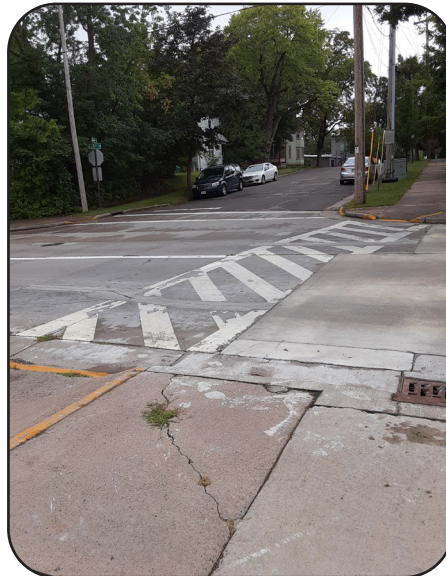
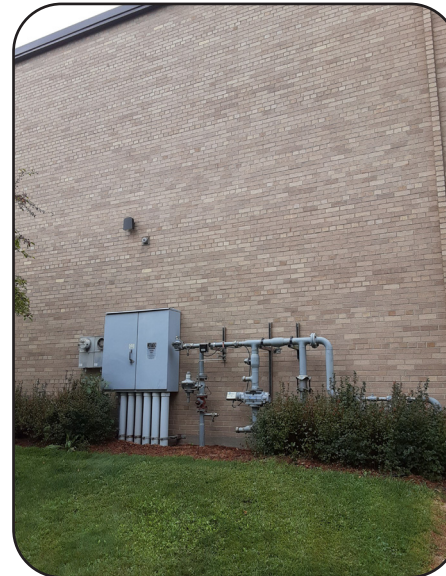
Building System	General Description	Recommendation	Cost Estimate
Interior - Kitchen Equipment	The kitchen is functioning well for the current school capacity. Equipment however is aging and beginning to cause downtime.	Invest in new kitchen equipment over the next 2-10 years.	\$75,000
Site & Landscape	Multiple walk concrete slabs with transitional and divided cracks.	Replace cracked concrete walk slabs.	\$23,000
Site Utilities	Gas valve on side of the building not secured inside fencing.	Enclose and secure valve access.	\$4,500
Site & Landscape	Minor bent fence pickets in perimeter fencing.	Repair bent pickets.	\$1,000

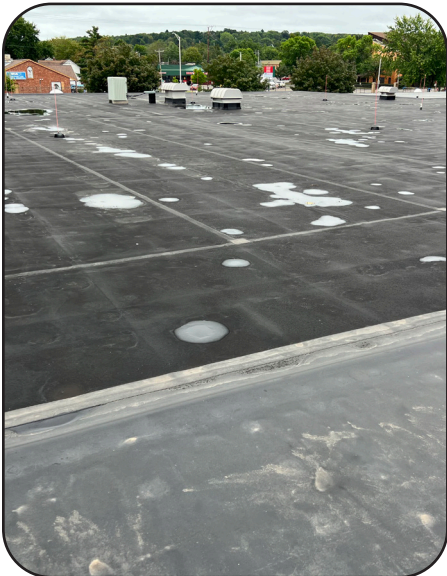
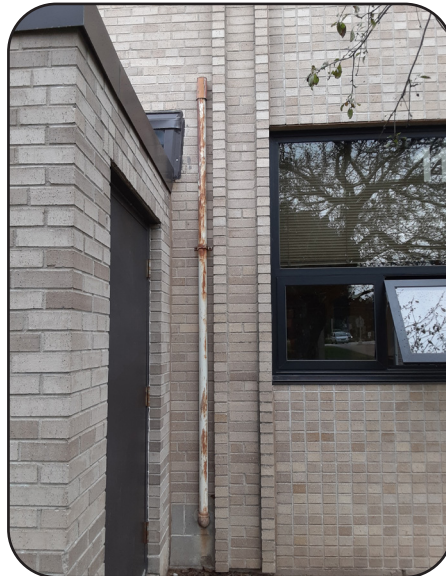
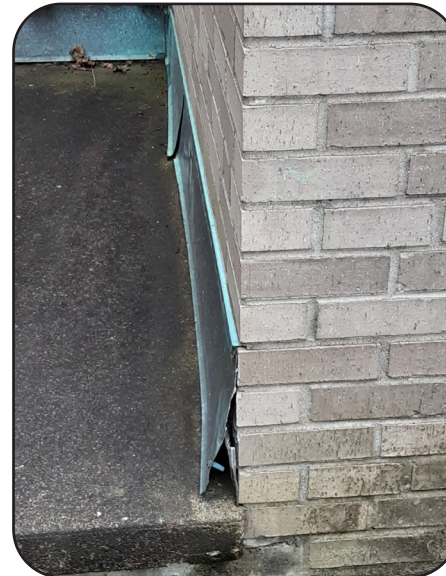
Building System	General Description	Recommendation	Cost Estimate
Exterior Building - Roofing	Roof sections E & F are 19 years old and out of warranty. Both sections are holding ponding water but no major leaks were reported.	Replace roof sections E & F in the next 1-5 years. Correct insulation elevation for proper drainage of roof sections. Recommend a 60 mil 20 year adhered black EPDM membrane.	\$112,000
Exterior Building	Exterior wall vertical pipe unguarded and rusty.	Prepare and coat pipe with weather durable coatings. Consider guarding pipe to eliminate use as climbing assistance to adjacent roof.	\$2,000
Exterior Building	Exterior wall open wall base metal flashing.	Remove, seal, and replace.	\$3,800
Exterior Building	Exterior wall loose roof edge corner brick.	Stabilize area, repair, and replace.	\$5,500

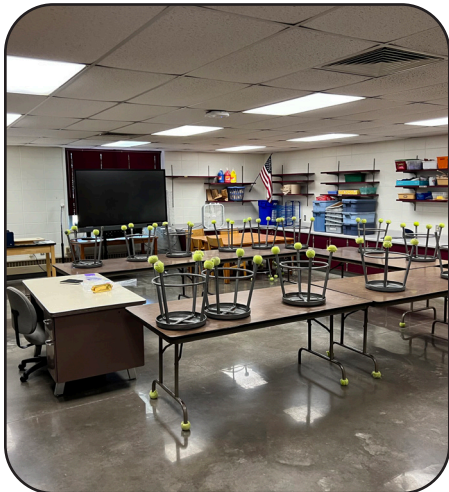
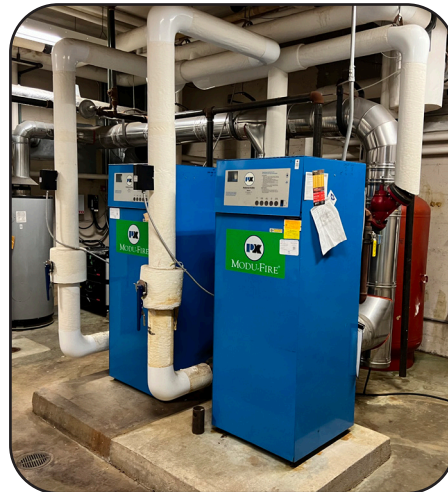
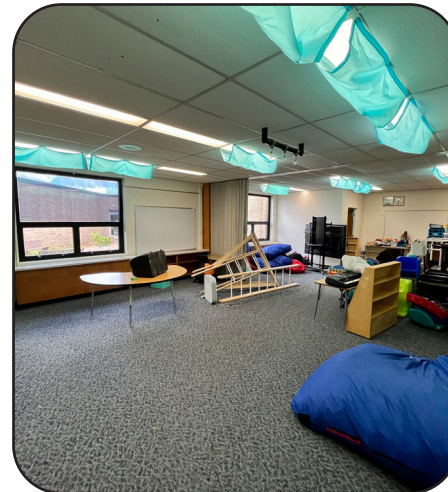
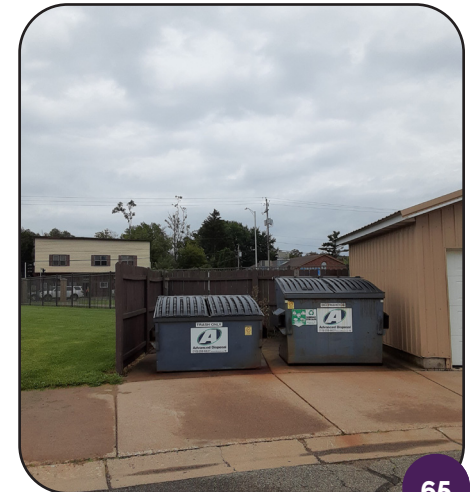
Building System	General Description	Recommendation	Cost Estimate
Interior - Ceilings	Although minimal, some rooms are showing early signs of ceiling failure with curled corners. Ceiling is mainly of 2x4 construction, which degrades faster than 2x2.	Replace ceiling of 5 classrooms in 3-5 years, recommend switching to 2x2 grid layout. Postpone ceiling work if large scale above-ceiling HVAC measures are being considered.	\$20,000
Mechanical - Boilers	Lincoln ES is heated by two 20-year-old boilers, each 2.0MBTU. The boilers are holding up well, however approaching their expected useful life, and inefficient to today's standards.	Expect to replace the boilers and pumps in the next 3-5 years. High efficiency condensing boilers are recommended.	\$200,000
Electrical - Whole Building Lighting Upgrade	The facility is in need of a whole building lighting upgrade from fluorescent to LED. Many classrooms were noted having fabric light filters hung over fixtures due to the harshness and intensity of existing lighting systems. Interior lighting projects provide roughly a 6 year simple payback, along with giving building occupants the ability to adjust light levels to their liking. Additionally, the systems have a 20+ year lifespan, drastically reducing maintenance required to change lamps and ballasts.	Replace classrooms, offices, corridors and common large spaces (gyms) with appropriate LED fixtures, occupancy sensors, and dimming controls. Complete this project at the same time of any major HVAC/ceiling work.	\$110,000

Site & Landscape	Dumpster roll over concrete curbs cracked and open.	Replace, patch, cut, grind, and/or mud jack as needed.	\$8,500

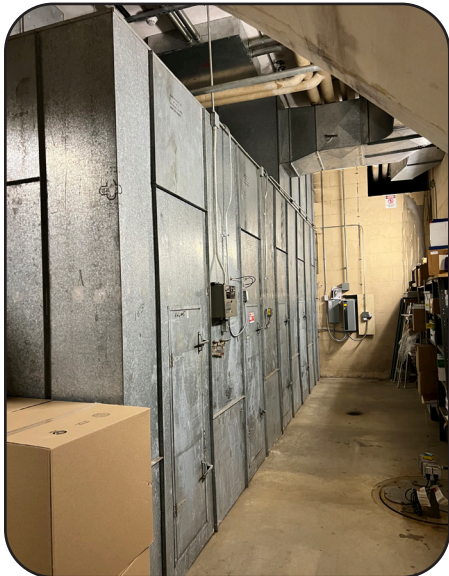
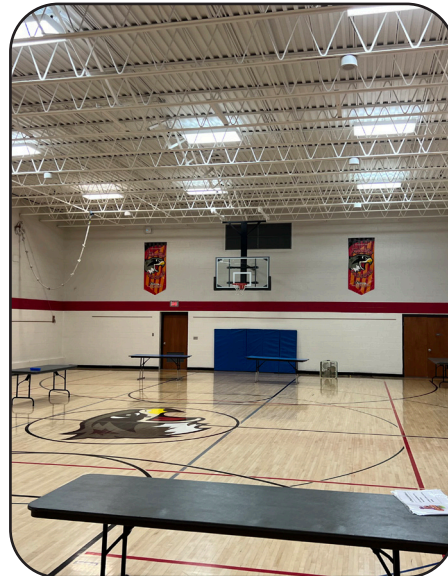
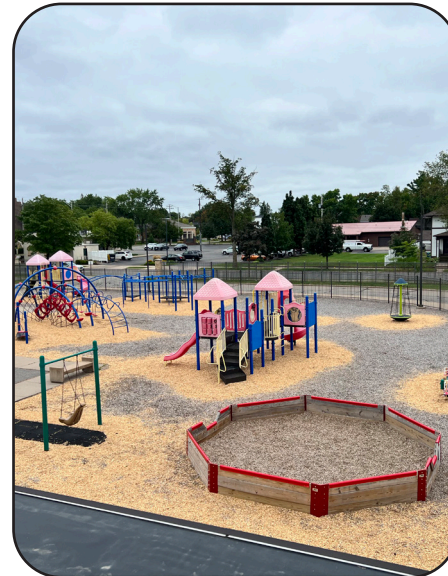
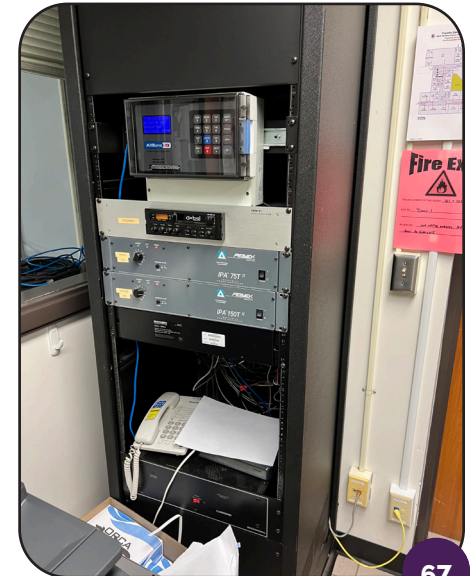
Building System	General Description	Recommendation	Cost Estimate
Mechanical - HVAC	Air-side HVAC in Franklin is mainly provided by original 1965 air handlers, 60 years old. This equipment is 25 years past its expected service life and obsolete. Air is provided to perimeter classrooms directly through the tunnel systems unducted. Asbestos is present in the tunnels, however the tunnels themselves appear to be dry and in very good condition.	Complete HVAC replacement of approximately 80% of the facility moving to overhead air distribution and vacating the tunnels. Pricing given assuming the 1991 Classroom/Multi/IMC addition will remain as is, however it may be desired to replace these units to add them to chilled water. Asbestos abatement will be necessary.	\$1,725,000
Mechanical - Gym Ceiling Fans	No gym destratification fans are present. Ceiling fans in high ceiling spaces help distribute heat from the ceiling to the occupants in winter, and can help maintain comfort in spring/fall.	Install gym destrat fans. Include schedulable control through the DDC system so fans can automatically turn on and off as desired.	\$20,000

Electrical	Minimal exterior area lighting inside of play area fencing.	Add LED area lighting to play areas for improved security and safety.	\$18,000
Electrical - Bell/PA & Communication	PA/Bell/Clock/mass communication systems due for upgrade. Existing system is obsolete using decades old technology.	Replacement recommended with the district's Single-wire system standard.	\$177,600
