## **PROJECT REPORT**

Date: October 25, 2013  
STR Project Number: 13123

### **District Administration Building Assessment**

### **Board of Education of Oak Park Elementary School District 97**

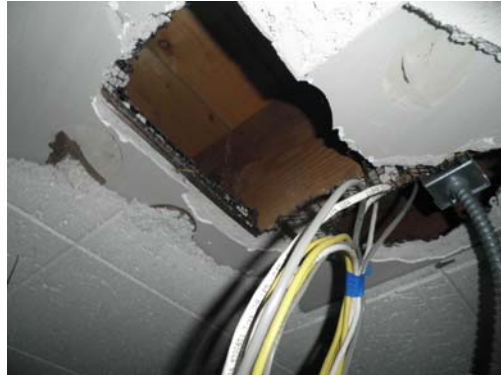
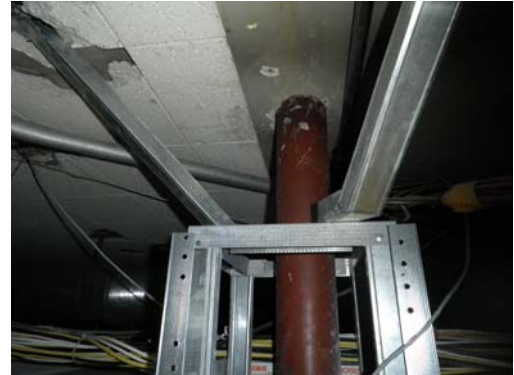
Wood Joists and Steel Framing at Second Floor

The building is a masonry, steel and wood structure. There is a two story portion of the building located in the north west corner. The remainder of the building is one story. The second floor framing consists of steel beams and columns supporting 2x14 framing at 12 inches on center.

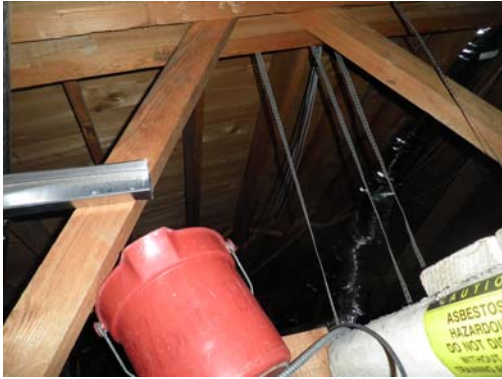
Bowstring Trusses Above Second Floor

The roof of the second floor is bow string trusses spanning north south from the exterior north wall to either an interior bearing wall or steel supports.

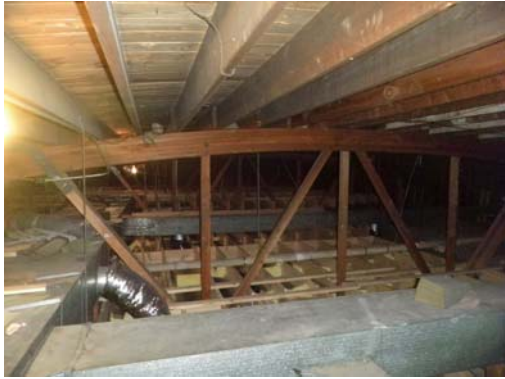
Bowstring Trusses at South West Area

The remainder spaces have wood framed roofs that appear to be supported on exterior masonry bearing walls or steel beams. The roof areas directly south of the two story portion and the area over the print shop are framed with wood bow string trusses. It appears that the trusses are supported on the masonry at the exterior and columns at the interior. The east portion of the roof area appears to be a flat roof, sloped for drainage. That is supported on bearing walls or steel beams.

The bow string trusses that support the mechanical equipment have been reinforced to support the equipment weight. Per the information provided by the District the remainder of the trusses in the south west portion of the building have been reinforced.

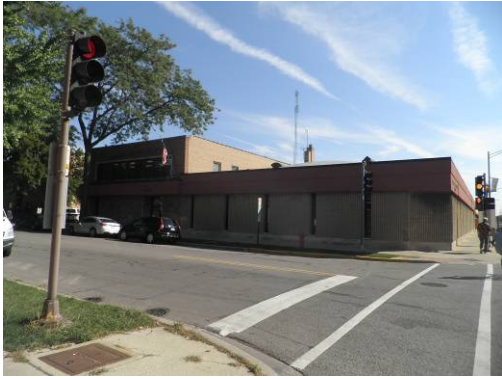
Exterior Split Face Masonry

The exterior masonry consisting of split faced concrete masonry units, concrete masonry units (cmu) and brick appeared in good condition. There are a minimum of cracks or joint deterioration. It appeared that the two story masonry has been recently tuck pointed.
