C.E.S.A. 10
 Facilities Management Services

Facility Improvement Measures Wausau - Hewitt-Texas Elementary School

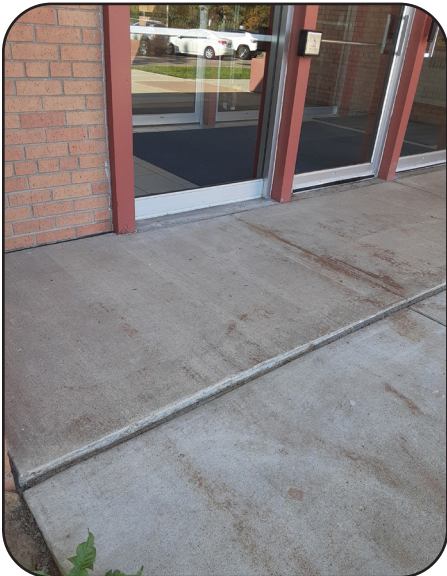
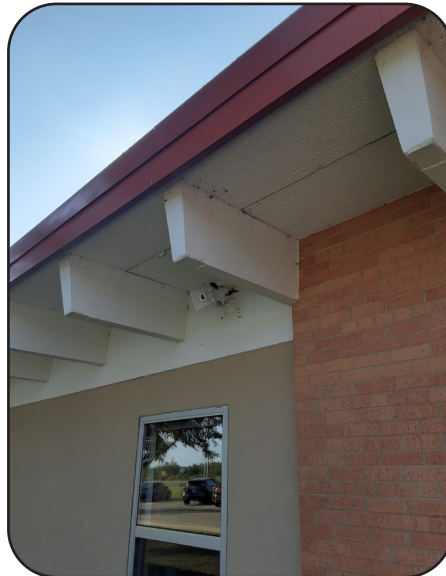
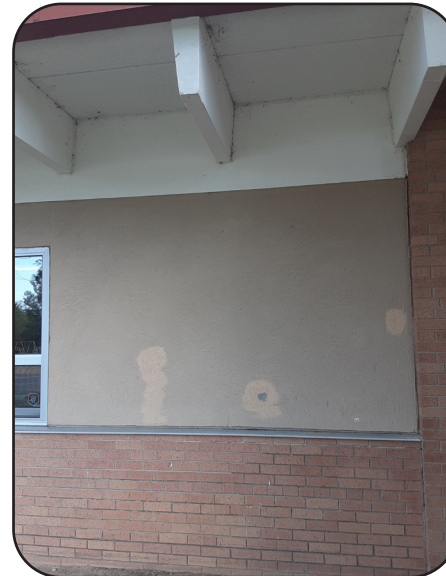
Building System	General Description	Recommendation	Cost Estimate
Site & Landscape	Concrete entrance landing raised edge transition to walk.	Replace, patch, cut, or grind to eliminate trip hazard.	\$85,00
Exterior Building	Soiled soffits between outlookers.	Clean and paint where needed.	\$5,500
Exterior Building	Exterior wall EIFS blemishes and paint discoloration.	Skim patch and paint to match existing.	\$1,000
Exterior Building	Exterior wall base below face brick cracked and open.	Patch and seal.	\$4,500

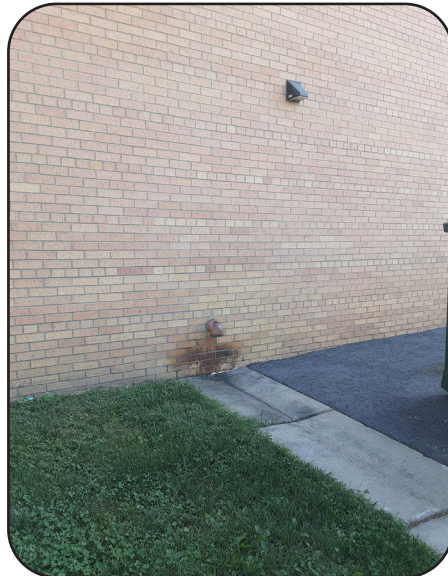
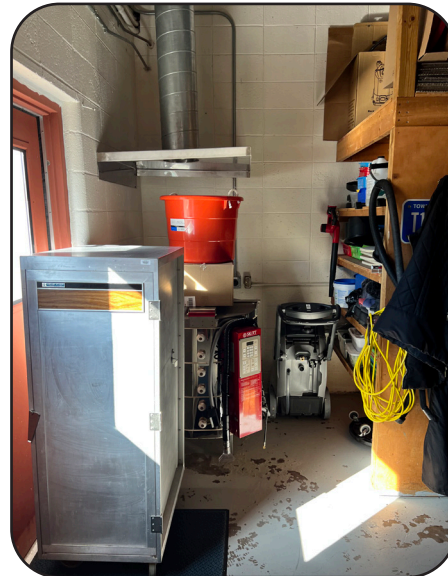
Building System	General Description	Recommendation	Cost Estimate
Exterior Building	Open roof edge flashing.	Add metal flashing to close opening.	\$1,000
Exterior Building	Exterior wall roof drain discharge wall stains.	Clean stains. Consider extending discharge away from brick face.	\$1,000
Interior - Kiln Safety	Art kiln is housed along with combustible materials.	Clean and organize the space. Store combustibles appropriately a safe distance away.	\$500
Interior - Wall Patching	Minor CMU block wall patching is needed in the boiler room. Determine if walls are fire rated.	Patch masonry and seal penetrations with caulk for noise. If a fire wall is present, properly seal with fire caulk.	\$2,000

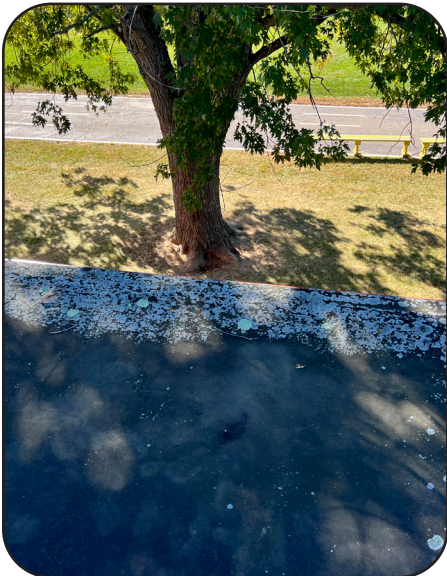
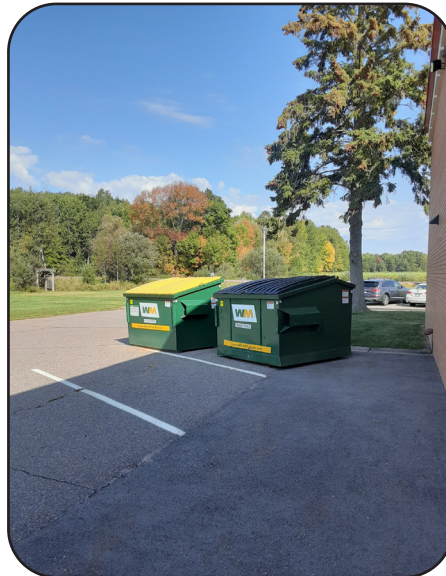
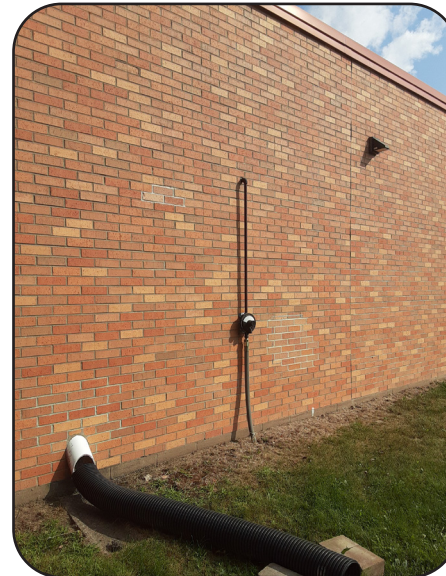
Building System	General Description	Recommendation	Cost Estimate
Site & Landscape - Trees	One tree on the south side of the facility is overhanging the roof, too close to the building. Trees overhanging the building shed leaves on the roof which block roof drains, create mold and mildew on the building, allow a path for intruders to access the roof creating a security hazard.	Take down the tree and remove remaining stump.	\$3,000
Site & Landscape	Dumpsters on asphalt.	Install concrete pads for dumpsters.	\$6,800
Site & Landscape	Propane pipe tubing unprotected on side of building.	Isolate or guard pipe tubing.	\$1,000
Site & Landscape	Electrical service supply meter and cabinet unprotected and providing potential climbing assistance to roof.	Fence in to isolate. Consider fencing with other adjacent HVAC and generator mechanical equipment.	\$3,000

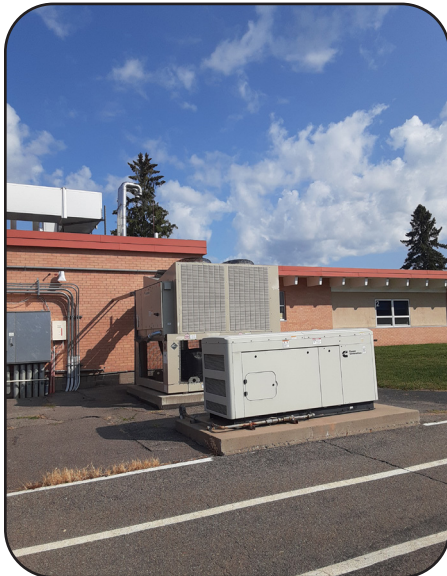
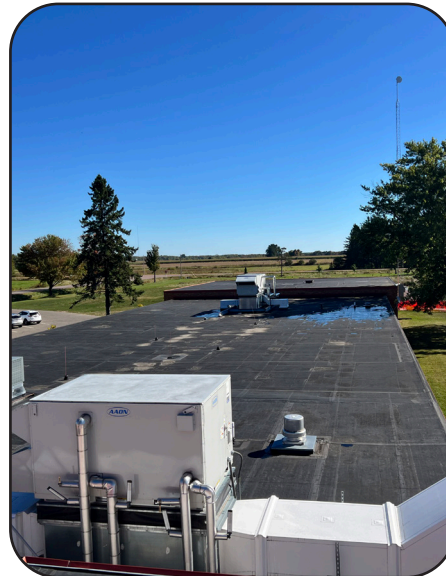
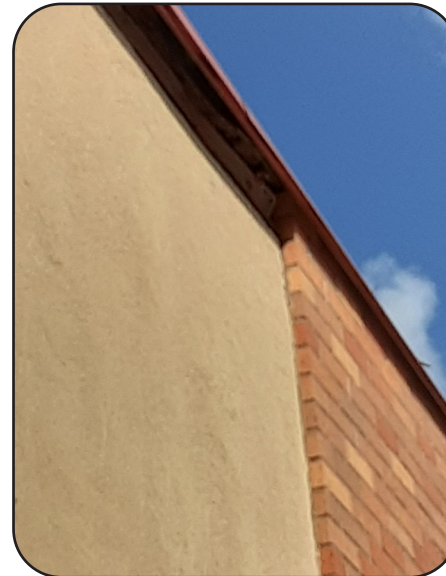
Building System	General Description	Recommendation	Cost Estimate
Site & Landscape	Mechanical equipment (HVAC & generator) unprotected.	Fence in to isolate. Consider fencing with adjacent electrical supply meter and cabinet.	\$6,500
Exterior Building - Roofing	Roof sections B-D are 23 years old and many years out of warranty period. The roofs are showing signs of degradation, slightly ponding water and frequent patches were observed.	Replace roof sections B-D in the next 2-5 years with an adhered 60 mil black EPDM 20 year warranty roof.	\$192,000
Exterior Building	Open narrow soffit area under roof edge.	Seal and paint. Consider cladding to close open areas.	\$12,000
Exterior Building	Exterior wall step cracks at exit overhang.	Investigate and eliminate cause. Tuck point bricks and mortar.	\$18,500

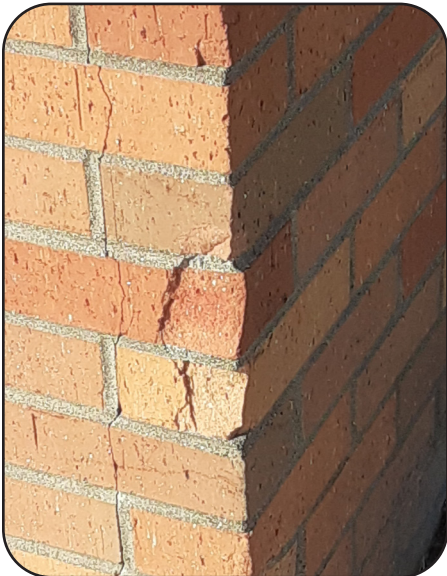
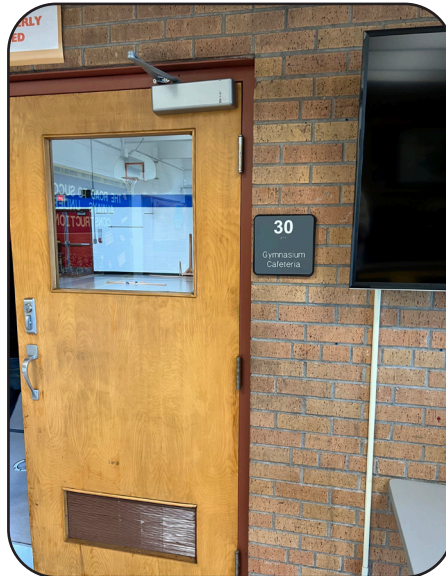
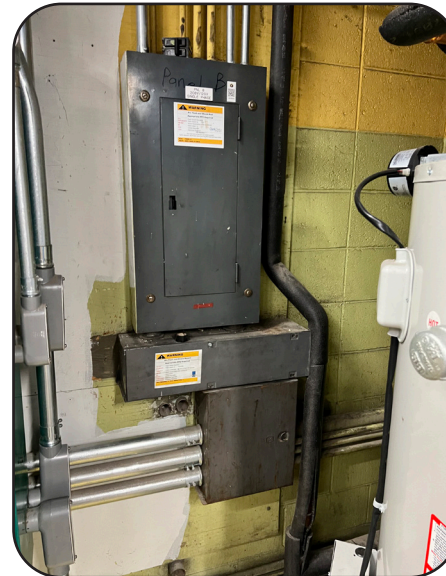
Building System	General Description	Recommendation	Cost Estimate
Exterior Building	Exterior wall low corner bricks cracked.	Replace and tuck point.	\$3,800
Interior - Wood Doors	Minimal older interior wood doors throughout the facility are showing age; de-laminating, stained, and chipped.	Replace aged and damaged interior wood doors. Estimate given for 5 doors.	\$7,500
Electrical	Minimal original construction 1961 obsolete electrical subpanels were noted throughout the facility. If failures arise, replacement breakers will be difficult to find.	Replace panels and breakers. Ensure functional locking enclosure doors are in place.	\$20,000
Electrical	Although interior lighting in the facility has mainly been completed, spot small areas around the entrance look to still be fluorescent.	Complete remaining lighting conversion.	\$5,000

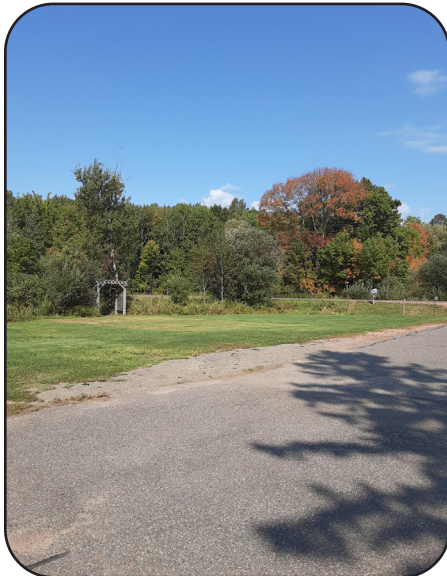
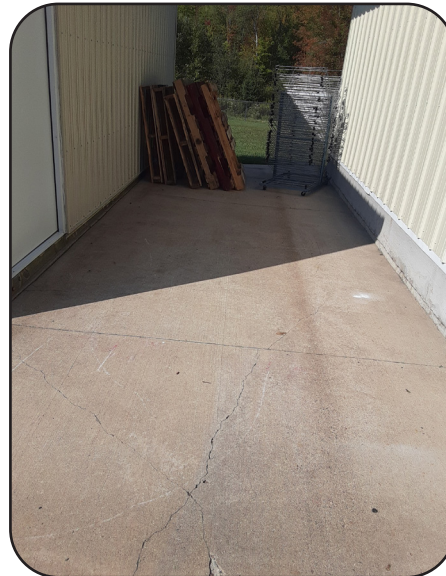
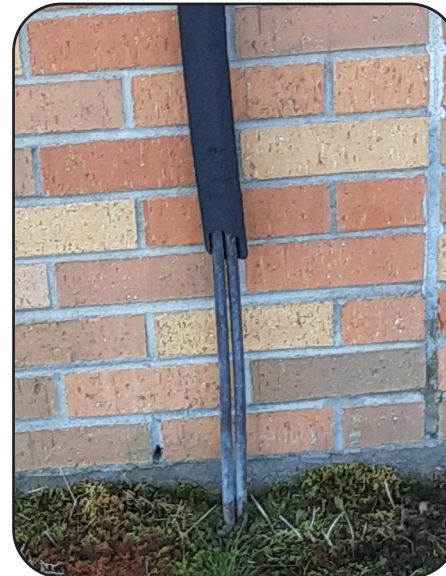
Building System	General Description	Recommendation	Cost Estimate
Site & Landscape	Asphalt drive too narrow. Drive off area formed on edge.	Widen asphalt drive.	\$15,500
Site & Landscape	Multiple walk concrete slabs with transitional and divided cracks.	Replace cracked concrete walk slabs.	\$6,000
Site & Landscape	Missing insulation and unprotected tubing on side of building.	Isolate or guard pipe tubing.	\$1,000
Site & Landscape	Dock wall and bumper deteriorating.	Replace wall and bumpers.	\$14,500

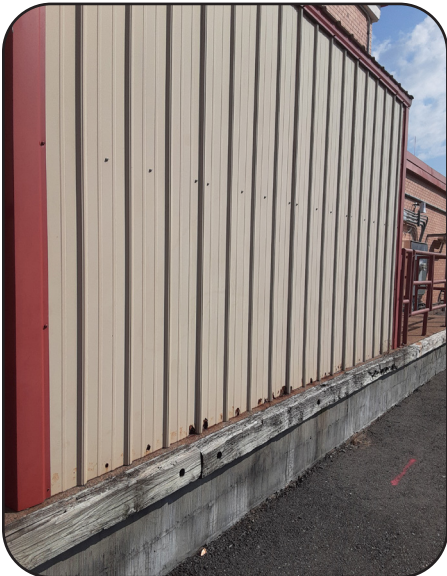
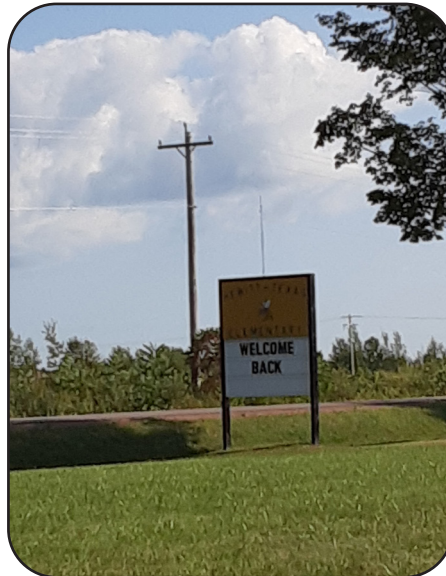
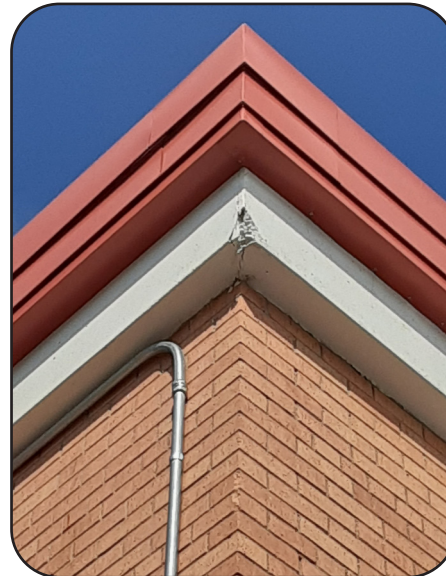
Building System	General Description	Recommendation	Cost Estimate
Site & Landscape	Dock metal wall panel base rusting.	Patch, repair, and paint or replace.	\$7,500
Site & Landscape	School sign due for upgraded replacement.	Replace sign.	\$12,500
Exterior Building	Wall top concrete edge cracked.	Patch, seal, and paint.	\$4,000
Exterior Building	Exterior wall face bricks spalling in multiple areas.	Replace and tuckpoint spalling bricks.	\$75,000

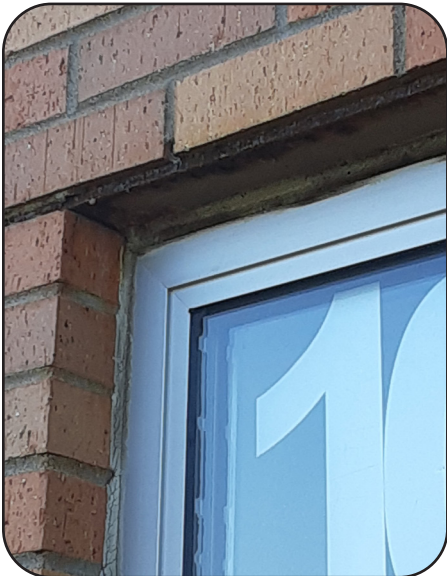
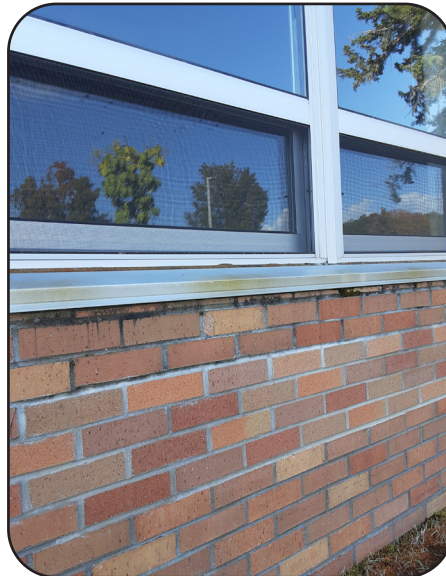
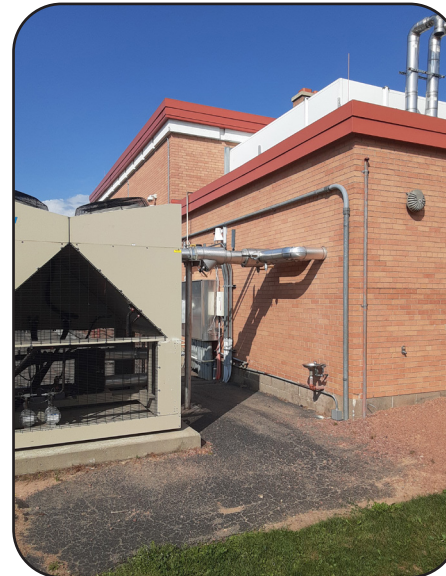
Building System	General Description	Recommendation	Cost Estimate
Exterior Building	Exterior window lintels rusted and loose.	Coat to prevent rust and tuckpoint around lintels.	\$20,000
Exterior Building	Exterior window sills stained under drip edges.	Clean edges and bricks.	\$2,500
Exterior Building	Exterior wall drinking fountain located next to large outdoor HVAC equipment.	Relocate drinking fountain.	\$3,000
Interior - Acoustical Ceiling	Most of the buildings acoustical ceiling is in good condition. A small section on the east end has 2x4 tile beginning to sag and show its age.	Replace ceiling in the newer addition in the next 5-10 years.	\$12,500

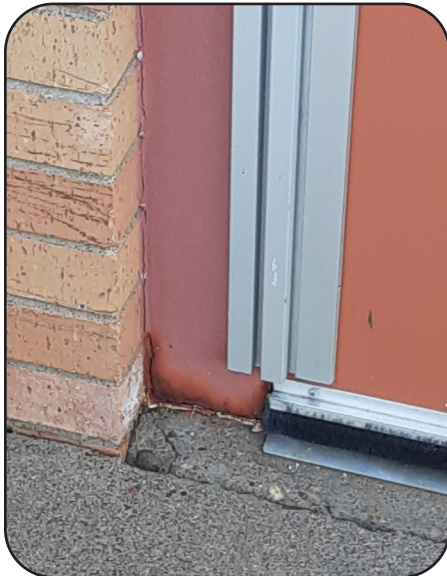
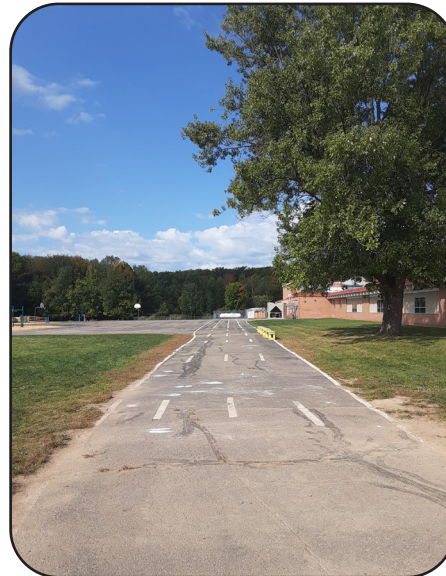
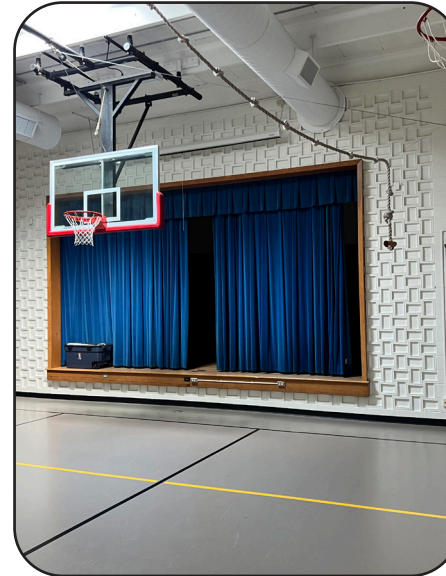
Building System	General Description	Recommendation	Cost Estimate
Hewitt Texas ES	Exterior Building - Doors	Minimal exterior doors and frames are showing sign of deterioration and rust.	Replace deteriorating door frames and doors if necessary.
Site & Landscape	Substantial crack filled areas without top sealing.	Continue to crack clean and crack fill as needed. Approximately every 3-5 years additionally seal and repaint asphalt.	\$7,500
Interior - Stage Renovation	The stage area off the gym is original and dated. Stage curtain appears to be original and of a combustibile materials commonly called out by insurance for replacement.	Renovate the space into usable square footage, consider removing the curtain entirely if never used.	\$100,000

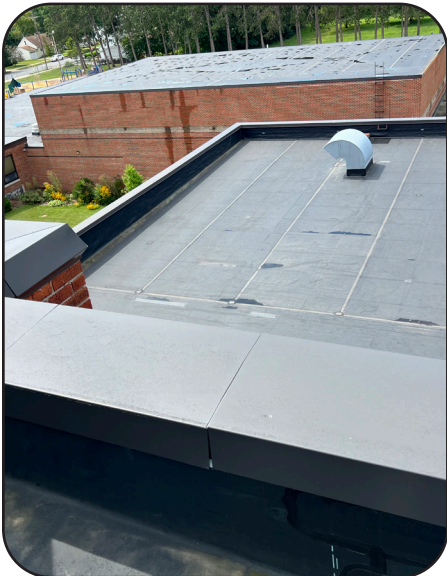
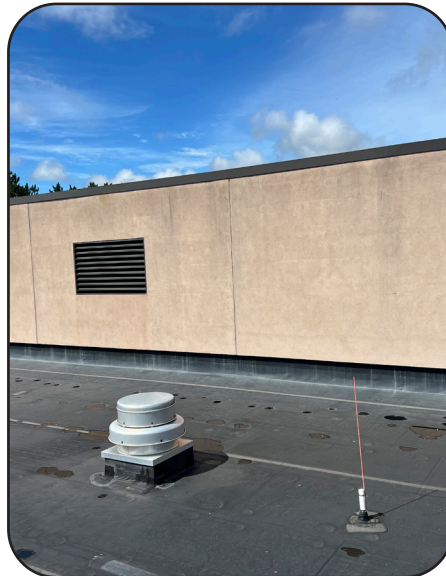
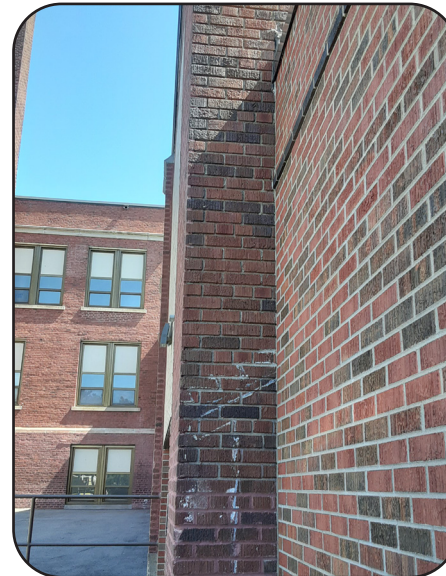
Building System	General Description	Recommendation	Cost Estimate
Exterior Building - Roofing	Roof section D is 22 years old and beyond its warranty period. Although this roof appears in good condition, its deck is showing signs of failure from past leaks.	Replace roof section D in the next 1-5 years dependent on a structural assessment identified in a separate FIM. Replace with an adhered 60 mil black EPDM 20 year warranty roof. Pricing given including wood deck replacement. If wooden structural beams must also be replaced, this will be an additional cost.	\$72,000
Exterior Building - Gym EIFS Wall	The southern upper wall of the gym is of EIFS construction. This EIFS is beginning to fail with cracks through the surface. The EIFS caulk joints have failed and need to be replaced.	To address this problem long-term, consider removing the EIFS and replacing with a standard insulated brick cavity wall with weeps to the roof. Otherwise bring in an EIFS repair specialist to address the EIFS failures, remove, and re-caulk the joints. Pricing given for repair.	\$15,000

Exterior Building	Face brick paint stained.	Remove failed and around areas of missing caulk. Re-caulk without blocking or sealing weeps.	\$12,500
Exterior Building	Wall grill exhaust duct contains debris.	Remove rust, paint or coat, and seal with proper water shedding allowance.	\$1,000

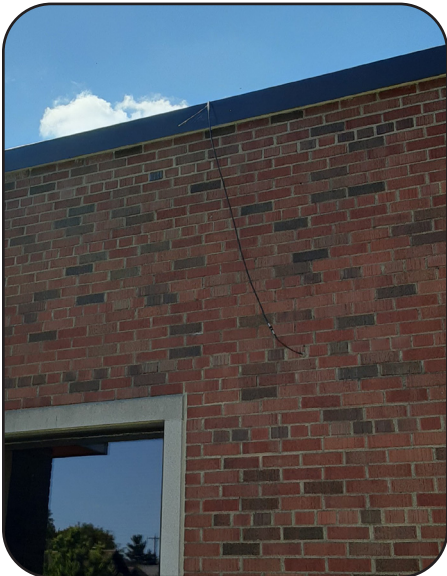
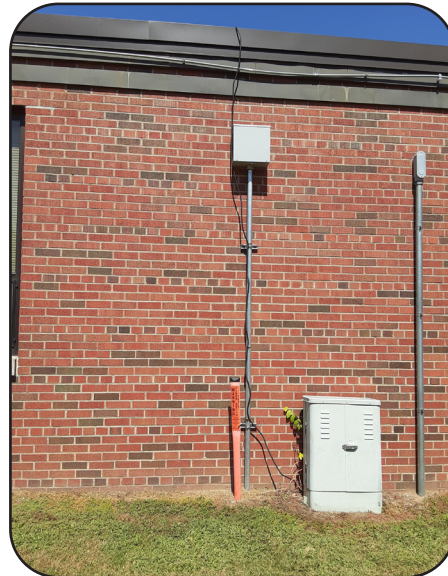
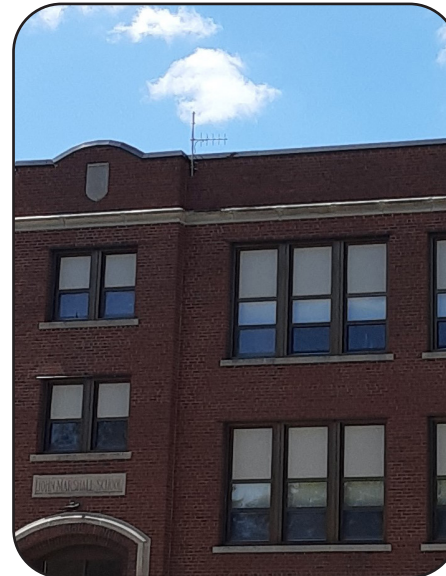
Building System	General Description	Recommendation	Cost Estimate
Exterior Building	Unsecured cable from roof into brick face.	Secure cable in fixed conduit.	\$1,000
Exterior Building	Unsecured fiber cable from ground to roof.	Secure cable in fixed conduit.	\$3,500
Exterior Building	Upper decorative stone belt piece missing.	Replace missing stone. Seal and weather proof.	\$14,500
Exterior Building	Stone window sill rebar steel exposed.	Patch surface.	\$1,000

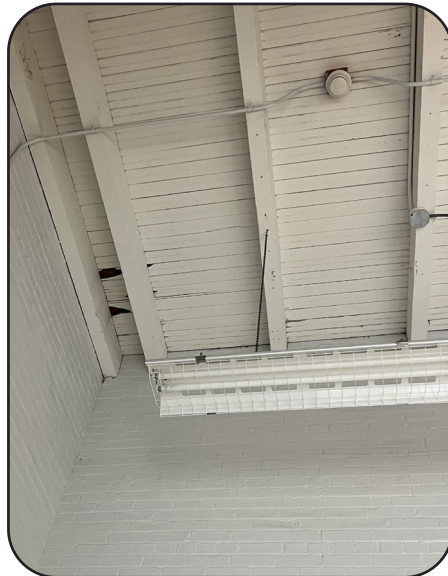
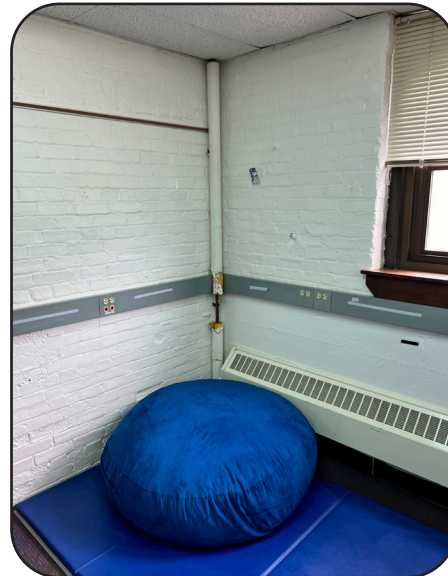
Building System	General Description	Recommendation	Cost Estimate
Exterior Building	Flashing fasteners rusting and staining metal flashing.	Clean metal flashing and replace fasteners with non-ferrous replacements.	\$1,000
Interior - Multi-Roof Deck	The wood roof deck of the multipurpose room is showing water damage from the interior.	Hire a structural engineer to closely examine the damage from a lift and determine the urgency. Examine both decking and wooden beams. If the structure does not pose an immediate danger, replace deck with steel decking during re-roofing of roof D, which should be reroofed at any time. Urgency and pricing given for structural examination. Deck replacement included in roof D FIM.	\$7,500
Mechanical - Pipe Insulation	Missing and/or damaged pipe insulation was noted in various locations around the building. Although the missing insulation pictured in room 114 does not appear to be asbestos containing, the exposed pipe can pose a burn hazard and should be addressed immediately.	Replace damaged and missing pipe insulation. Address issues in child areas as soon as possible. Presence of asbestos and abatement needed can drastically change pricing. Pricing given for spot replacement seen around the building, not for potential abatement.	\$10,000

Mechanical - Boilers	John Marshall ES is heated by three 34-year-old standard efficiency atmospheric boilers, each 1.5MBTU. The boilers have held up well, however are beyond their expected useful life and are inefficient to today's standards.	Replace the boilers and pumps in the next 1-3 years with high efficiency sealed combustion air condensing boilers. Test nearby materials for hazardous materials.	\$325,000

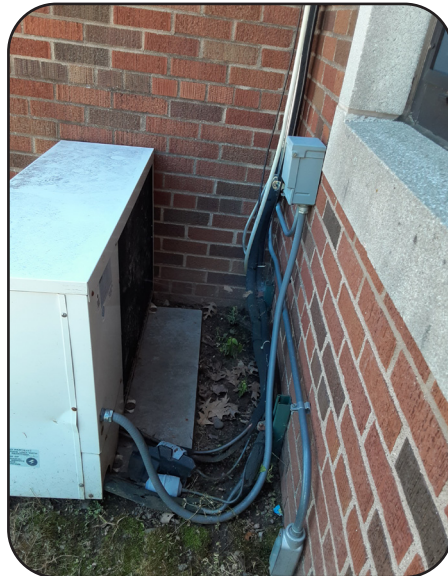
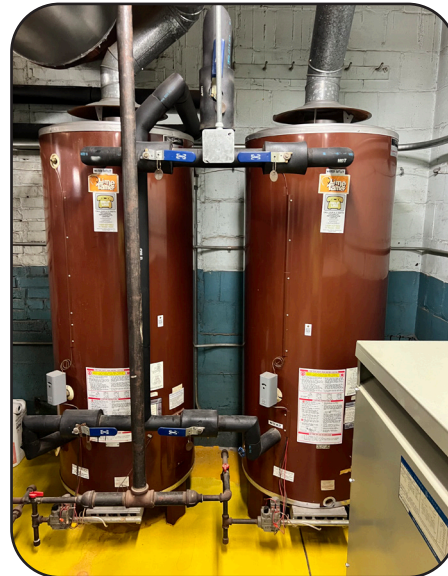
Building System	General Description	Recommendation	Cost Estimate
Mechanical - Kitchen Cooling	It was noted during staff interviews that the kitchen area is hot. Air conditioning was provided to this area in the 2016 mechanical renovation and it should be cooled.	Balance the final S-1 diffuser to the kitchen to ensure proper air flow at the end of the line. Ensure no short cycling is occurring with incoming air being immediately exhausted.	\$3,000
Mechanical - Air Conditioning	Outdoor mechanical equipment directly on ground slab with no drainage or protective clearance.	Raise equipment on a stand, rack, or curb to protect from ice, water, and debris.	\$2,500
Plumbing - Domestic Hot Water	The two 100 gallon gas fired atmospheric water heaters in the boiler room are 35 years old and 15-10 years beyond their expected useful life.	Replace water heaters with sealed combustion/power exhaust high efficiency units within the next 1-3 years.	\$15,000

Electrical - Classrooms	Room 114 was formerly a computer lab re-purposed to a new child space. Many surface mount outlets are present at finger height creating a safety hazard. Avoiding surface mount electrical in a facility of this vintage will be difficult without constructing a furring wall.	Eliminate unnecessary outlets and mount at an appropriate height with tamper proof outlets.	\$10,000

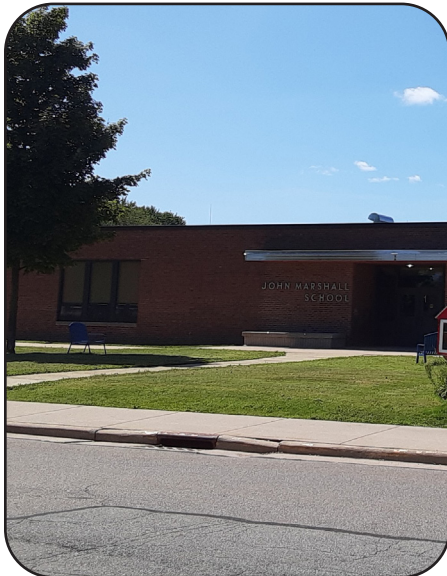
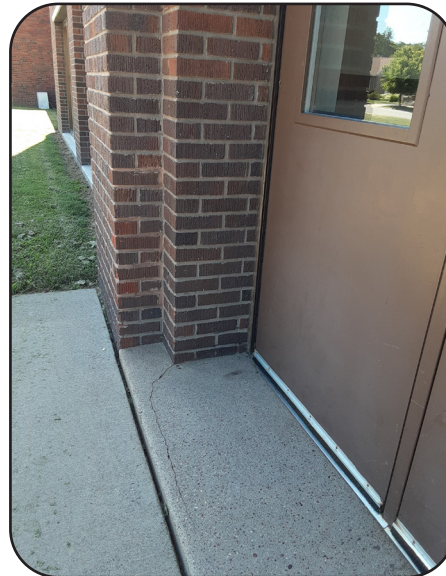
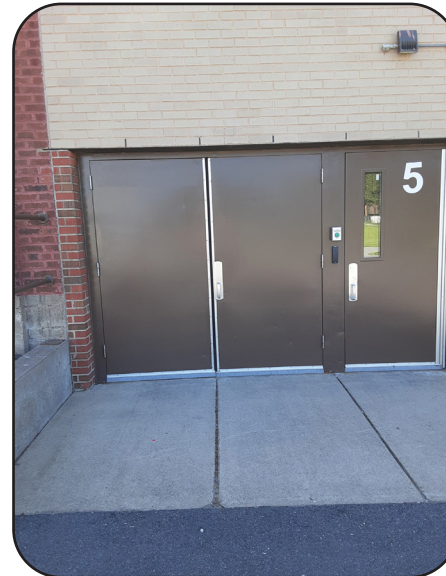
Building System	General Description	Recommendation	Cost Estimate
Site & Landscape	Concrete curb sinking.	Replace or mud jack to elevate.	\$1,000
Site & Landscape	Concrete exit door landing raised edge and cracked.	Replace with smooth transition to walk concrete.	\$3,500
Site & Landscape	Wide concrete land slab gaps.	Back fill gaps with sand and backer rod. Caulk and seal with appropriate joint filler. Heat melt in place material recommended for smooth, clean appearance.	\$8,500
Site & Landscape	Building perimeter transition to hardscape gaps.	Back fill gaps with sand and backer rod. Caulk and seal with appropriate joint filler. Heat melt in place material recommended for smooth, clean appearance.	\$5000

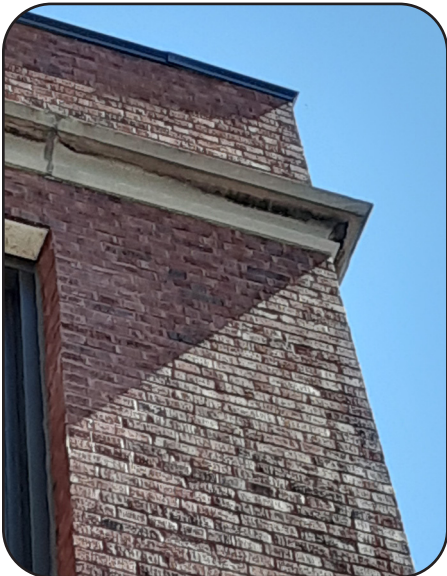
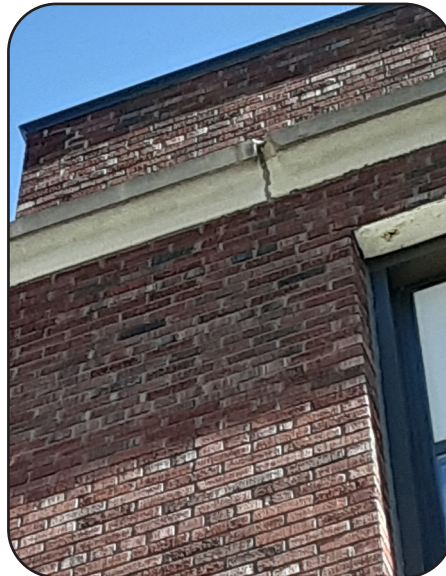
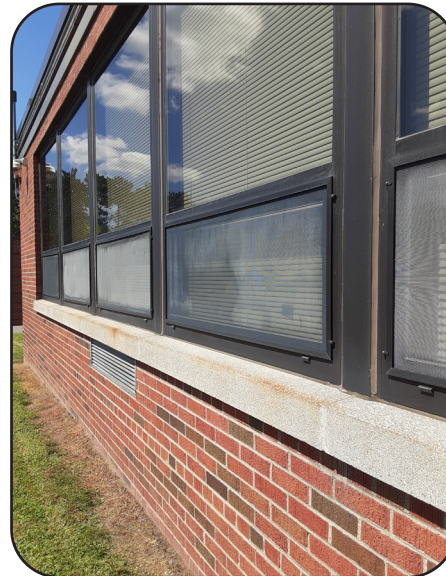
Building System	General Description	Recommendation	Cost Estimate
Exterior Building	Under side of decorated belt stained.	Clean decorative stone.	\$15,000
Exterior Building	Decorative stone belt cracked.	Verify permanence. Patch crack or replace.	\$3,500
Exterior Building	Stone window sills stained.	Clean sills.	\$8000
Exterior Building	Window lintels rusting and open.	Prepare and appropriately coat to prevent rust. Stabilize and close open or loose edges.	\$60,000

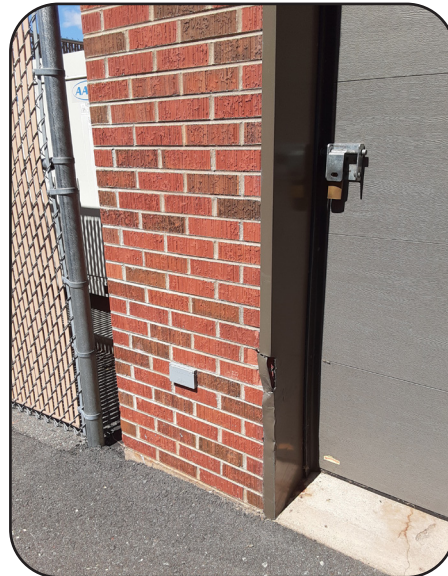
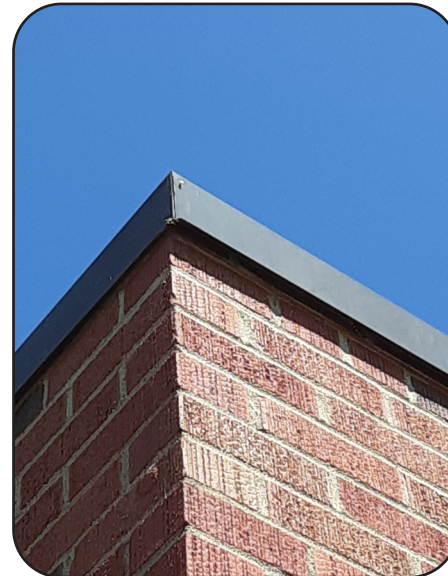
Building System	General Description	Recommendation	Cost Estimate
Exterior Building	Window screen frame colors mismatched.	Match screen frame color per each elevation.	\$6,000
Exterior Building	Outdoor overhead storage door frame and gasket edge damaged.	Repair and replace frame cladding and gaskets.	\$2,000
Exterior Building	Roof edge flashing open gap underneath. Wasp nesting observed under gaps.	Verify components inside of gap. Spray foam insulation to close openings.	\$3,000
Exterior Building	Main entrance over hang wood soffit due for repainting.	Prepare and repaint. Consider cladding to extend maintenance frequency.	\$5,500

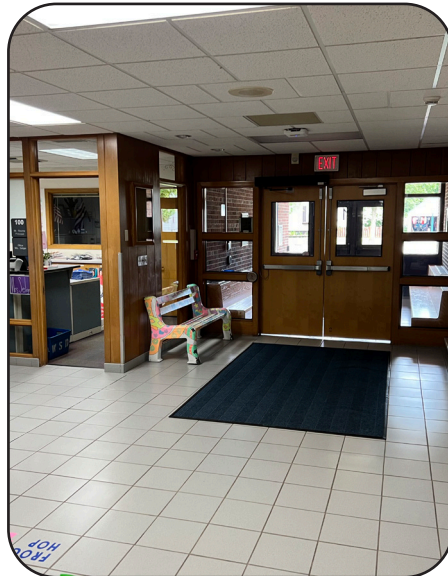
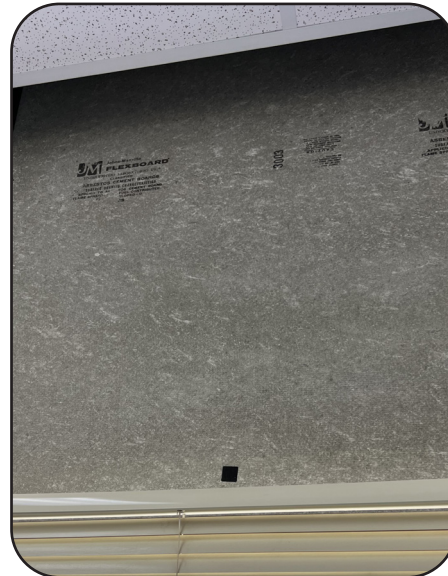
Building System	General Description	Recommendation	Cost Estimate
Exterior Building	Older face brick spalling.	Repair as part of larger masonry improvement project.	\$45,000
Interior - Secure Entrance	Although the entrance is secure with a vestibule and electronic vetting area, visitors are not directly routed through the office prior to being given access to the building. This can be accomplished cost effectively at John Marshall with the addition of a wall or storefront glass and door modifications.	Install secure entrance measures routing visitors through the office prior to being given access to the full school.	\$100,000
Interior - Windows	The original facility windows contain an upper opaque section, this fiber board is made of asbestos material and is unpainted from the inside, giving off an unfinished look to the classrooms.	The much more costly and recommended option is to abate the panels and replace with spandrel glass. Another option would be to paint the interior side of the asbestos panel. Pricing given for painting.	\$15,000

Interior - Gym Flooring	Although in good overall condition, the main gym floor is scuffed and scratched.	Maintain a wood floor refinishing cycle, recommended every 5-10 years dependent on use and condition.	\$25,000

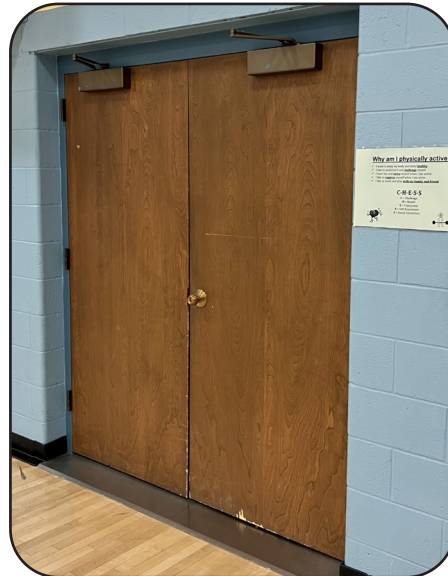
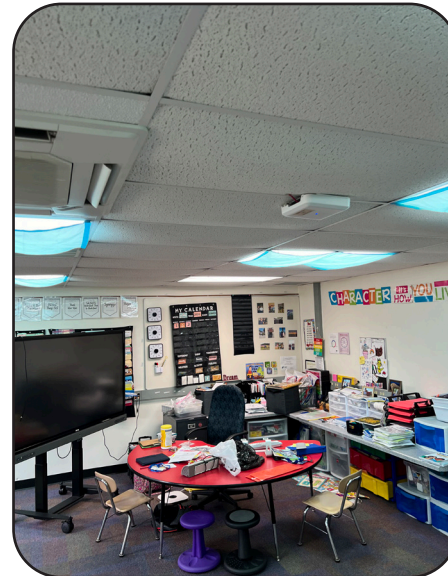
Building System	General Description	Recommendation	Cost Estimate
Interior - Lunch Flow	The single door and frame from the multipurpose room to the kitchen area creates a bottleneck for students getting through lunch.	Ensure the door is not a required fire door, it does not appear to be. Check for load bearing points. If acceptable, remove the door, frame, and surrounding wall to open up the entry.	\$10,000
Interior - Wood Doors	Minimal older interior wood doors throughout the facility are showing age; de-laminating, stained, and chipped.	Replace aged and damaged interior wood doors. Estimate given for 10 doors.	\$15,000
Interior - Ceilings	Ceilings in John Marshall are in good condition, however they all must come down if undertaking a major HVAC renovation.	Replace ceilings with mechanical renovation.	\$125,000
Mechanical - HVAC	Marshall is provided HVAC through a mix of air handling solutions ranging from 30 year old equipment in the original 3-story building to 50+ year old equipment in the 1955 wing. All beyond it's expected service life and not providing A/C. The multipurpose room's HVAC is modern with A/C.	Replace all air handling equipment in the facility with modern above ceiling VAV equipment. Take space within the school to create a new mechanical room in the 1955/89 wings. Replace the 1923 building RTU with modular penthouse rooftop equipment, and install new VAV's. The gym AHU likely has life remaining, but is ready for replacement by age, and must be replaced if moving to chilled water. Replace the 1999 renovation DX unit one-for-one. Leave the multipurpose equipment in place.	\$2,000,000

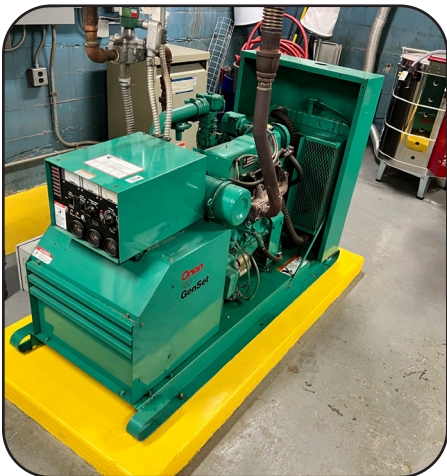
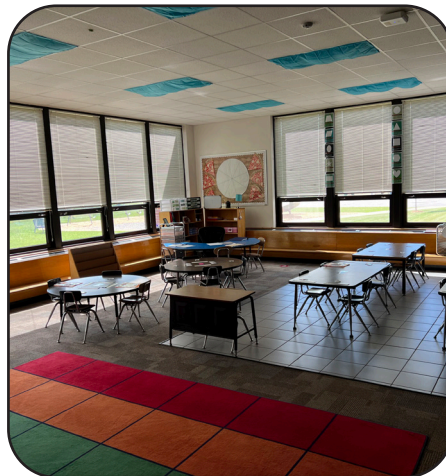
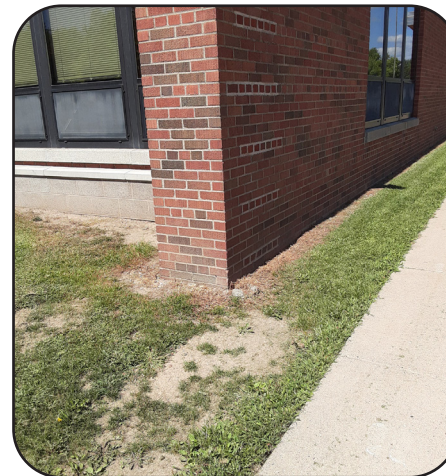
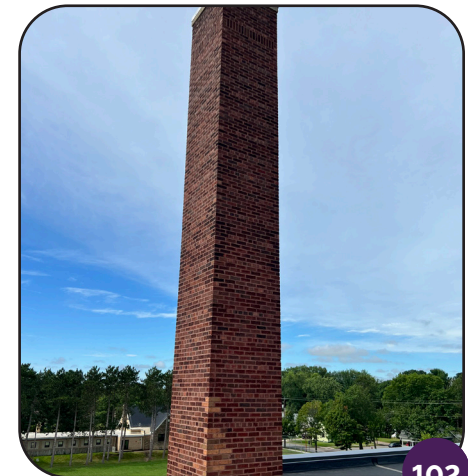
Building System	General Description	Recommendation	Cost Estimate
Electrical - Generator	Emergency generator is 34 years old and at its expected useful life, the unit appears to be undersized to supply both emergency lighting and building heat.	Replace generator with modern outdoor unit capable of both emergency lighting and supplying building heat electricity. Pricing given to replace generator, emergency lighting rewiring possibly necessary not included.	\$150,000
Electrical - Whole Building Lighting Upgrade	The facility is in need of a whole building lighting upgrade from fluorescent to LED in approximately 85% of the building. Many classrooms were noted having fabric light filters hung over fixtures due to the harshness and intensity of existing lighting systems. Interior lighting projects provide roughly a 6 year simple payback, along with giving building occupants the ability to adjust light levels to their liking. Additionally, the systems have a 20+ year lifespan, drastically reducing maintenance required to change lamps and ballasts.	Replace classrooms, offices, and corridors with appropriate LED fixtures, occupancy sensors, and dimming controls. Pricing given to upgrade 85% of the facility.	\$106,000

Site & Landscape	Worn grass turf at building corner along walk.	Cultivate soil and replant turf. Consider placing paved or crushed stone extension off walk edge if used as a common pathway.	\$1,000
Exterior Building - Chimney	It appears the old boilers stack is no longer in use and is deteriorating. This adds to maintenance load and creates roofing leak avenues. Vintage tall stacks are no longer necessary with the elimination of coal fired boilers.	Verify the stack is no longer in use, maintain with tuckpointing if it is. The base recommendation is to demo the stack to the second story roof line. Accomplish this during any major roofing effort.	\$35,000

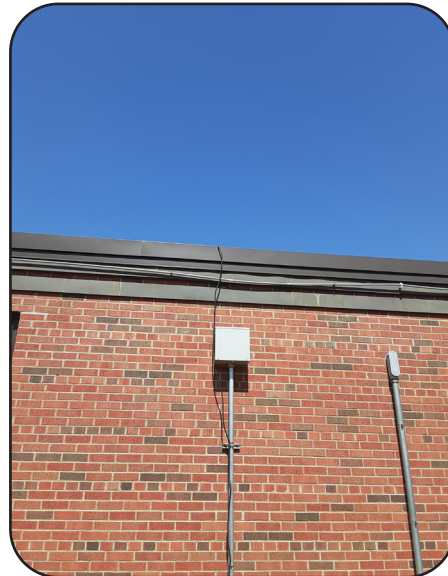
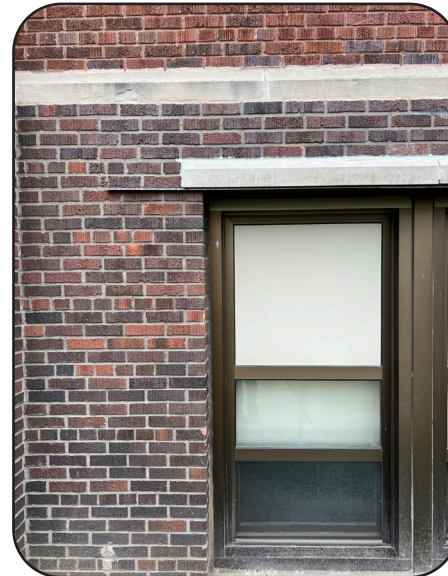
Building System	General Description	Recommendation	Cost Estimate
Exterior Building	Open face brick mortar.	Investigate and eliminate cause. Clean and remove stains.	\$6,500
Exterior Building	Conduit is sagging and was potentially used for climbing access to the roof.	Straighten conduit. Consider placing guards around conduit to deter potential use for climbing assistance.	\$5,500
Exterior Building	Limestone belt surface deteriorating.	Resurface decorative limestone.	\$35,000
Exterior Building	Stone window sills cracked.	Patch cracks or replace.	\$12,500

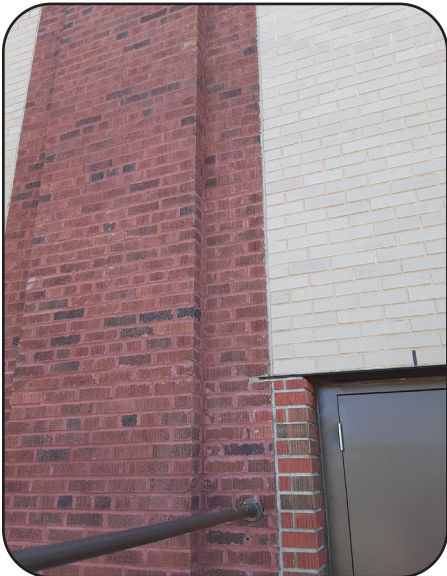
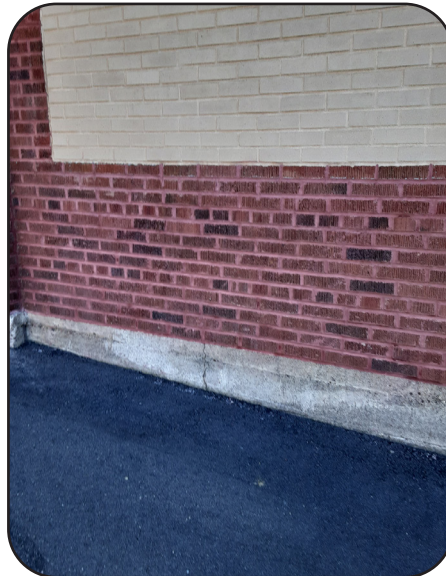
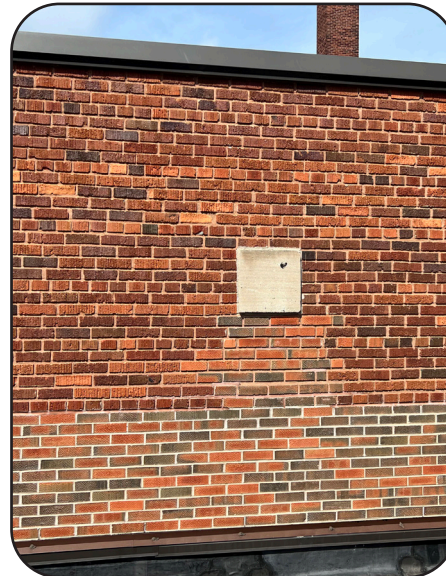
Building System	General Description	Recommendation	Cost Estimate
Exterior Building	Poor quality tuck pointing.	Redo poor quality work. Consider as add on to more extensive masonry work to reduce mobilization and down-time costs.	\$18,000
Exterior Building	Exterior wall base crack below brick face.	Repair or replace. Waterproof to prevent infiltration.	\$1,000
Exterior Building	Newer face brick spalling.	Repair as part of larger masonry improvement project.	\$35,000
Exterior Building	Window spandrel panels are asbestos cement boards.	Abate and replace.	\$82,000

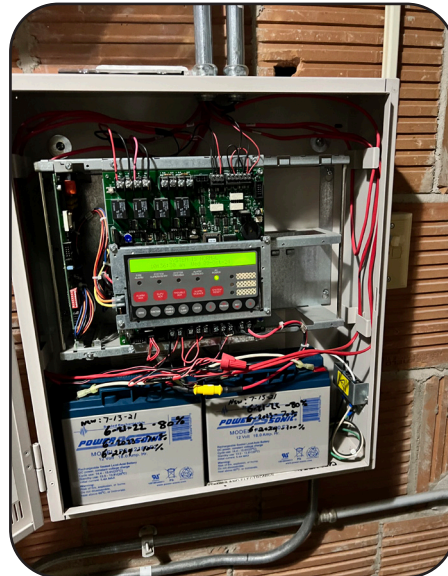
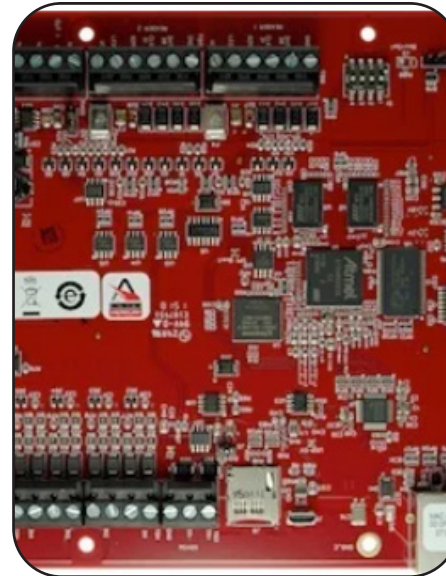
Building System	General Description	Recommendation	Cost Estimate
Electrical - Bell/PA & Communication	PA/Bell/Clock/mass communication systems due for upgrade. Existing system is obsolete using decades old technology.	Replacement recommended with the district's Single-wire system standard.	\$210,000
Electrical - Fire Panel	Fire panel at end of expected usable life.	Replace or upgrade to Edwards standard.	\$155,000
Electrical - Door Access	Card Access systems across the district are in need of upgrade to their board controllers. Information was compiled through district IT interviews and recommended per school individual need.	Replace HID Vertx boards to Mercury LP1502's.	\$8,000
Exterior Building -Gym Masonry Wall	The gym masonry wall is holding water. This water is at times transferring through to the interior of the gym. A horizontal crack has developed along the upper perimeter of the gym on three walls, likely related to the water infiltration.	Address crack that has developed with a flexible joint. Apply Tri-Siloxane to exterior split faced block section and continue to do so every 5-7 years.	\$50,000

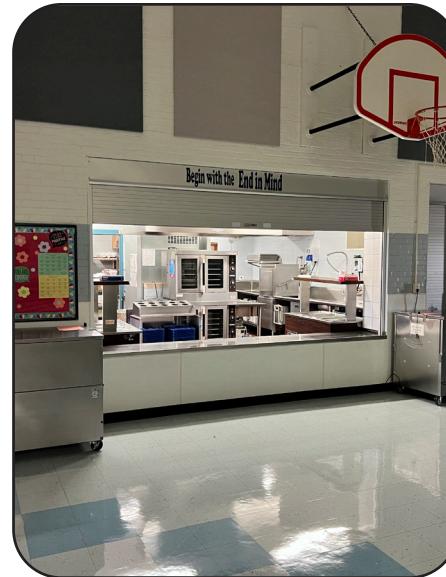
Building System	General Description	Recommendation	Cost Estimate
Interior - Classroom Casework	Casework throughout the facility is dated, much is original, wood paneling is present throughout the main entry corridors. Some casework is damaged and chipped.	Verify interior modifications will not affect historical designation. Replace classroom casework and corridor paneling as desired. Estimate for 15 classroom upgrades and corridor walls.	\$425,000
Interior - Window Treatments	Window treatments were observed as being of low quality for a school setting with some damaged.	Replace plastic blinds with roller shades across the school.	\$50,000
Interior - Kitchen Storage	The serving kitchen is in good condition and well maintained, however small, with little storage space and difficulties getting the kids through.	Consider a renovation of the kitchen serving and custodial office area, adding additional square footage to the east of the custodian office for food storage and custodian space. Open up the front of the kitchen wall to create a walk-thru tray line.	\$843,750

Mechanical - Air Conditioning	The facility is mainly unairconditioned, creating an uncomfortable environment for teaching and learning.	Install chilled water based air conditioning. Pricing given assuming the large HVAC renovation recommendation occurs simultaneously. Running chilled water and creating cooling duct space throughout Marshall in the 1923 building will be challenging, leading to added cost.	\$875,000

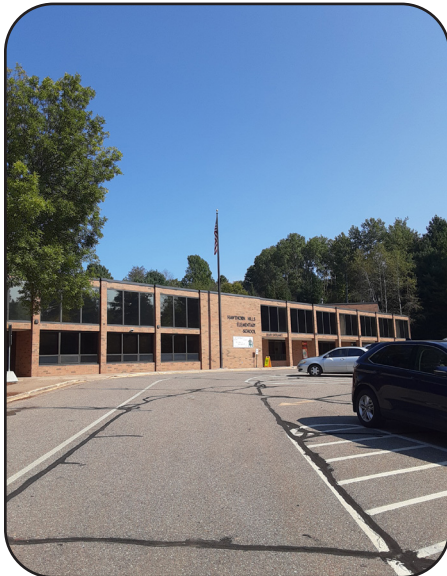
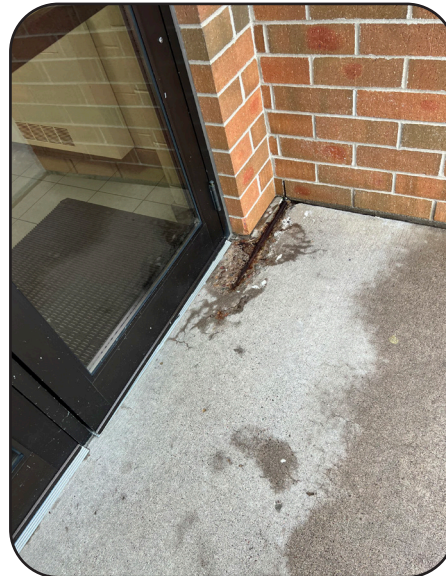
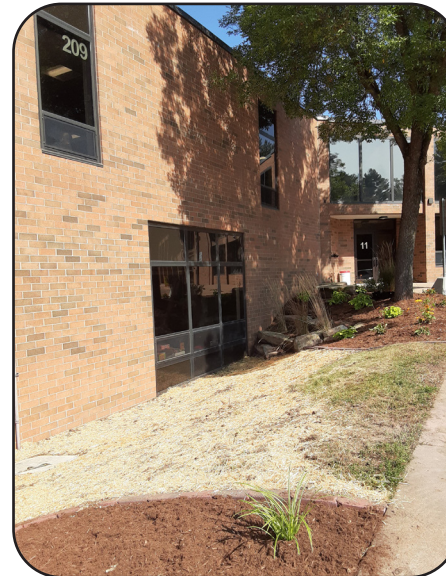
Building System	General Description	Recommendation	Cost Estimate
Site & Landscape	Substantial crack filled areas without top sealing.	Continue to crack clean and crack fill as needed. Approximately every 3-5 years additionally seal and repair asphalt.	\$6,500
Site & Landscape	Concrete landing for door #8 deteriorating and rebar exposed.	Replace concrete landing.	\$6,500
Site & Landscape	Exterior window sills at landscaping fill level.	Pull back grounds materials to create slope down and away from window sills.	\$3,500
Exterior Building	Paint on exterior brick wall.	Remove paint.	\$1,000
