C.E.S.A. 10
 Facilities Management Services

Facility Improvement Measures Wausau - Hewitt-Texas Elementary School

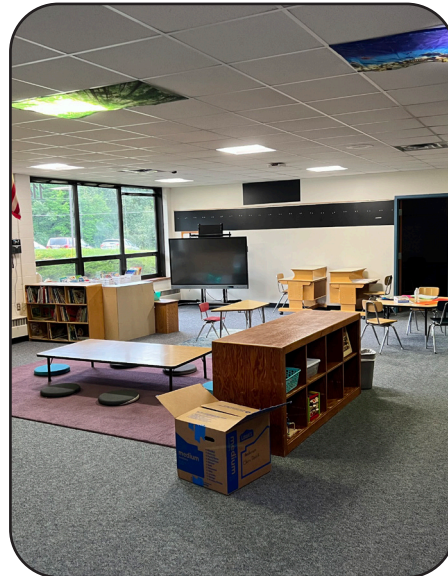
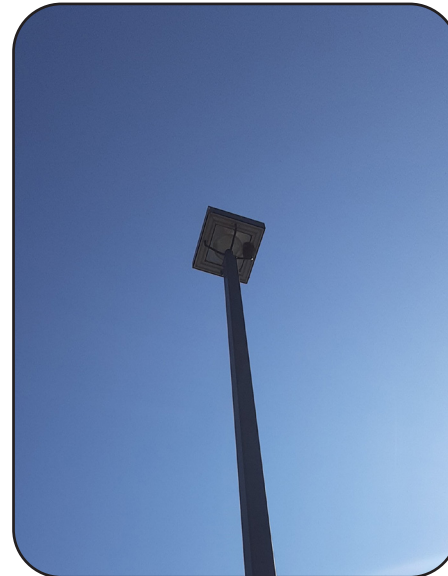
Building System	General Description	Recommendation	Cost Estimate
Mechanical - Piping	The hot water pipes to the large AHU above the 2016 addition are insufficiently supported and sagging.	Install drop support leg(s) to floor and re-insulate.	\$3,500
Electrical - Lighting Controls	Recent fluorescent to LED lighting conversions installed two-way dimming vs infinite slider dimming switches. The two choices leave teachers with either too bright or too dark of classrooms. Teachers are forced to cover new LED lighting with light filters.	Replace switches with slider dimmer control.	\$15,000
Electrical - Parking Lighting	Parking lot area lighting fixture has wasp nest blocking lens.	Check other fixtures. Remove nest and clean fixture lens.	\$1,000
Site & Landscape	Concrete light pole base cracked.	Patch crack. Consider painting with yellow warning paint.	\$1,000

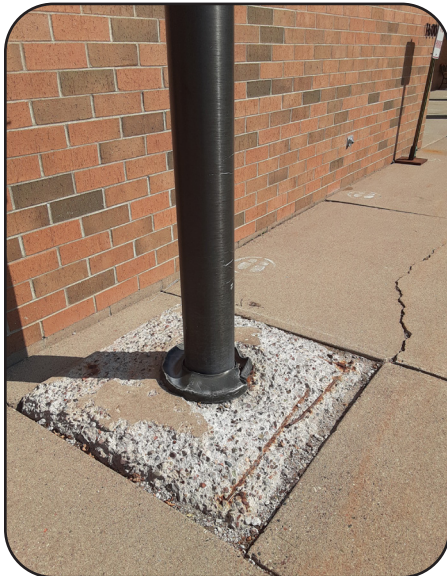
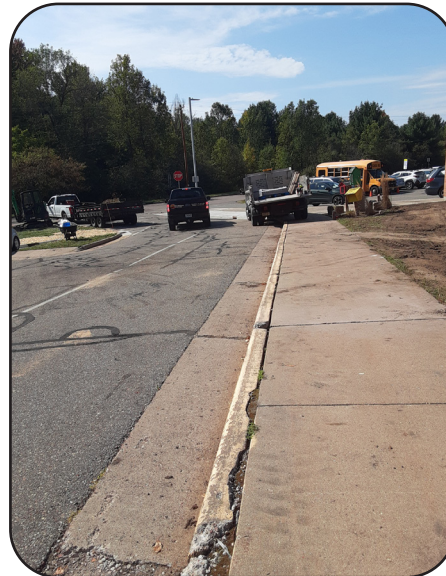
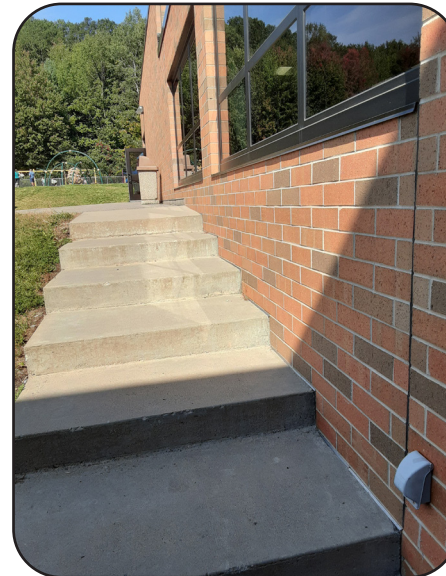
Building System	General Description	Recommendation	Cost Estimate
Site & Landscape	Concrete flag pole base deteriorating, rebar exposed, and metal pole collar bent.	Skim coat with weather-proof coating. Replace bent pole collar.	\$1,000
Site & Landscape	Concrete curbs cracked and pieces missing.	Replace cracked and failed concrete curbs.	\$20,000
Site & Landscape	Concrete stairs without handrails.	Add ADA-compliant handrails to outdoor concrete stairs.	\$2,500
Site & Landscape	Unsecured mechanical equipment area.	Fence to enclose and secure access.	\$7,500

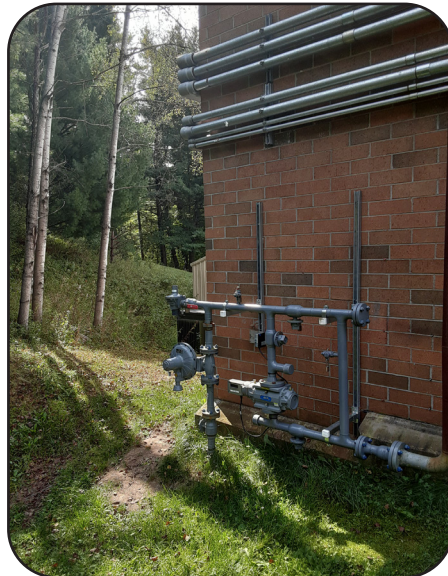
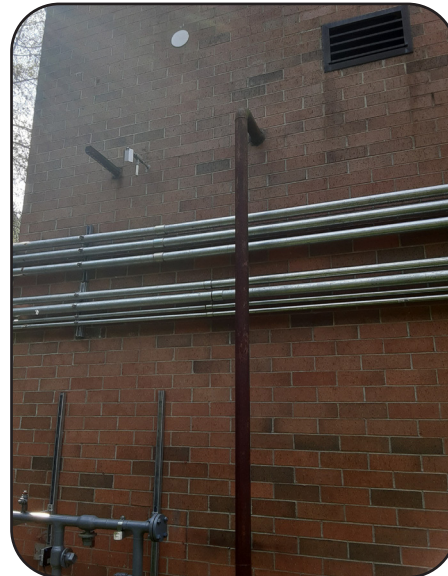
Building System	General Description	Recommendation	Cost Estimate
Electrical - Bell/PA & Communication	PA/Bell/Clock/mass communication systems due for upgrade. Existing system is obsolete using decades old technology.	Replacement recommended with the district's Single-wire system standard.	\$174,000
Site & Landscape	Unsecured gas valve and tree.	Enclose and secure valve access.	\$4,500
Site & Landscape	Gas supply pipe rusty.	Prepare and paint with appropriate coating.	\$1,000
Site & Landscape	Building perimeter and hardscape gaps.	Back fill gaps with sand and backer rod. Caulk and seal with appropriate joint filler. Heat melt in place material recommended for smooth, clean appearance.	\$3,500

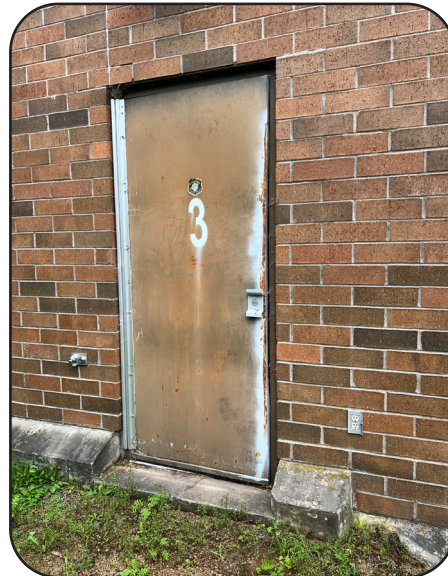
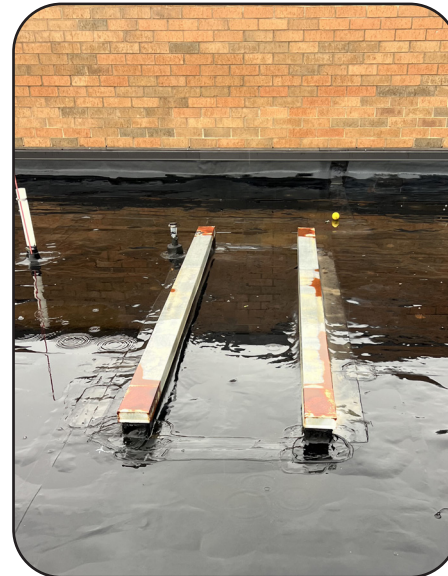
Building System	General Description	Recommendation	Cost Estimate
Site & Landscape	Metal outbuilding panel base rusty.	Prepare and paint.	\$1,500
Exterior - Doors	Although minimal, some sets of exterior steel doors and aluminum entrance doors are in rough shape.	Complete a thorough facility exterior door inventory and replace as necessary. Expect to replace several doors in the next 1-5 years.	\$20,000
Exterior Building - Roofing	One abandoned roof curb was identified being in place on section B after equipment removal. Roof penetrations allow avenues for new leaks, abandoned equipment and curbs should be removed and roofed over.	Demo roof curbs to deck, insulate, and roof over. Consider work done with re-roofing of section B if priority moves up in time.	\$3,000
Exterior Building	Open flashing along roof edge.	Add flashing metal and seal.	\$1,000

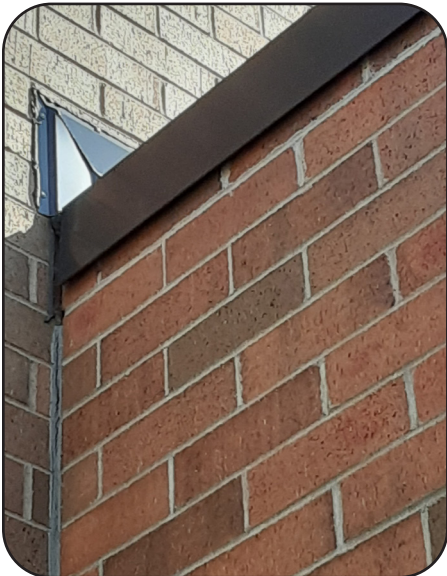
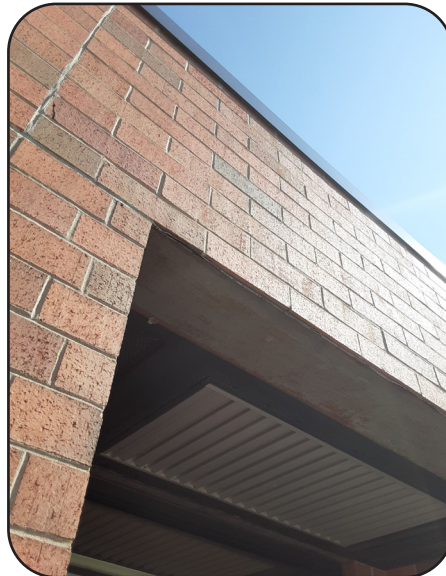
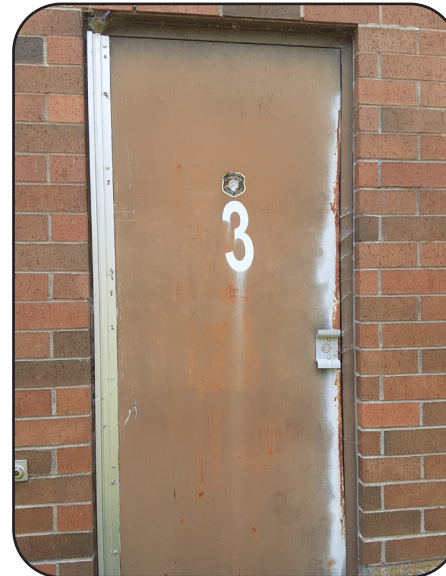
Building System	General Description	Recommendation	Cost Estimate
Exterior Building	Exterior wall corner joint caulk failed.	Remove existing failed joint compound and replace.	\$1,000
Exterior Building	Exit door lintel due for painting.	Paint lintel.	\$1,000
Exterior Building	Exterior metal door faded and discolored.	Paint door.	\$1,000
Exterior Building	Exterior window spandrel panels faded and spotted.	Paint panels.	\$1,000

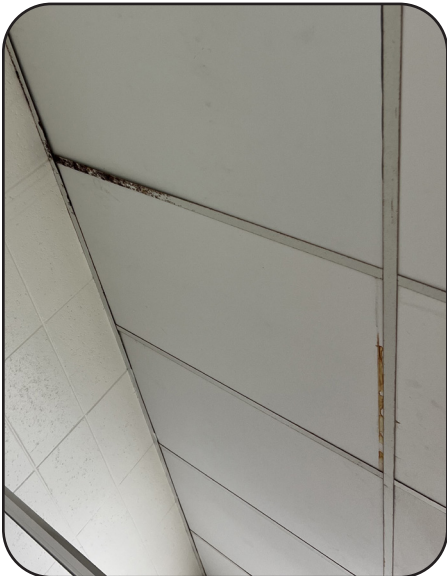
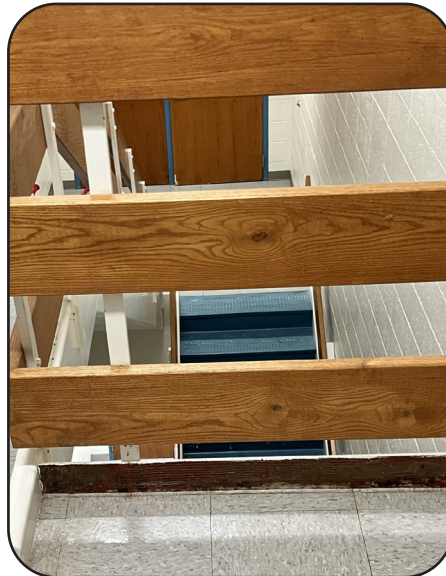
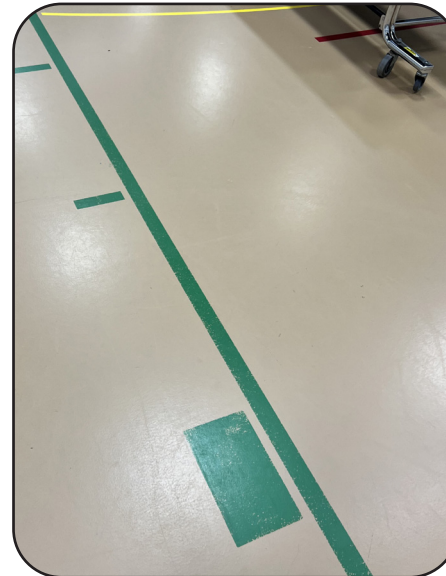
Building System	General Description	Recommendation	Cost Estimate
Interior - Ceilings	Although minimal, some rooms are showing signs of ceiling failure with rusted grid and stained tile.	Replace failing ceilings in minimal areas.	\$10,000
Interior - Stairwells	Minimal cosmetic upkeep needed in stairwells. Floor base, stair tread repair, and paint issues were noted.	Inspect and perform upkeep needed in stairwells.	\$5,000
Interior - Multi Floor	Although generally in good condition, the multipurpose gym floor is ready for a new paint and stripe.	Paint and stripe multipurpose floor.	\$15,000
Mechanical - Pipe Insulation	Missing and/or damaged pipe insulation was noted in various locations around the building.	Insulate DHW piping up to water heaters. Replace damaged and missing pipe insulation. Presence of asbestos and abatement needed can drastically change pricing. Pricing given for minimal work noted in mechanical rooms.	\$5,000

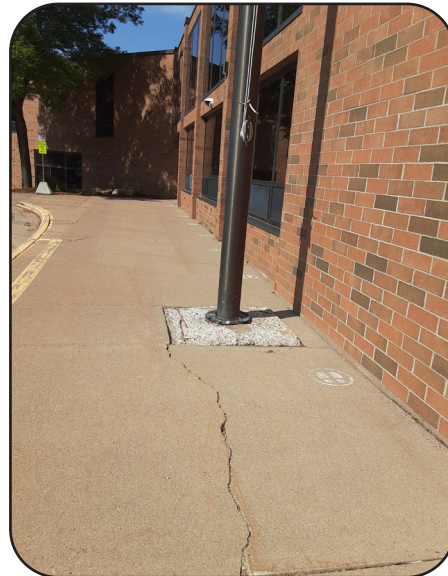
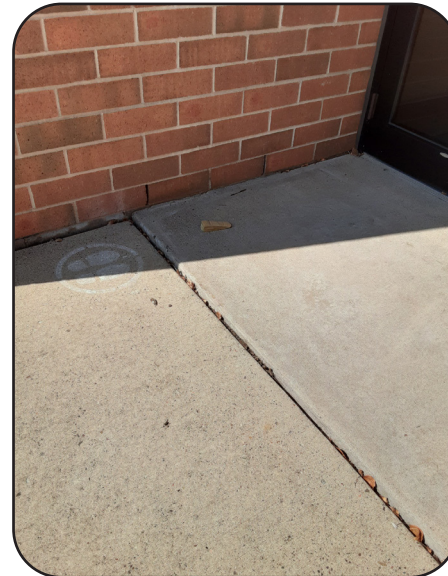
Building System	General Description	Recommendation	Cost Estimate
Electrical - Lighting	Although interior lighting in the facility has mainly been completed, small areas were spotted to still be fluorescent.	Complete remaining lighting conversation.	\$15,00
Site & Landscape	Concrete walk slabs cracked.	Replace cracked concrete walk slabs.	\$18,000
Site & Landscape	Concrete door landing raised creating trip hazard.	Replace or grind to smooth transition edge.	\$1,000
Exterior Building - Roofing	Roof section B is 17 years old and out of warranty. Roof section C is 14 years old and has one year of warranty remaining. Roofs appear in good condition and to be holding up well overall. Roof B is bubbling and has been patched.	Expect to replace roof section B in 5-10 years unless extensive leaking occurs.	\$230,000

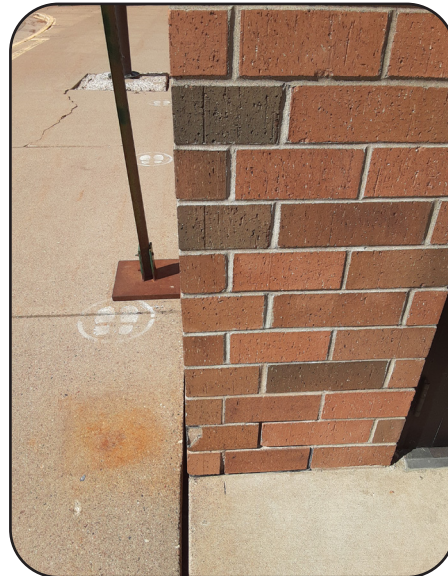
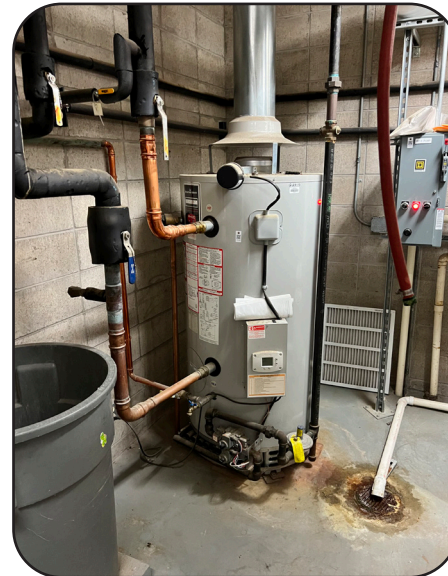
Building System	General Description	Recommendation	Cost Estimate
Exterior Building	Face brick corners chipped.	Replace bricks. Consider completing with other more extensive masonry projects.	\$2,500
Exterior Building	Exterior wall base brick cracked.	Replace bricks. Consider completing with other more extensive masonry projects.	\$2,000
Plumbing - Domestic Hot Water	The 80-gallon gas fired atmospheric water heater in the boiler room is 11 years old and approaching its expected useful life.	Replace water heater with a high efficiency direct combustion/power exhaust unit within the next 5-10 years.	\$10,000
Electrical - Door Access	Card Access systems across the district are in need of upgrade to their board controllers. Information was compiled through district IT interviews and recommended per school individual need.	Replace HID Vertx boards to Mercury LP1502's.	\$12,000

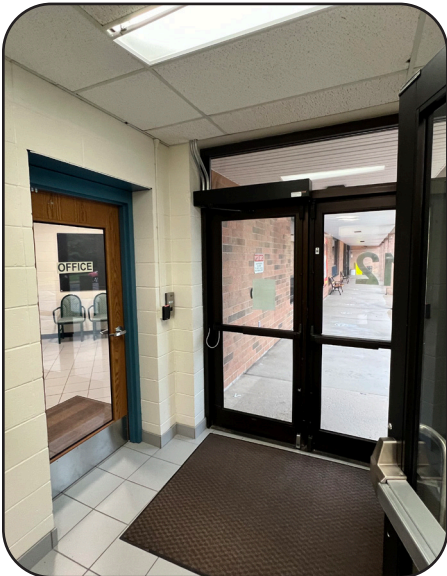
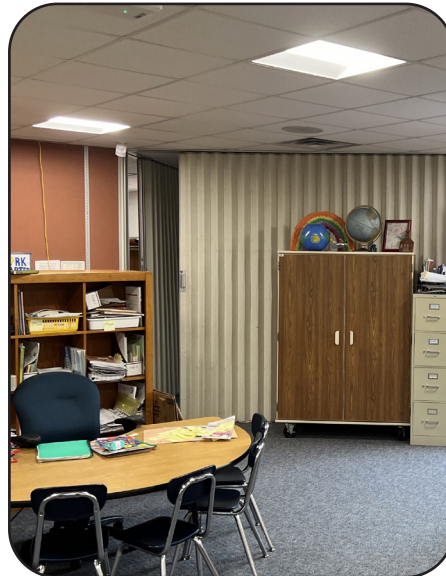
Building System	General Description	Recommendation	Cost Estimate
Electrical - Security Cameras	Through district IT staff interviews, certain schools were identified as in need of camera investment. Recommendations based on individual need per school.	Replace obsolete cameras and or add new.	\$18,000
Interior - Partition Walls	Hawthorne was constructed with 8 interior partition walls and accordion wall shared teacher work rooms. These walls transfer sound through to adjacent classrooms obtrusively and aren't used as their intended purpose.	Construct solid stud walls with sound batts in lieu of partition walls, install solid walls with wood doors to each teacher work room. Install electrical and data in new walls.	\$150,000

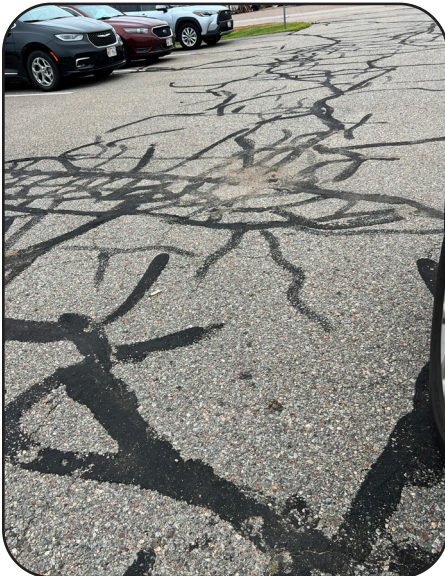
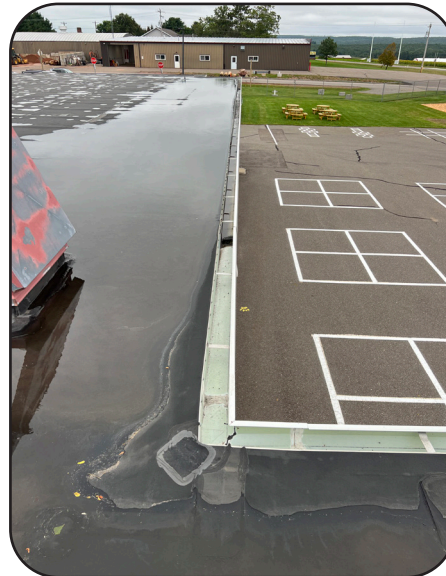
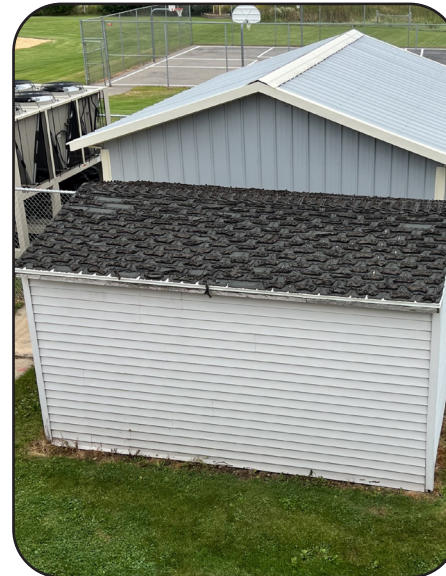
Building System	General Description	Recommendation	Cost Estimate
Site & Landscape	Substantial crack filled areas without top sealing.	Continue to crack clean and fill as needed. Approximately every 3-5 years additionally seal and repaint asphalt.	\$4,500
Exterior Building - Roofing	Roof sections B-E are all between 22-24 years old. All four sections are out of warranty and have been problematic. Section B is an externally pitched roof, however the last 10' of the roof edge is lower than the drip-edge, creating significant ponding. These roofs are .045 mil, a substandard thickness.	Replace sections B-E in the next 1-2 years with an adhered 60 mil black EPDM 20 year warranty roof. Add additional insulation on roof B so it properly sheds water to the gutters. Roof mounted utilities will need to be addressed in this project, mount pipe stands to deck with sealed boots.	\$333,000
Exterior Building - Roofing	The small maintenance storage shed needs a new roof.	Replace with asphalt shingle.	\$2,000

Exterior Building - Roofing	One abandoned roof curb was identified on section D, after equipment removal. Roof penetrations allow avenues for new leaks. Abandoned equipment and curbs should be removed and roofed over.	Demo roof curbs to deck, insulate, and roof over. Complete work with re-roofing identified. Demo abandoned conduit and pipe stands.	\$3,000

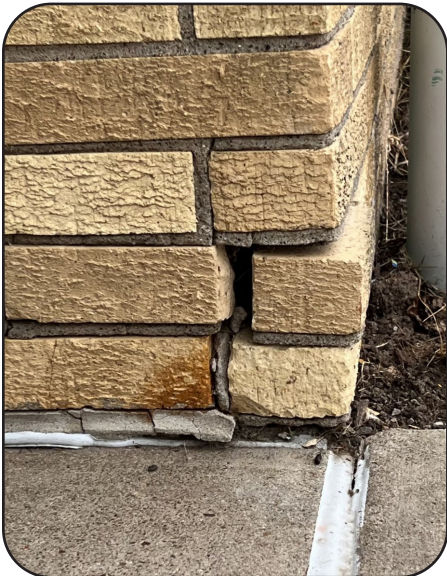
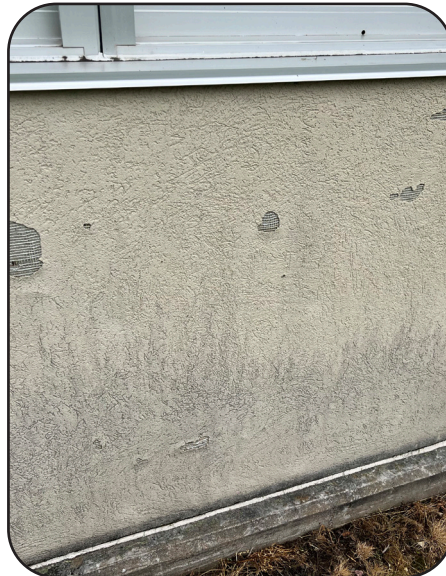
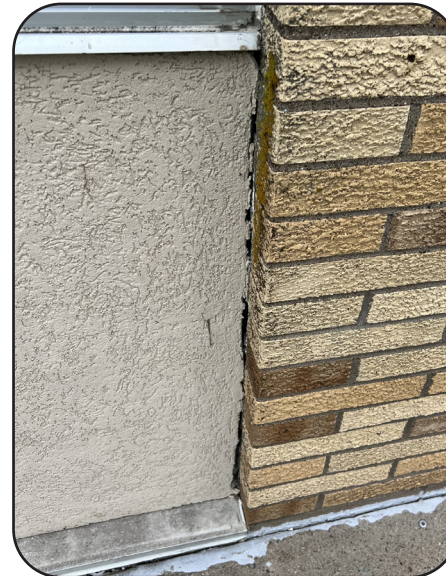
Building System	General Description	Recommendation	Cost Estimate
Exterior Building - Tuckpointing	Minor tuckpointing is needed across the facility. Areas of concern are around the northern entrance, and surrounding an old utility chase on the south side of the boiler room.	Have a masonry tuckpointing expert perform a whole-building inspection. Address problem areas at northern entrance and at lintels. If the utility duct can be removed, demo and fill - or tuckpoint. Brick replacement will be necessary at the mechanical chase if salvaging.	\$25,000
Exterior Building - EIFS Repair	EIFS damage and deterioration was noted on several panels.	Have an EIFS repair specialist address problem areas and repaint EIFS panels.	\$50,000
Exterior Building - EIFS Caulk	Exterior caulk joint between EIFS panels and masonry are in very poor condition.	Remove and re-caulk areas in conjunction with masonry and EIFS repair project.	\$10,000

Exterior Building	Exterior wall louver stains on bricks.	Investigate and eliminate cause. Clean bricks.	\$2,000

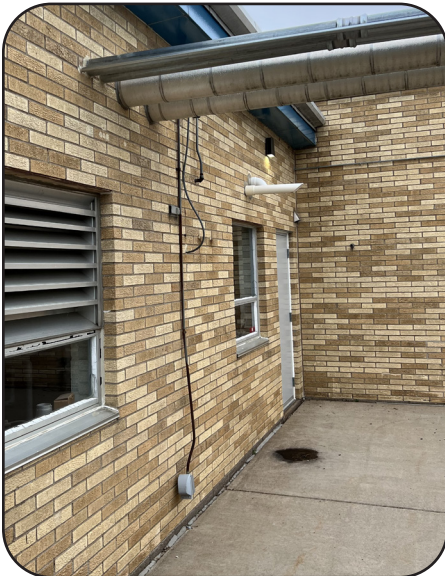
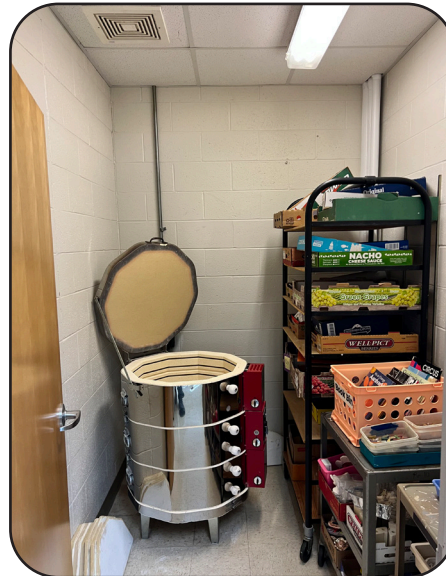
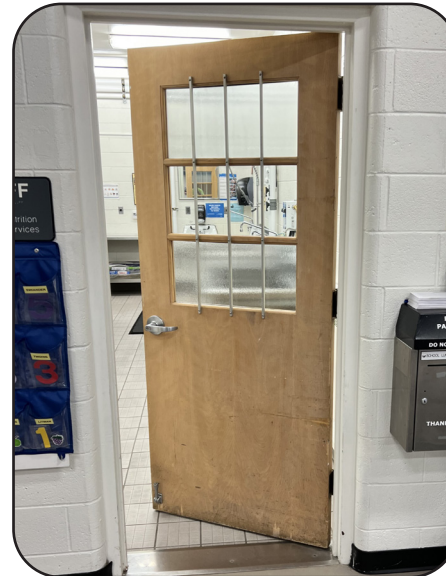
Building System	General Description	Recommendation	Cost Estimate
Exterior Building	Exterior wall unsecured cables and tubing.	Secure cables and tubing. Remove and discard if no longer in use.	\$1,000
Interior - Kiln Safety	Art kiln is housed in close proximity to combustible storage racking, creating a fire hazard.	Store combustible materials a safe distance away from kiln.	\$500
Interior - Wood Doors	Minimal older interior wood doors throughout facility are showing age; delaminating, stained, and chipped. Image shown is the kitchen door from gym.	Replace aged and damaged interior wood doors. Estimate given for 5 doors.	\$7,500
Mechanical - Rooftop Unit	The small office heating/cooling unit on the roof has significant hail damage and is 24 years old, at it's expected useful life.	Replace the unit in the next 1-3 years. Cooling efficiency gains will be seen with functional condensing unit fins. Consider running gas to the unit and switching to gas vs. electric heat for operating cost reductions.	\$12,000

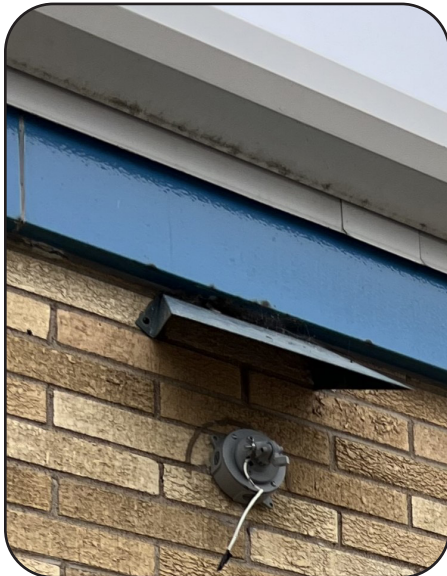
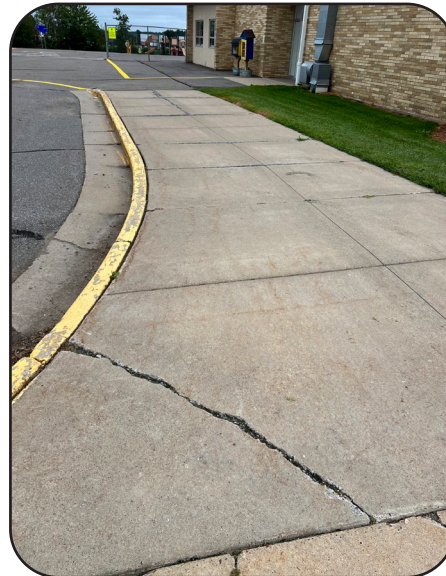
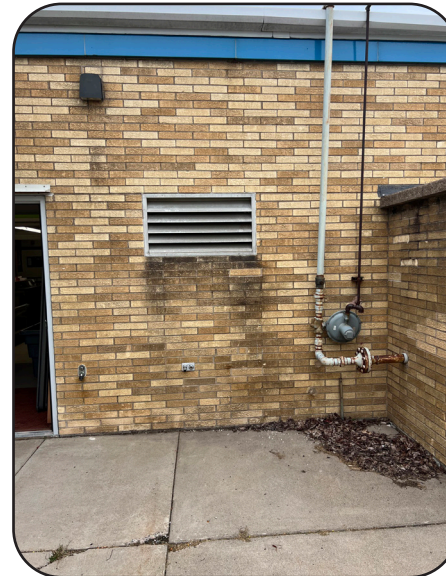
Building System	General Description	Recommendation	Cost Estimate
Electrical - Exterior Lighting	Exterior lighting appears to be deficient with no pole mount lighting observed. One broken building mounted light was noted.	Consider installing pole mounted security lighting at a high cost for student and staff security. Address any failed wall pack lighting replacing with LED.	\$5,000
Site & Landscape	Multiple walk concrete slabs with transitional and divided cracks.	Replace cracked concrete walk slabs.	\$15,000
Site & Landscape	Gas valve on side of building not secured inside of fencing. Piping to roof provides potential assistance for climbing.	Enclose and secure valve access. Eliminate climbing assistance access.	\$4,500
Site & Landscape	Unsecured mechanical equipment (generator) area.	Fence to enclose and secure access.	\$4,000

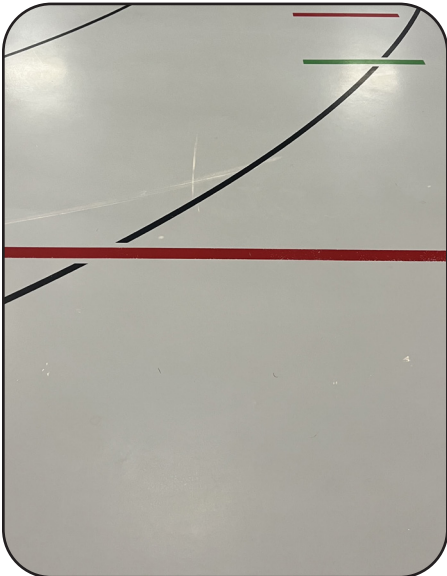
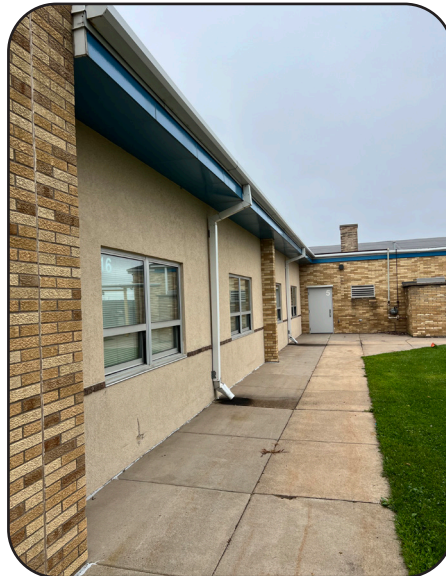
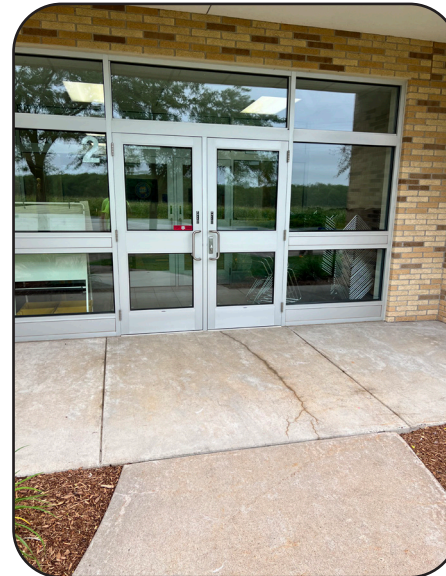
Building System	General Description	Recommendation	Cost Estimate
Interior - Multi Floor	Although generally in good condition, the multipurpose gym floor needs attention due to wear and tear.	Have synthetic floor installer in for extended maintenance, consider restriping.	\$10,000
Site & Landscape	Concrete walk stains from downspout discharge. Damaged downspouts short extensions.	Install under slab drainage discharge system. Clean stains.	\$18,000
Site & Landscape	Concrete door landings cracked	Replace concreted door landings.	\$8,500
Exterior Building Glass Block	The upper east end of the gym contains glass block to allow natural light into the space. Glass block is very inefficient as a building envelope material.	Remove and replace with a custom aluminum window or translucent panel.	\$15,000

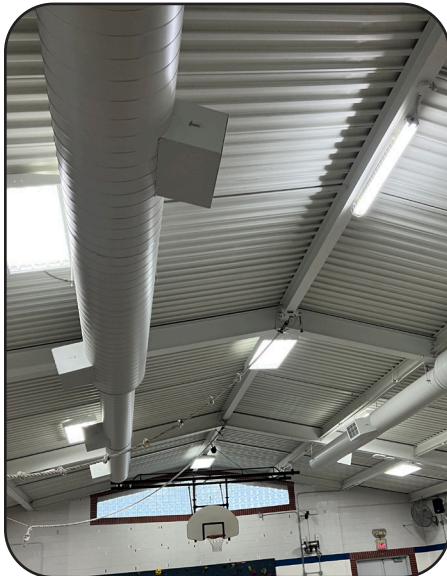
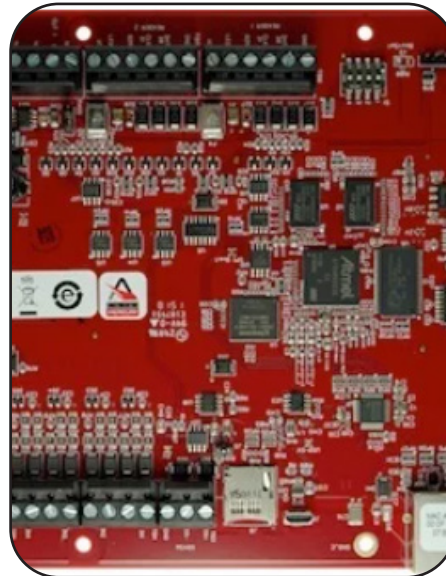
Building System	General Description	Recommendation	Cost Estimate
Mechanical - Gym Ceiling Fans	No gym destratification fans are present. Ceiling fans in high ceiling spaces help distribute heat from the ceiling to the occupants in winter, and can help maintain comfort in spring/fall.	Install gym destrat fans. Include schedulable control through the DDC system so fans can automatically turn on and off as desired.	\$15,000
Electrical - Door Access	Card Access systems across the district are in need of upgrade to their board controllers. Information was compiled through district IT interviews and recommended per school individual need.	Replace HID Vertx boards to Mercury LP1502's.	\$8,000

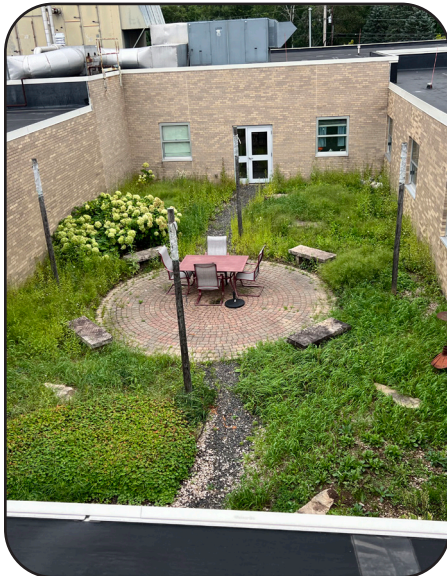
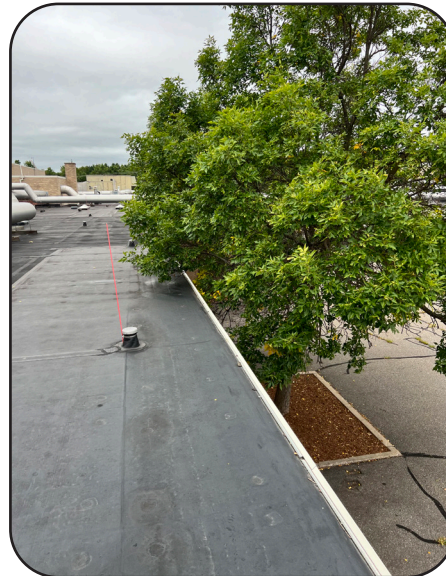
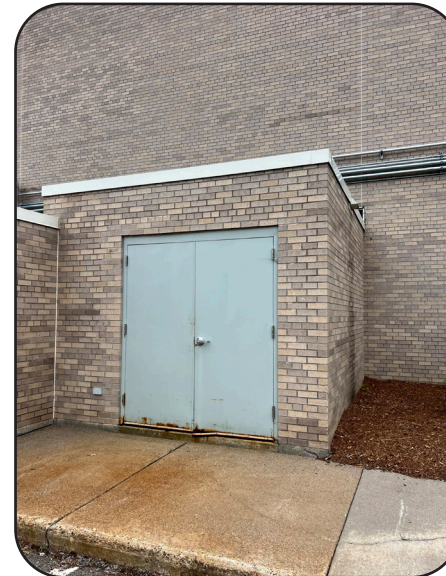
Building System	General Description	Recommendation	Cost Estimate
Site & Landscape Courtyard	Internal grass turf courtyard in state of disrepair. Vegetation along masonry walls will prematurely deteriorate the building and can block brick weep drainage..	Mow and landscape, install a 12" by 6" deep stone perimeter barrier with landscape fabric along building edge.	\$3,500
Site & Landscape - Trees	Two trees were noted overhanging the roof, close to the building. Trees overhanging the building: shed leaves on the roof which block roof drains, create mold and mildew on the building, and allow a path for intruders to access the roof creating a safety hazard.	Take down trees and remove remaining stumps.	\$3,500
Site & Landscape	Concrete walk stained.	Clean concrete walk.	\$1,500
Site & Landscape	Stump left in planters.	Remove stump.	\$1,000

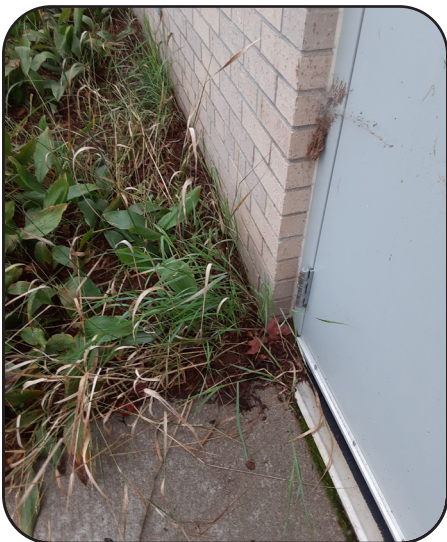
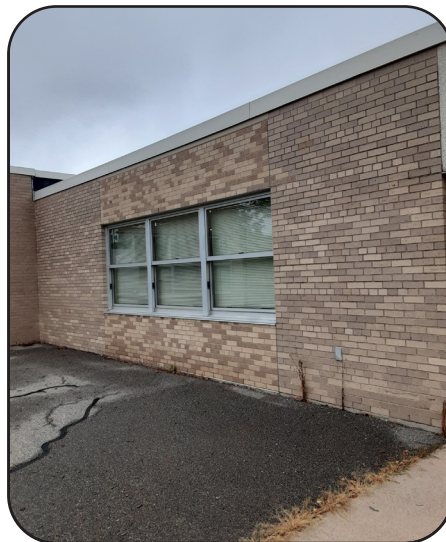
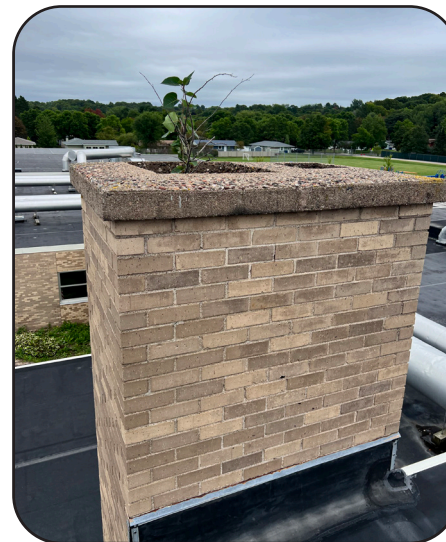
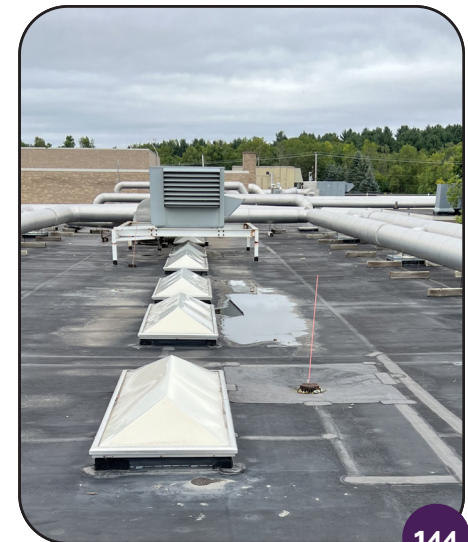
Building System	General Description	Recommendation	Cost Estimate
Site & Landscape	Vegetation encroaching on door landings.	Annually or more often if needed remove vegetation around building perimeters, fencing, hardscape surface edges, utility supply areas, and planters.	\$2,500
Site & Landscape	Vegetation growing around building perimeter.	Annually or more often if needed remove vegetation around building perimeters, fencing, hardscape surface edges, utility supply areas, and planters.	\$1,500
Exterior Building - Chimney	It appears the old boiler stack is no longer in use and is deteriorating. This adds to maintenance load and creates roofing leak avenues.	Verify the stack is no longer in use, maintain with tuckpointing if it is. The base recommendation is to demo the stack below roof line, preferably to the floor freeing up floor space, and fill the roof voids. Accomplish this during any major roofing effort.	\$20,000

Exterior Building - Roofing	All roof sections of the building except L & M are in fair to poor condition, many are actively leaking. They are between 21-26 years old and none are still in warranty. Roof leaks rapidly degrade building interiors and structure, and can lead to mold.	Replace roof sections A-K as soon as possible. This project will need to be in coordination with mechanical reconfiguration or renovation. Eliminate and fill all corridor skylights. Pricing given for roofing only, at a higher cost due to the vast amount of penetrations.	\$1,280,000

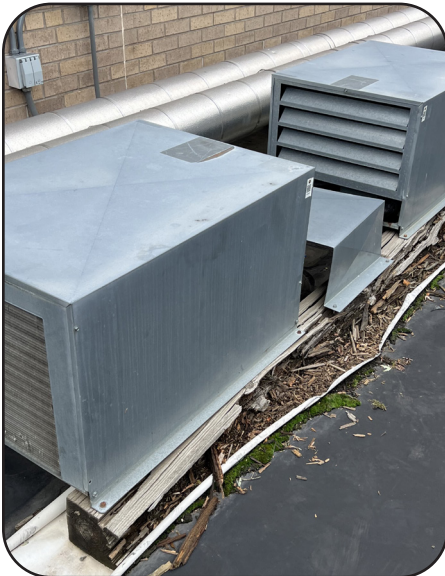
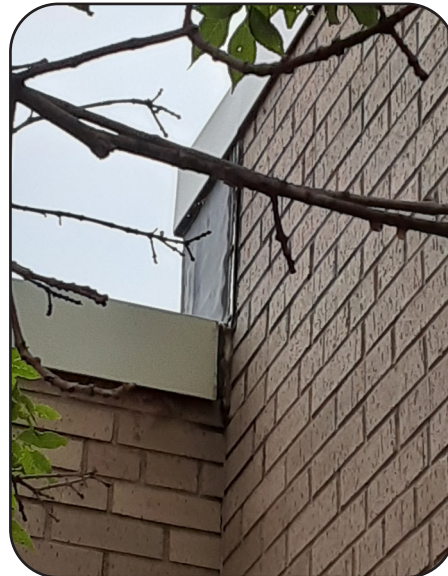
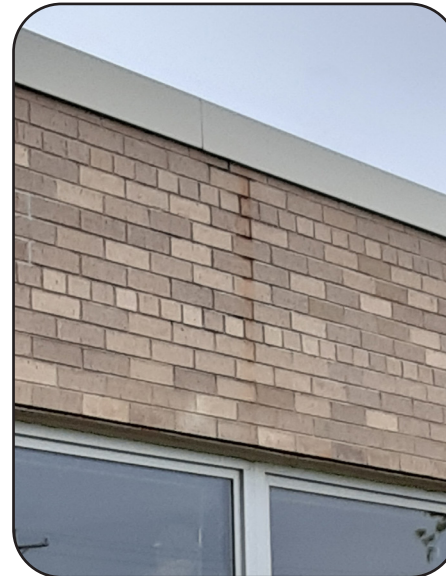
Building System	General Description	Recommendation	Cost Estimate
Exterior Building - Roofing	Kitchen condensing unit equipment was noted sitting on top of extremely rotted wood. Other rooftop equipment and pipe stands are also surface mounted on wood.	Swap kitchen equipment wood as an immediate step. Properly place any rooftop equipment or piping on appropriate roof curbs to deck or deck mounted pipe stands. Complete this endeavor during major roofing effort.	\$1,000
Exterior Building	Exterior roof flashings open.	Add flashing to close and seal.	\$1,000
Exterior Building	Roof flashing leaking and staining wall.	Investigate cause and correct. Seal flashing and clean wall.	\$2,500
Exterior Building	Roof scupper causing brick wall staining.	Extend scupper to prevent discharge on wall.	\$3,200

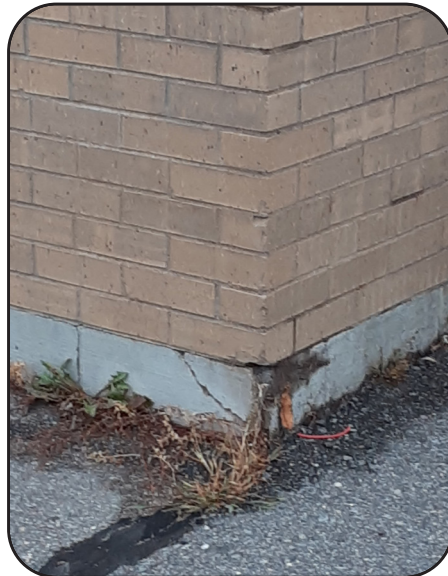
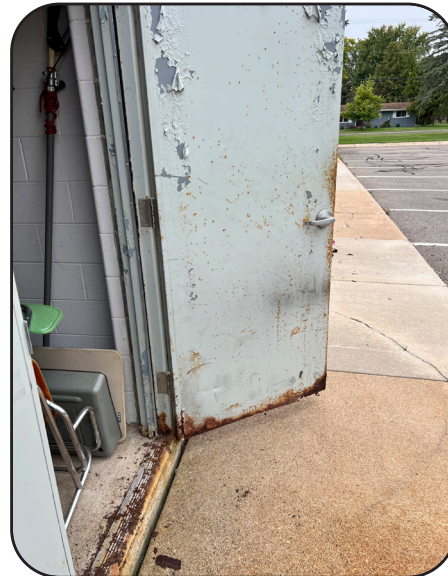
Building System	General Description	Recommendation	Cost Estimate
Exterior Building	Exterior window sills and frames soiled.	Clean frames and sills.	\$4,500
Exterior Building	Exterior wall base cracks.	Patch and seal base wall cracks.	\$2,500
Exterior Building	Exterior metal storage door rusted.	Replace metal doors and frames.	\$2,500
Exterior Building	Exterior metal door dented and rusted.	Repair dent and prepare and paint door.	\$1,000

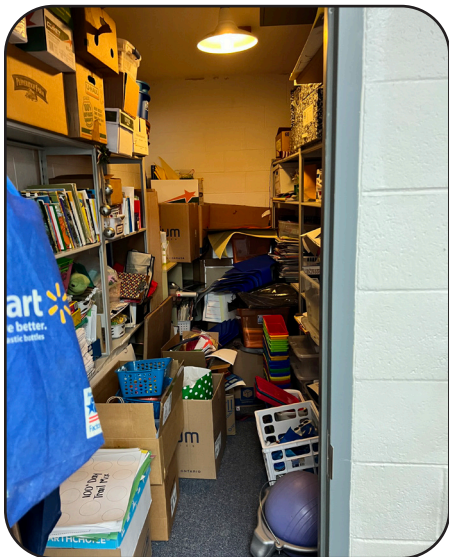
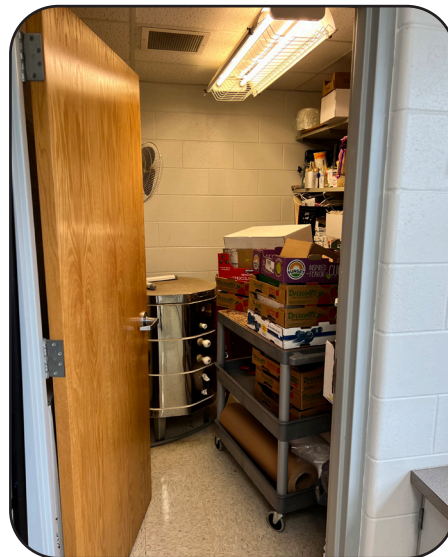
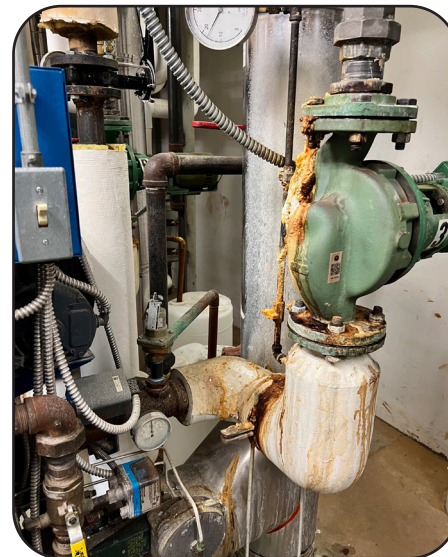
Building System	General Description	Recommendation	Cost Estimate
Interior - Storage Safety	Several storage spaces were noted to be over-packed and cluttered. Along with freeing up storage space and setting best practice for facilities personnel, cluttered spaces such as this create a fire hazard.	Clean, organize, and purge. Consider additional shelving.	\$1,000
Interior - Kiln Safety	Art kiln is stored along with cluttered combustible materials.	Clean and organize the space, store combustibles appropriately a safe distance away.	\$1,000
Mechanical - Boiler Maintenance	Leaky boiler circulation pumps along with disturbed likely asbestos insulation was observed in the boiler room.	Test for asbestos and abate if necessary. Perform boiler maintenance with new gaskets and potentially new pump(s). Re-insulate.	\$5,000
Mechanical - HVAC Renovation	Existing HVAC is largely accomplished through extravagant rooftop equipment along with exterior mounted ductwork and piping run on the roof. Much of this equipment is surface mounted on top of the roof rather than flashed roof curbs to deck. The hundred+ penetrations associated with this work has created a poor roofing condition, impossible to stay ahead of and impossible to reroof without major mechanical demolition.	Major HVAC renovation in all but the 2016 and 2022 additions. Eliminate rooftop duct and piping altogether. The two 1963 classroom wings will be challenging, traditional corridor supplied overhead HVAC is not possible without major construction. Two possible solutions are 4 RTU's for the two wings, or back to individual classroom unit vents style HVAC.	\$2,400,000

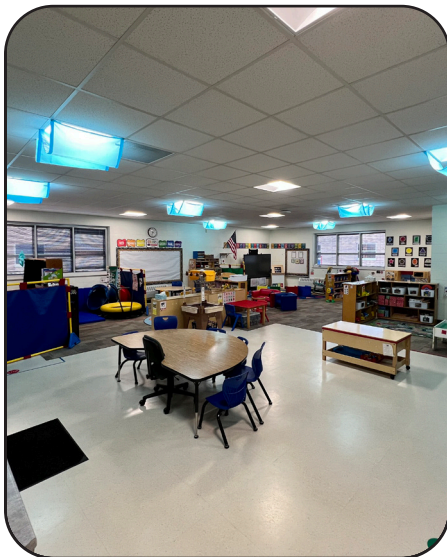
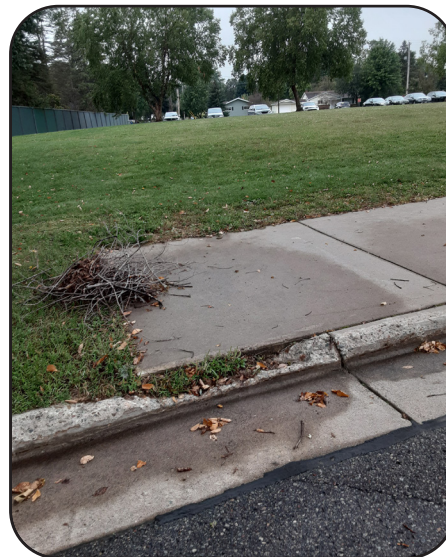
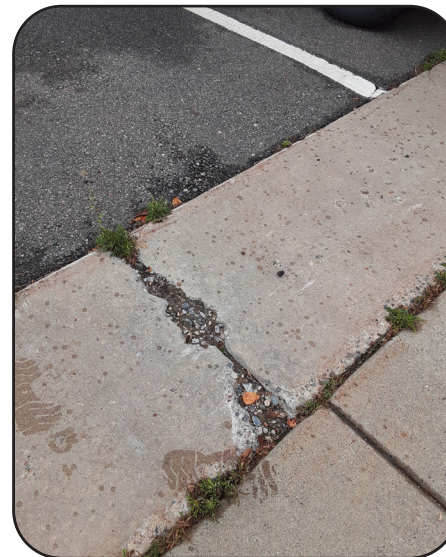
Building System	General Description	Recommendation	Cost Estimate
Electrical - Lighting Controls	The 2016 addition installed two-way dimming vs infinite slider dimming switches. The two choices leave teachers with either too bright or too dark a classroom. Teachers are forced to cover new LED lighting with light filters.	Replace switches with slider dimmer control.	\$10,000
Site & Landscape	Concrete curb deteriorating	Replace curbs.	\$18,000
Site & Landscape	Concrete roll over curb joints open.	Patch or replace curbs.	\$12,000
Site & Landscape	Concrete walk slab joints failed.	Replace concrete slabs.	\$17,000

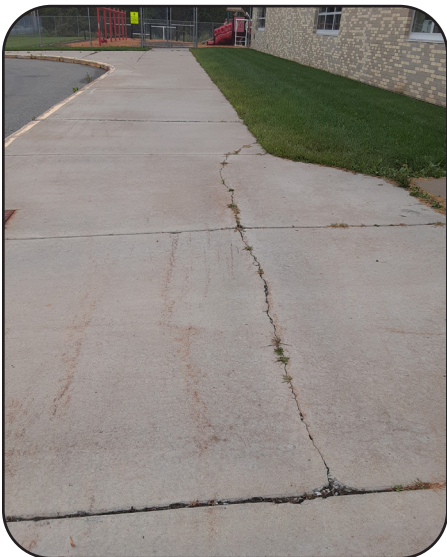
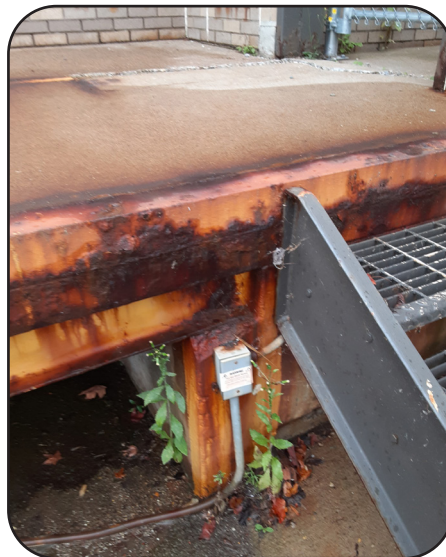
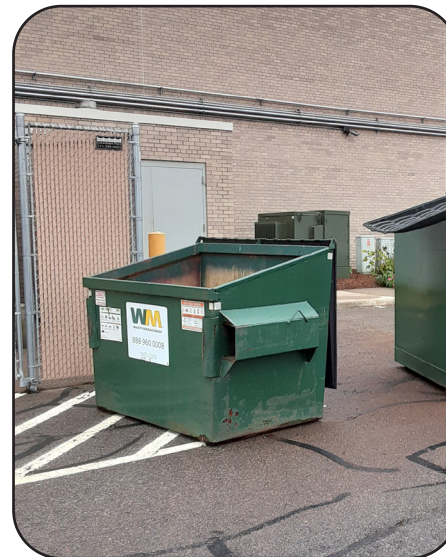
Building System	General Description	Recommendation	Cost Estimate
Site & Landscape	Concrete walk slabs cracked.	Replace concrete slabs.	\$22,000
Site & Landscape	Dock rusted and deteriorating.	Evaluate condition and uses. Replace dock.	\$25,000
Site & Landscape	Dumpsters on asphalt	Add concrete pads for dumpsters	\$12,800
Site & Landscape	Planter bushes too close to building.	Open area between bushes and building to prevent pests, infiltration, and screening from street view.	\$6,500

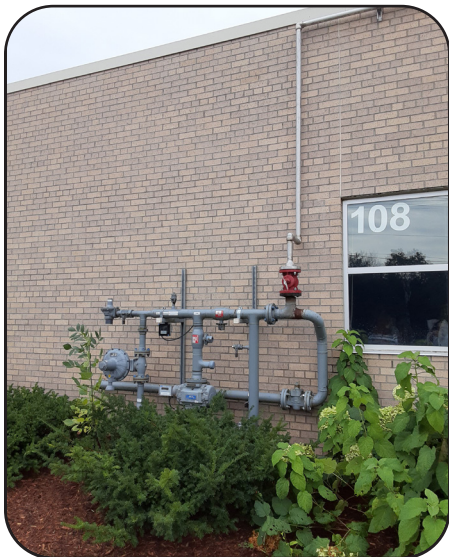
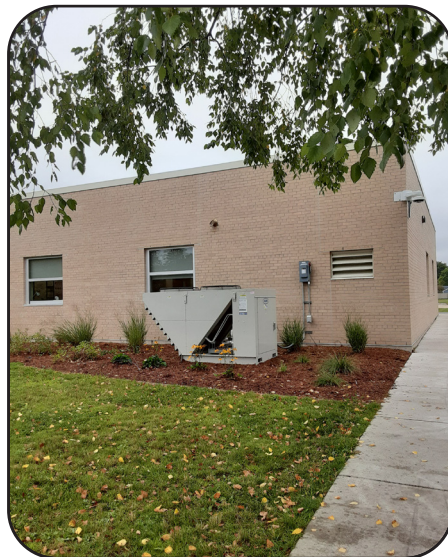
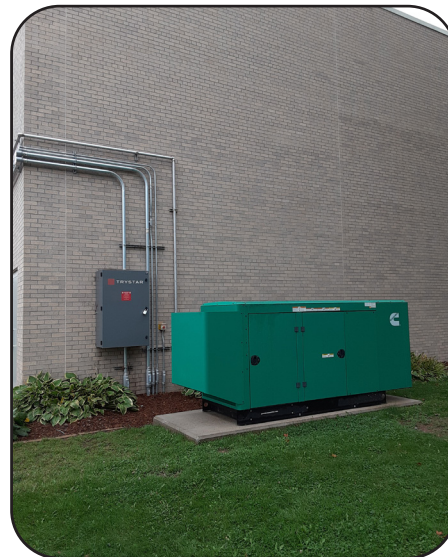
Building System	General Description	Recommendation	Cost Estimate
Site & Landscape	Unsecured gas tree and valve along building. Gas piping provides climbing assistance to roof.	Enclose gas tree, valve, and access to vertical pipe.	\$4,500
Site & Landscape	Unsecured mechanical equipment.	Enclose mechanical equipment.	\$10,000
Site & Landscape	Unsecured electrical generator.	Enclose generator.	\$7,500
Exterior Building - Wall Panel	The wall panel which houses mechanical louvers located in the interior courtyard is in poor condition and rusting through.	Replace the wall panel and louvers, reroute conduit through wall. This could be a new insulated solid panel, or brick & masonry (recommended). Pricing given for wall panel.	\$12,500
