Historic Old Central High School Independent School District 709 Facility Assessment

June 12th 2019

Executive Summary

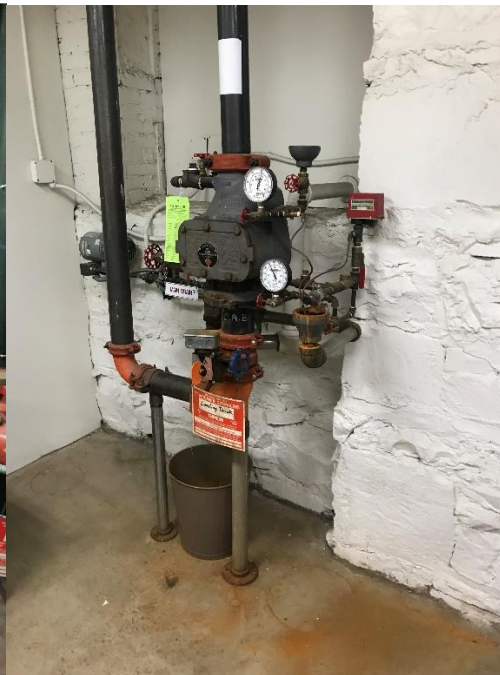
DRY SPRINKLER VALVE

There are also areas that will require additional coverage that are not currently protected with due to relocation of partitions or changes in NFPA 13 requirements.

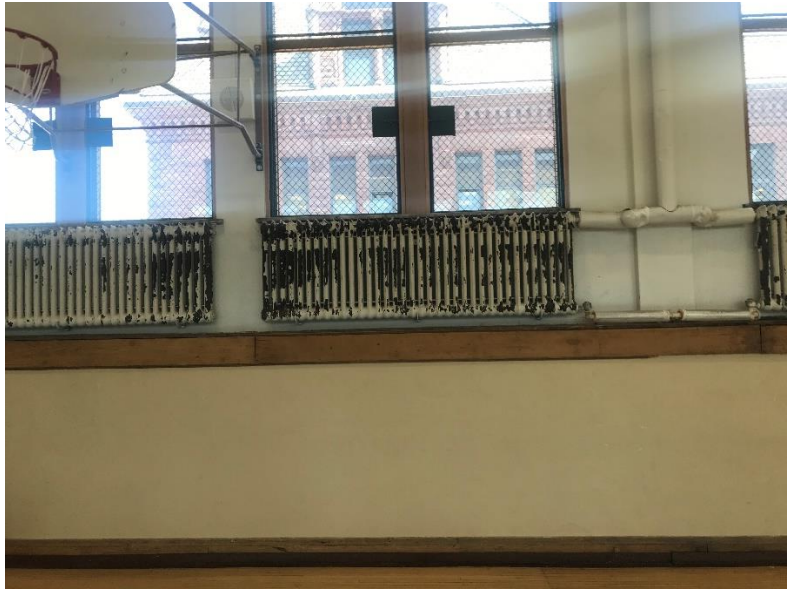
1920'S RADIATION

Terminal heating devices (radiation) were largely replaced during the 1973 remodel, with small areas having later updates. This radiation however is approaching 46 years old and at or beyond its expected life. Devices in the gym addition are largely original from the 1920's. This radiation is the traditional sectional cast iron. Multiple styles are shown below:

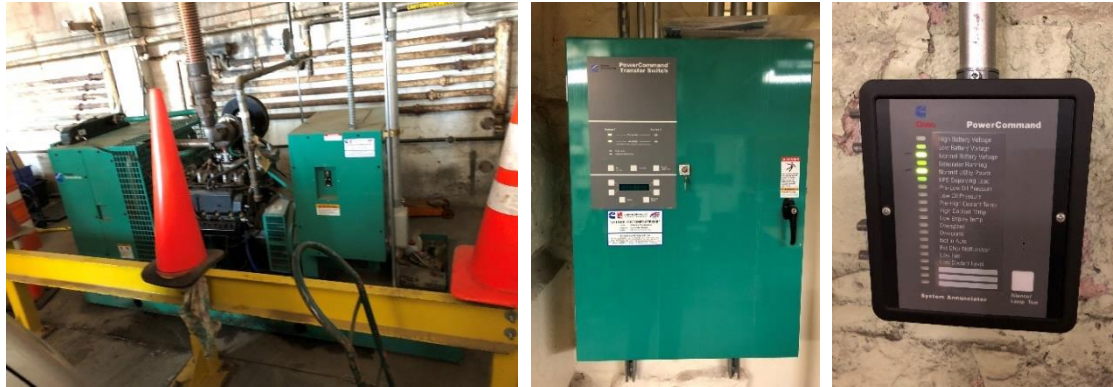
GENERATOR AND TRANSFER SWITCH

The existing natural gas generator and transfer switch appear to be recently replaced. An upgrade of these systems would only be needed if additional loads are added to the standby system that it wouldn't have capacity for. Standby power for the building IT infrastructure is handled by this 85KW Natural Gas generator. Standby power upgrades would also incorporate VOIP phone system equipment, and potentially egress and exit lighting.

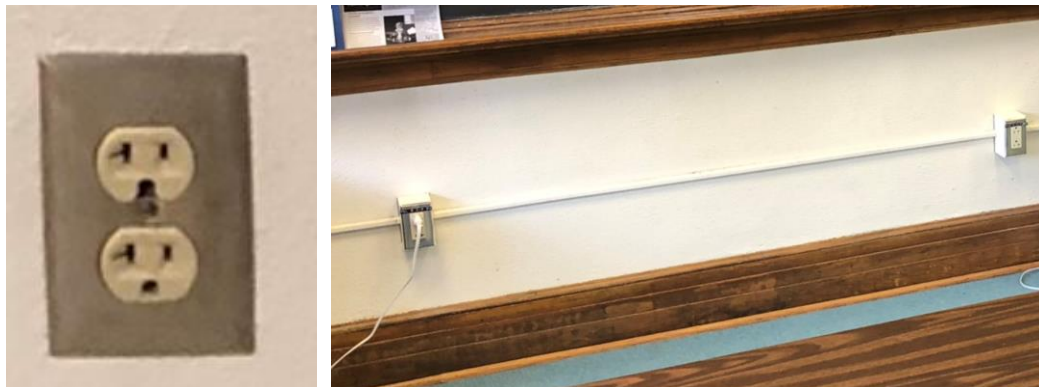
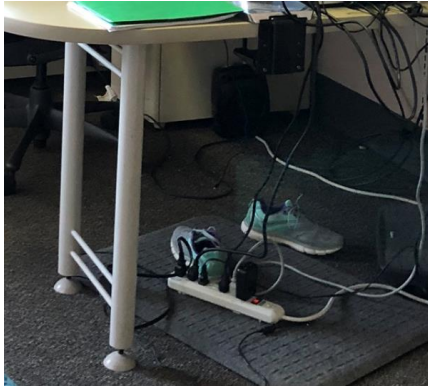
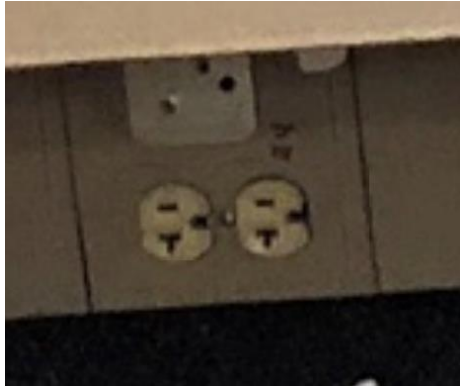
RECEPTACLES

The replacement of most receptacles should be done, especially if from the 1970's or older. These tend to wear out over time and parts break. Some rooms do have newer receptacles installed and wouldn't need to be replaced if still in working condition and not damaged. Some spaces will require additional receptacles to curtail the use of power strips.
