# Turtle Lake School District

Facility Condition Assessment Performed by:

## Facility Condition Index (FCI)

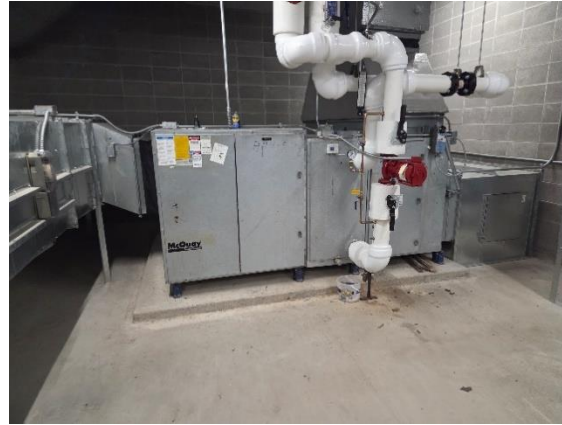
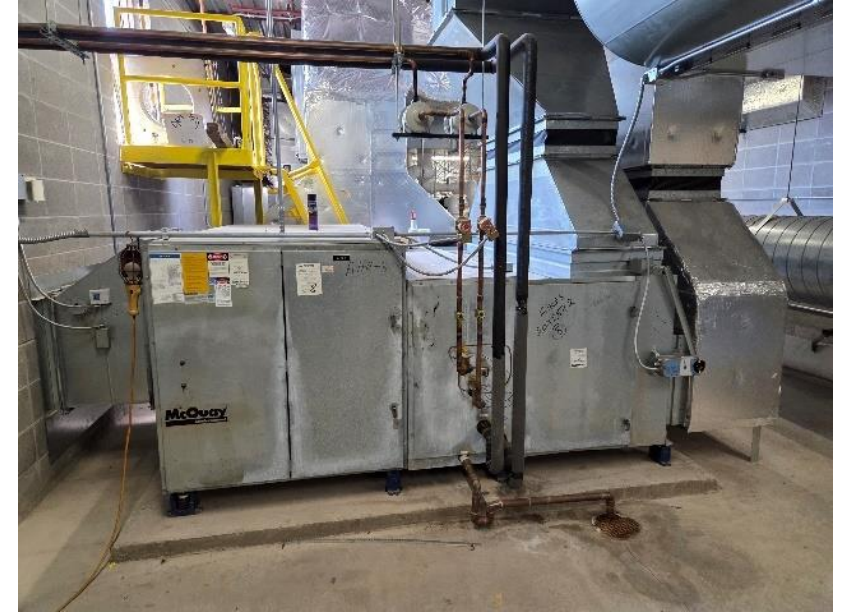
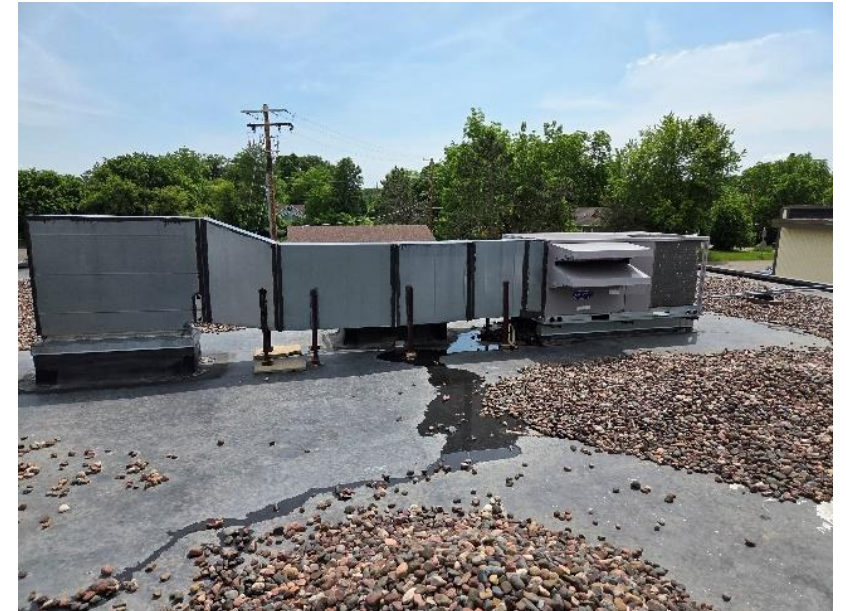
- Lack of HVAC can cause odor problems and uncomfortable conditions
- Current system mostly lacks air conditioning
  - Office area has cooling only
- Recent project have classroom unit ventilators
- Building Hot Water system with new boilers
- Evaluate new building automation system with non-proprietary automation systems

| | | \$15,118,000 |
|---|---|---|
| <b>Building Automation Replacement</b> - Replace the existing BAS with a new web based system | Building Wide | \$140,000 |
| <b>Classroom HVAC Replacement</b> - New HVAC equipment for the classrooms, Central Plant, Support Spaces | Elementary School | \$7,742,000 |

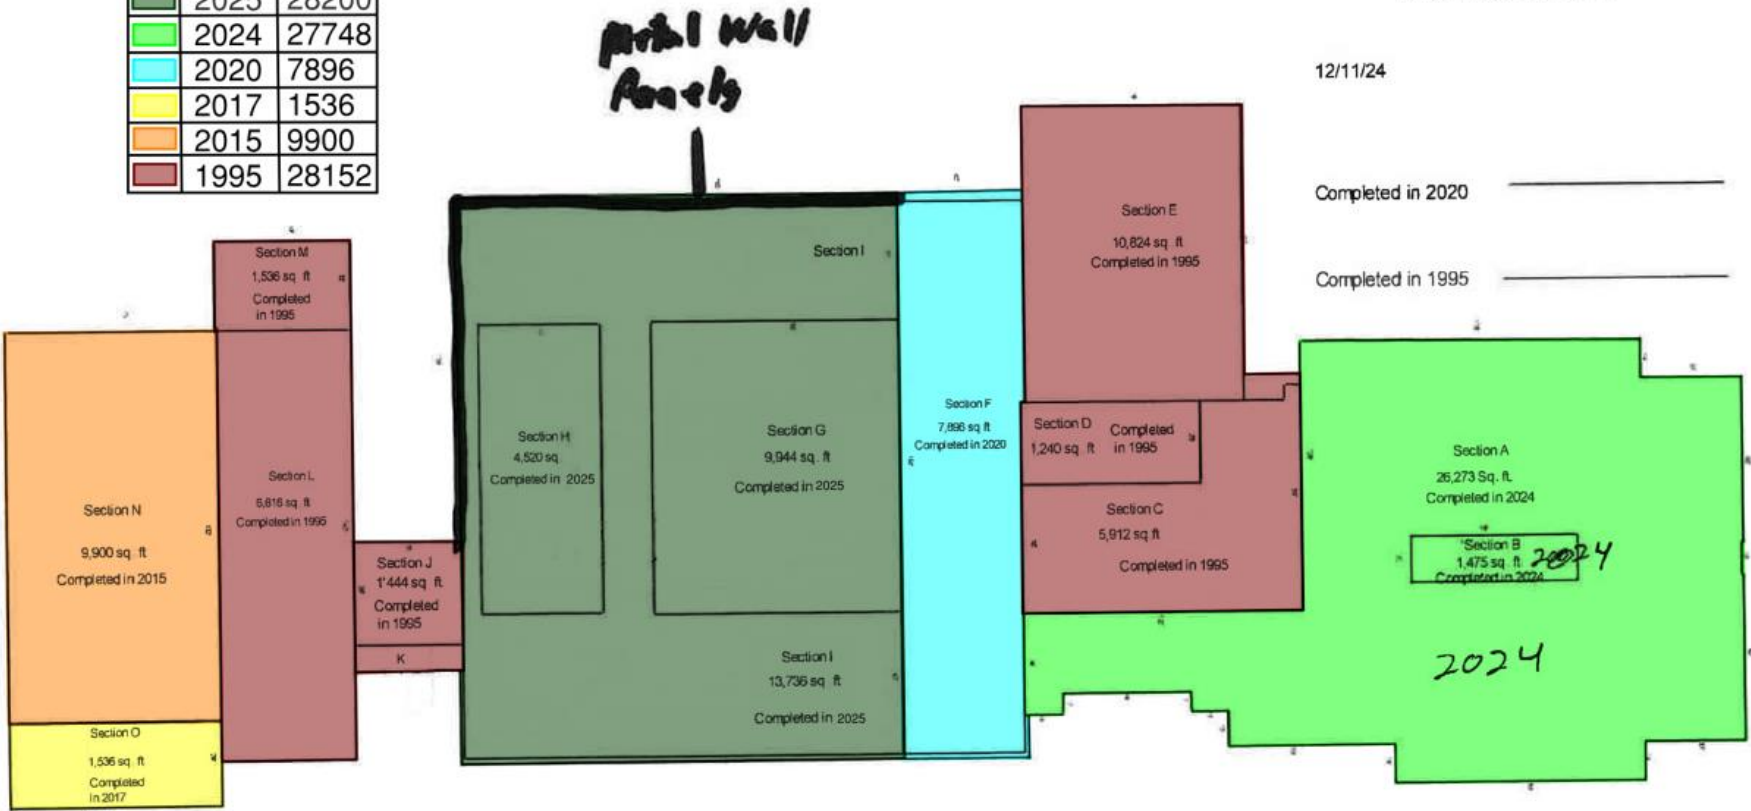
- School has newer fully adhered EPDM roofing (2015–2025) and older ballasted EPDM from 1995
- Newer sections are in good condition; older ballasted areas are worn and damaged

- Consider replacing 1994 ballasted roof soon
- Add permanent ladders or safe access for maintenance

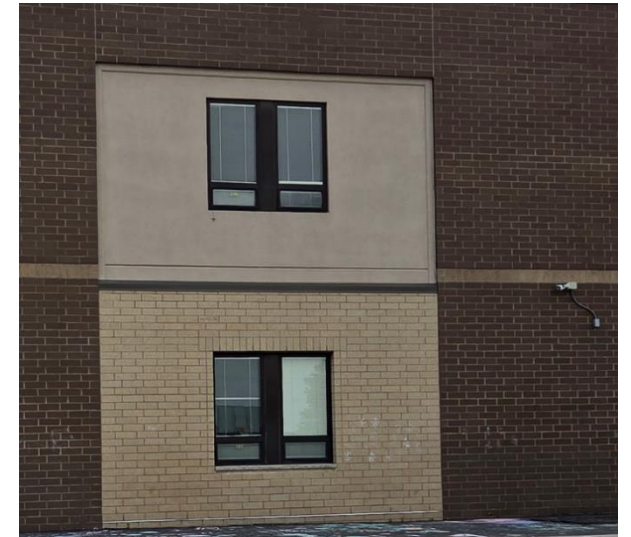
- Generally intact with no major damage
- Blinds sealed between panes that can't be repaired
- Failures often require full window replacement
- Poor seals can make rooms colder and reduce energy efficiency

- Prioritize replacement of problem windows
- Remove built-in blinds for easier maintenance and better efficiency

| | | \$15,118,000 |
|---|---|---|
| <b>Window Replacement</b> - Replace blind windows area | Elementary School | \$555,000 |

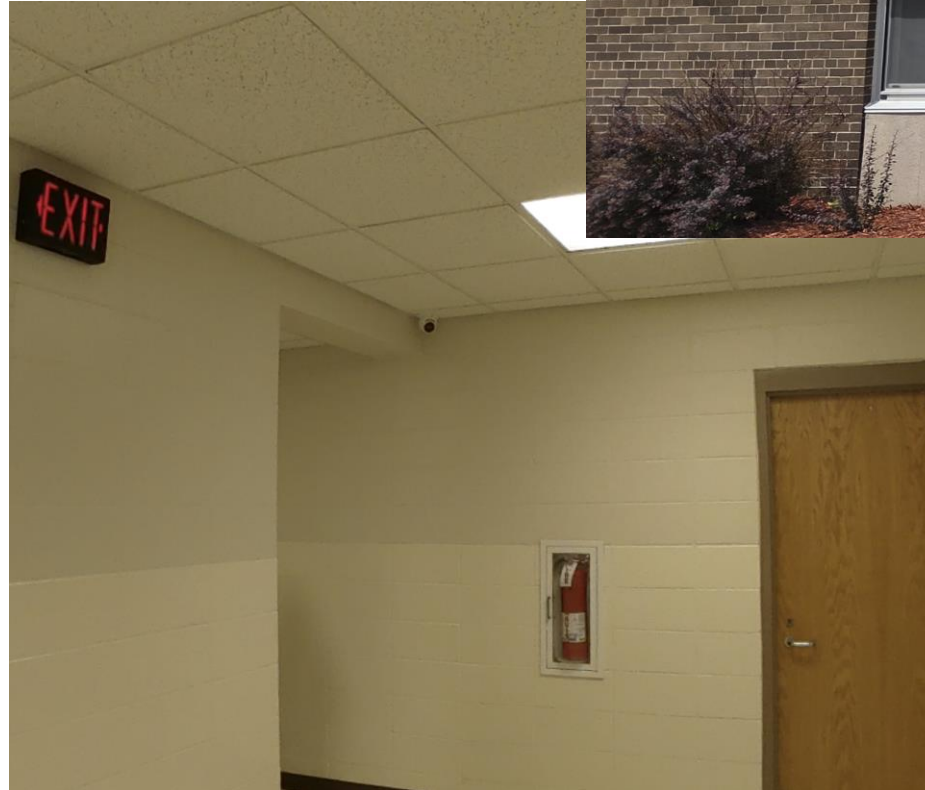
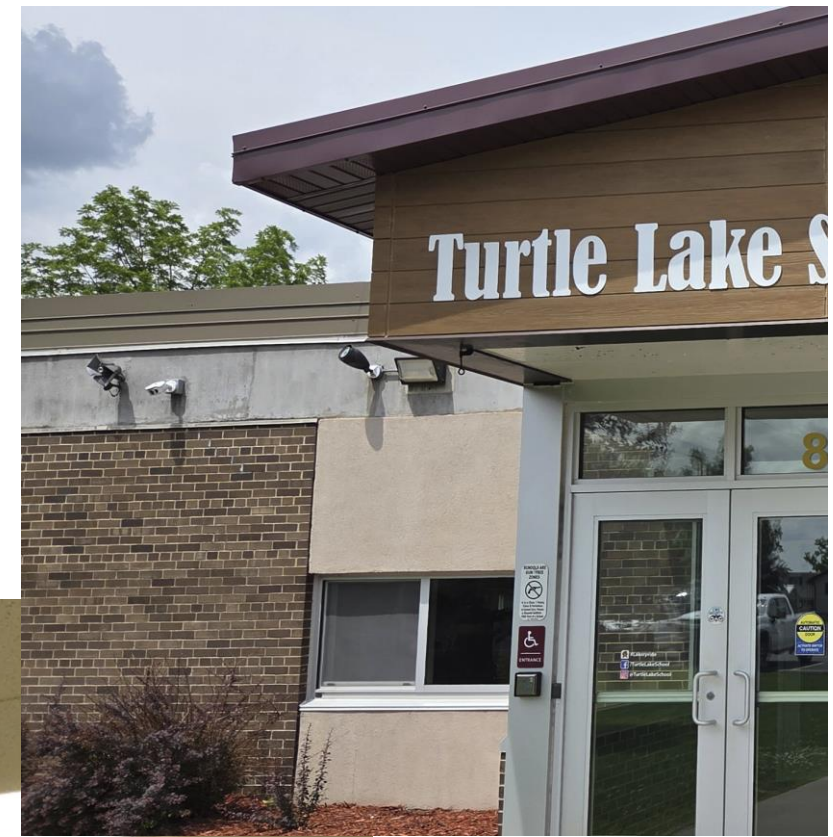
- **Card Access**
  - On all exterior doors and 5 interior doors
- **Camera System**
  - 60 total cameras
- **Security System**
- **Public Address**
- **Fire Alarm System**
  - Older system that needs to be replaced
  - Could be incorporated with PA system for verbal alarm

| | | \$15,118,000 |
|---|---|---|
| <b>Fire Alarm Replacement</b> - New Voice Fire Alarm System | Building Wide | \$1,412,000 |

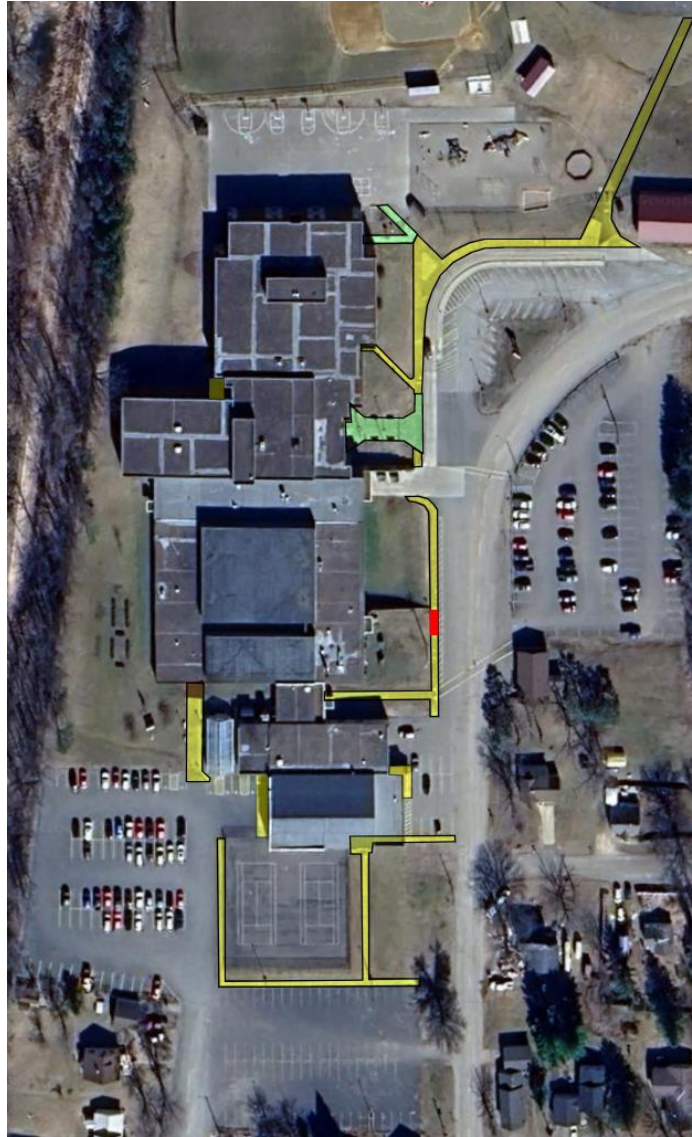
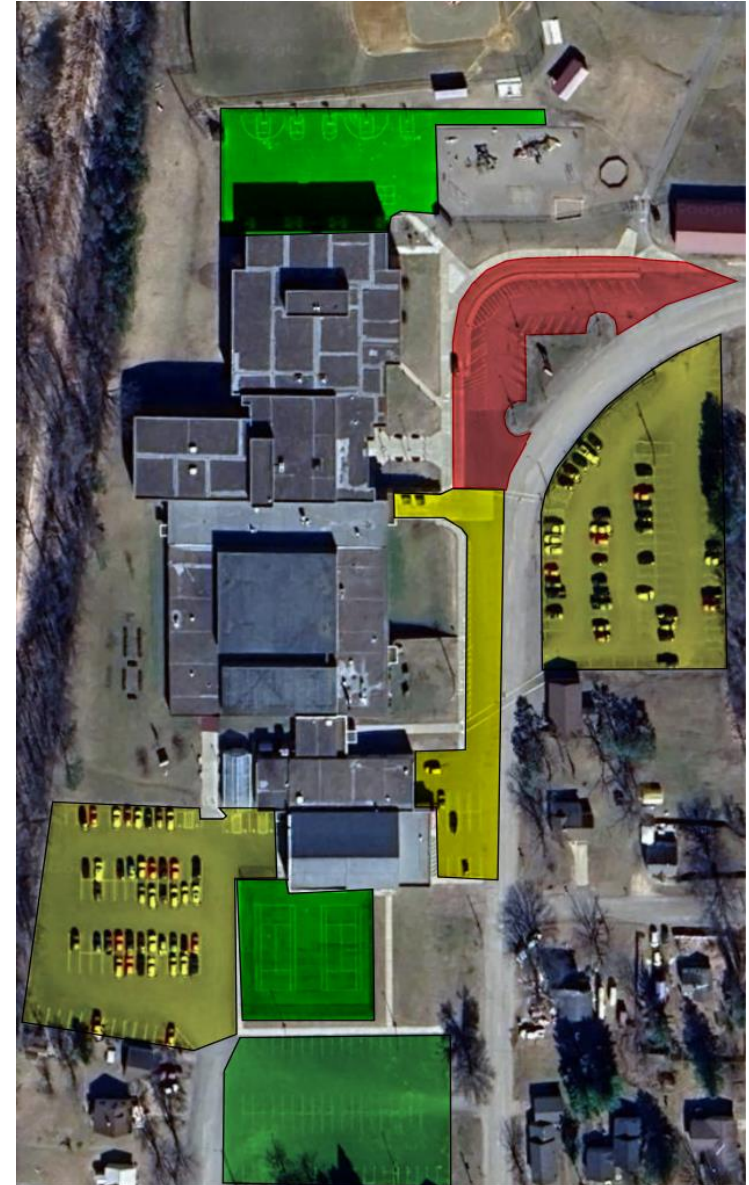
- Current sidewalks show signs of wear and cracking
- Cracks are spread throughout perimeter of the building
- Multiple areas have major cracking that could be repaired

- Asphalt shows signs of aging and surface wear
- Some areas may require patching or resurfacing

- Replace damaged concrete sidewalk sections
- Repair or resurface worn parking lot areas

| | | \$15,118,000 |
|---|---|---|
| <b>Parking Lot Replacement</b> - Replace Visitors Parking Lot | High School | \$455,000 |
