Edwards Early Childhood Campus Map

1605 Rand Rd, Kaufman, TX 75142

March 3rd, 2025

Kaufman Independent
School District

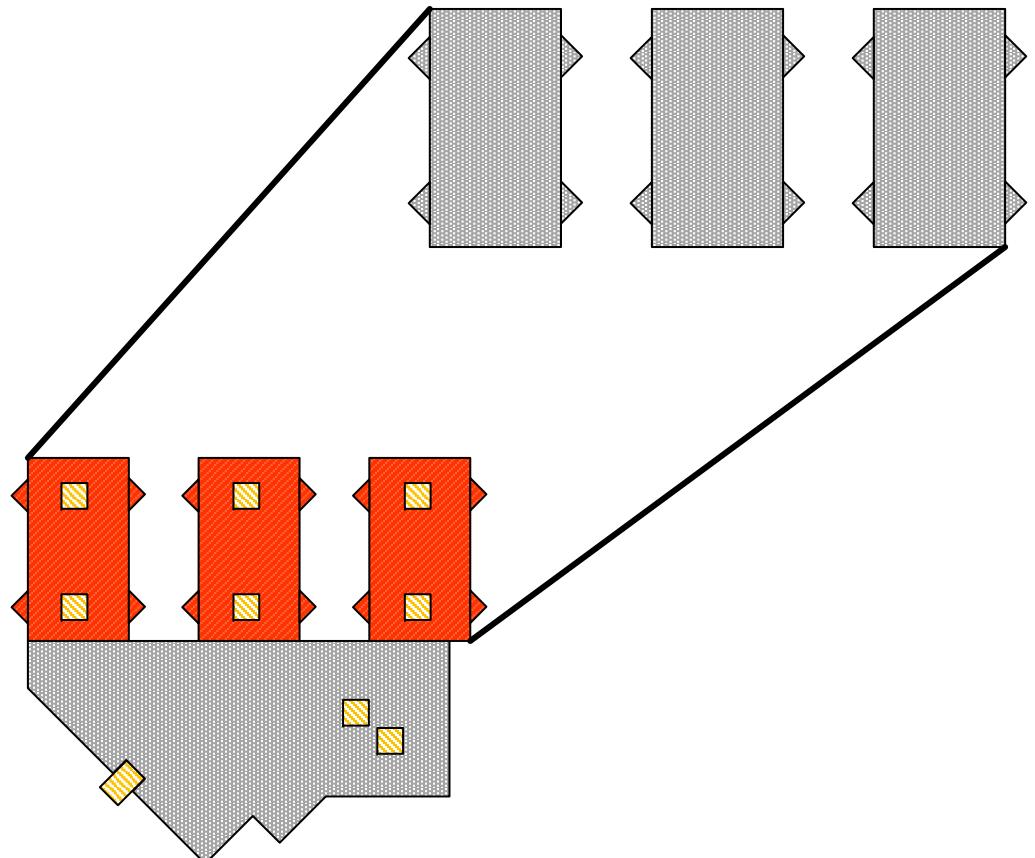
ROOF SECTION AREA

Roof Section Name: North Extension Fingers
Square Footage: 40,500
Year Installed/Age: 20+
System Type: Single Ply
Slope: 1/4:12
Height: ~25
Drainage System: Internal Drains
Accessibility: Roof Hatch
Inspection Rating: Failed
Notes: N/A

- Core Analysis: Coating, Single Ply, 2 Layer ISO
- Metal Deck
- Structurally Sloped

- The single-ply membrane exhibits **advanced aging and deterioration**.
- Numerous **fractured seams** were observed, compromising the waterproofing integrity.
- **Widespread surface wear** is evident, with sections of the membrane appearing brittle and discolored.
- Visible **cracking and splitting** along stress points, particularly near seams and transitions.

- Multiple **open and fractured seams** were noted throughout the roof.
- **Adhesion failure** was observed at seam overlaps, leading to water infiltration.
- In some sections, seam separation has resulted in **exposed insulation and substrate**, increasing the risk of structural damage.

- Flashings around penetrations and parapet walls are **failing or detached**, further contributing to water ingress.
- Edge terminations show **lifting and shrinkage**, indicating prolonged exposure to UV degradation.

Repair Water Tight
Estimate \$24,000
