Peak Innovation Center – Roof Drainage Systems Assessment for Fort Smith, Arkansas

Date: 05/11/2023

Building: Peak Innovation Center
5900 Painter Lane
Fort Smith, Arkansas

Reported by: M. Scott Archer, P.E.

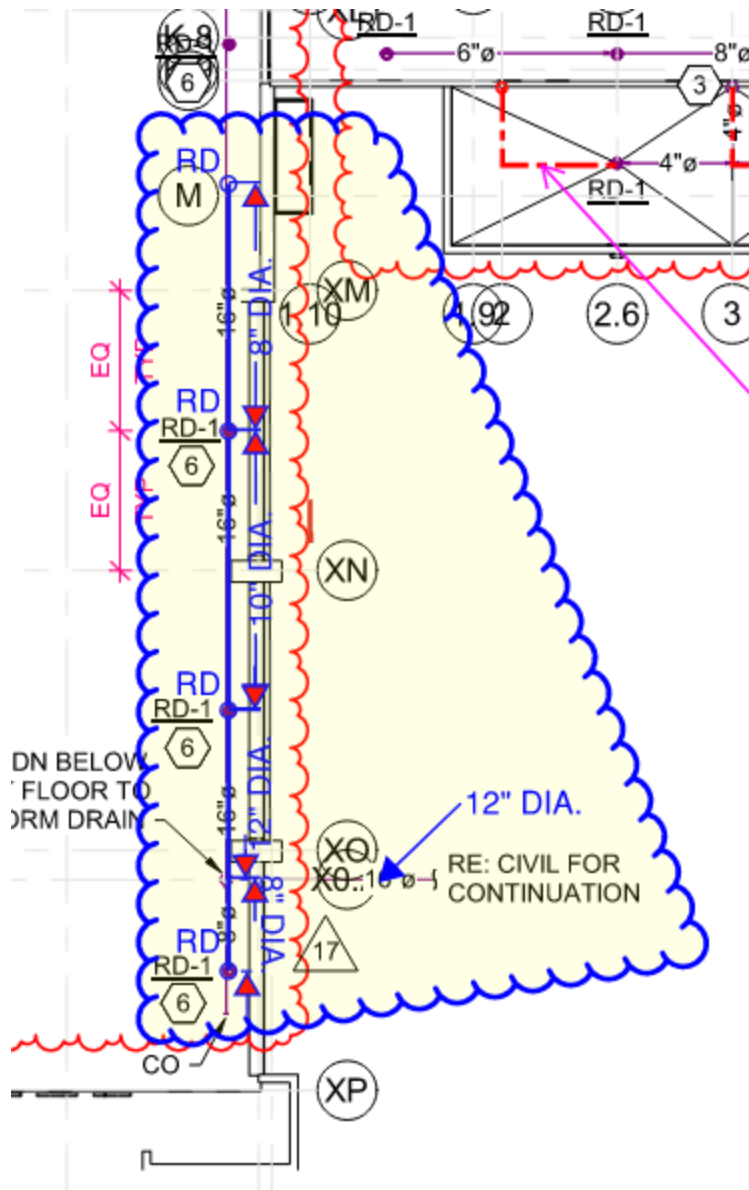
Here is a sketch for the revised roof drain leaders (Blue markups) along grid X6. Let me know if you have any questions.
