Roof Asset Management Program

Pana High School Roof Report

Prepared By
Ryan Benson

February 07, 2022

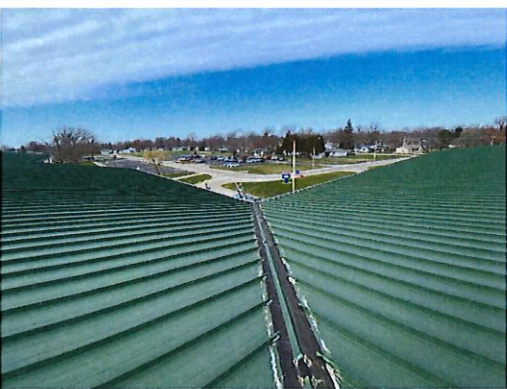
Photo 5

Valley Area has been a leak location for sometime.

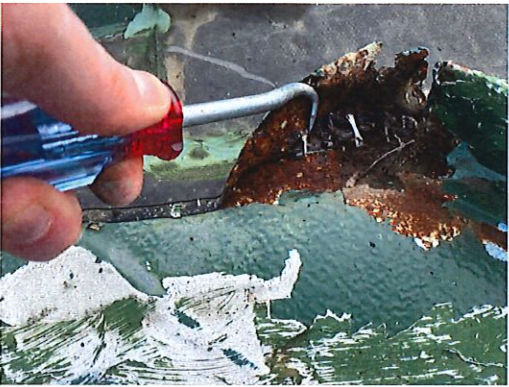
Photo 10

This has resulted in the panel starting to rust. A repair was made with a fluid applied roof system.

The EPDM was removed
All rust was wire brushed
The entire area was primed
Base and Top Coat were applied to the valley area.

No active leaks have been reported since the repair was made in April of 2021 , and this area has seen a tremendous amount of rain fall in the 2021 summer and fall.
