LAKE BLUFF SCHOOL DISTRICT 65

RE: Facility Assessment

Lake Bluff School District 65

Updated Facility Assessment Report

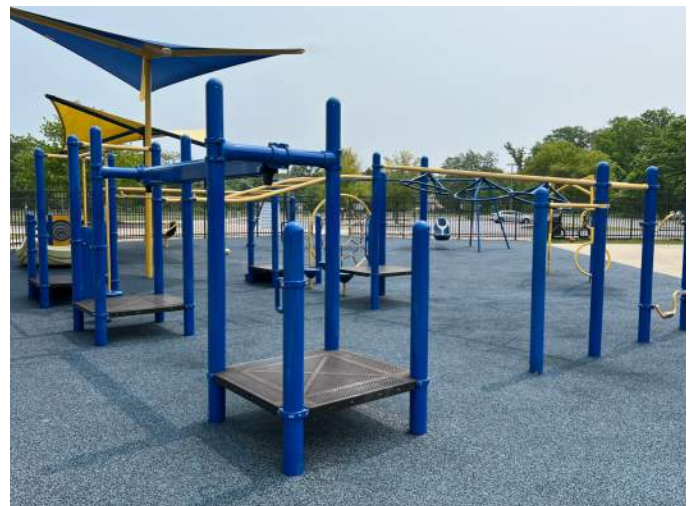
A limited visual assessment of the playground equipment was performed as part of this report and the equipment at both playgrounds appears to be in good condition. We recommend that a safety inspection be conducted on both playgrounds for a more detailed analysis and further recommendations. Wight & Company is happy to perform such an inspection if the District so chooses.

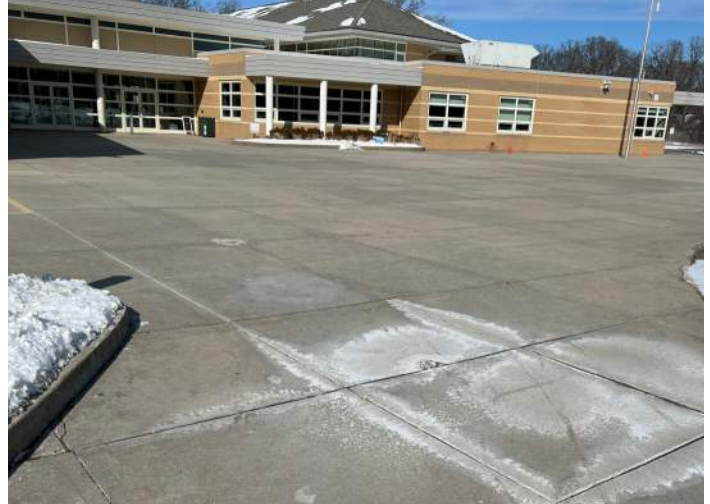
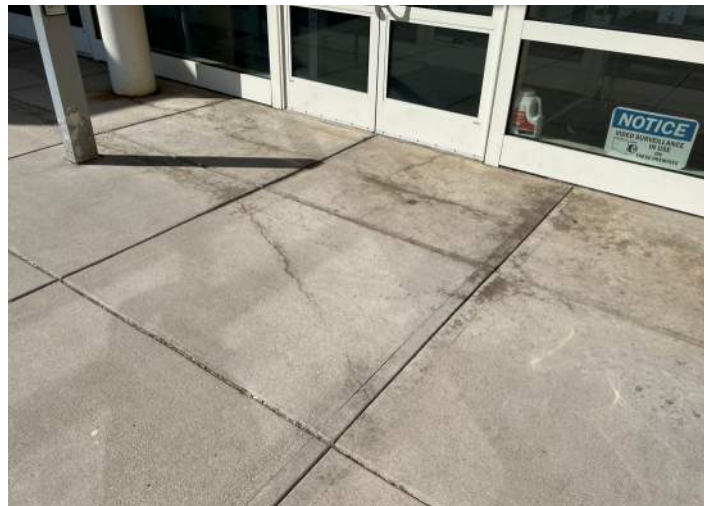
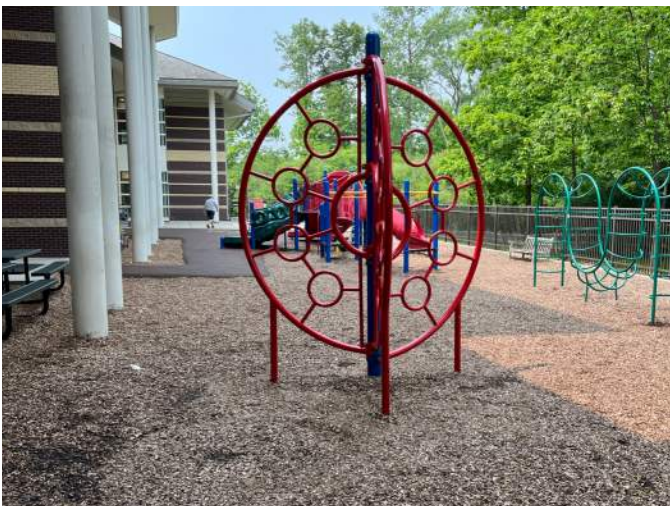
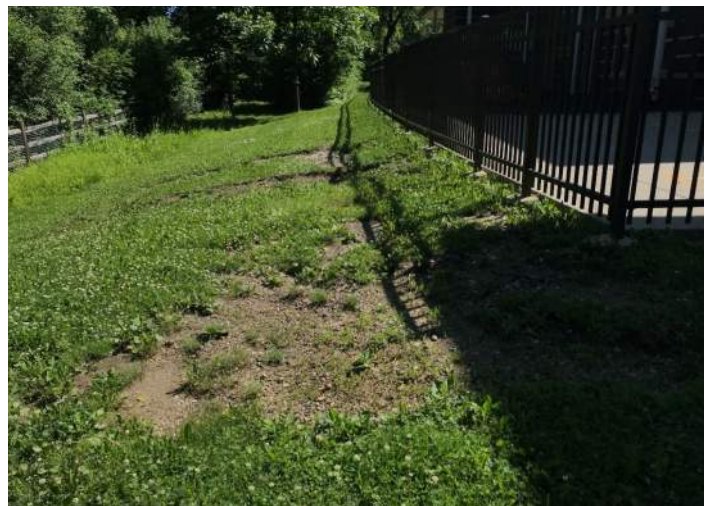
Overall, the site drainage appears to be functioning well. The northwest corner of the site includes a relatively steep slope and small areas without grass or other vegetation. It is recommended that this area be monitored and be restored/reseeded as necessary to limit erosion. If preferred the District could also implement a hardscape solution such as riprap to minimize erosion from water runoff.

Concrete sidewalks around the perimeter of the building are generally in good to fair condition. There is minor cracking of sidewalks throughout the site but no repairs are required at this time.

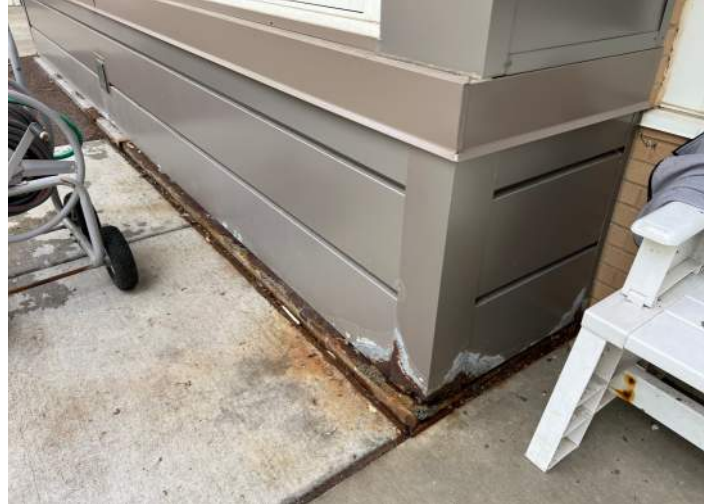
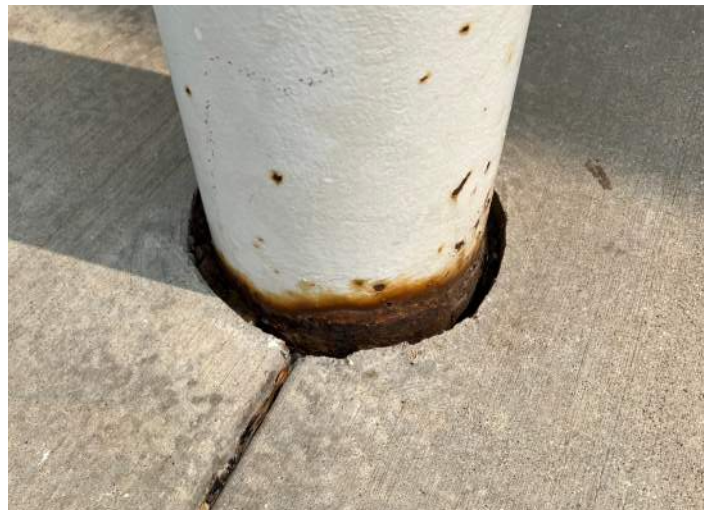
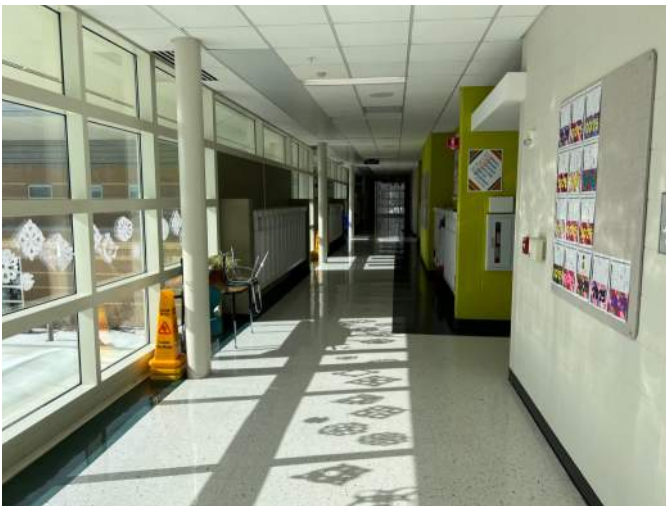
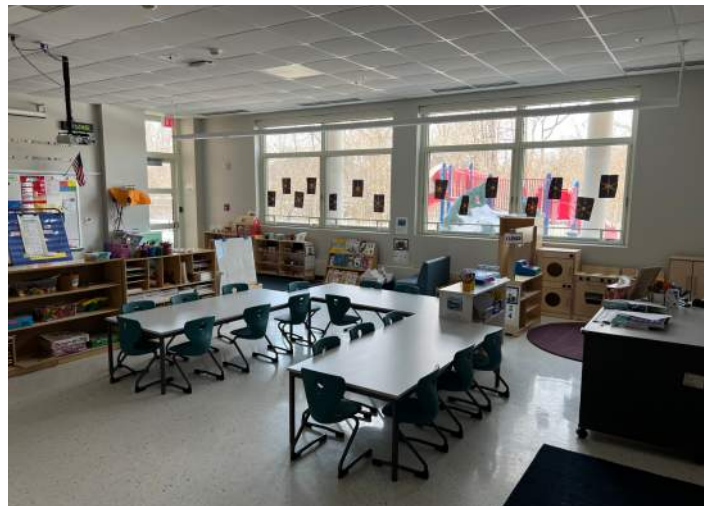
The building also includes metal siding at various locations, which is generally in good condition with the exception of the bottom portions metal siding that are adjacent to walking surfaces and especially entrances. At these locations there is corrosion resulting from the salt usage required. The most significant area of corrosion observed was at the north door to the playground area. Any replacement of these areas will likely require replacement of the siding up to the window sill, where there is a transitional condition, and it is recommended that any such replacement include a more salt-tolerant material at the base of the wall.

A visual assessment of the exposed exterior structural frame and foundation elements was performed and those elements were generally found to be in good condition. There is surface corrosion at the base of the exterior steel pipe columns that are adjacent to walking surfaces, which is a result of the salt usage required in those areas. It is recommended that the corrosion be removed down to bare metal and a high-performance corrosion inhibiting coating be applied to the base of the columns. It is also recommended that the gap between the columns and the concrete be sealed to reduce the amount of water being captured and held next to the base of the columns.

In general the interior of the building is in very good condition. There is some minor slab settlement telegraphing through the floor tile at the north end of the building. It is recommended that any future flooring replacement projects includes patching/leveling these areas of the floor to reduce/eliminate these conditions.

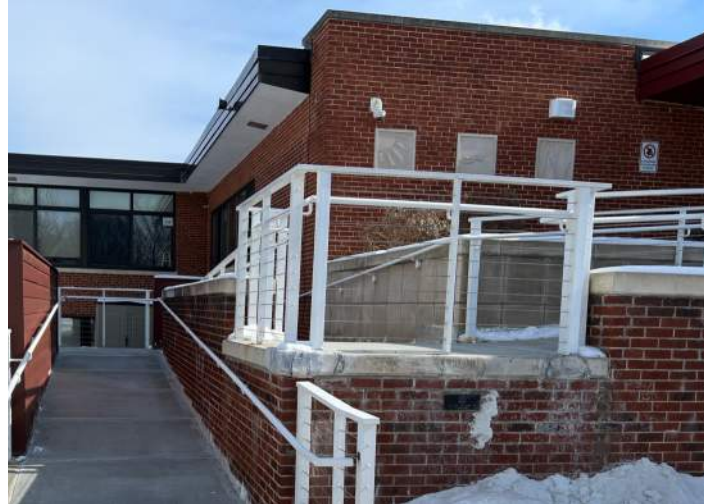
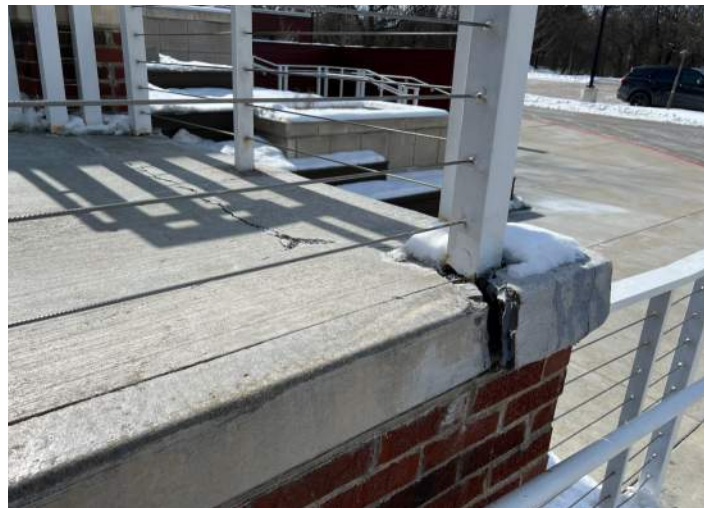
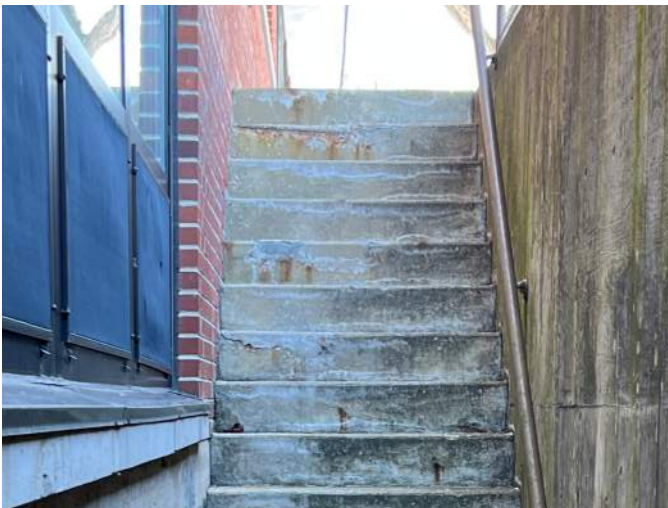
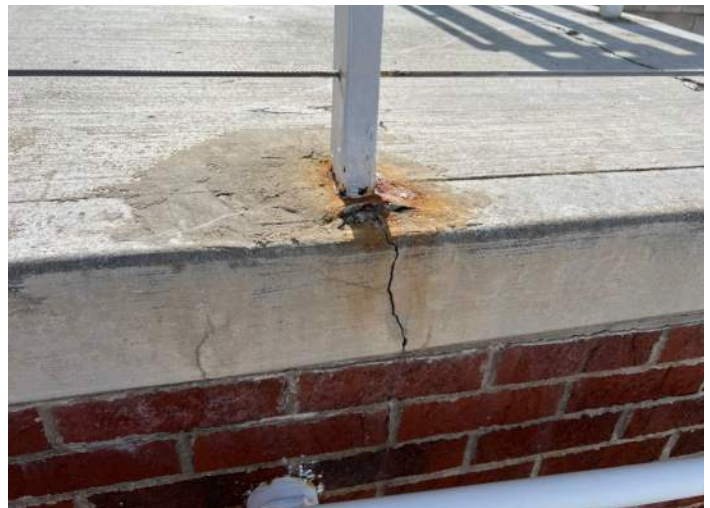
The exterior stair that extends below grade outside Door 15 has damage at several nosings. It is recommended that the nosing conditions be patched to restore the original nosing profile.

The elevated landing outside Door 10 has a large crack across the width of the landing. It is recommended that this landing be maintained by continuing to seal the crack as needed. A more comprehensive repair would require complete landing replacement, which is not recommended at this time.

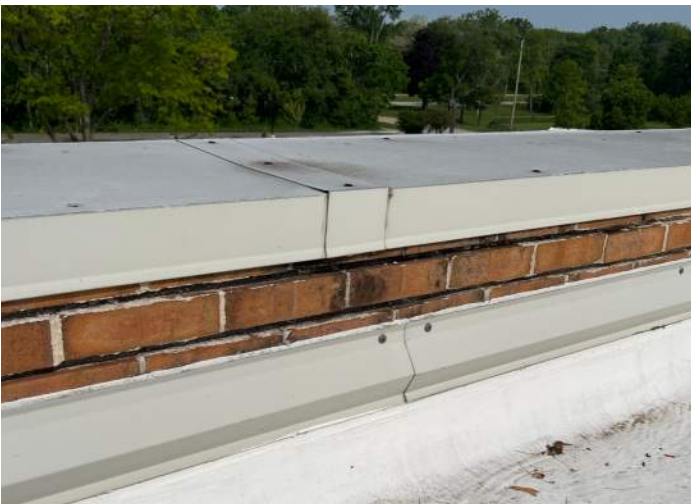
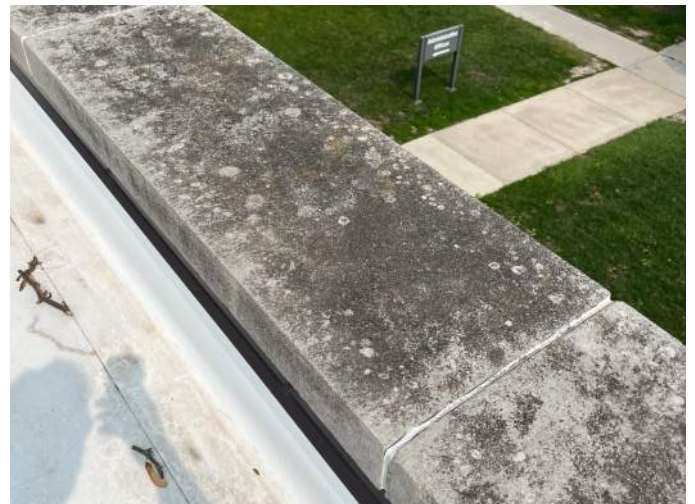
The brick facade at the 1986 gymnasium addition is generally in good condition with the exception of the north wall of the gymnasium (located above a lower roof level). This wall has deteriorated more than the other elevations and more extensive tuckpointing is recommended at this particular elevation. Additionally, the parapet wall at the gymnasium roof has significant deterioration on the roof side of the parapet and tuckpointing is required at several locations, with general tuckpointing recommended for all sides.

The brick facades at the 2016 classroom and arts additions are in very good condition with no work recommended.

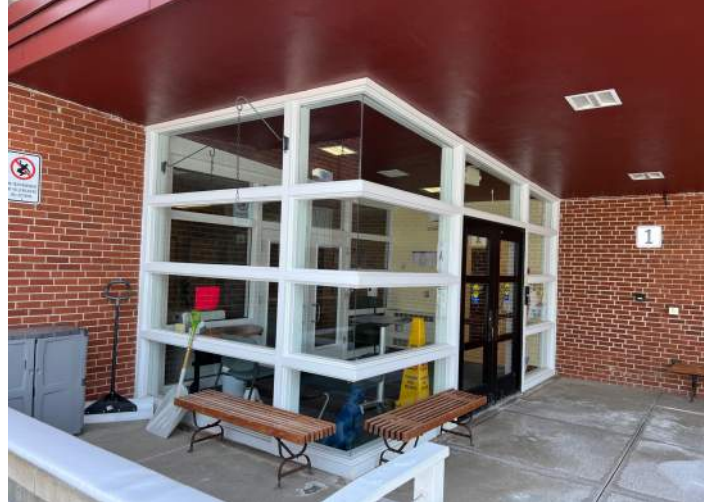
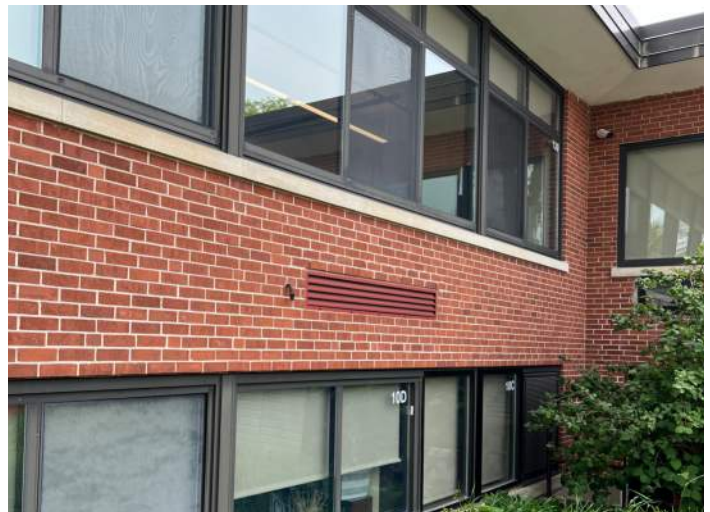
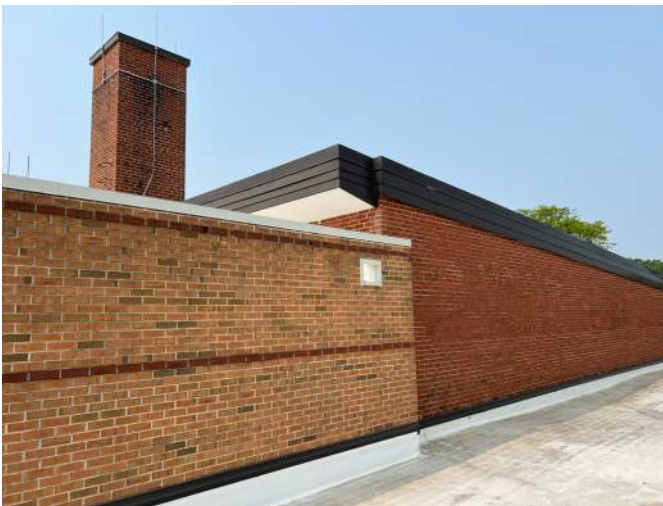
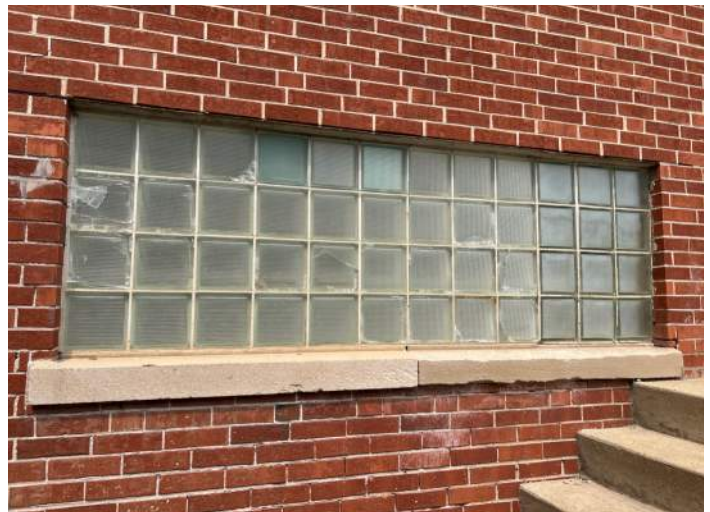
The existing windows range from good to fair condition depending on age, with all existing windows being serviceable for the foreseeable future. Replacement of older windows is only recommended if the District wants to increase the energy performance of the building envelope.

The existing glass block windows are in poor condition with several areas of cracking. It is recommended that the damaged glass block units be replaced in kind.

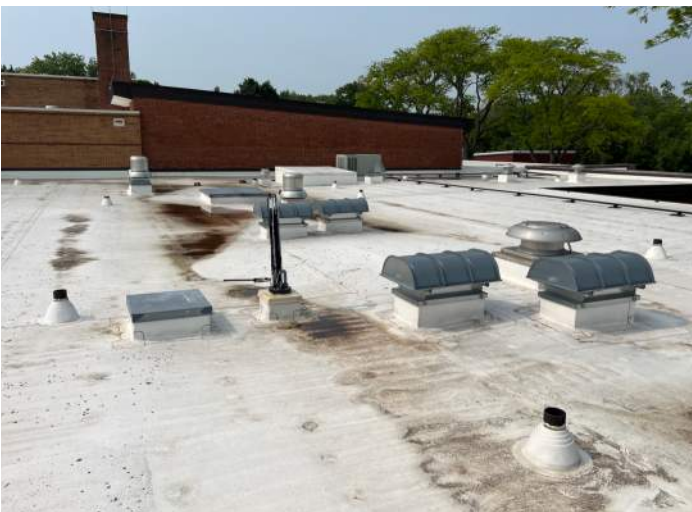
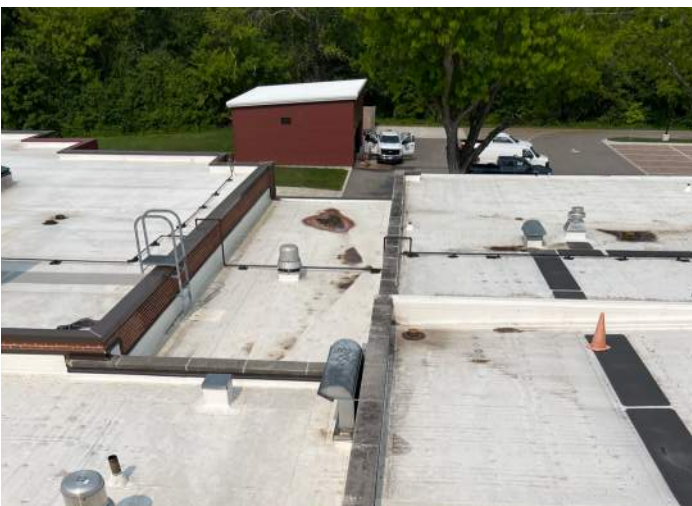
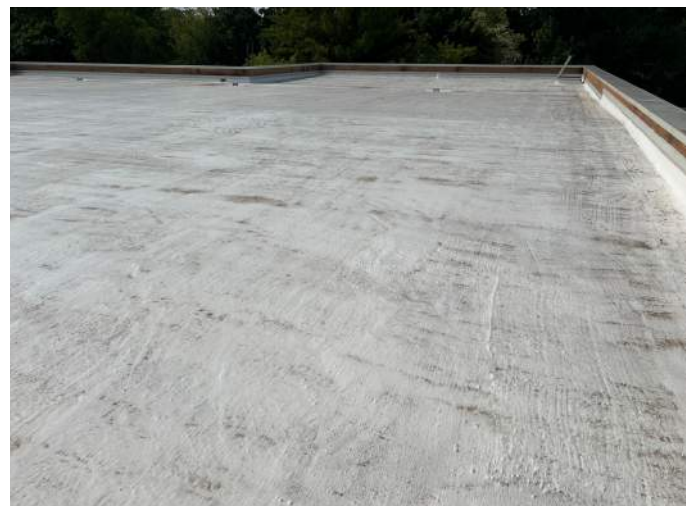
The roofs at the original 1954 building and the 1959 south classroom wing addition appear to be in good condition and no work is anticipated within the next 5 years. It is recommended that these roofs be reevaluated in 3-5 years to determine a replacement schedule for the roofs.

The 2016 classroom and arts additions roofs are still covered by the manufacturer's standard 20-year product warranty and should be expected to last at least another ten to fifteen years or more.
