Morrow County School District Facilities Assessment

May 9, 2024

Morrow County School District Facilities Assessment Report

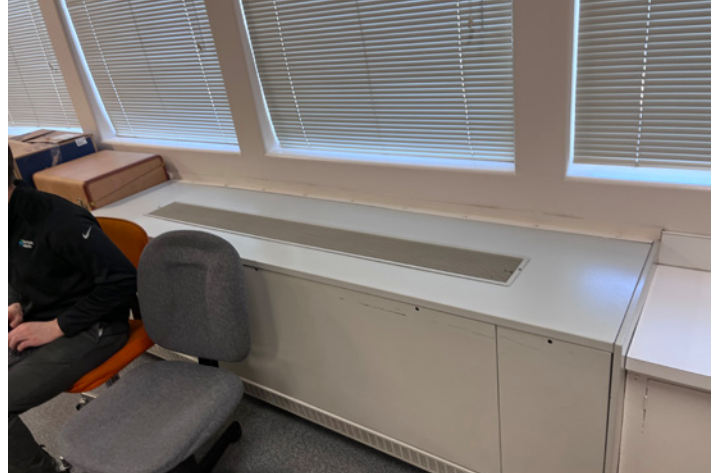
Unit ventilator

- The classrooms are heated and cooled with a wall mounted unit ventilators consisting of hot water and chilled water coils, a fan, and a thermostat for control. The unit ventilators were installed in 2010 and have a 15 year median life.

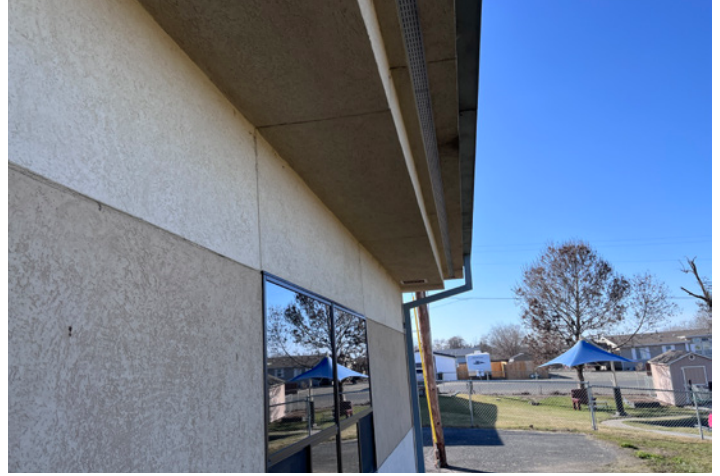
Exterior soffit

- At this site the parking, driveways, sidewalks, and curbs need repairs, repaving and restriping. Limited ADA access. Lack of security fencing.
- On the exterior the siding needs repair and repaint; soffits and fascias have damage from either water and/or bird nesting.

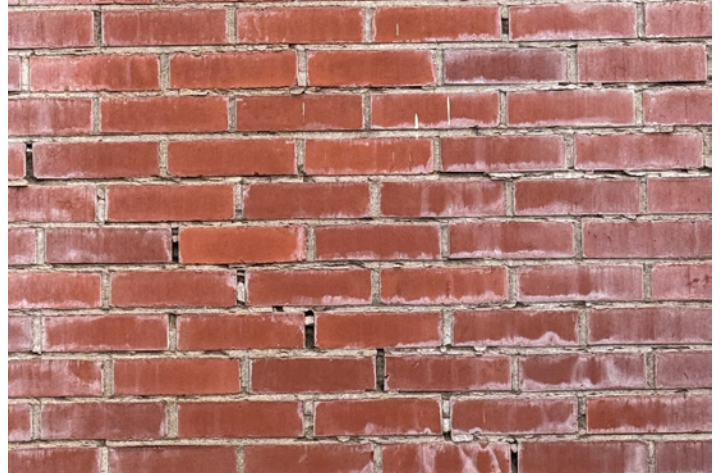
- A larger crack exists above the door to the Boiler Room in the downstairs hallway.
- Mortar has deteriorated in the brick on the West

face of the building below the large glass block area.

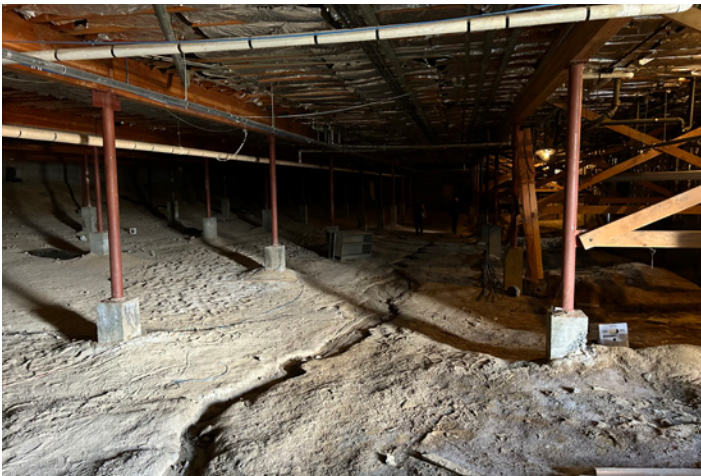
Crawl space

- Several concrete pilasters in large crawl space have damage at the corners and rusted reinforcing. Additionally, storm drainage is currently flowing through this crawl space and adjacent to these pilasters and footings below.
- Glulam floor beams for classrooms above were installed upside down with "Top" being visible from the bottom of the beam.
- Significant damage has occurred where the guard rail at the exterior ramp attached to the concrete wall on the South end of the Gymnasium.
- There are signs of roof leaks due to visible stained ceiling tiles in the small wrestling room & band room.
- Upstairs classrooms and hallways look good with minimal cracks in sheet rock and proper gapping at doors.
- Shop building structure appears in good condition

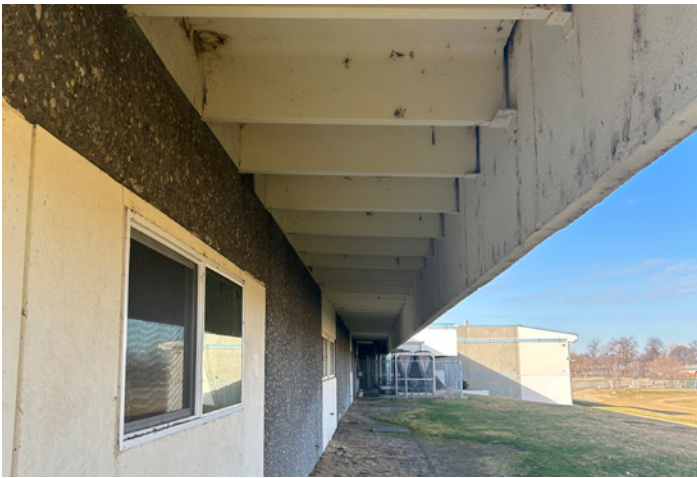
Soffit

Main Building: Siding needs repair and repaint; soffits and fascia's have damage from either water and/or bird nesting.

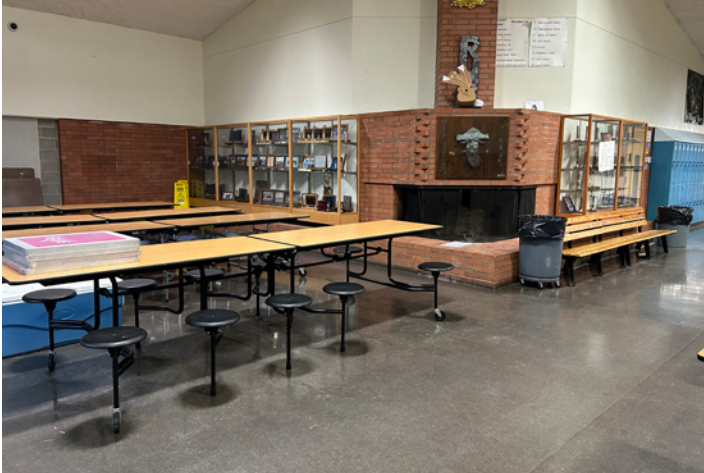
Commons and inactive fireplace

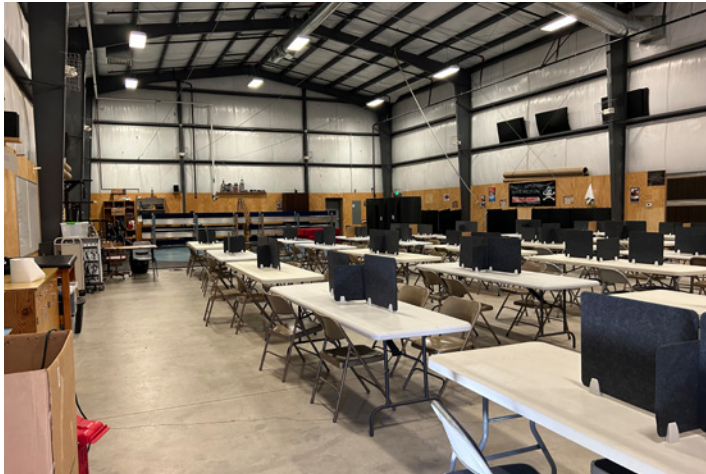
Temporary testing area in multi-purpose building

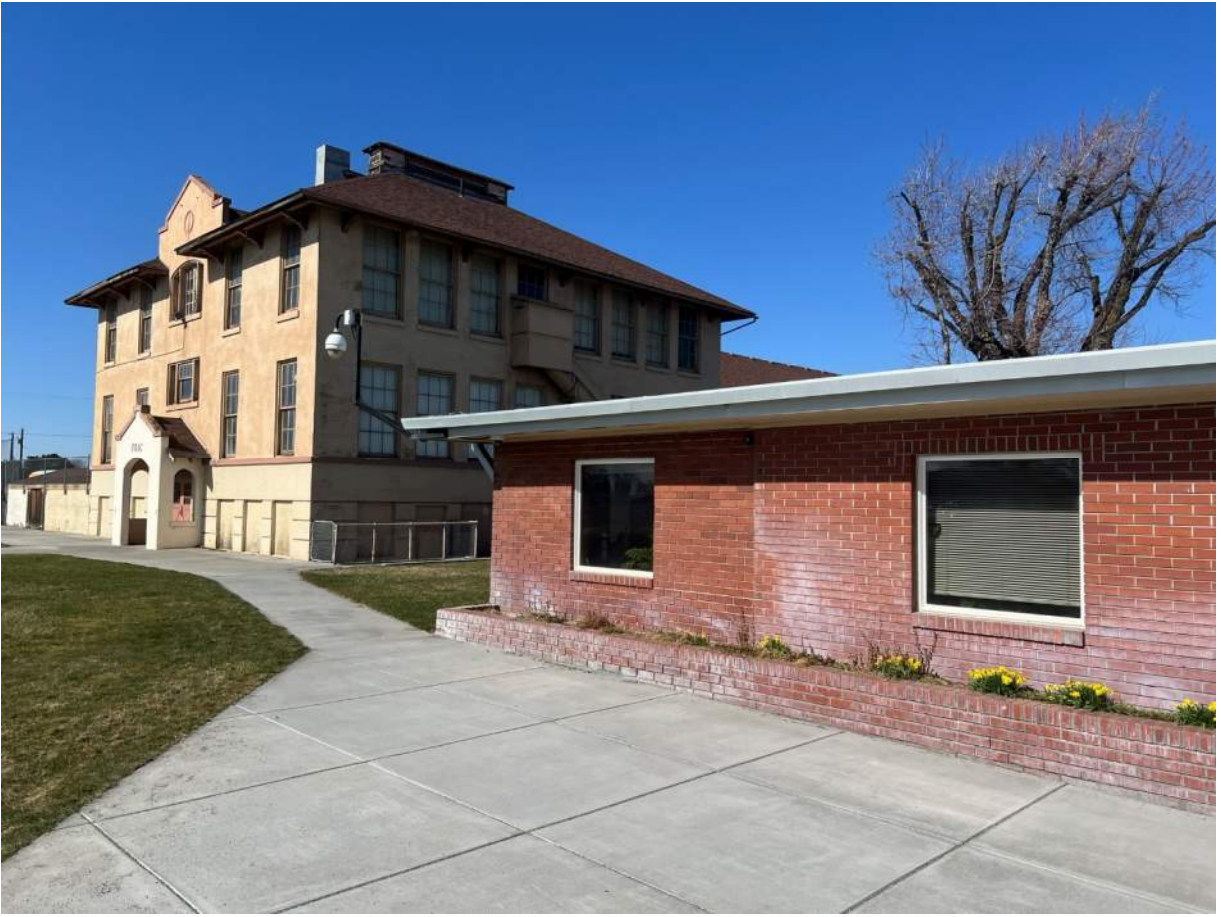
(Above: Planter bed next to building)

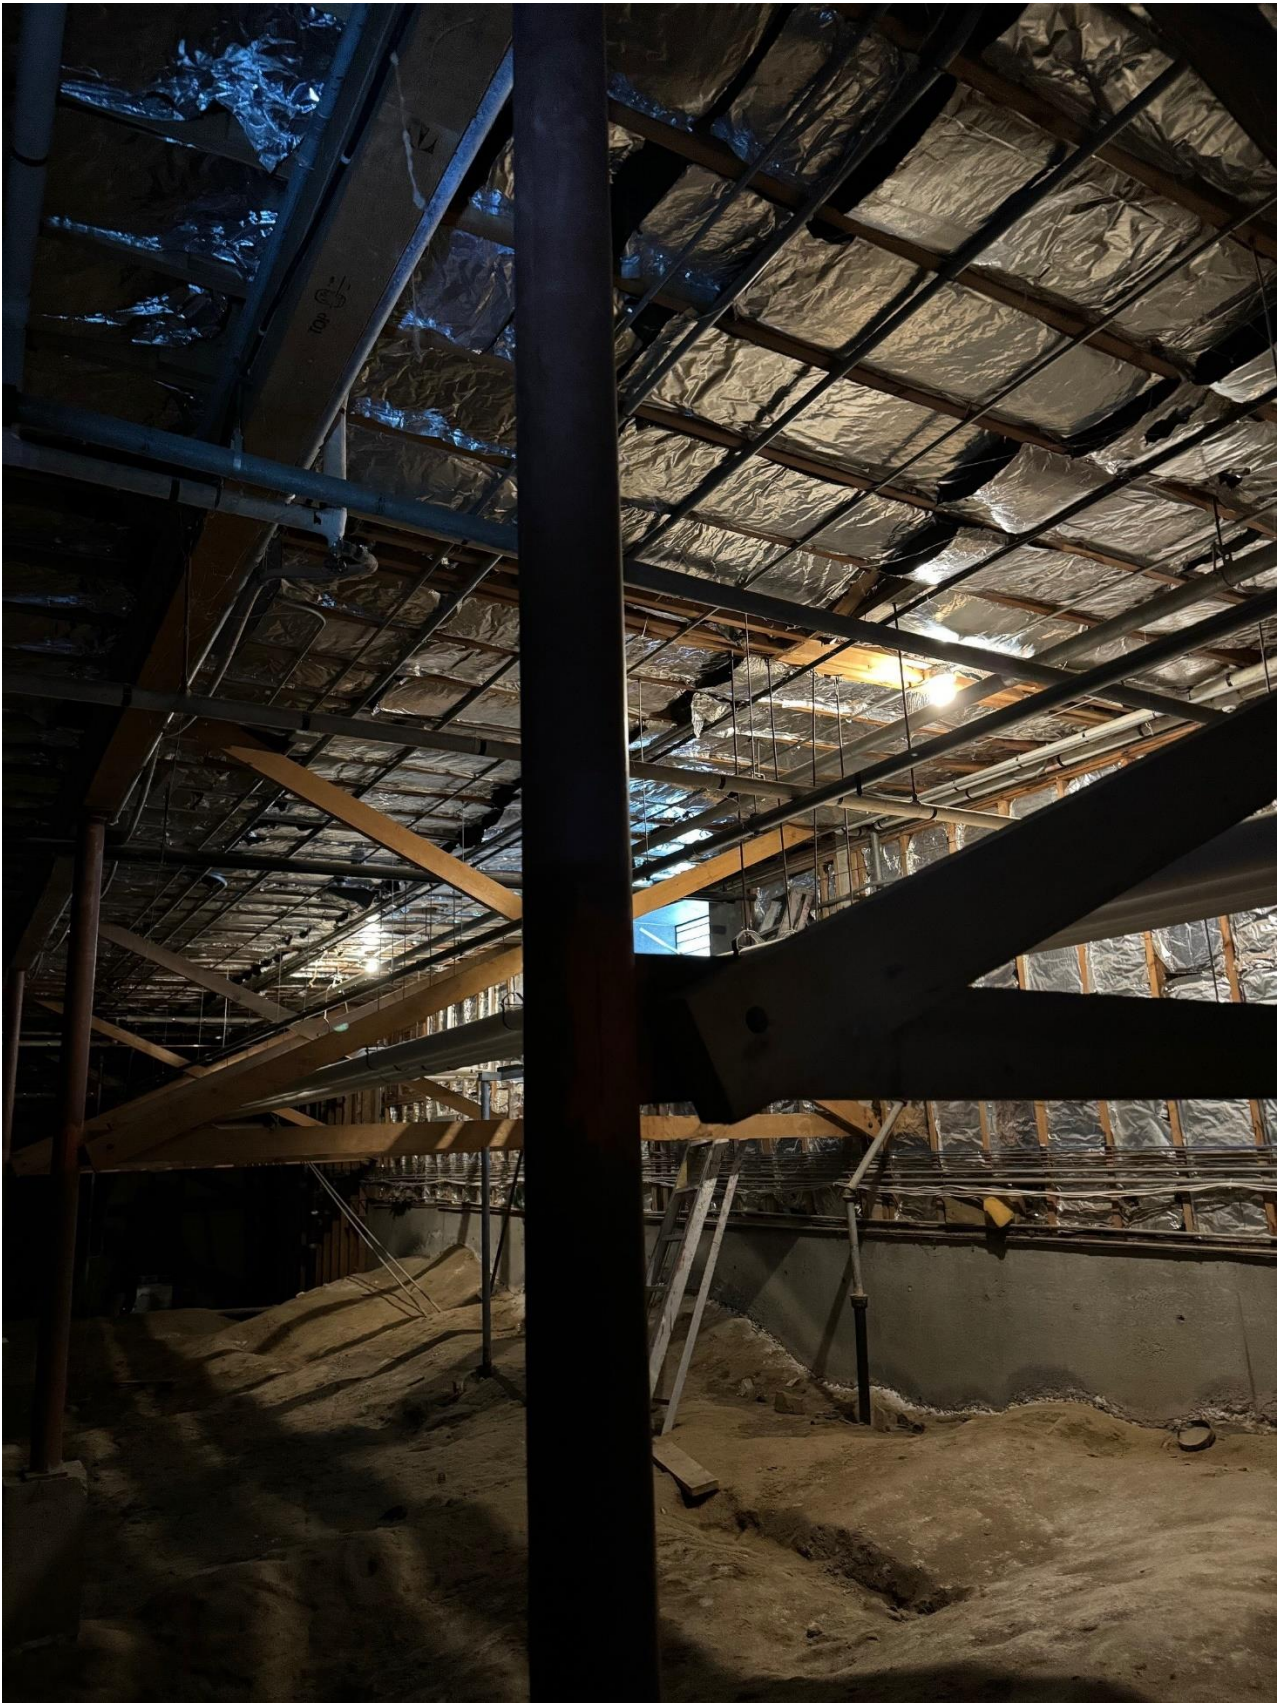
(Above: crawl space framing)

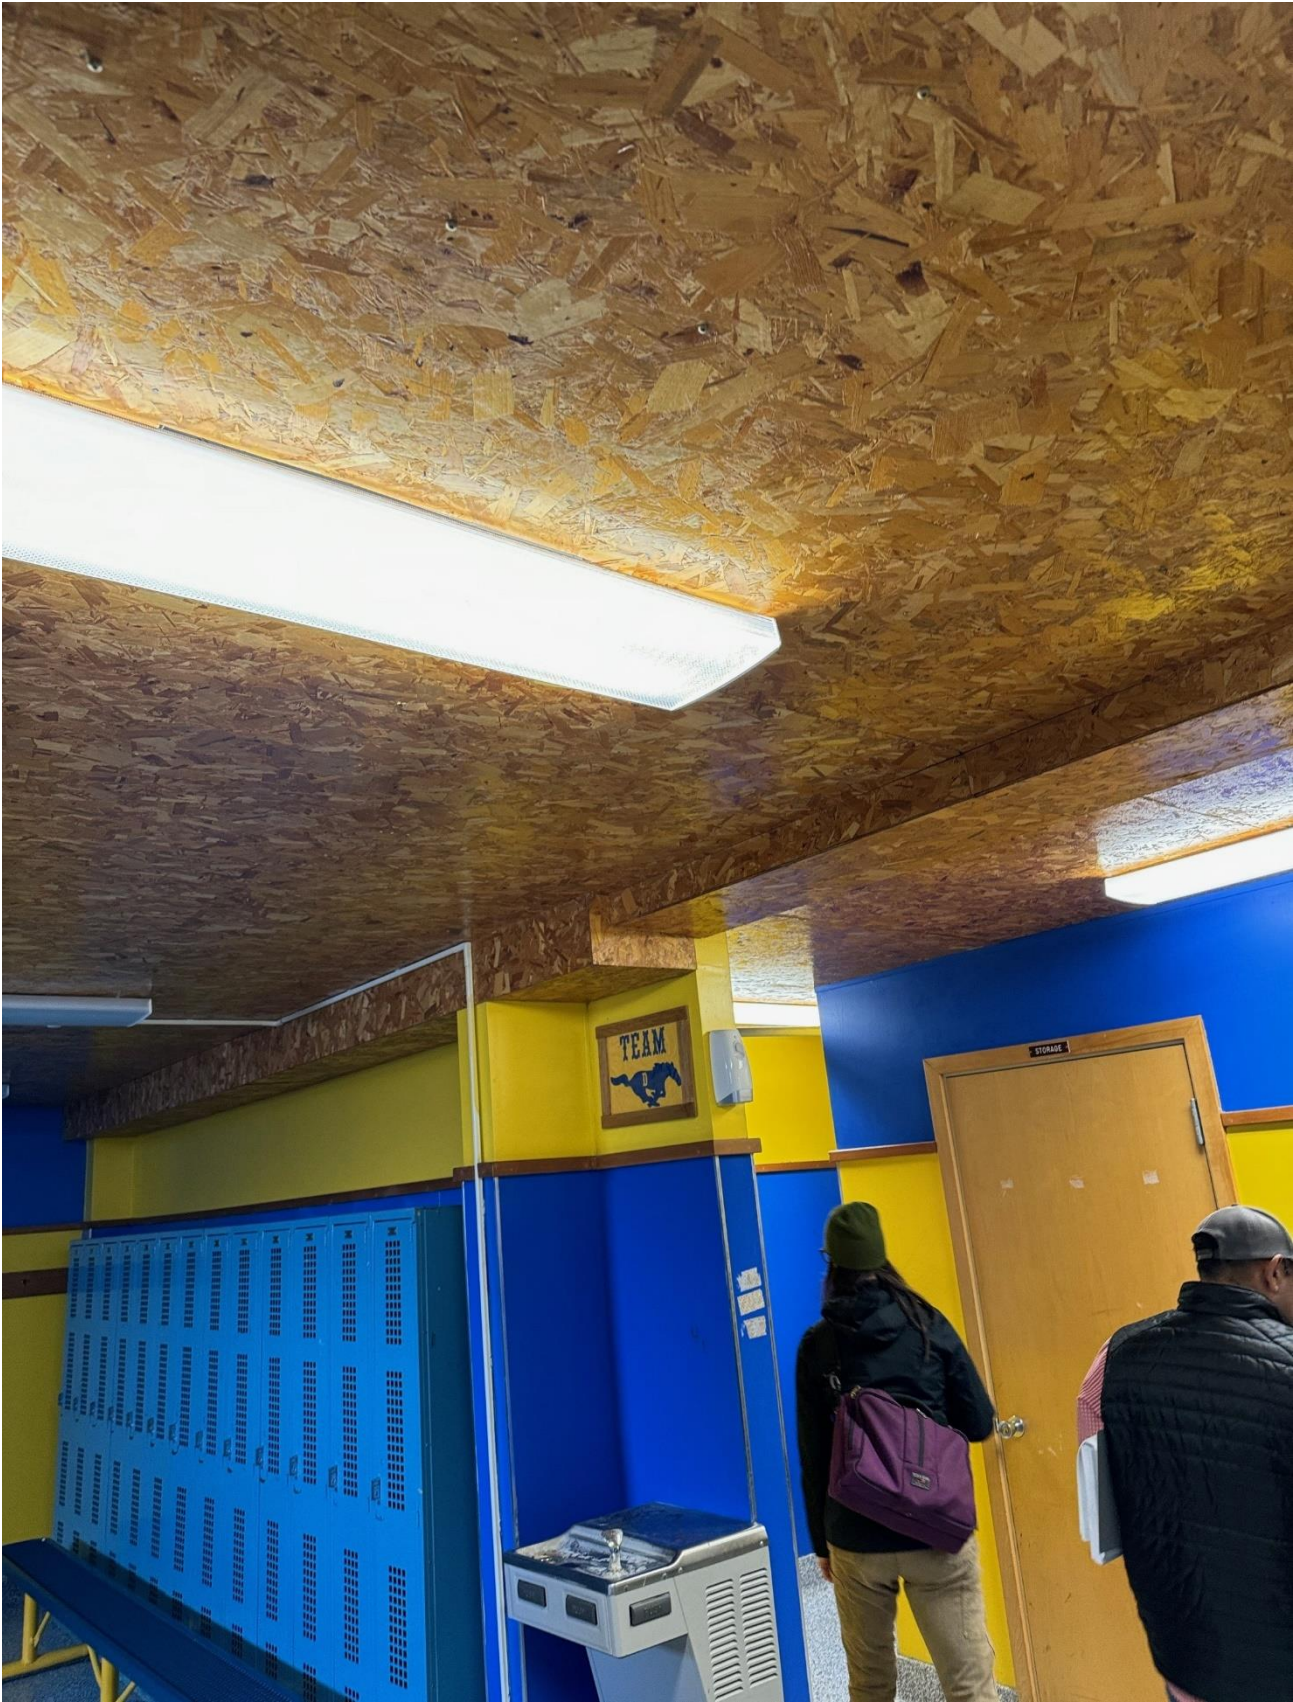
(Above: sheathing below framing for mezzanine w/ weight room above)
