Geneva CUSD 304 5-yr Capital Improvement Plan 2012

Geneva Community Unit School District #304

July 30, 2012

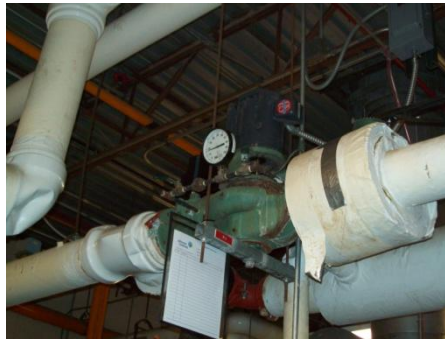
Primary Boiler Pump

Primary and Secondary Boiler Pumps

Original to the building. Need replacing with energy efficient design and variable frequency drives for increased energy efficiency.
