PEAK Drainage Assessment

June 19, 2023

Scott Archer - PE LEED AP, BD+C

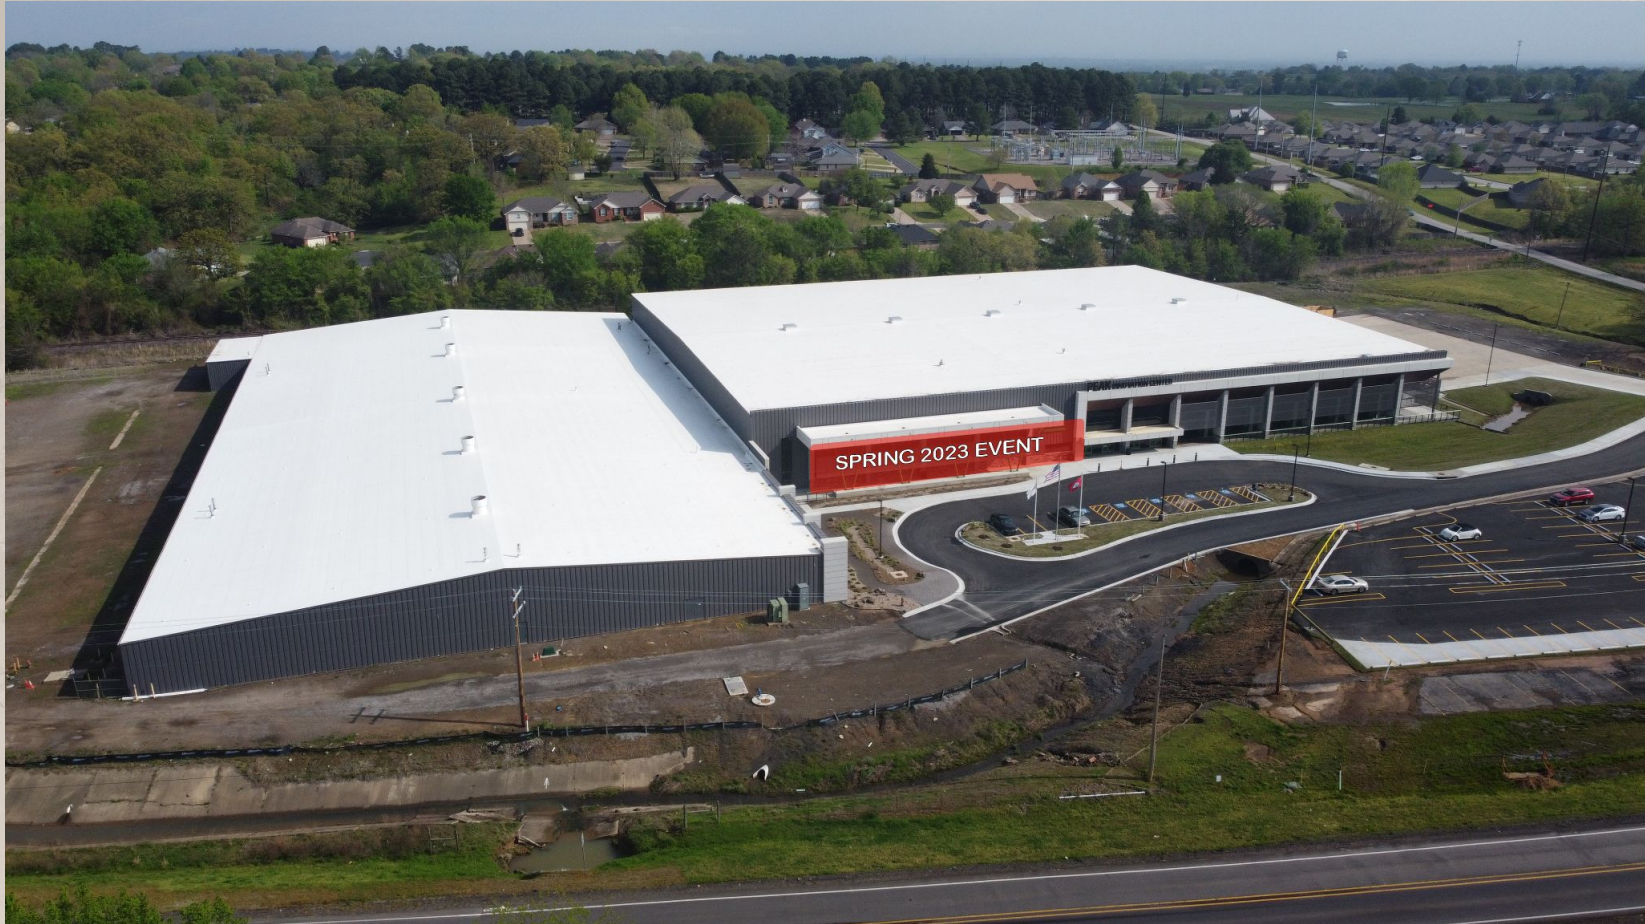
Photo 1 - Infiltration along grade beam and slab

- **Recommend to abandon existing below slab drainpipe. Reroute roof drains between east and west buildings to exposed drainage at ceiling and take south to ditch**
- **Rework the below grade roof drain piping on the south side of the east wing to allow adequate relief of the drainage**
