**Soderstrom Architects**

Facilities Assessment Report  
Parkrose School District  
Multnomah County, Oregon

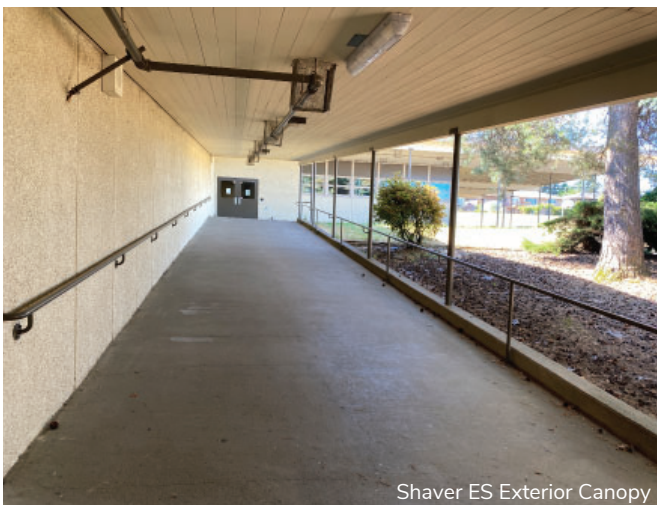
Shaver ES Exterior Canopy

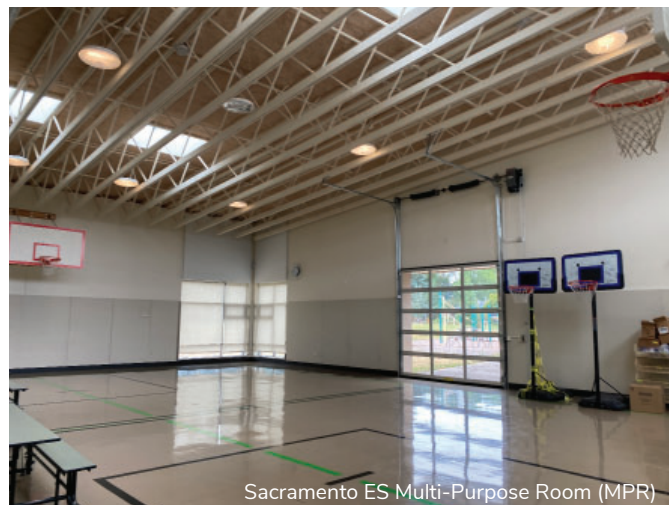
Sacramento ES Multi-Purpose Room (MPR)

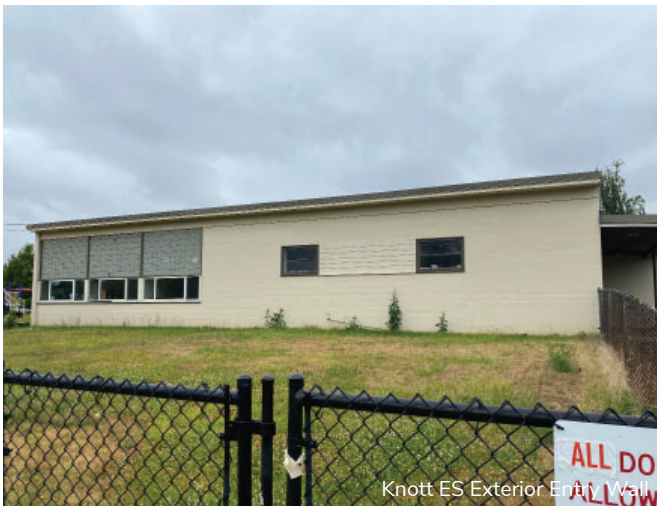
Knott ES Exterior Entry Wall

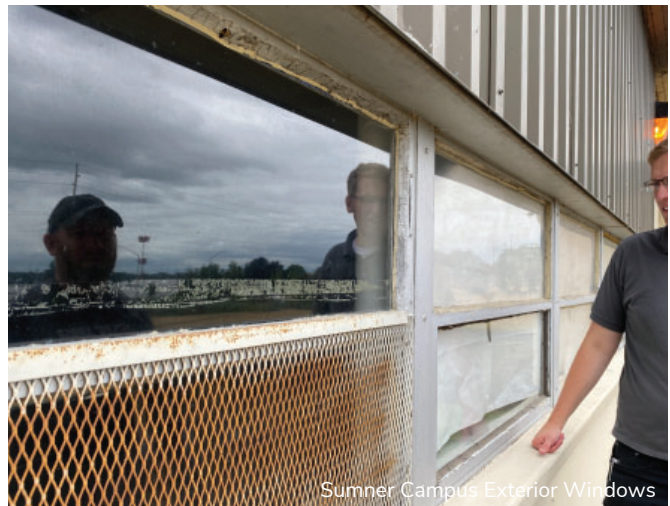
Sumner Campus Exterior Windows

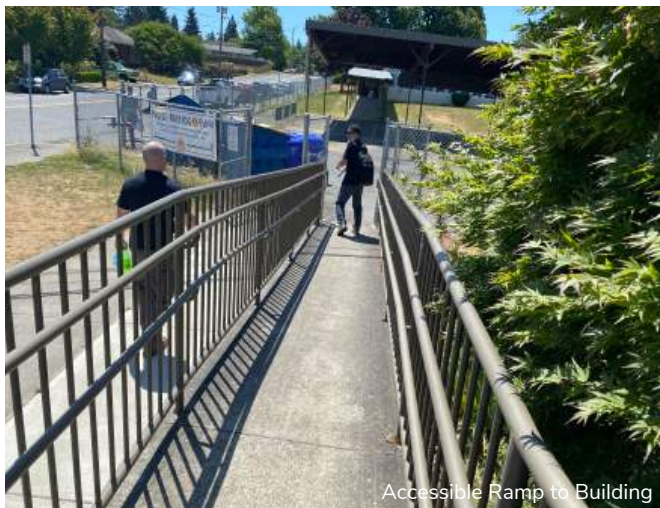
Accessible Ramp to Building

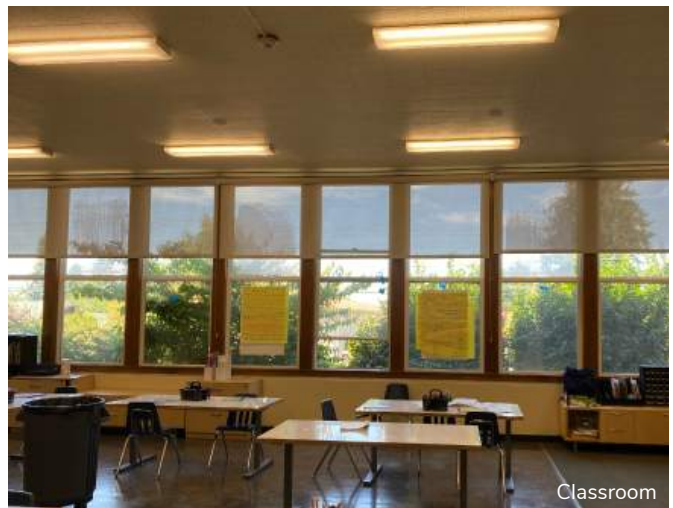
Classroom

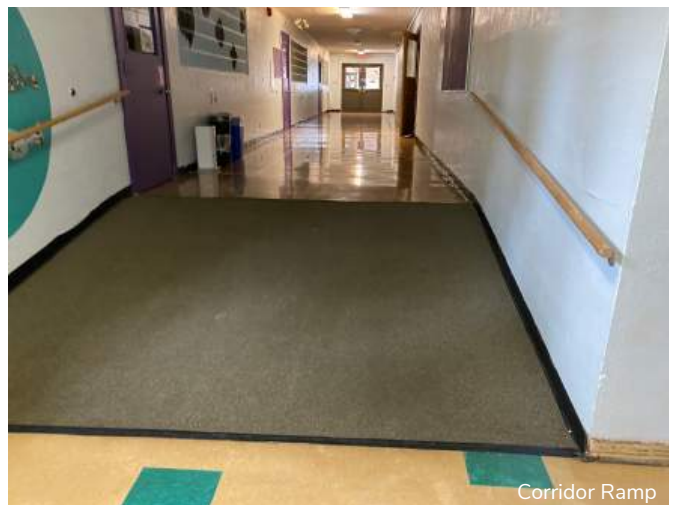
Corridor Ramp

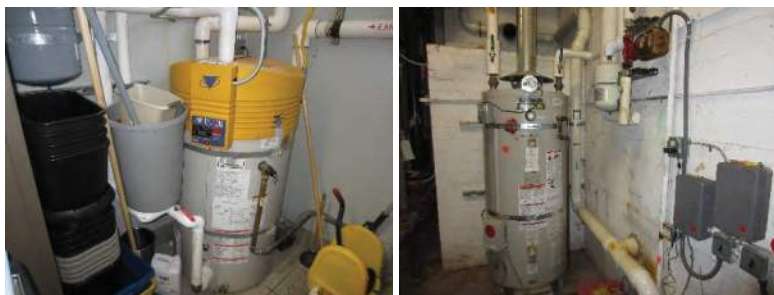
There are two gas-fired tank type domestic hot water heaters to provide domestic hot water for the whole school. One is located in the main building boiler room, and it's a 100-gallon A.O. Smith gas-fired tank heater with 199,000 Btu/hr. of heating capacity that was installed in 2004; the other unit is a 60-gallon A.O. Smith gas-fired tank heater with 125,000 Btu/hr. of heating capacity that was installed in 2002.

- Control upgrade for classroom building \$75,000
- Replace old DHWs \$60,000
- Replace plumbing pipe between buildings \$55,000

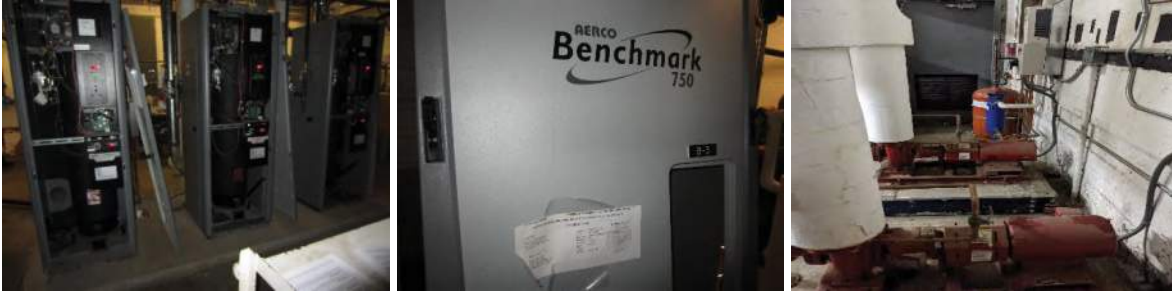
The whole HVAC system was upgraded in a 2013 renovation project. The main building currently has one central heating system that consists of three Aerco gas-fired condensing hot water boilers with an input heating capacity of 750,000 Btu/hr each.

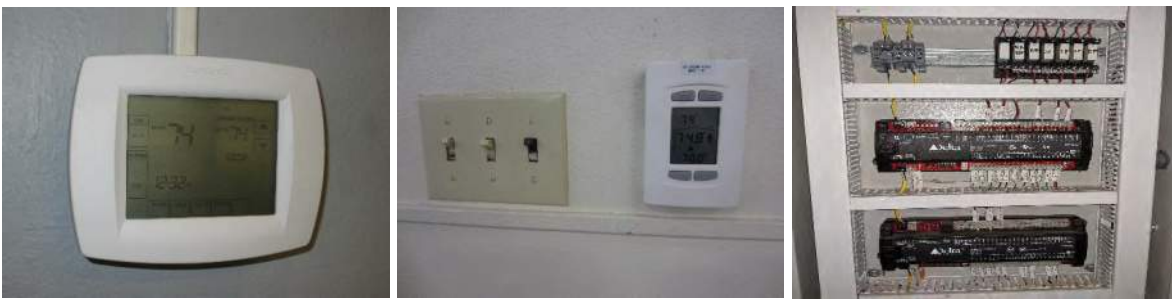
The HVAC control system was upgraded as part of the 2013 project. The main building has a Delta DDC control system that is tied into the district-wide BAS to control all the major HVAC equipment. The separate classroom building has stand-alone programmable thermostats that control the 10 RTUs.

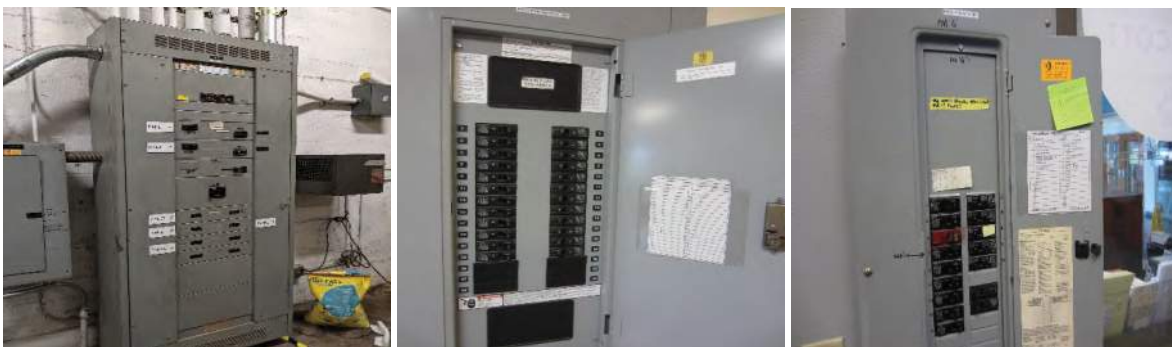
The school's main distribution panel is in the boiler room and was upgraded in 1987. It's a 1200 A 120/208 V three-phase 4-wire Siemens I-T-E switchboard that provides electrical service for the whole school. Most of the subpanels were upgraded as part of 2013 project and those observed in the walk through have enough space for current conditions.

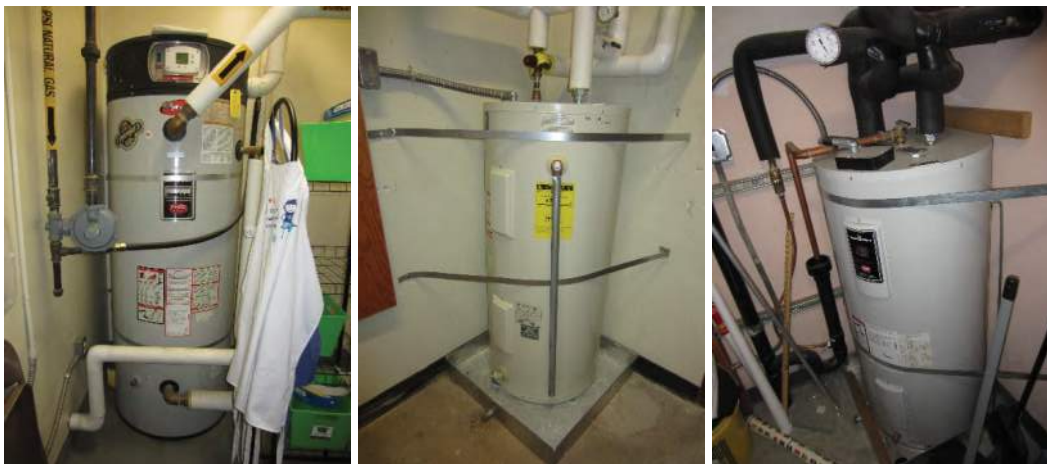
There are a total of five (5) domestic hot water heaters to provide domestic hot water for the whole school. The major one is a 100-gallon Bradford gas-fired tank type heater with 199,999 Btu/hr. of heating capacity. It was installed in 2013 and is located in the kitchen area to serve the majority of the school's hot water. The other four (4) are tank type electric hot water heaters installed in 2013 to serve specific areas.

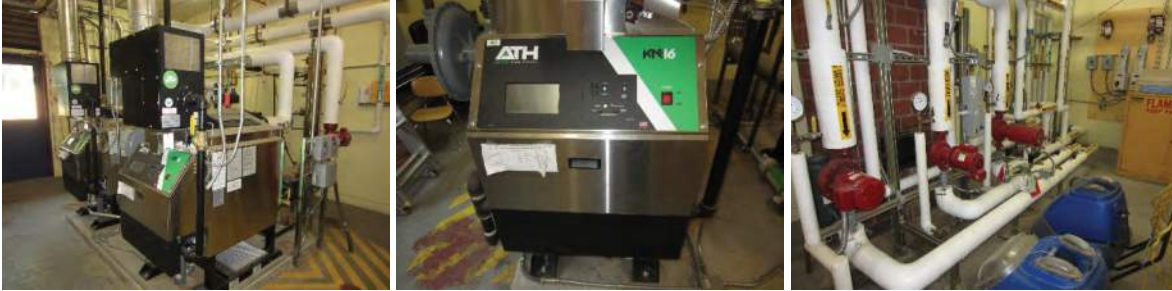
There is one central heating system that consists of two Advanced Thermal Hydronics gas-fired condensing hot water boilers with an input heating capacity of 1.6 MMBTU each that were installed in 2013. New heating water pipe for whole school was installed at the same time.

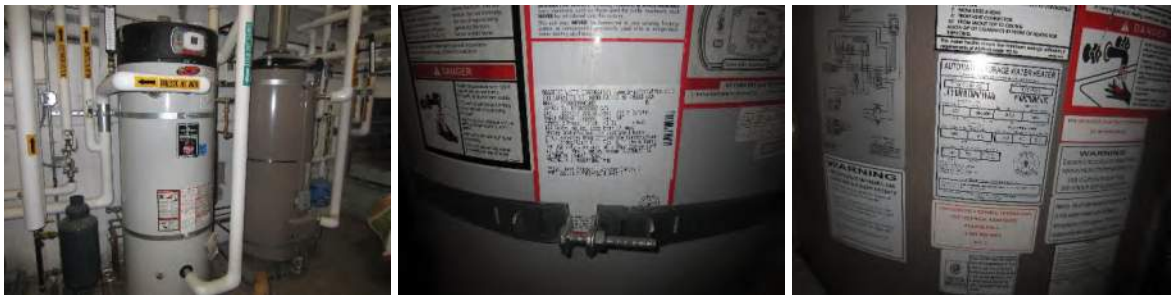
There are two gas-fired tank type domestic hot water heaters located in the boiler room to provide building hot water. One unit is a 100-gallon American Standard gas-fired tank heater with 199,000 Btu/hr. of heating capacity that was installed in 2009. The other unit is a 100-gallon Bradford gas-fired tank heater with 199,999 Btu/hr. of heating capacity that was installed in 2013.

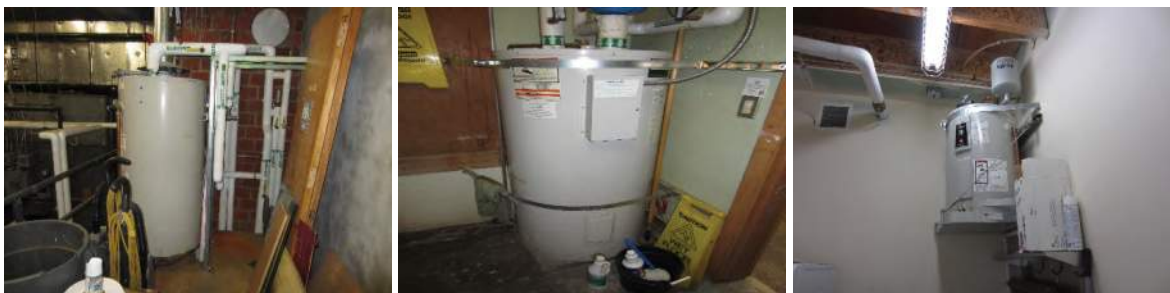
There are three domestic hot water heaters to provide domestic hot water for the school. The major one is a 100-gallon A.O. Smith gas-fired tank type heater with 199,000 Btu/hr. of heating capacity installed in 2003. It is located in the boiler room and provides hot water for the kitchen and north wing of the school. One 80-gallon A.O. Smith electric tank type heater with 3 kW of heating capacity was installed in 2013 and is located in a custodial room. It provides hot water for the south wing. One 30-gallon Bradford electric tank type heater with 4.5 kW of heating capacity was installed in 2013. It provides hot water for the new multi-purpose room.

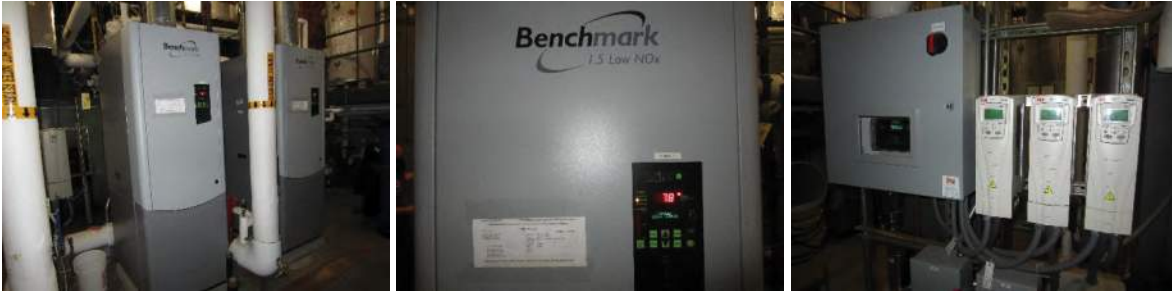
There is one central heating system that consists of two Aerco gas-fired condensing hot water boilers with an input heating capacity of 1.5 MMBTU each that were installed in 2013. They provide heating for the majority of the school.

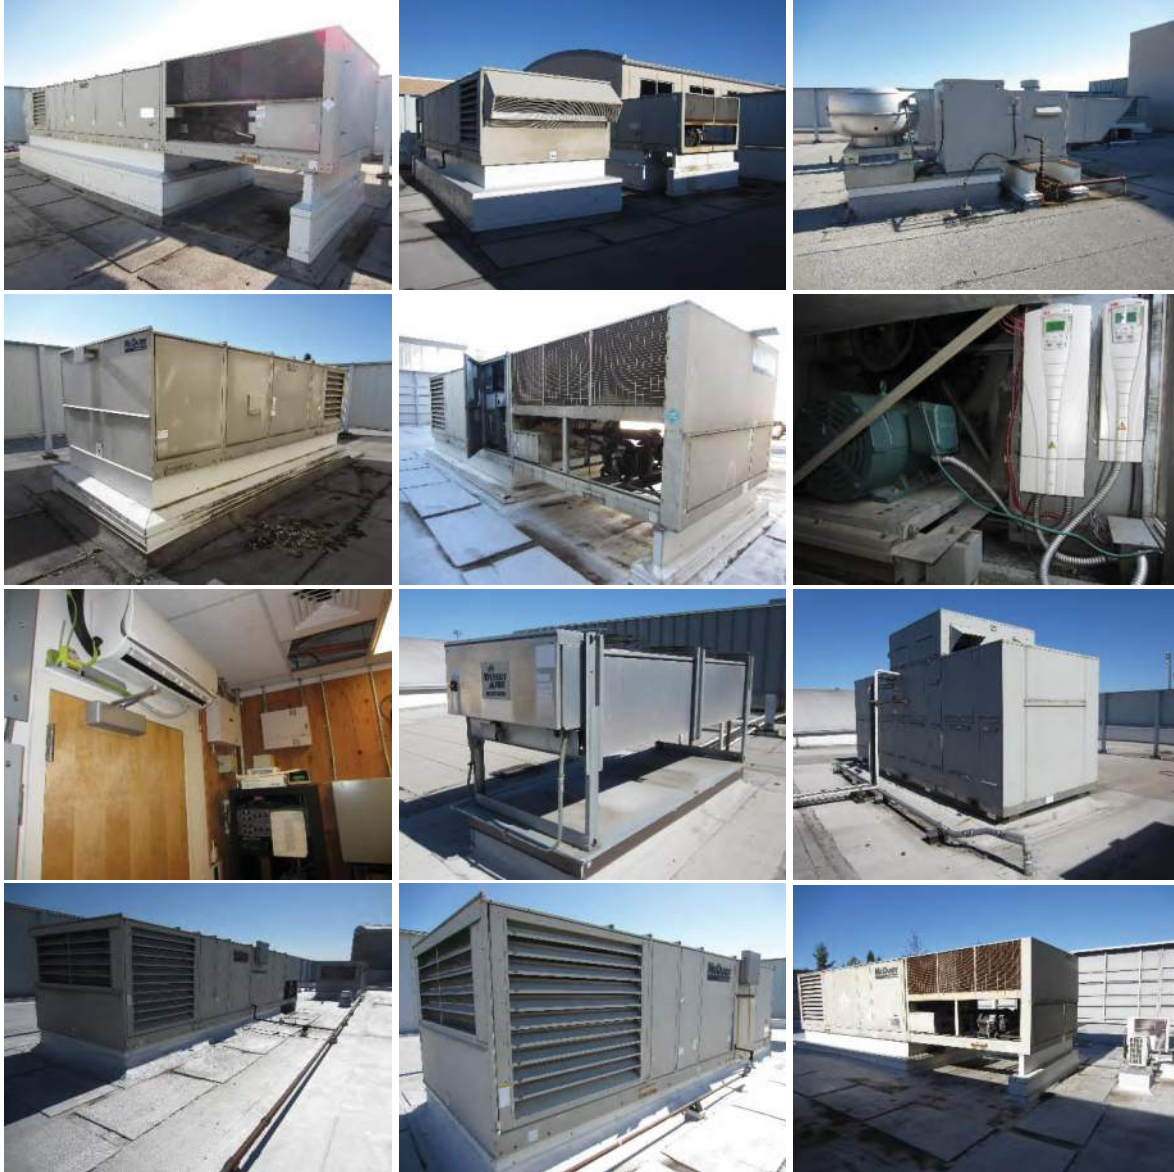
The main building has 18 rooftop units (RTUs) installed between 1996 and 1997, but the unit that serves the indoor pool was replaced 12 years ago. They provide space heating, cooling and ventilation. Eight RTUs have gas-fired furnaces as heating source. Seven RTUs are constant volume units and the other 11 RTUs are variable volume that use inlet guide vanes to modulate air flow based on space load. Those 11 VAV RTUs have terminal VAV boxes with hot water reheat coils connected to the central heating system. The district is working with a contractor to replace the existing inlet guide vanes with VFDs to provide better flow control and save energy. Only 14 out of the 18 units have cooling capacity. The RTUs that serve the student center, kitchen and weight lost cooling capacity due to compressor issues. The remote air-cooled condensing unit to cool and dehumidify supply air currently is not working.

| • Old RTU replacement for main building | \$3,200,000 |

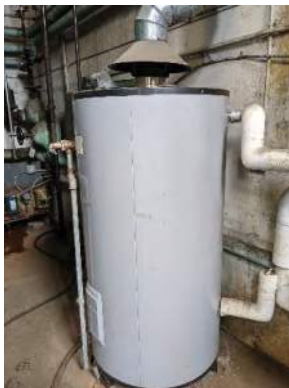
There is one gas-fired State Industries 100-gallon tank type domestic hot water heater located in the boiler room that was installed in 1994 with a heating capacity of 199,990 Btu/hr. This unit is beyond its useful life expectancy and is recommended to be replaced with a new unit.

- Replace existing DHW \$30,000

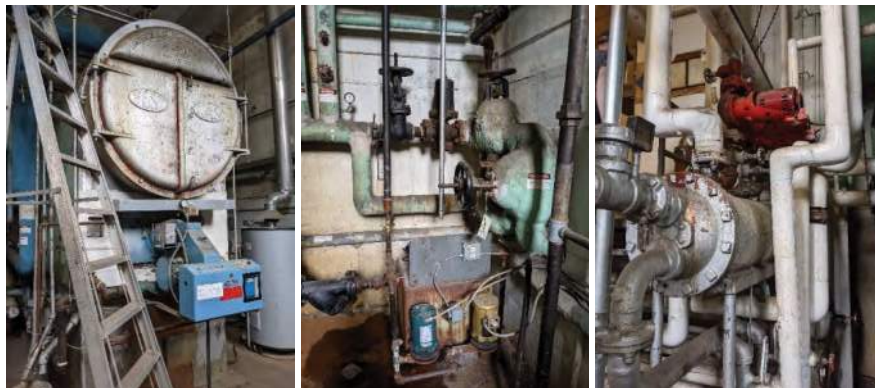
There is one central heating system for the majority of the building that consists of one original gas-fired low pressure steam boiler located in the boiler room. Steam is used directly in fan systems and fin tube radiators. In addition, there is a steam-to-hot water converter in the boiler room to provide heating hot water to floor radiant

panels, but the district maintenance team reports there were some leaking issues in the system so it was shut off. Therefore, some of the spaces do not have floor heating to maintain space heating setpoint during peak winter season. The main office area is served by steam radiators. A heating system replacement is recommended.

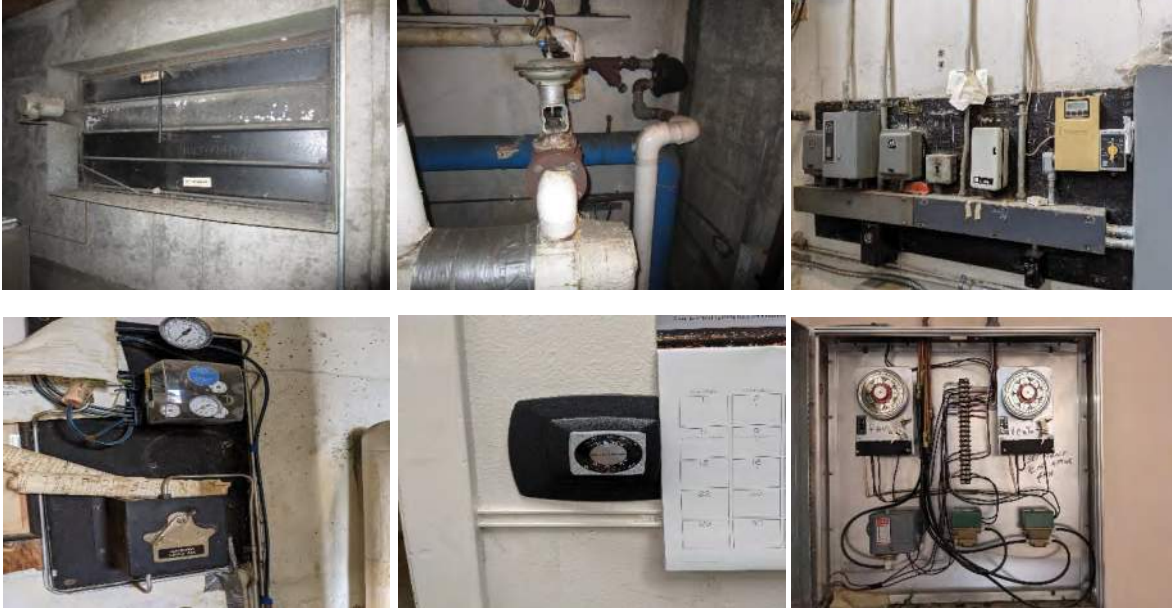
The majority of the existing control system is the original pneumatic system, and it appears minimal Honeywell electronic controls were installed in the 1996 upgrade to provide scheduling control. Some local thermostats are in disrepair. Overall, the control system is in poor condition and a new DDC control system upgrade is recommended in addition to the mechanical system replacement.

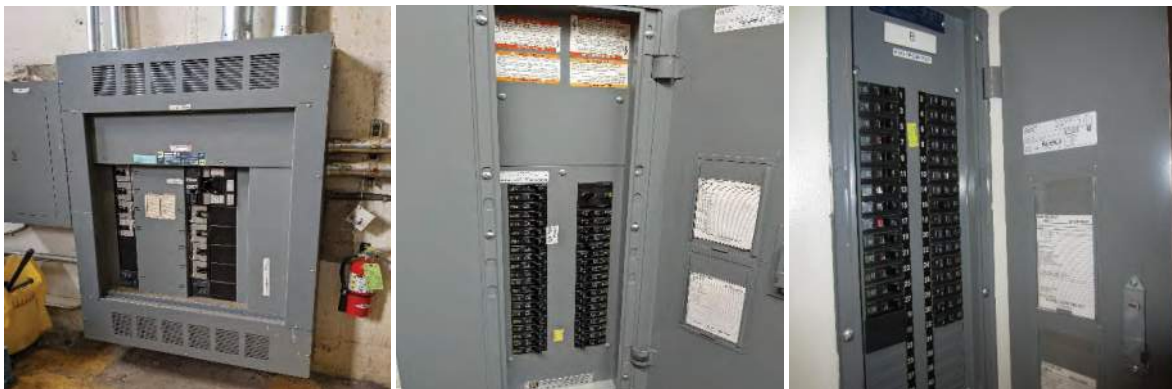
The main electrical panelboard is located in the boiler room and was replaced in the 1996 renovation project. The current distribution panel is 800 A 208/120 V three-phase 4-wire panelboard (Square D). There are some old electrical panels that were noticed during the visit, but overall the power infrastructure is sufficient to support the current building condition.

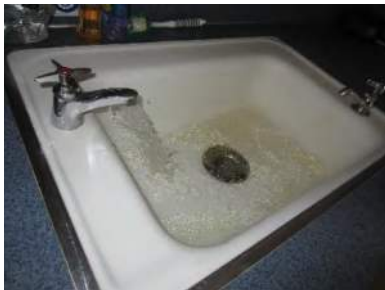
The school uses the city water and sewer system. Most of the plumbing fixtures are original with high water usage. The water from the tap flows dusty yellow, which indicates that the existing plumbing piping system is corroded. A plumbing system replacement is recommended.

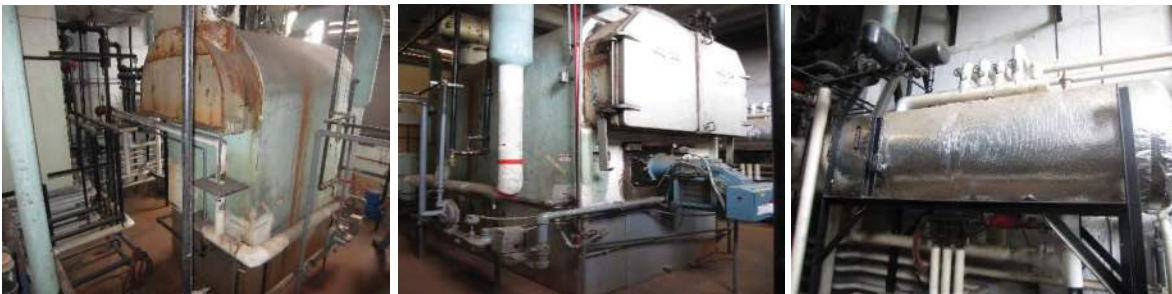
There is one central heating system for the majority of the building that consists of one original Birchfield gas-fired low pressure steam boiler located in the boiler room. Steam is used directly for coils in fan systems and fin tube radiators. The steam is also converted to heating water in the boiler room with a heat converter and pumped to floor radiant panels. Per the district maintenance team, there were some leaking issues in the floor radiant panels so those heating water loops were shut off for certain locations. Therefore, some of the spaces do not have floor heating to help maintain space heating setpoints during peak winter season. A heating system replacement is recommended.

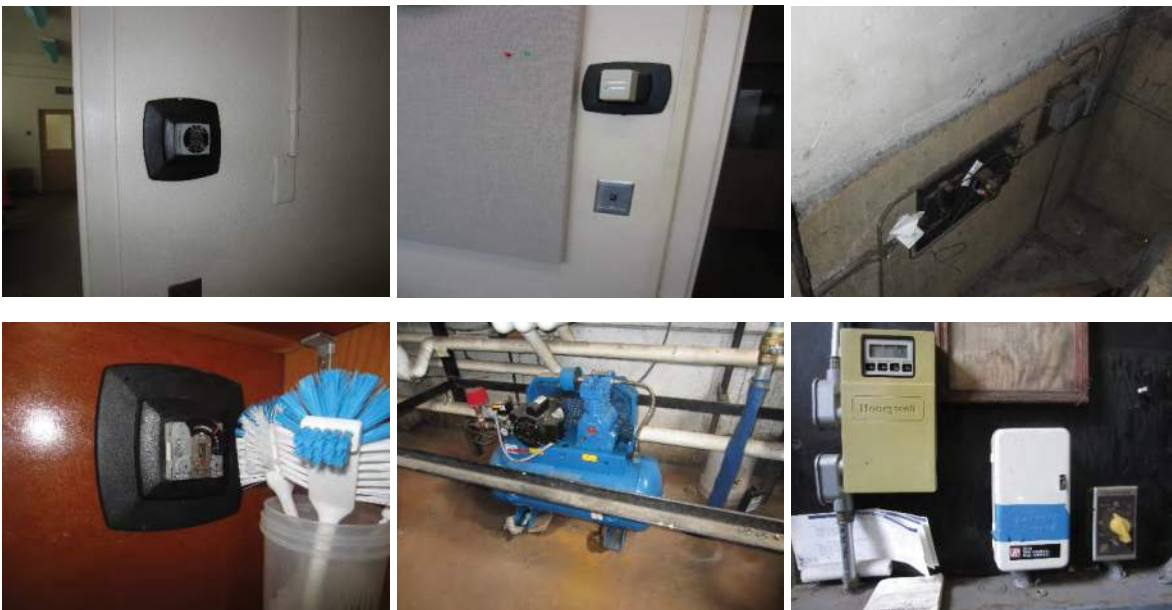
The majority of the existing control system is the original pneumatic system and minimal electronic controls were installed for scheduling major equipment operation. All of the window ACs are controlled manually. Overall, the control system is in poor condition and a new DDC control system upgrade is recommended in addition to the mechanical system replacement.

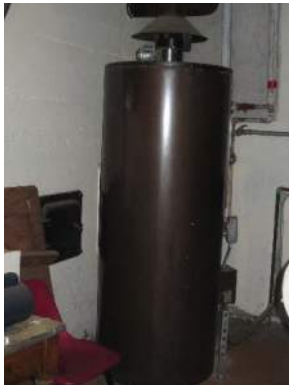
There is one gas-fired State Industries 100-gallon tank type domestic hot water heater located in the boiler room that was installed in 1991 with a heating capacity of 199,990 Btu/hr. This unit is beyond its useful life expectancy and it is recommended to replace it with a new unit.

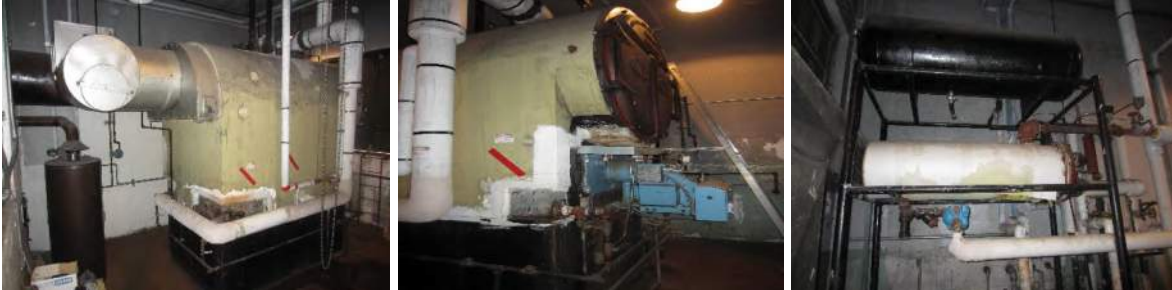
tube radiators. The steam is also converted to heating water in the boiler room with a heat converter and pumped to floor radiant panels. Per the district maintenance team, there were some leaking issues for floor radiant panels serving the south section of the school so the heating water loops were shut off to that section. Therefore, some of the spaces do not have floor heating to maintain space heating setpoints during peak winter season. A heating system replacement is recommended.

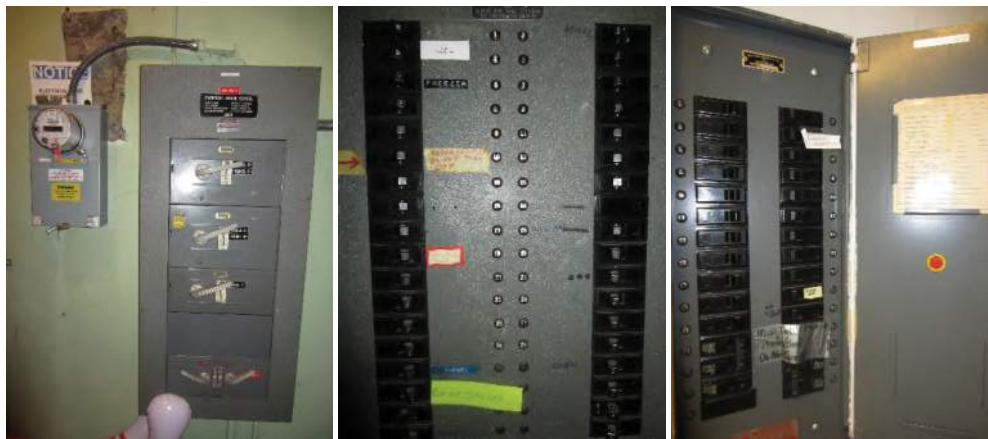
The main electrical panelboard is located in the boiler room and is the original one. The current distribution panel is a 400 A 480 V three-phase panelboard working with local transformers to provide electrical service for the whole building. Some old electrical panels were noticed during the visit. Overall, the power infrastructure is sufficient for current conditions but replacement of the old panels is recommended.

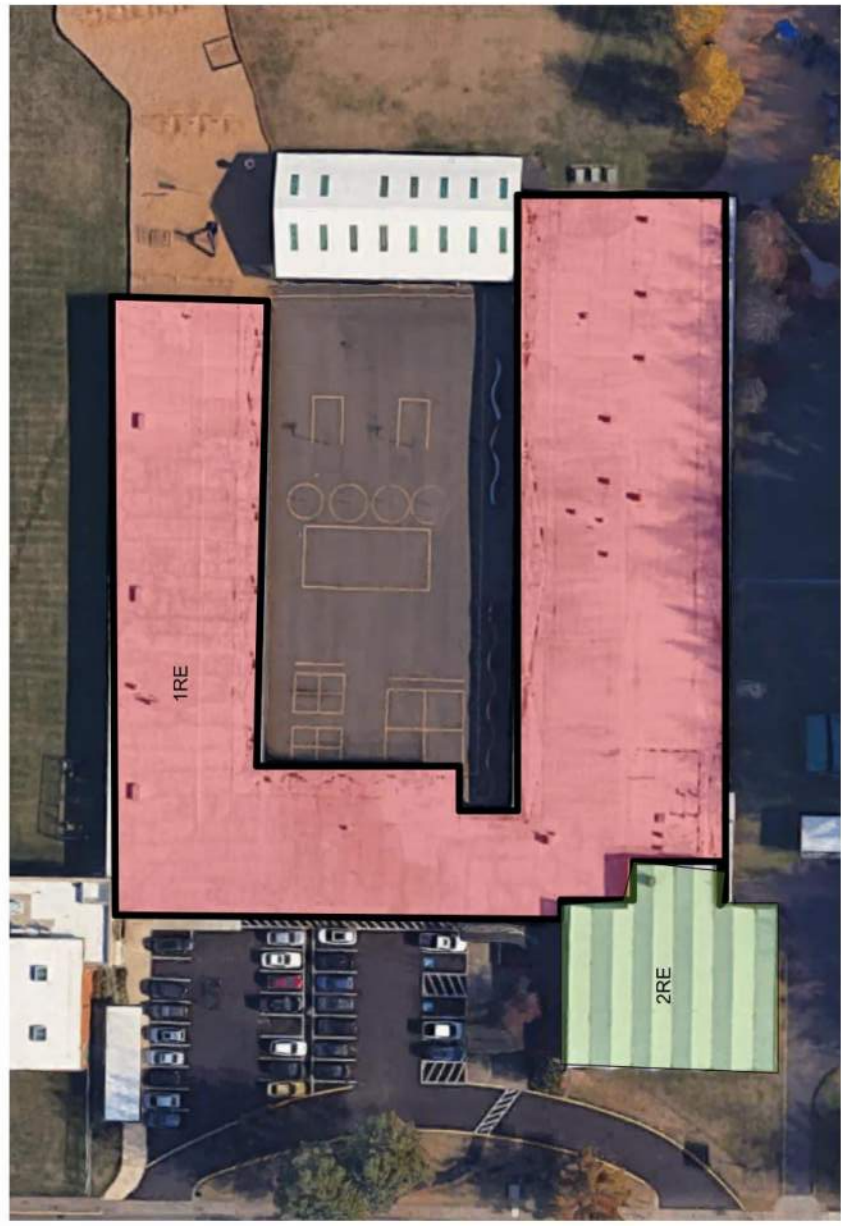
Russel Elementary

| Color | Existing | Scope | Action Years | Estimated Cost | Expected Life |
|---|---|---|---|---|---|
| | Bur<br><b>1RE</b> | New Roof | N/a | | 25 |

| Color | Existing | Scope | Action Years | Estimated Cost | Expected Life |
|---|---|---|---|---|---|
| | BUR/Coating<br><b>2RE</b> | Replace/retrofit | 2027 | \$145,000 | 30 |
