Re: Bleacher Inspection for Pana CUSD #8
BLDD Project No.: 151EF27.200

BLDD Architects, Inc. conducted an inspection of the Pana High School and Junior High School indoor and outdoor bleachers. The following information is based on the conditions at the time of the inspection and is subject to change. This Bleacher Inspection includes the inspection of all indoor and outdoor bleachers, the operation of the indoor telescoping bleachers (from stored to fully extended), checking the condition of the substructure (angle iron, fasteners and attachments, rollers and operators), the condition of the seat boards, foot boards, supports, connections, handrails and steps. The result of the inspection is as follows:

Pana High School Football Field Bleachers

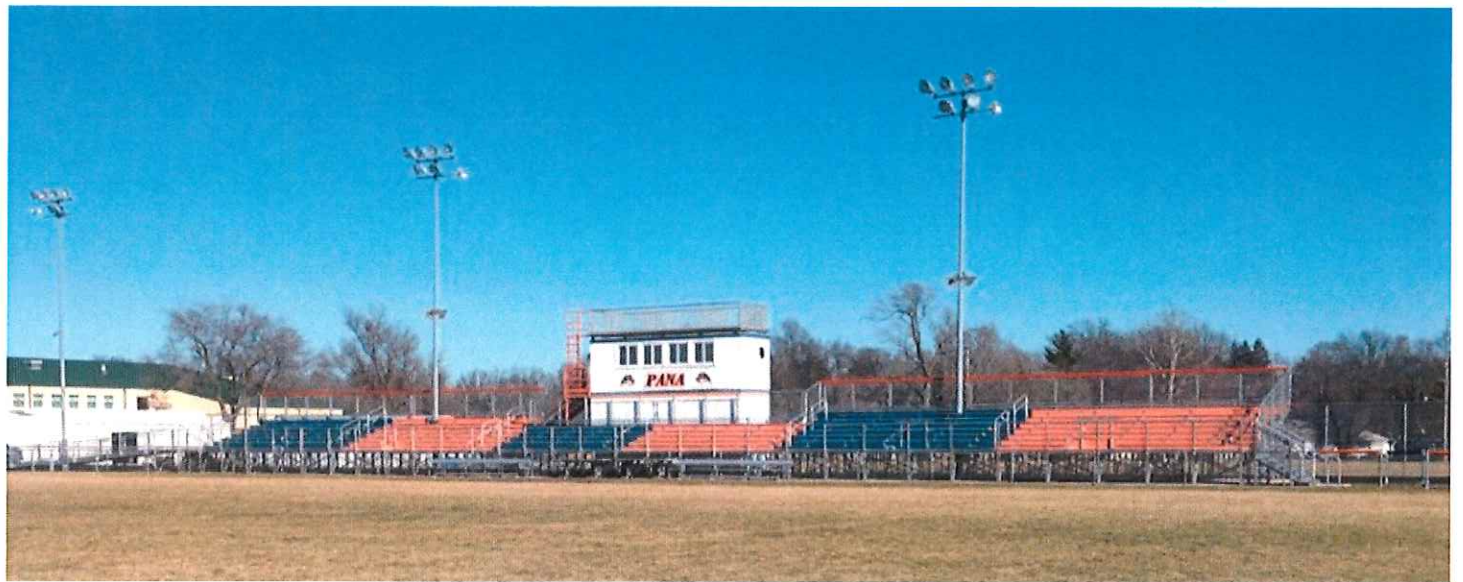
IMAGE A-1
DATE: 02/04/16
Football Field - Home Bleacher

1. The "Home" side bleachers located on the east side of the football field consists of a fixed, 7-row aluminum bleacher system. (See photos A1 – A11).

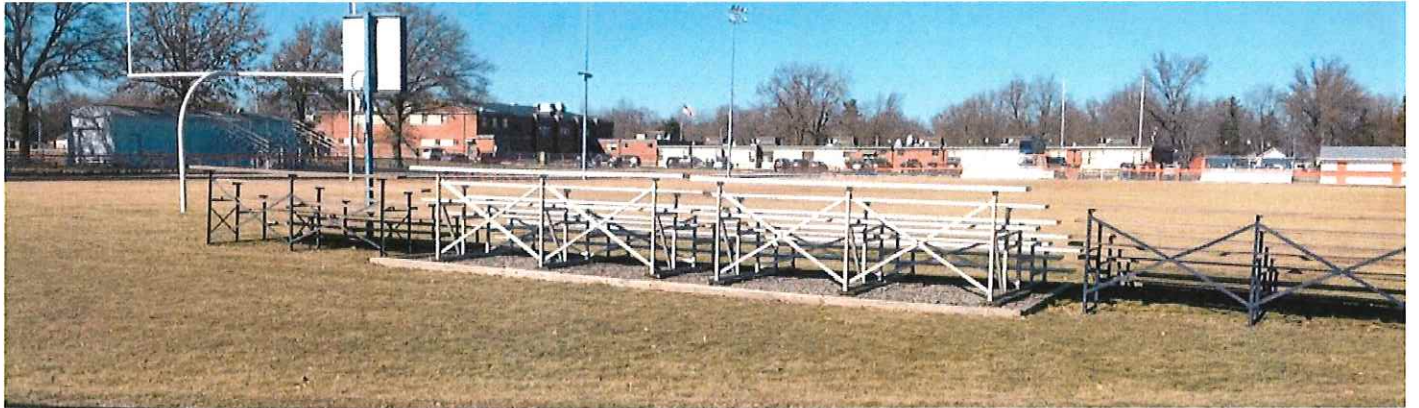
IMAGE A-29
DATE: 02/04/16
Football Field - South Bleacher

- d. No issues were found with the aluminum bleacher system.
4. The south end zone bleachers consist of two (2) fixed, 5-row aluminum bleachers and two (2) steel frame (5) row bleacher with wood seats and wood foot boards. (Images A27 – A29)

- a. Addition of intermediate supports to the wood seats and foot boards is recommended.
 - b. The two sets of aluminum bleachers are sitting tight together, but are not level or even with each other resulting in a potential trip hazard transitioning from one set to the other. (Image A28).

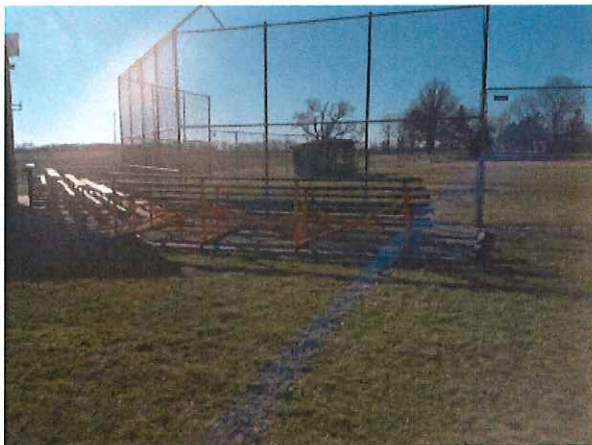
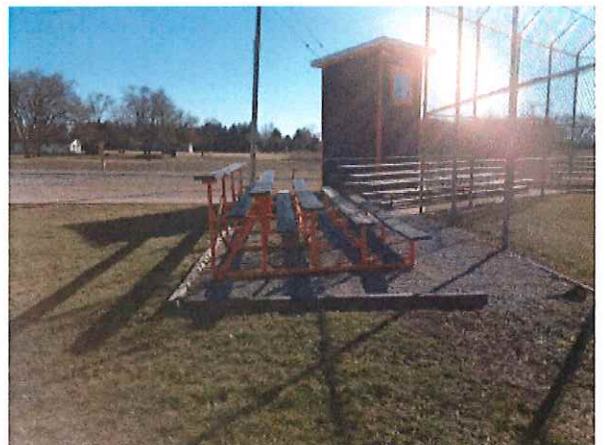
IMAGE A-30
DATE: 02/04/16
Baseball Field - 1st Base Line Bleacher

1. The baseball field bleachers consist of Three (3) fixed, 5-row steel frame bleachers, with wood seats and wood foot boards. (Images A30- A36).
 - a. The first base line bleachers are out of level. Re-set bleachers to level.
 - b. Replace any cracked or damaged wood seats or foot boards.
 - c. The addition of intermediate supports to the wood seats and foot boards is recommended.
 - d. The third base line bleachers are sitting directly on grade with no wood sleepers, and the bottom rails have become partially submerged. Install wood sleepers.

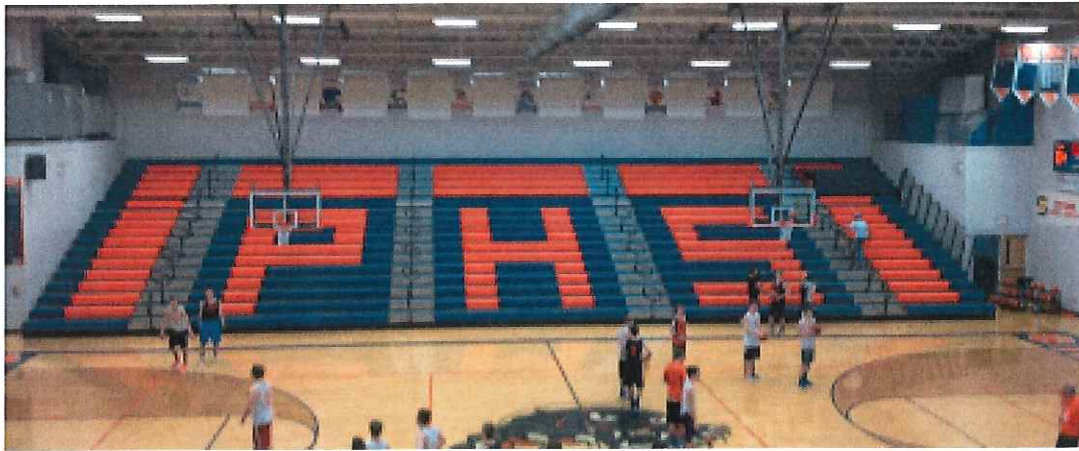
IMAGE A-37
DATE: 02/04/16
High School Gymnasium South Bleacher

1. The High School Gym bleachers consist of five (5) sections, seventeen (17) rows high on the south side and eighteen (18) rows high on the north side. Both sides are electrically operated telescoping bleachers. It is recommended that all moving parts be cleaned and lubricated. (Images A37-A38).
 - a. Replace all worn anti-skid strips on bleacher Steps.
 - b. Lubricate all moving parts.

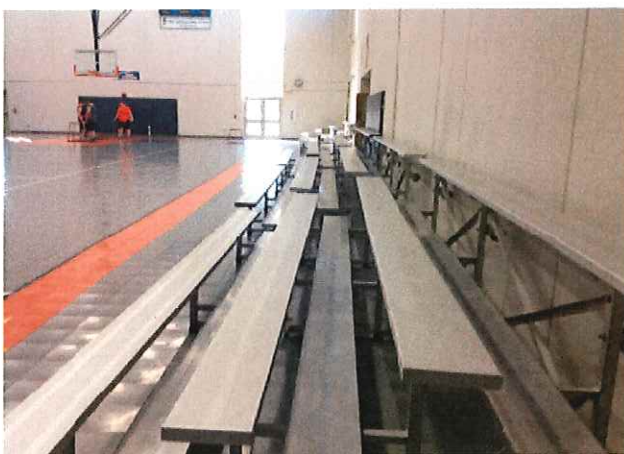
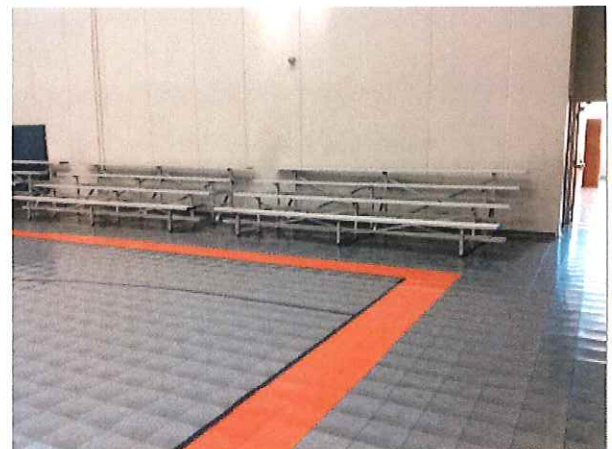
IMAGE A-39
DATE: 02/04/16
High School Practice Gymnasium Portable Bleachers

1. The High School practice Gym has five (5) fixed bleachers. They consist of one (1) section, four (4) rows high. (Images 39-41).
 - a. Two of the portable bleachers have bent posts at the bottom seat row, resulting in un-level seats at the bottom row. (Image-40)
 - b. Replace all bent / damaged seat board end caps. (Image-41).
