# EROSION & SEDIMENTATION MITIGATION

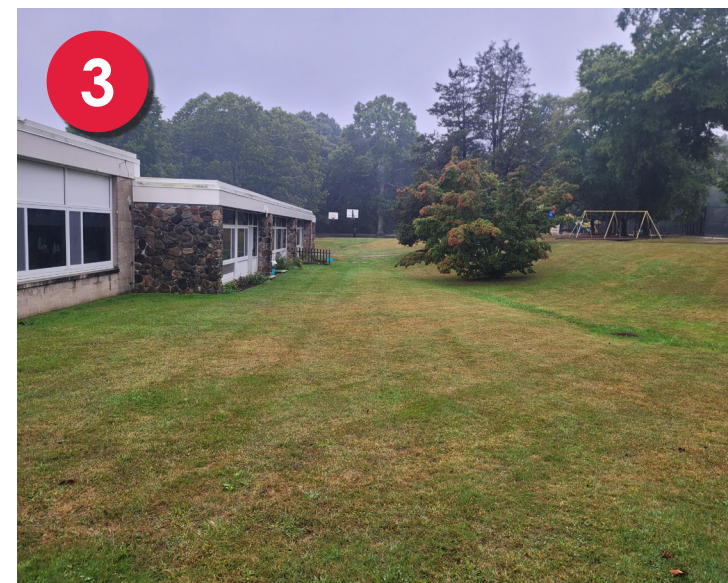
**Biofiltration Swale**  
Drainage Area 1

**Priority: Med/High**

Biofiltration swale was not installed at this location. The walk at this location has been repaved since 2011

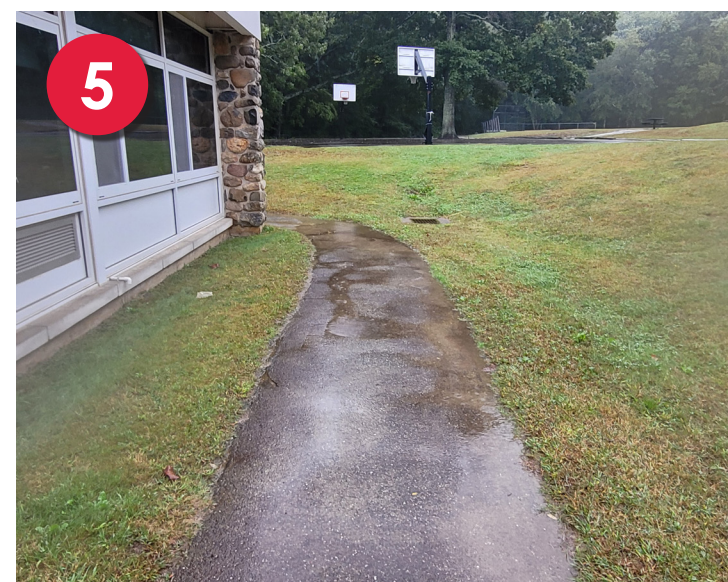
**Biofiltration Swale**  
Drainage Area 1

**Priority: Med/High**

Biofiltration swale has not been installed at this location.

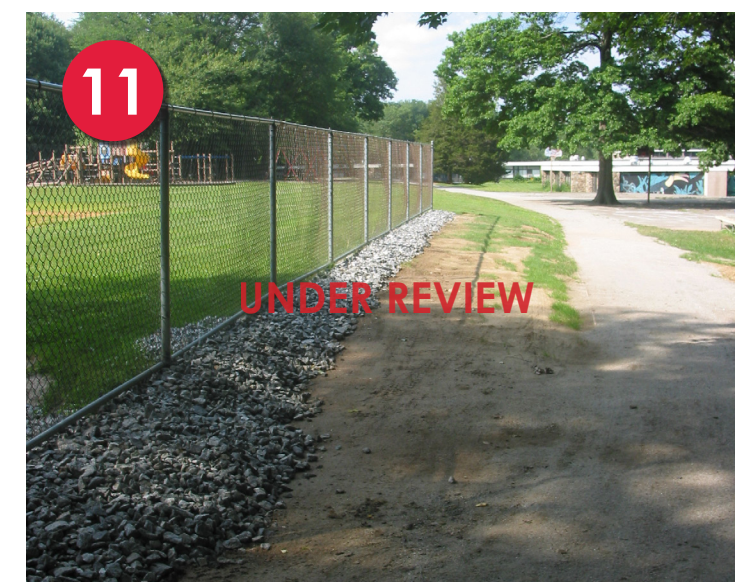
**Formalize Walk  
Revegetate Slope  
Biofiltration Swales**  
Drainage Area 1

**Priority: Med/High**

A formalized walk to the playground has been installed at this location. Ornamental shrubs and bioswale have not been installed per 2011 recommendation. Bare spots remain at this location

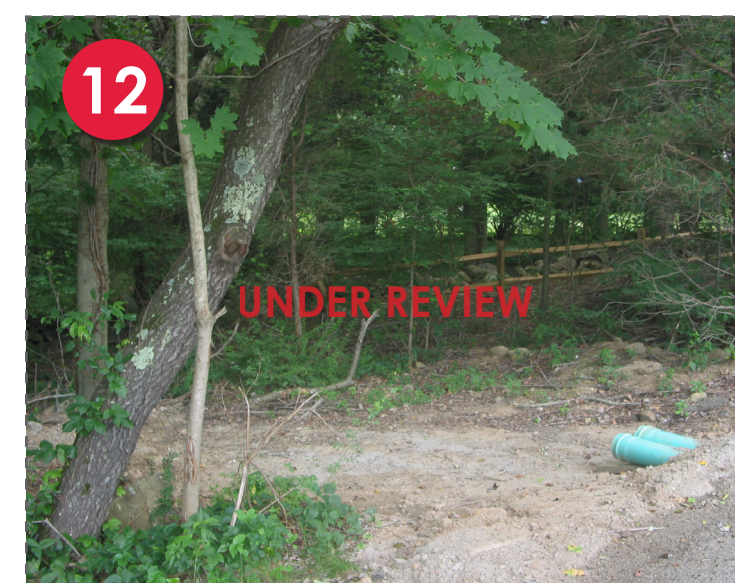
**Establish Gravel Edge  
Biofiltration Swale**  
Drainage Area 1

**Priority: High**

AOC ES 11 was not verified during 9/25/2023 visit.

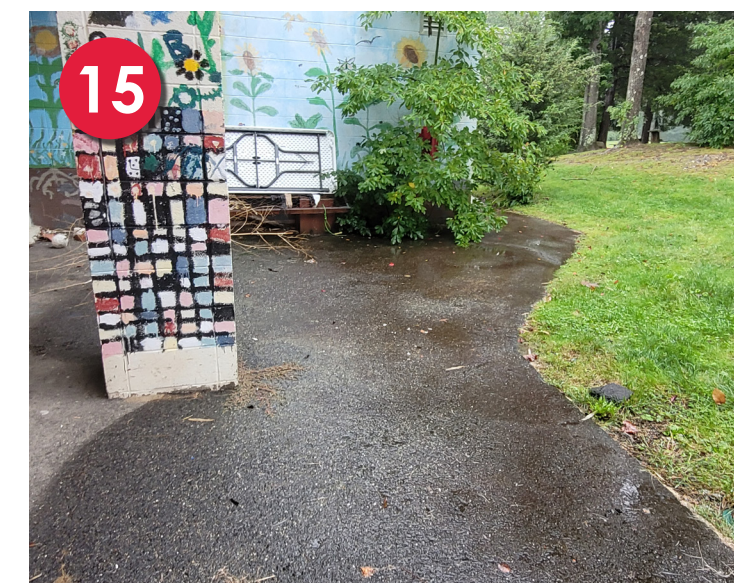
**Establish Gravel  
Gathering Area  
Revegetate Slopes**  
Drainage Area 1

**Priority: High**

A formalized gathering / volleyball area has not been established. Evergreen groundcover and native shrubs have not been installed. Portions of this area remain bare and erodible.

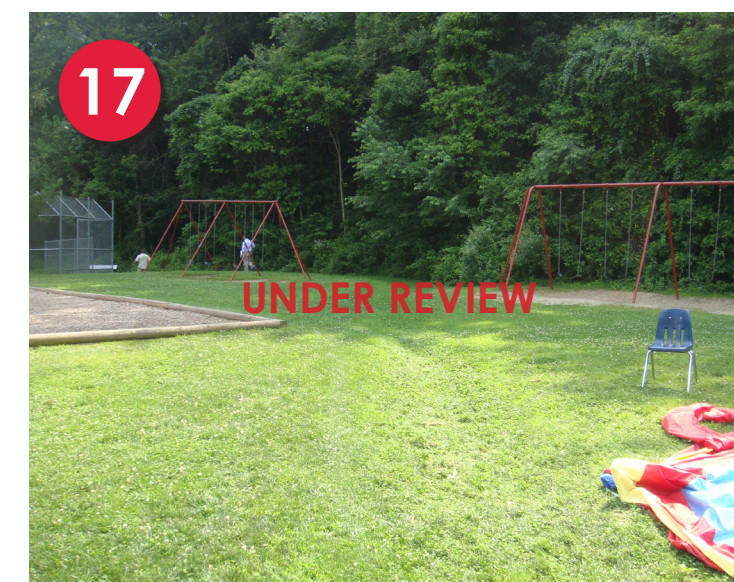
**Rain Garden**  
Drainage Area 1

**Priority: High**

Rain garden has not been installed at this location. Catch basin invert appears unchanged with no dome top frame. Major sedimentation and ponding was observed at this location during 9/25/2023 visit.

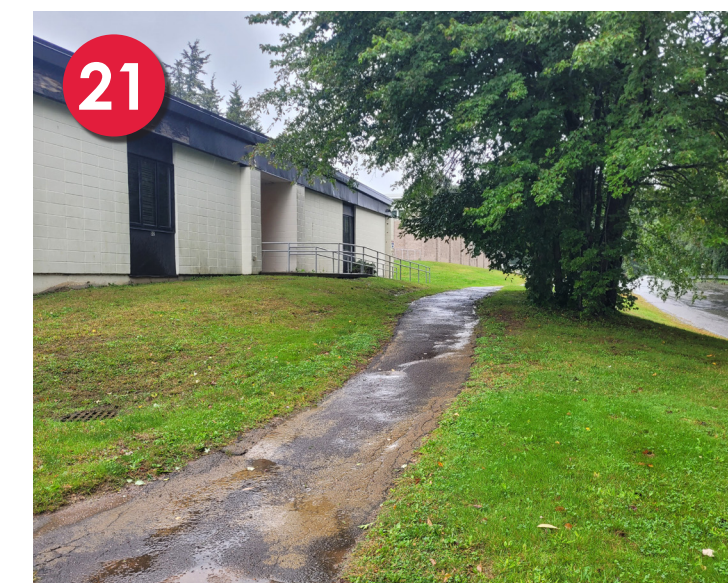
**Revegetate Slope**  
Drainage Area 4

**Priority: Low**

Evergreen groundcover and native shrubs have not been installed at this location.

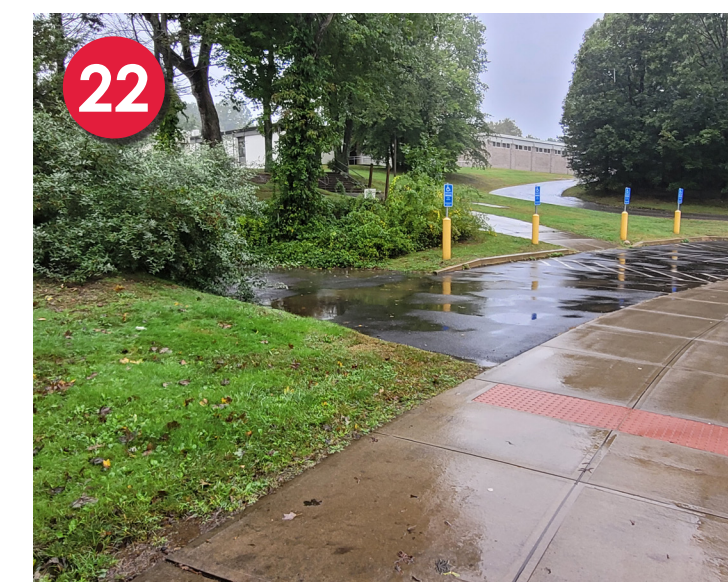
**Biofiltration Swales**  
Drainage Area 4

**Priority: Med**

Biofiltration swales have not been installed along the existing drive at this location.

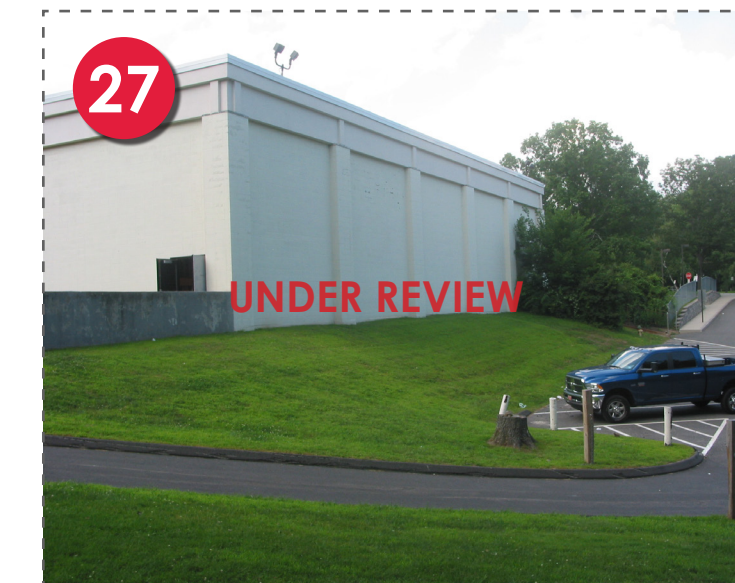
**Biofiltration Swales**  
Drainage Area 5

**Priority: Med/High**

New concrete walk has been installed at this location since 2011. Biofiltration swales have not been installed along new walkway.

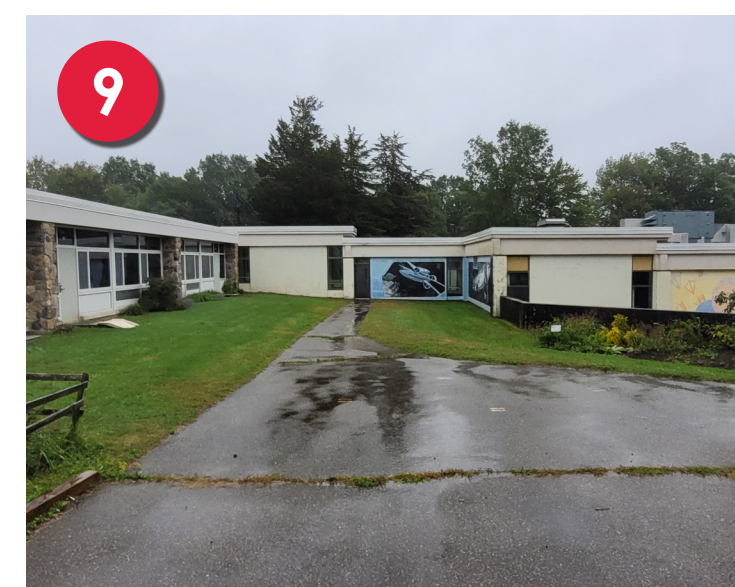
## Pavement Repair Drainage Improvements

Priority: Med

Ponding was observed at this portion of walk. Provide swale to nearby drain. Reset and lower basin. Repave as required.

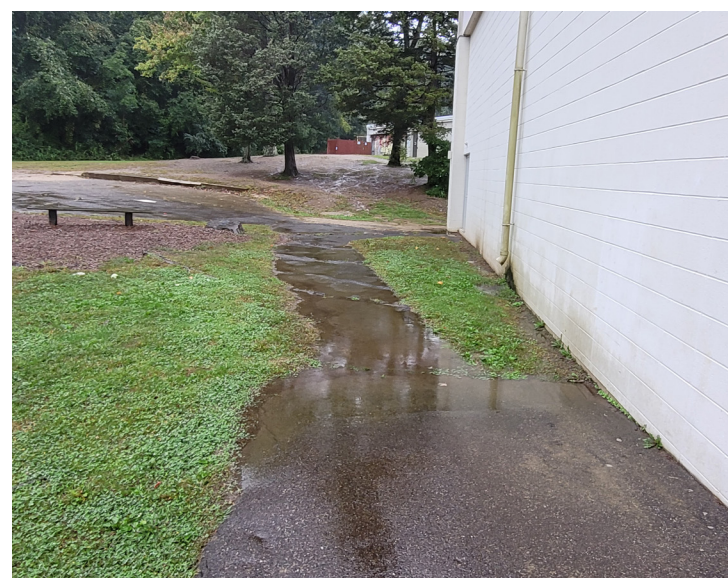
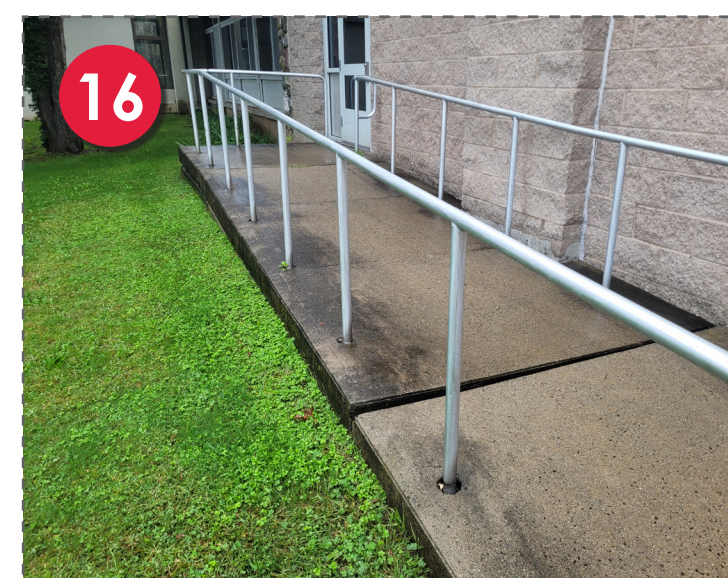
## Ramp Repair

Priority: High

Heaving of concrete ramp was observed creating a tripping hazard / accessibility issue. Repair ramp.
