Badger School District ISD #676

Facilities
Assessment

June 2021

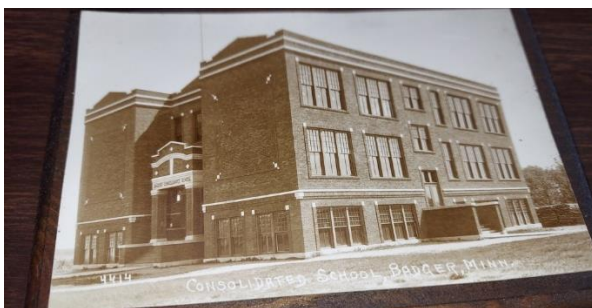
3: The original 1916 school burned down in 1986

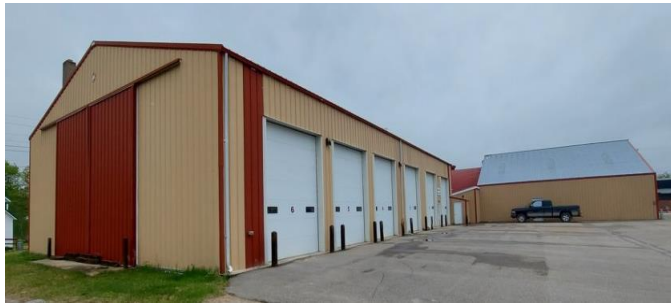
10: Bus Garage

The bus garage building doesn't have many large needs, as it's in good condition overall. However, there are a few items that should be addressed. The garage door on the Quonset hut is quite large and is opened manually. Currently, the Quonset hut houses another bus that is used often, so installing a garage door opener would be beneficial. Also, the site slopes into the north side of the west side garages. This has led to water infiltration into the office. Maintenance has used foundation tar to seal this up. There is a sloped trough area in front of the bus garage stalls that diverts water to the north. Sloped paving could be added to the north side of the west side garages to redirect the water to the sloped trough to carry water away from this corner.
