Geneva CUSD 304 5-Year Capital Improvement Plan 2013

Geneva Community Unit School District #304

March 11, 2013

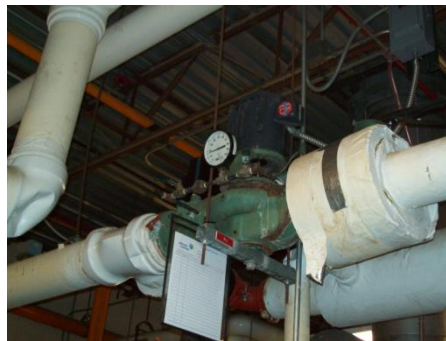
Primary Boiler Pump

Original to the building. Need replacing with energy efficient design and variable frequency drives for increased energy efficiency.
