NORTHWEST ARCTIC BOROUGH SCHOOL DISTRICT

Property Services

February 2026

Preventive Maintenance Site Visit Report

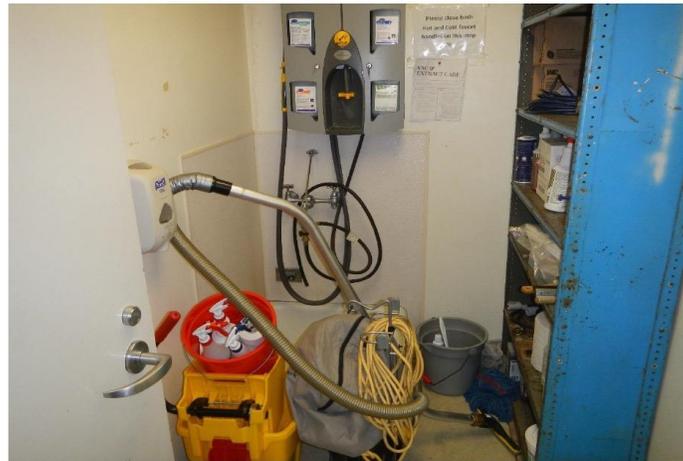
Areas needing improvement were also identified. Mechanical rooms and custodial closets were cluttered and disorganized, and preventive maintenance did not appear to be consistently completed. At the Kisimigiutq School in Kivalina, which has been open for just over two years, several required preventive maintenance tasks are clearly not being performed. Examples include emergency eyewash stations without water supply, wastewater treatment plant screens and filters not being cleaned or replaced, and one boiler that has not operated since the school opened.

Figure 11 Custodial closet

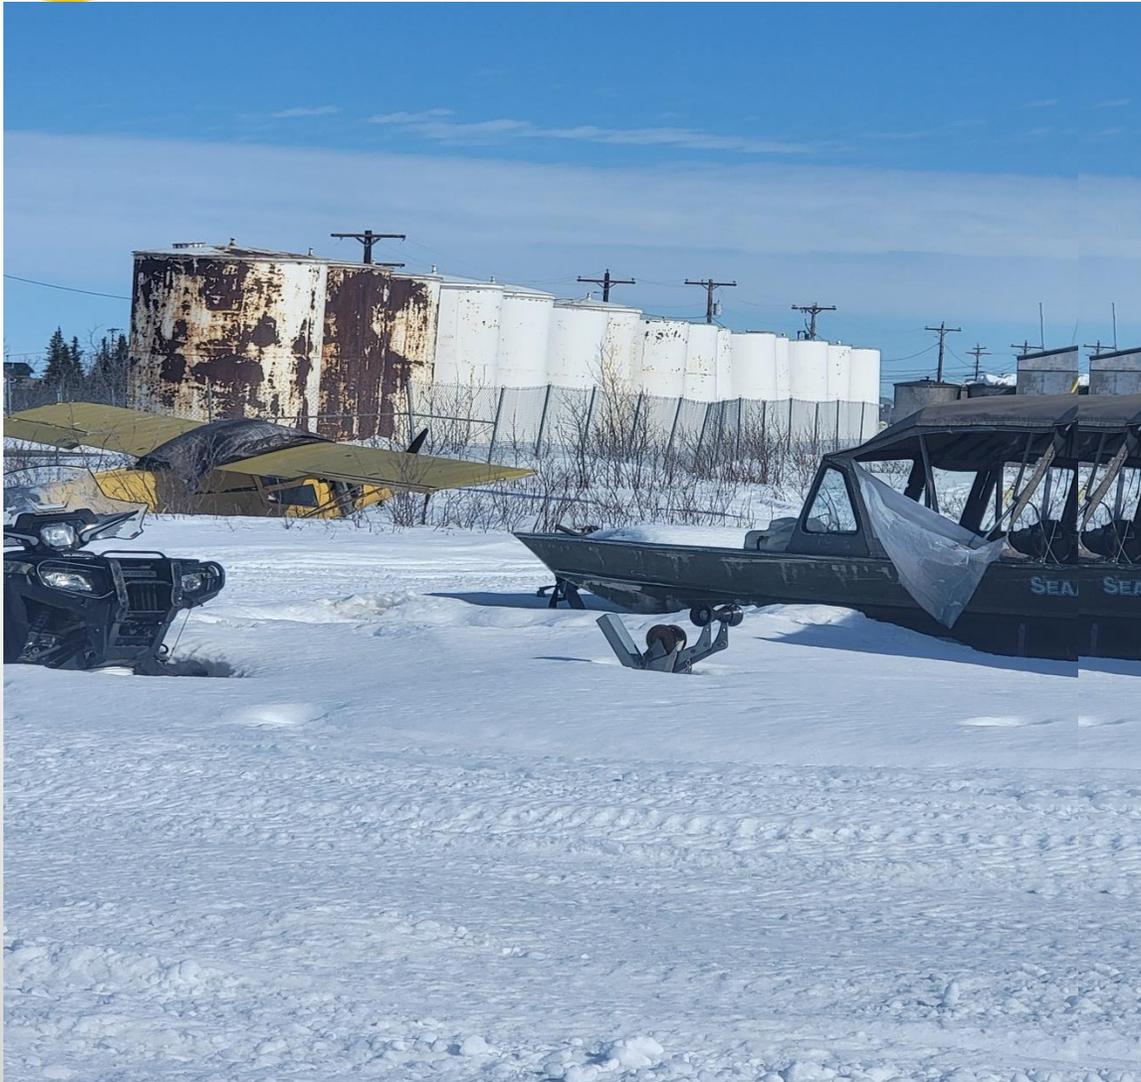
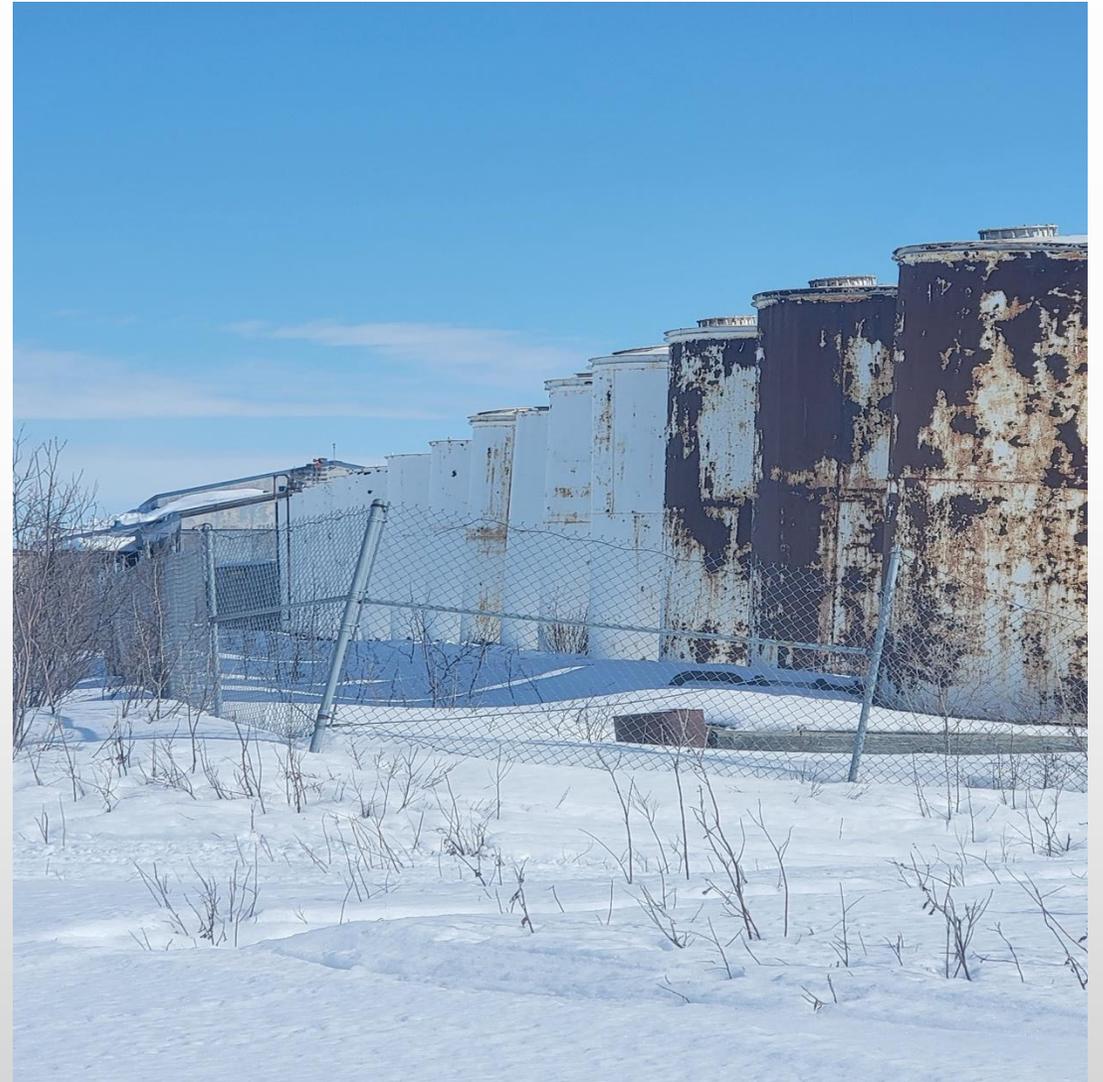
Noatak Tank Farm needing future removal
