## NORCOAST MARINE SURVEYORS, INC.

**SURVEY / APPRAISAL #** 1194680  
**DATE OF INSPECTION:** 9/5/2019  
**DATE OF REPORT:** 9/10/2019

**SUBJECT PROPERTY:** Southeast Islands School District residential float house  
(Formerly the Southeast Islands School District Administration Building and the J. R. Gildersleeve Floating School)

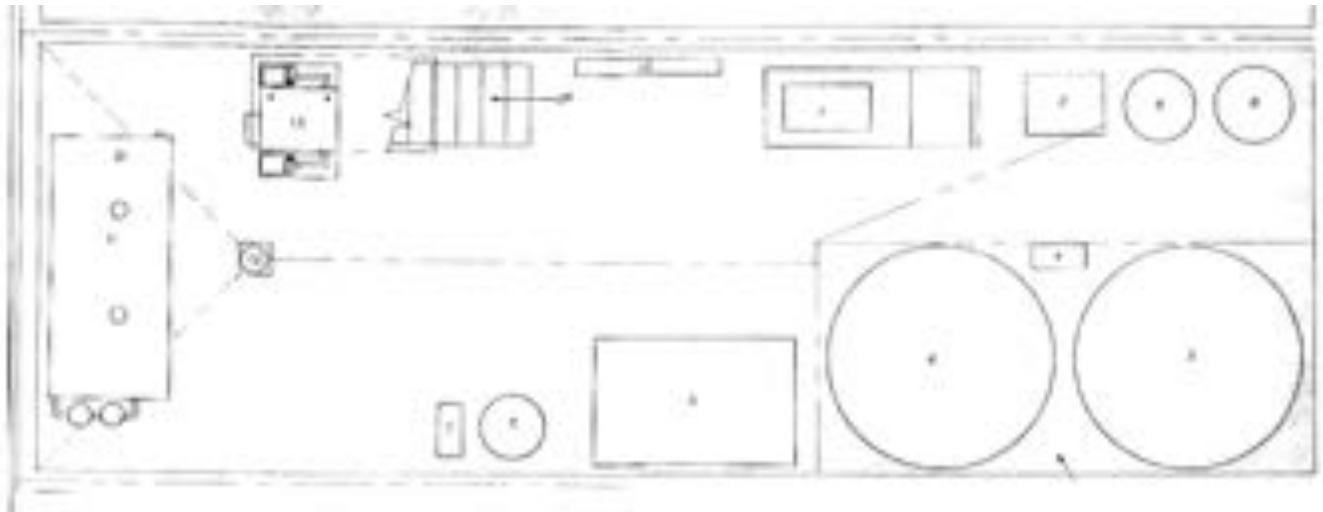
LAYOUT - Mechanical Room

Entered from left (South) side, down stairs (left of center, top). MSD at left and upper left, potable water pump and accumulator left of center bottom, treated and untreated water tanks right bottom, electrical panels center top, generator to right, space heater and water heaters right top. See photos below.

A deficiency in the form of weeping and alkaline deposit noted on the concrete interior wall to the North and west walls of the lower mechanical compartment. The north wall is a cell wall abutting the "moon pool" that is open to the sea, and where effluent is discharged. The most obvious weeping emanates approximately 48" above the floor of the compartment, near the water heaters, with a secondary area adjacent the #2 potable water reservoir. These deficiencies have not increased in scope significantly and do not appear to be of a serious nature at present. The severity of the weeping is slightly more apparent than as viewed during the previous inspections conducted in 2008 and 2014.

2. Leakage continues in the wall of the utility room. Repair with epoxy or other suitable material.
3. Hull potential reading at lower panel indicates a system fault. Repair as found necessary, and verify correct operation of the hull protection monitoring system.

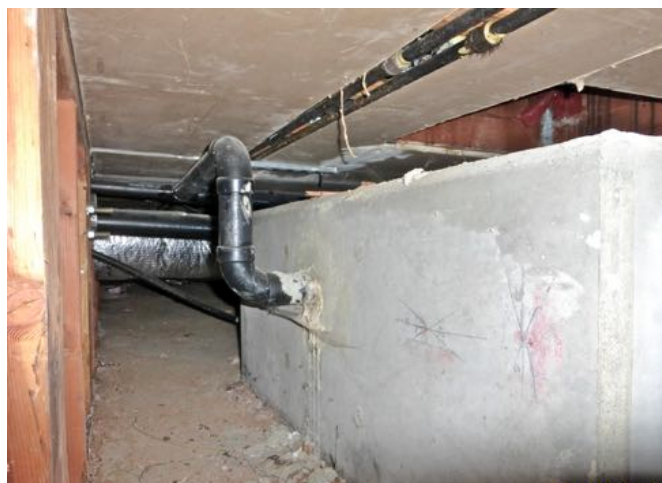
Crawl space and treatment tank

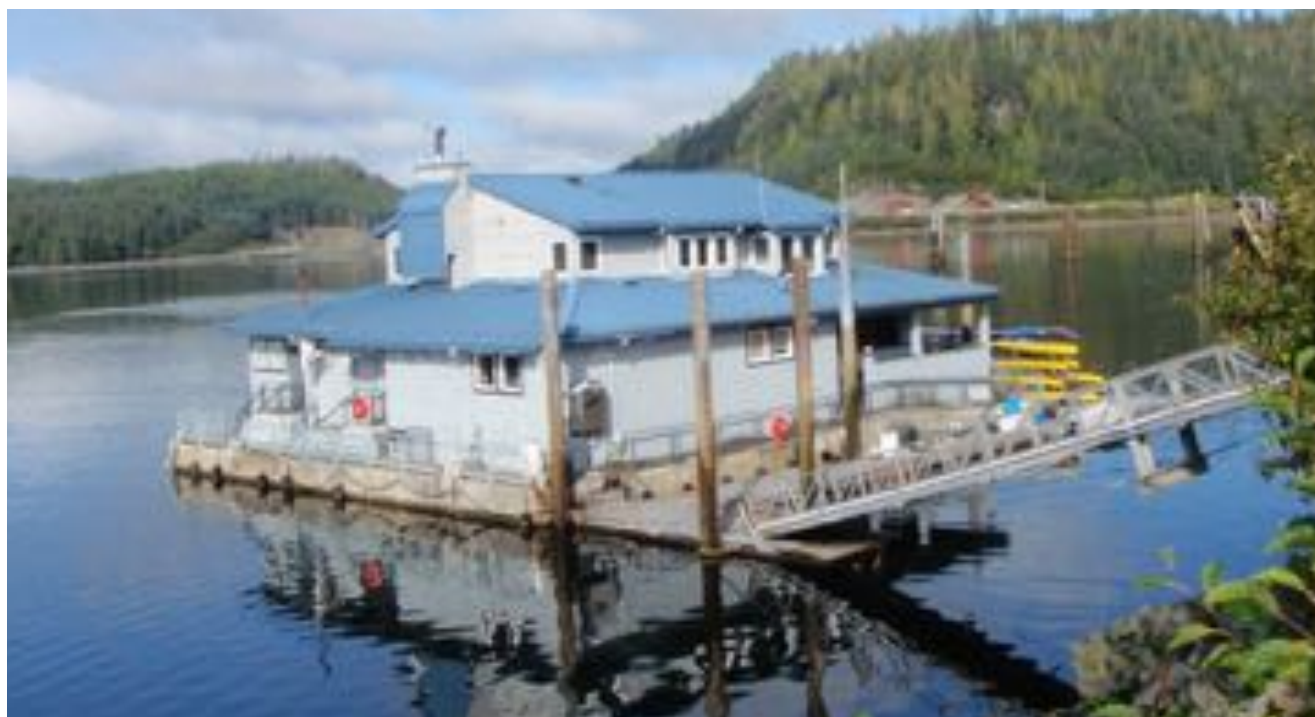
**BOARDING GANGWAY** Welded aluminum, 69' length X 6' width, with 36' hand railings. Built with one 1/4 X 4 X 8" I-beam underlaid with one 1/4 X 2 X 6" channel main stringer each side and same transverse framing 4' on center with diagonal cross bracing. Bottom truss each side of 1/2" galvanized cable over 1/4 X 2 X 8" channel center chord. Deck is untreated wood with wire screen and asphalt shingle traction. Handrails are 2" square tube with 1 1/2" i.d. top pipe, repairs evident. This ramp is of light residential grade construction, sagging at center and possibly in need of additional structural reinforcement.

**Overall view of Southeast corner of subject and gangway**
