Carmel Clay Public Library

Building Condition Study

January 2013

**Carmel Clay Public Library
55 4th Avenue SE, Carmel, Indiana
Facility Study**

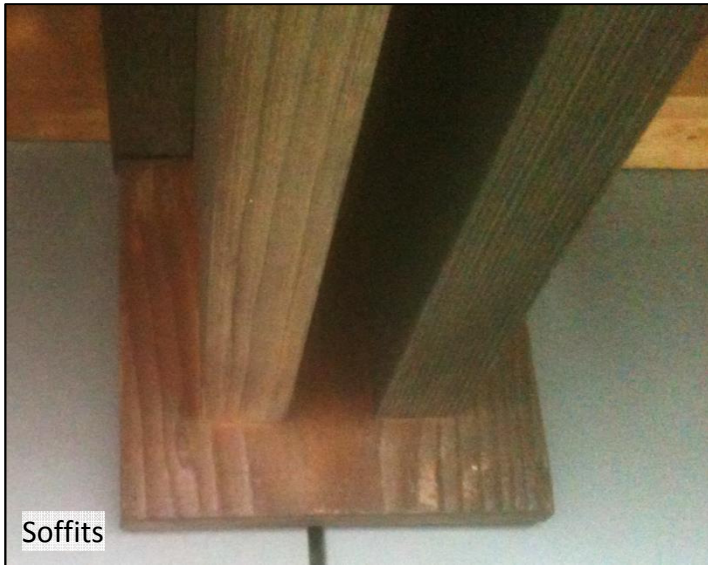
Soffits

The soffits below the standing seam roofs at the clerestories appear to be redwood. These soffits are in good condition, however there is dimensional lumber detailing which is beginning to show some sign of

drying and checking. No attention is required at this time, however this should be monitored to make sure that more degradation does not occur.

Redwood detailing

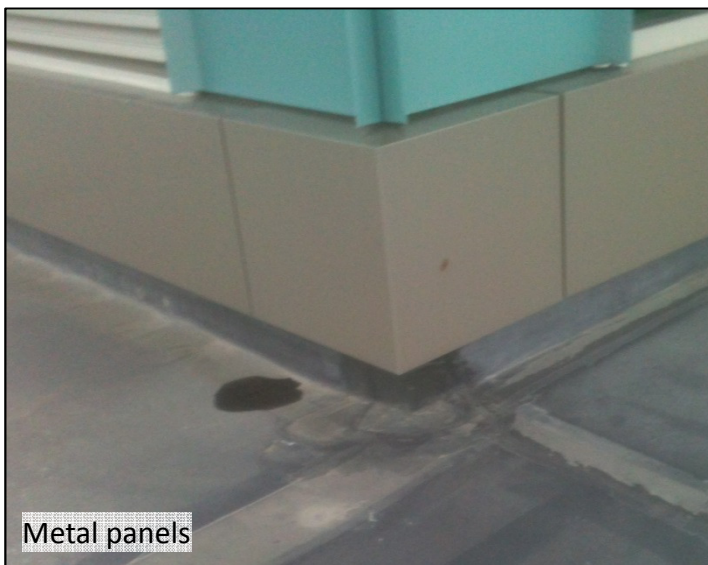
Metal panels

It should be noted that the detailing of the metal panels relative to the roof membrane may cause challenges at the time the roof does need to be repaired or replaced. Refer to the detail from the original contract documents included in the graphic portion this report. The detailer left little room between the top of the roof membrane and bottom of the panel and does not appear to have taken into account the slope of the roof. There are many locations where the metal wall panels are either nearly touching the roof membrane, or have even had to be modified to hold them above the roof. It may be necessary to remove the metal panels to allow the roof membrane to be turned up behind them when the roof membrane is replaced.

Roof slope to drain creates a condition where roof tapers up to metal panels.

Metal Panels are set close to the roof membrane.

Corner detail at metal panels

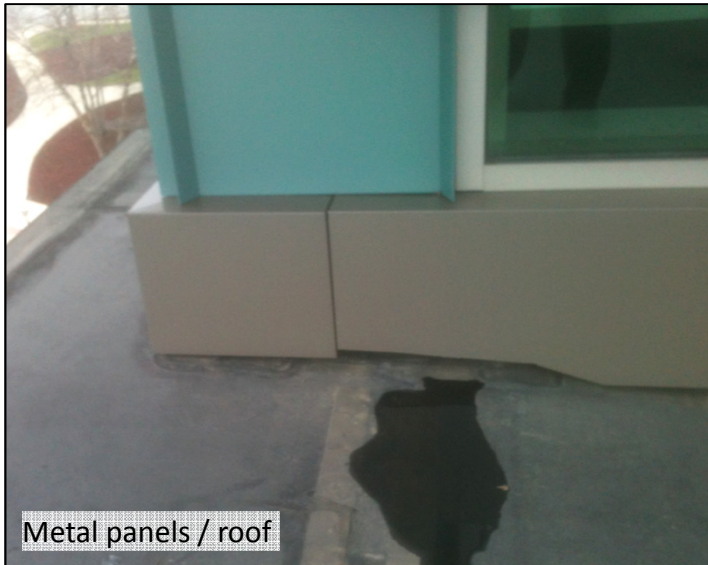
Close up of metal panel at roof.

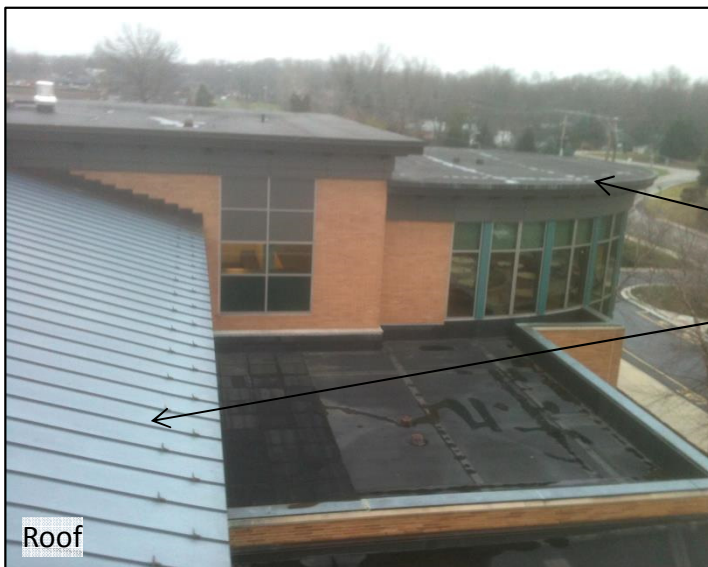
Mechanically fastened EPDM.

Standing seam metal roof.

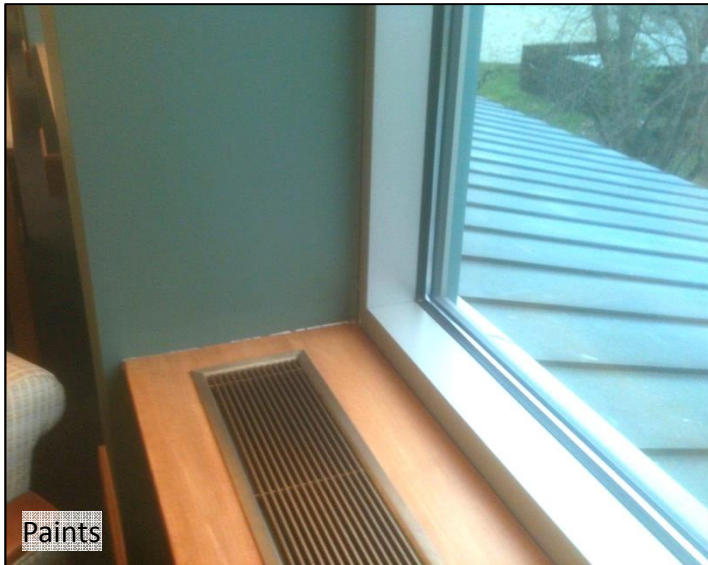
Exterior windows are aluminum and do not need to be set up on a schedule for refinishing.

Detail at exterior window.

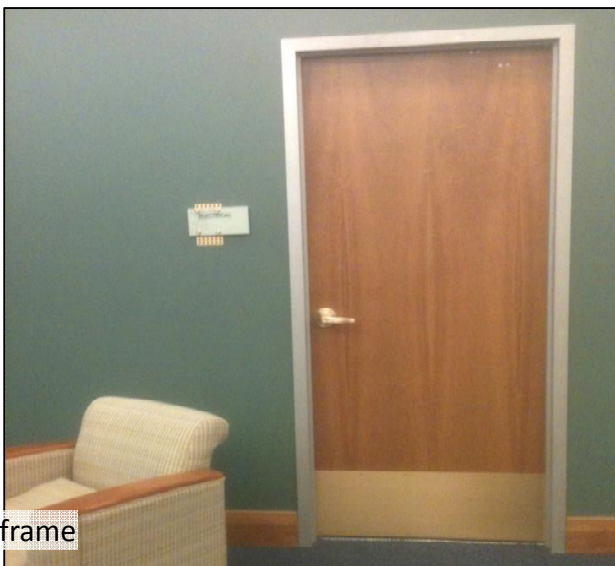
Aluminum door frames in public areas should not require any scheduled maintenance.

Door frames at public areas

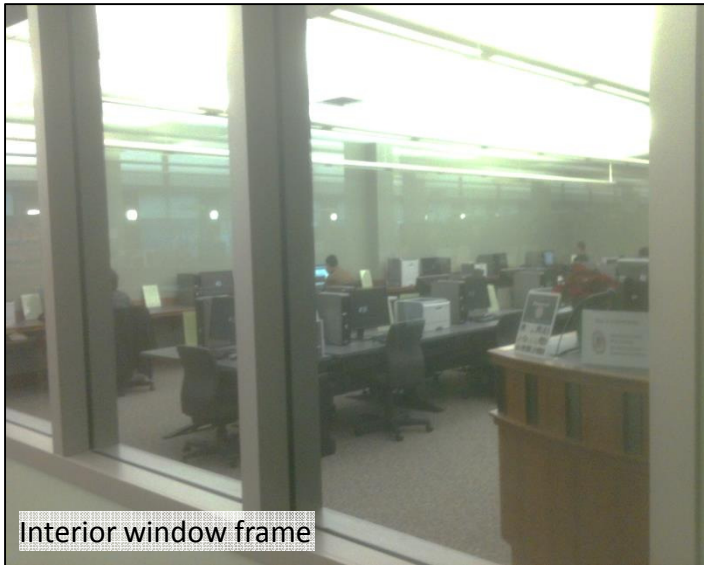
Interior window frame

Aluminum interior window frames should not need to be set on a regular maintenance schedule.

Window frame

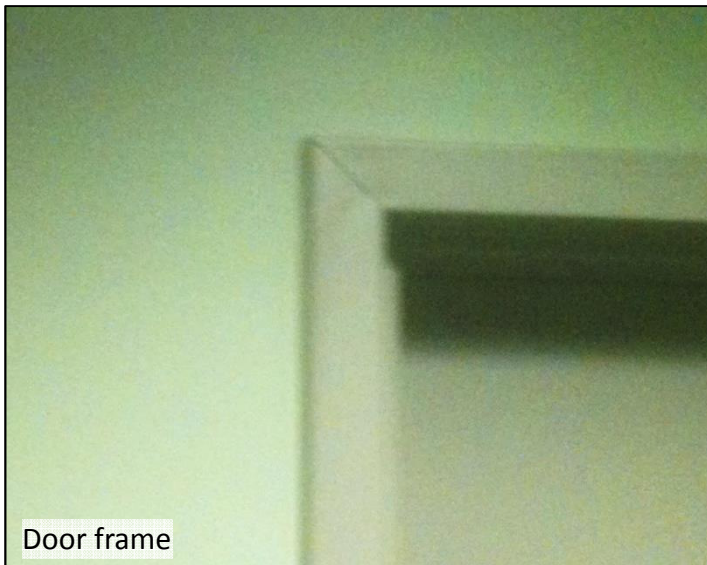
Door frame

The door frames at the non-public areas are painted hollow metal. Consider scheduling refinishing of these frames on the same schedule as wall paint.

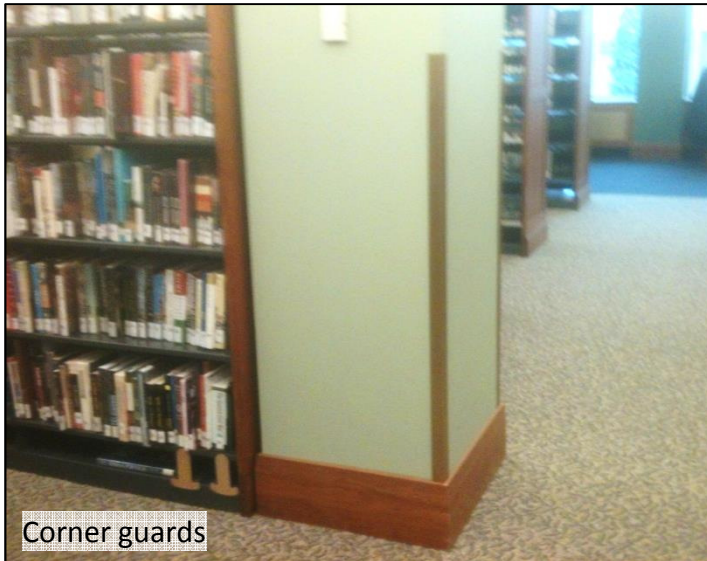
Corner guards are appropriately placed to reduce wall damage, no scheduled maintenance should be required. Guards in public areas are small, solid material.

Corner guard in public area.

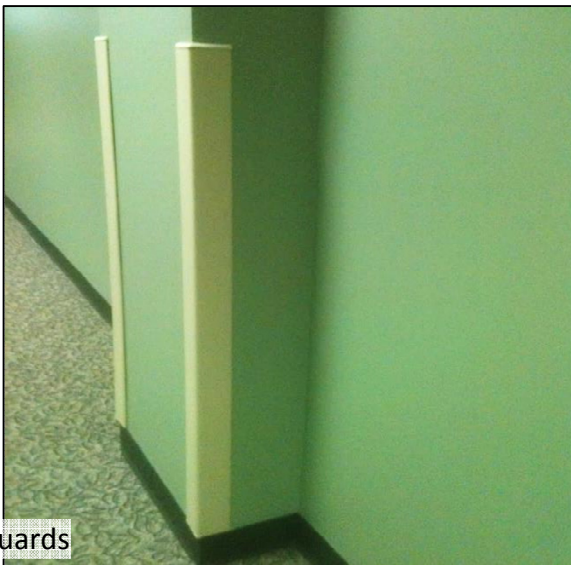
Corner guards in non-public areas are (2) piece resilient.

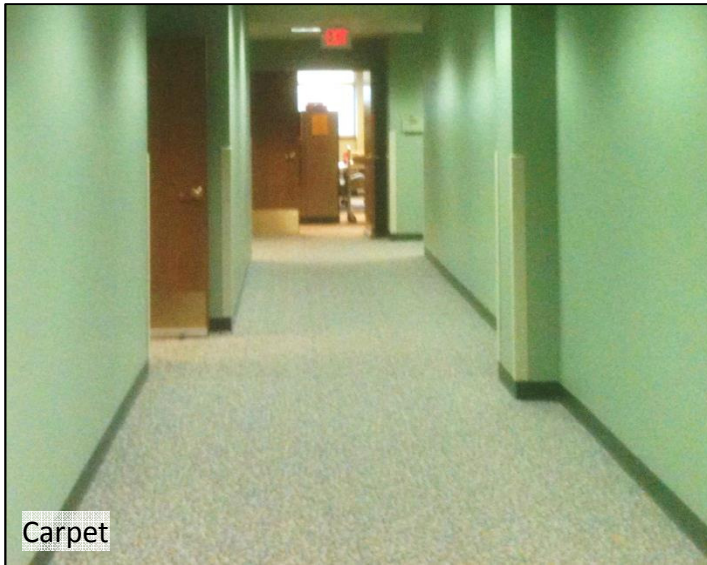
Carpet at non-public corridors.

Consider putting carpet on replacement schedule.

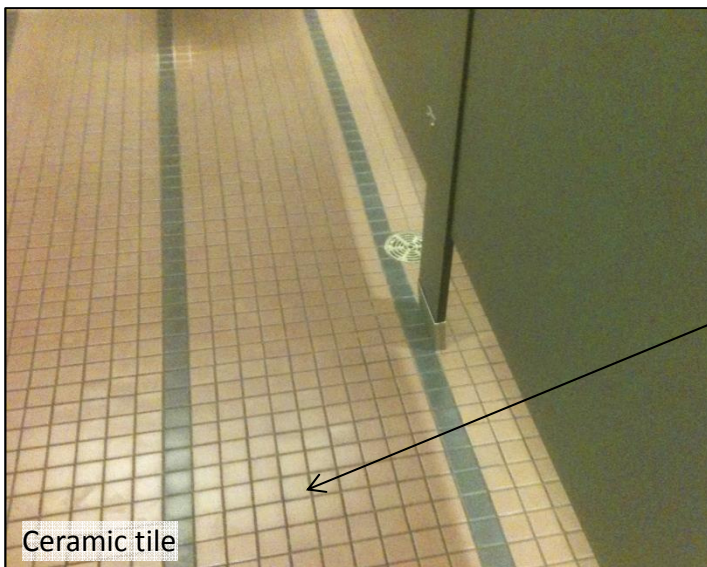
Ceramic tile floors do not need to be on any kind of replacement schedule. Consider resealing grout as maintenance.

Finish at toilet rooms.

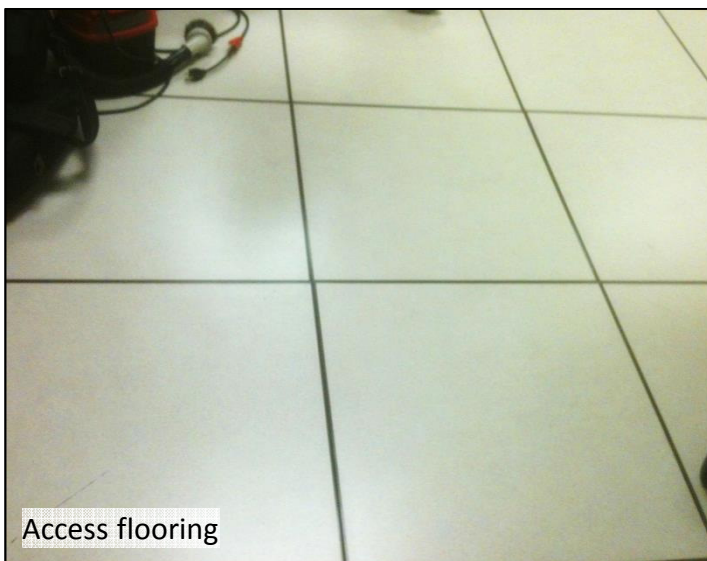
Access flooring will not need to be on replacement schedule..

Floor at server room

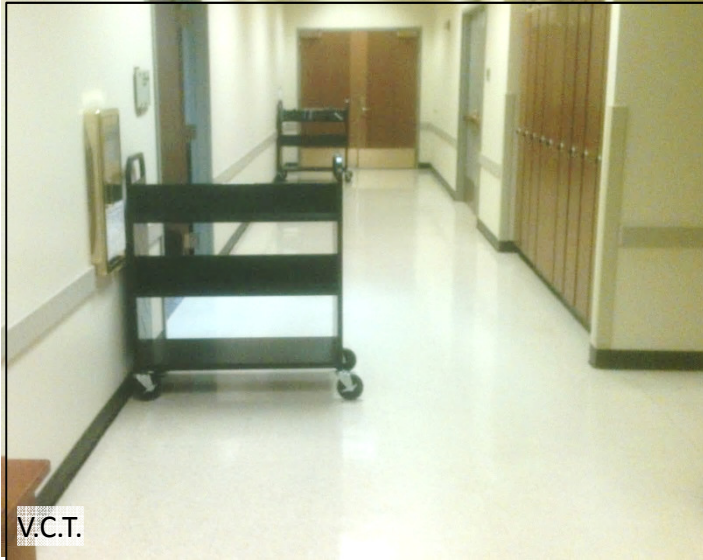
V.C.T.

Vinyl Composition Tile (V.C.T.) does not need to be on a replacement schedule. Regular cleaning and waxing should be done to assure maximum performance and to extend the life of the floor.

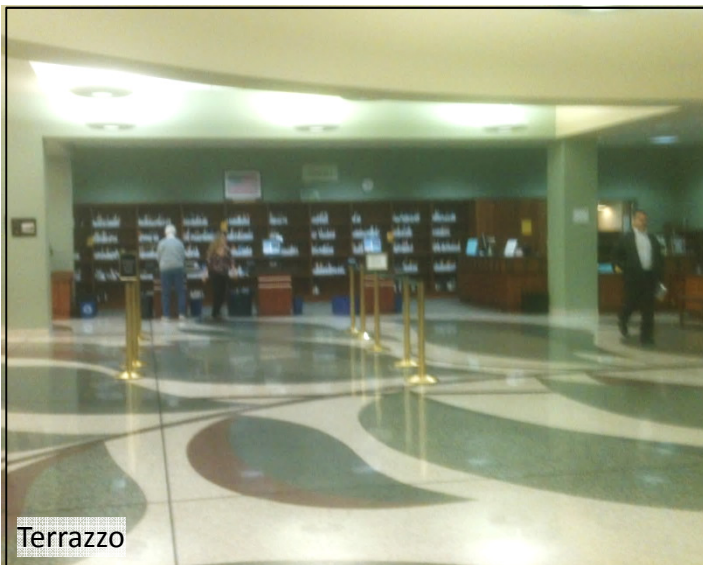
Terrazzo floors do not need to be placed on any type of replacement schedule. Waxing is NOT required to extend the material life.

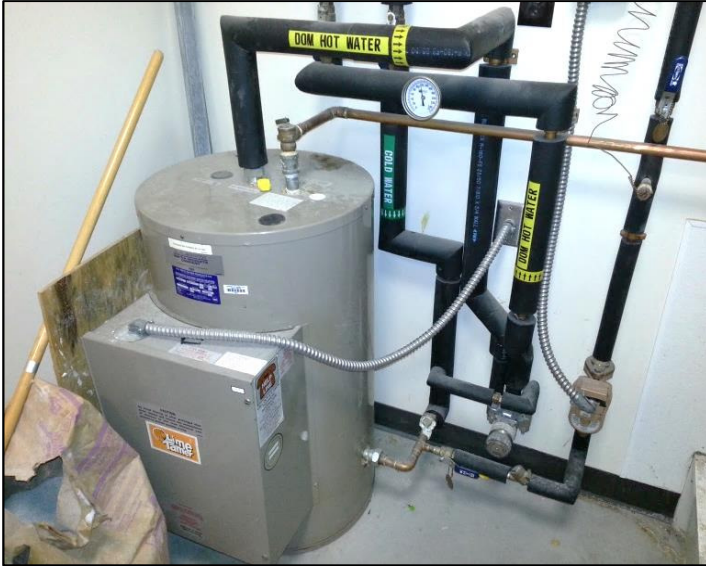
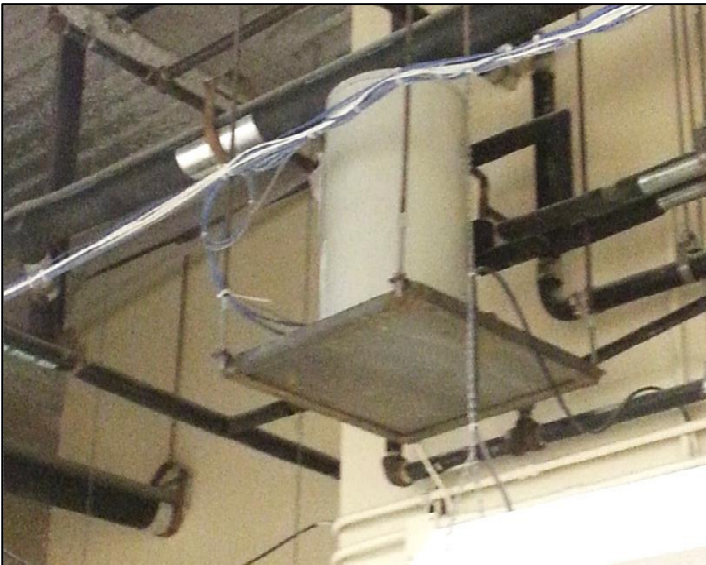
There are approximately 10 electric domestic water heaters installed at sink locations throughout the building. Distributing these tanks throughout the building reduces the amount of piping necessary and reduces the energy loss of a central circulated system. However each of these tanks will have a service life of about 10-15 years before pinhole leaks develop. The long term budget should plan on replacing one of these systems each year. The alternative to the installed system would be a central gas fired heater and tank with a new circulation loop throughout the building. The cost of the new piping may negate the maintenance savings of a centralized plant.

Point –of-use electric water heater with 3-way mixing valve. One of ten systems.

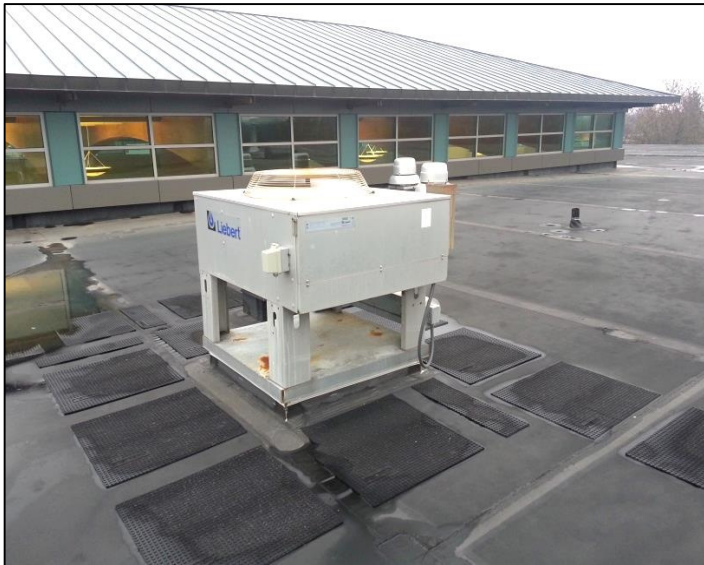
The computer room is served by its own Liebert system with a rooftop condensing unit which is in good condition but may become a maintenance problem in 5-8 years.

Data Room Air Cooled Condensing Unit.
