## Certificate of Substantial Completion

**PROJECT:** *(name and address)*  
2022-024.PRE - FRANKLIN CUB  
ACADEMY  
1049 Sloan Drive  
Franklin, IN 46131

# Site Visit Construction

VISIT NAME: Flooring Punch

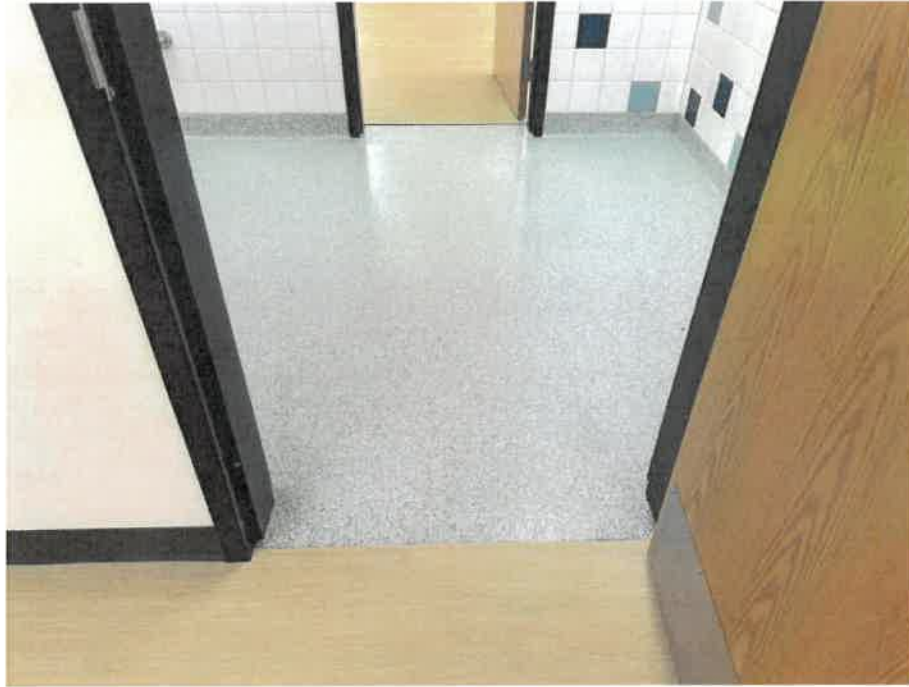
ITEM: 027-005

SUBJECT: General  
REMARKS: Wall base missing in storage rooms  
CATEGORY: Quality

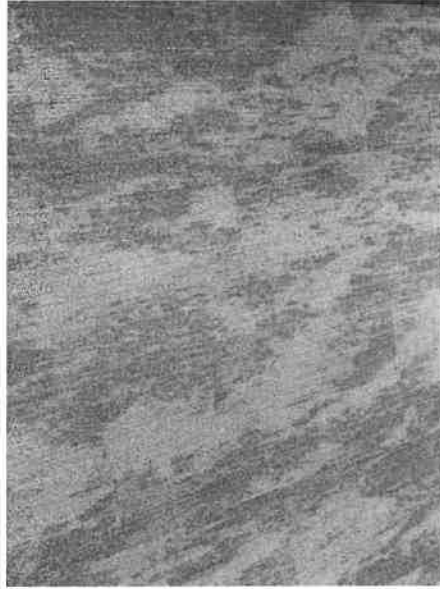
ITEM: 027-018

SUBJECT: D105a  
REMARKS: Missing carpet  
CATEGORY: Quality

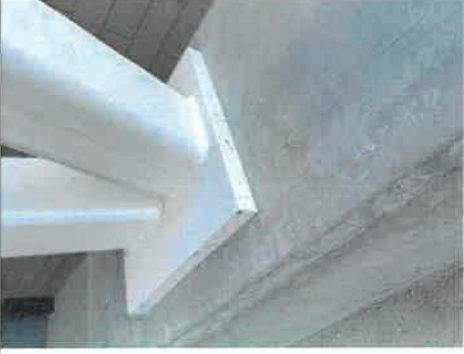
| SPACE NUMBER | SPACE NAME | ELEMENT | LOCATION | DESCRIPTION | STATUS LABEL | ID | SUPPORTING DOCS |
|---|---|---|---|---|---|---|---|
| | N/A | Exterior | | Touch up paint on column | Open | 0000<br>1 | |

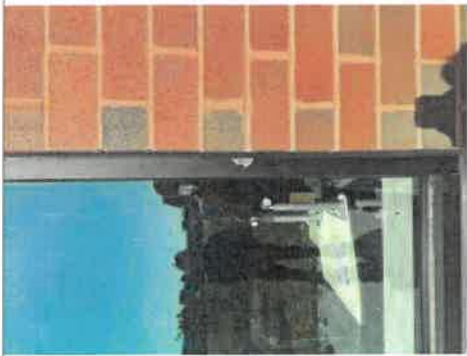
| SPACE NUMBER | SPACE NAME | ELEMENT | LOCATION | DESCRIPTION | STATUS LABEL | ID | SUPPORTING DOCS |
|---|---|---|---|---|---|---|---|
| | N/A | Exterior | | Finish coming off windows SE corner | Open | 00010 | |

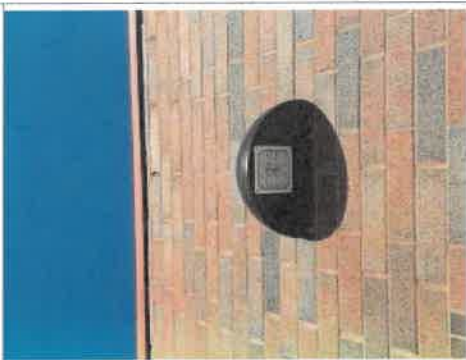
| SPACE NUMBER | SPACE NAME | ELEMENT | LOCATION | DESCRIPTION | STATUS LABEL | ID | SUPPORTING DOCS |
|---|---|---|---|---|---|---|---|
| | N/A | Exterior | | Fix weep at Northeast corner building | Open | 00018 | |

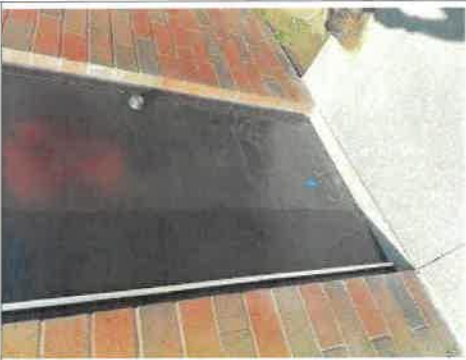
| SPACE NUMBER | SPACE NAME | ELEMENT | LOCATION | DESCRIPTION | STATUS LABEL | ID | SUPPORTING DOCS |
|---|---|---|---|---|---|---|---|
| | N/A | Exterior | | Touchup paint on exterior door Northeast corner building | Open | 00019 | |

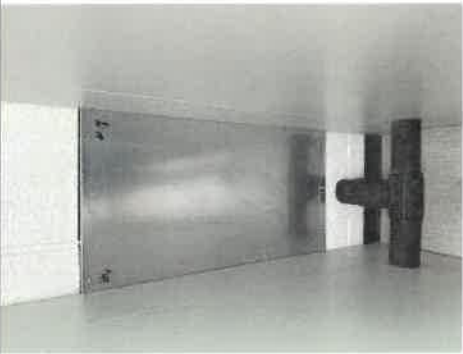
| SPACE NUMBER | SPACE NAME | ELEMENT | LOCATION | DESCRIPTION | STATUS LABEL | ID | SUPPORTING DOCS |
|---|---|---|---|---|---|---|---|
| | N/A | General | | Screws at louvers need to be cut flush | Open | 0002<br>7 | |

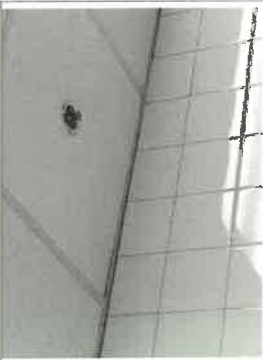
| SPACE NUMBER | SPACE NAME | ELEMENT | LOCATION | DESCRIPTION | STATUS LABEL | ID | SUPPORTING DOCS |
|---|---|---|---|---|---|---|---|
| | N/A | Kitchen C103 | | Caulk tile at ceiling | Open | 00040 | |

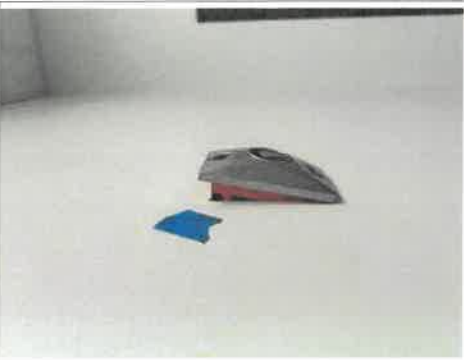
| SPACE NUMBER | SPACE NAME | ELEMENT | LOCATION | DESCRIPTION | STATUS LABEL | ID | SUPPORTING DOCS |
|---|---|---|---|---|---|---|---|
| | N/A | Handwashing C150 | | Mag hold open boxes are not secured with blocking | Open | 00048 | |

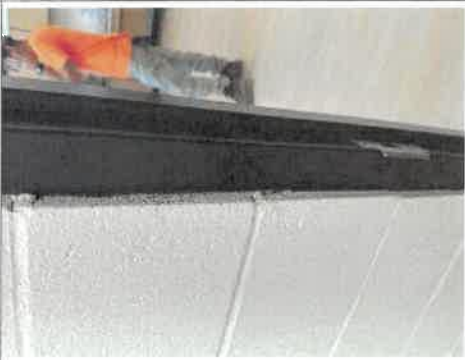
| SPACE NUMBER | SPACE NAME | ELEMENT | LOCATION | DESCRIPTION | STATUS LABEL | ID | SUPPORTING DOCS |
|---|---|---|---|---|---|---|---|
| | N/A | Storage C112A | | Caulk door frame to wall | Open | 00049 | |

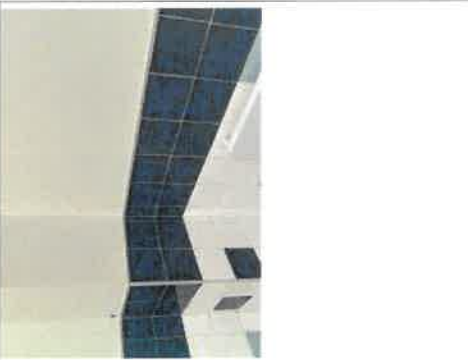
| SPACE NUMBER | SPACE NAME | ELEMENT | LOCATION | DESCRIPTION | STATUS LABEL | ID | SUPPORTING DOCS |
|---|---|---|---|---|---|---|---|
| | N/A | Family Restroom C154 | | Drywall not finish sanded | Open | 0005<br>2 | |

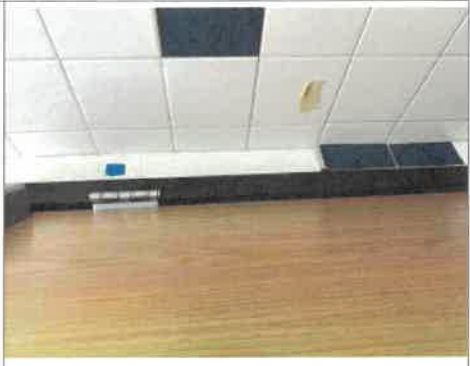
| SPACE NUMBER | SPACE NAME | ELEMENT | LOCATION | DESCRIPTION | STATUS LABEL | ID | SUPPORTING DOCS |
|---|---|---|---|---|---|---|---|
| | N/A | Family Restroom C153 | | Touch up drywall/paint | Open | 0005<br>3 | |

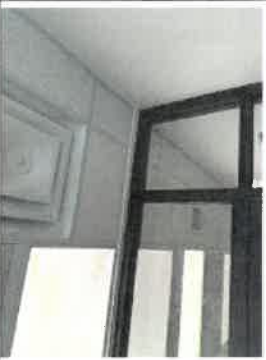
| SPACE NUMBER | SPACE NAME | ELEMENT | LOCATION | DESCRIPTION | STATUS LABEL | ID | SUPPORTING DOCS |
|---|---|---|---|---|---|---|---|
| | N/A | Vestibule V104 | | Touch up drywall/paint | Open | 0005 4 | |

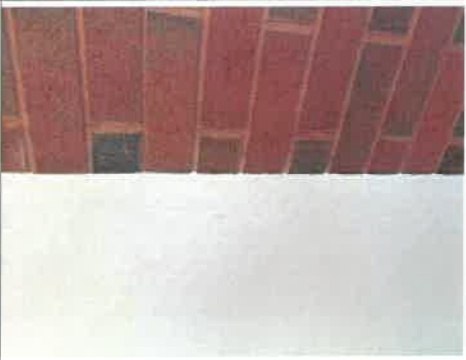
| SPACE NUMBER | SPACE NAME | ELEMENT | LOCATION | DESCRIPTION | STATUS LABEL | ID | SUPPORTING DOCS |
|---|---|---|---|---|---|---|---|
| | N/A | Vestibule V104 | | Drywall should sit back from Face of brick | Open | 0005 5 | |

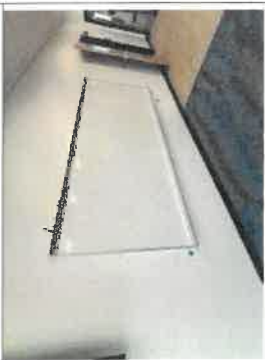
| SPACE NUMBER | SPACE NAME | ELEMENT | LOCATION | DESCRIPTION | STATUS LABEL | ID | SUPPORTING DOCS |
|---|---|---|---|---|---|---|---|
| | N/A | Classroom D105 | | Touch up drywall/paint | Open | 00058 | |

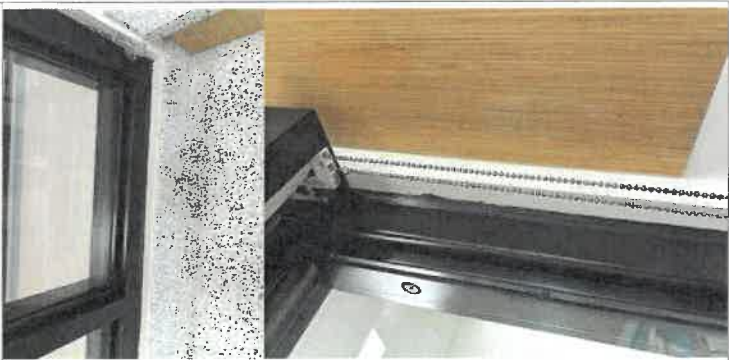
| SPACE NUMBER | SPACE NAME | ELEMENT | LOCATION | DESCRIPTION | STATUS LABEL | ID | SUPPORTING DOCS |
|---|---|---|---|---|---|---|---|
| | N/A | Classroom D106 | | Poor caulking workmanship | Open | 00059 | |

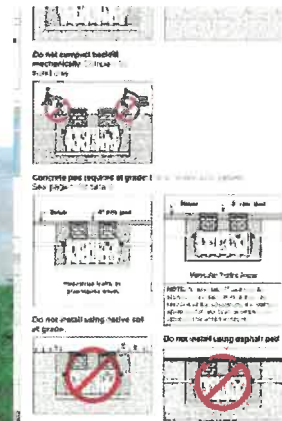
- i.
  - h. Construction debris was observed on multiple fixtures. Contractor shall clear all fixtures of construction debris.
  - i. Throughout – Piping and equipment is missing pipe labeling and equipment tagging as required by specifications.
2. The grease interceptor is not installed as per manufacturers installation requirements and is missing a concrete pad at grade. Install traffic rated lids on grease interceptor manholes.
