**SCHOOL DISTRICT OF NEW GLARUS
BOARD OF EDUCATION
FACILITIES, TRANSPORTATION AND TECHNOLOGY COMMITTEE MEETING
MONDAY, FEBRUARY 25, 2019
HIGH SCHOOL CONFERENCE ROOM
6:45 PM**

ELEMENTARY & MIDDLE HIGH SCHOOL STUDY
NEW GLARUS SCHOOL DISTRICT

Analysis & Needs Assessment

February 11, 2019

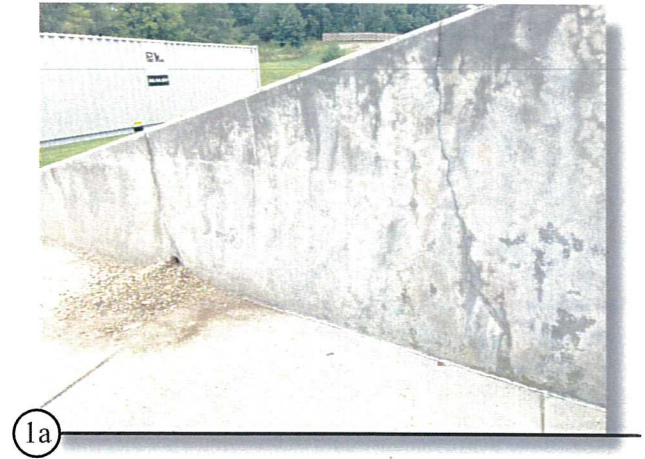
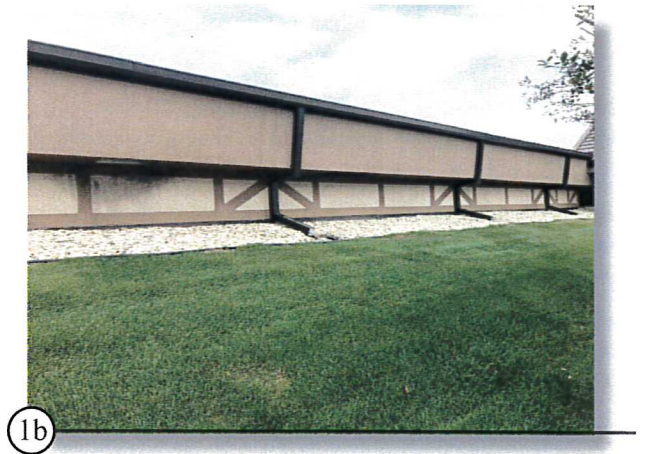
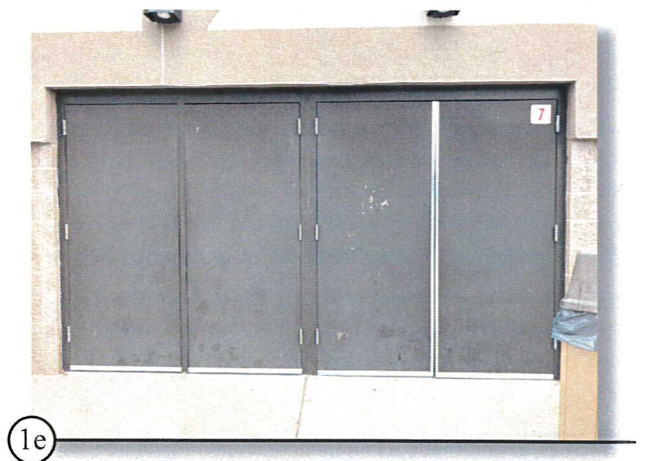
1. Exterior Needs Analysis:

- a. Exterior masonry walls are cracked, chipped, and damaged.
- b. Some exterior walls are stained with tar and rust.

- c. Some windows are dated, worn, single pane, drafty, and in need of repair or replacement.
- d. Some window sills have instances of damage.

- e. Some exterior doors are dated, worn, and rusted. Many are original to their respective existing building.

- f. Some canopy columns are worn, rusted, and in need of repair.

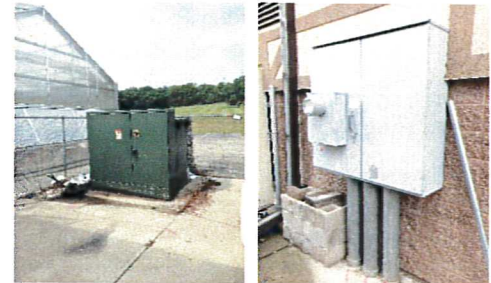
MDP-1

- E. The main distribution switchboard (MDP-2) feeds the Middle School addition via a 1200A 120/208 Volt 3-phase, 4-wire switchboard located in the middle school addition. The middle school switchboard (MDP-2) is an Eaton and is original to the middle school addition. The middle school panelboard has limited room for expansion

- F. The main service switchboard (MD) does have an integral surge protection device.
- G. The main distribution switchboards (MDP-1) and (MDP-2) do not have a surge protection device.

- A. The main switchboard (MD) is in good condition and can remain. If a large building addition or additional air conditioning is added, a new service upgrade may be required.
- B. The High School distribution switchboard (MDP-1) and Middle School distribution switchboard (MDP-2) are in good condition and can remain.

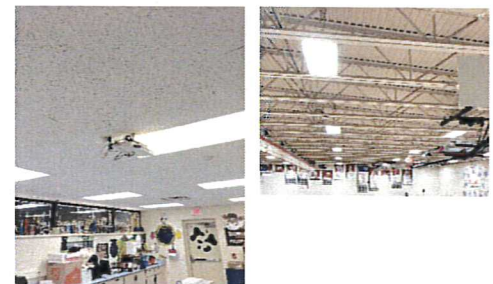
- A. The majority of the High School and Middle School is fluorescent T8-lamp light fixtures in classrooms, offices, gym and other support spaces. Occupancy sensors have been utilized in some areas.

- B. The majority of the corridors have been upgraded to lay-in type LED fixtures controlled via wall switches. Occupancy sensors have not been utilized. We noted battery powered egress lighting units in some locations. It is unclear how much of the of the facility lighting is connected to the emergency panels.
- C. The Cafeteria has some LED light fixtures.
- D. The main office pod including the offices within the main office area have been upgraded to LED light fixtures. Occupancy sensors have been utilized in some areas.
- E. The Auditorium seating area has compact florescent cans.
- F. Exit lights are in good condition. It is unclear how much of the of the facility's exit lights are connected to the emergency panels.
- G. Exterior canopy, building mounted and parking lot lighting have been upgraded to LED light fixtures.

- A. A possible upgrade to all LED interior lighting may be considered.
- B. A possible upgrade in the Auditorium is to replace compact florescent cans with LED type.

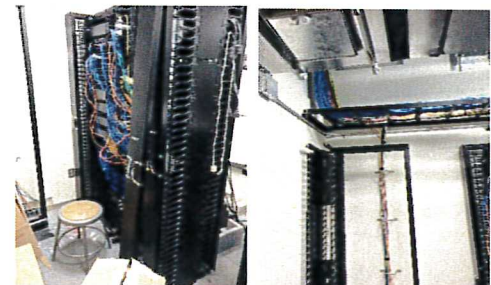
- A. The facility has incoming fiber to the facility. Fiber is also routed from this facility to Elementary School as an interconnection between schools.
- B. This facility contains a main data closet serving the High School portion of the facility and (1) remote data closet serving the Middle School portion of the facility.
- C. Both data rooms have open type floor mounted data racks. The main data room has limited rack space for expansion but has the room to add an additional rack. The remote data closet has space available in the existing racks.
- D. Data closets are connected with multimode fiber.
- E. We noted Cat 5e cables installed with the majority of the cables being non-plenum rated. There was very little plenum rated cables.
- F. The data closets are in conditioned spaces.

- A. If plenum spaces are utilized for the HVAC system within the facility, plenum rated data cable is required.
- B. Additional rack may be added to the main data closet if a large amount of data cabling is added.
- C. Additional data can be added to the remote data closet's existing racks.
- D. If a building addition would require that the data cable have a total installed length of over 300 feet, then an additional remote data closet will be required.

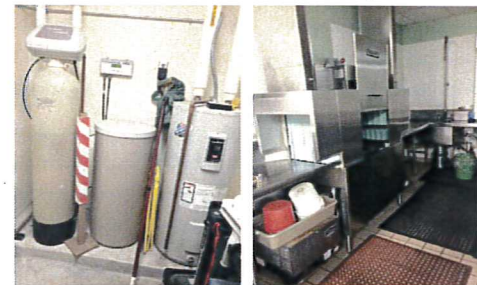
MS Water Heater

- B. The Middle School addition has a water heater system that serves this addition. A Professional Advantage single tank water softener provides conditioned water to a Bradford White LD40S33B090 40-gallon electric water heater. The equipment is in good working condition.

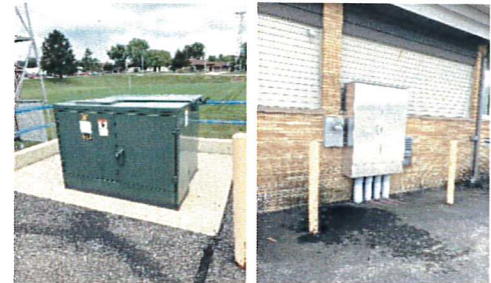
MD

- C. The main switchboard (MD) feeds the main distribution switchboard (MDP).
- D. The main distribution switchboard (MDP) is an 800A 120/208 Volt 3-phase, 4-wire switchboard located in the lower level electrical room. The main distribution switchboard (MDP) is Cutler-Hammer and was installed in 1999. The switchboard has no room for expansion.

- E. The main service switchboard (MD) has an integral surge protection device.
- F. The main distribution switchboard (MDP) has a remote surge protection device.

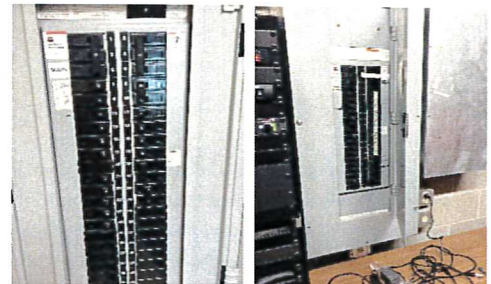
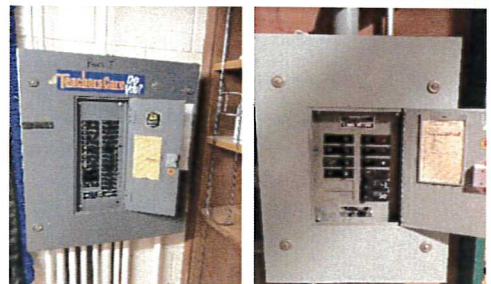
- A. We noted some newer but mostly older Cutler-Hammer and Square D panelboards throughout facility. We also noted some older Kinney and Siemens panelboards.
- B. The majority of the panelboards are full and do not have space for additional circuit breakers.

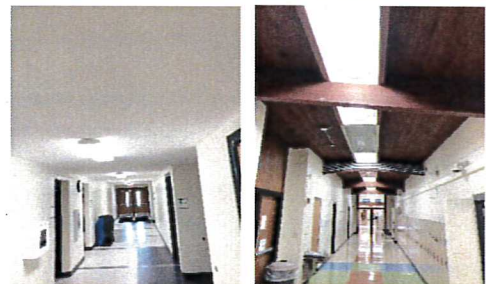
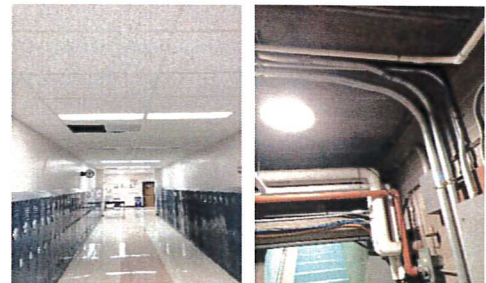
- A. The majority of the facility is fluorescent T8-lamp light fixtures in classrooms, offices, gym and other support spaces. We observed a combination of both surface mounted and recessed light fixtures throughout. Occupancy sensors have been utilized in some areas.
- B. The corridors have a combination of both surface mounted and recessed fluorescent T8-lamp fixtures. Some areas have been upgraded to LED fixtures. Corridors are controlled via wall switches. Occupancy sensors have not been utilized.
- C. The Cafeteria has LED light fixtures.
- D. The mechanical areas have compact fluorescent fixtures.

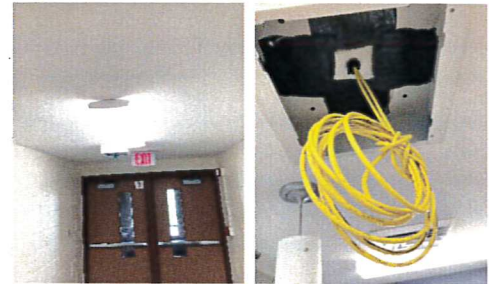
- A. The School District is currently in the process of upgrading their intercom system to a Valcom system. Once completed, the same upgrade process will be completed at the Middle/High school and tied back to the Elementary School system.
- B. Currently there are a combination of wall mounted speakers, wall mounted surface combination clock/intercom boxes and recessed ceiling mounted speakers throughout the facility.

- A. Expand system as required to any new or remodeled areas.
