## 10 YEAR HEALTH LIFE SAFETY SURVEY

**Pana High School**  
201 West Eighth Street  
Pana, Illinois 62557

Pana CUSD #8  
Christian County

# 10-year Safety Survey Report

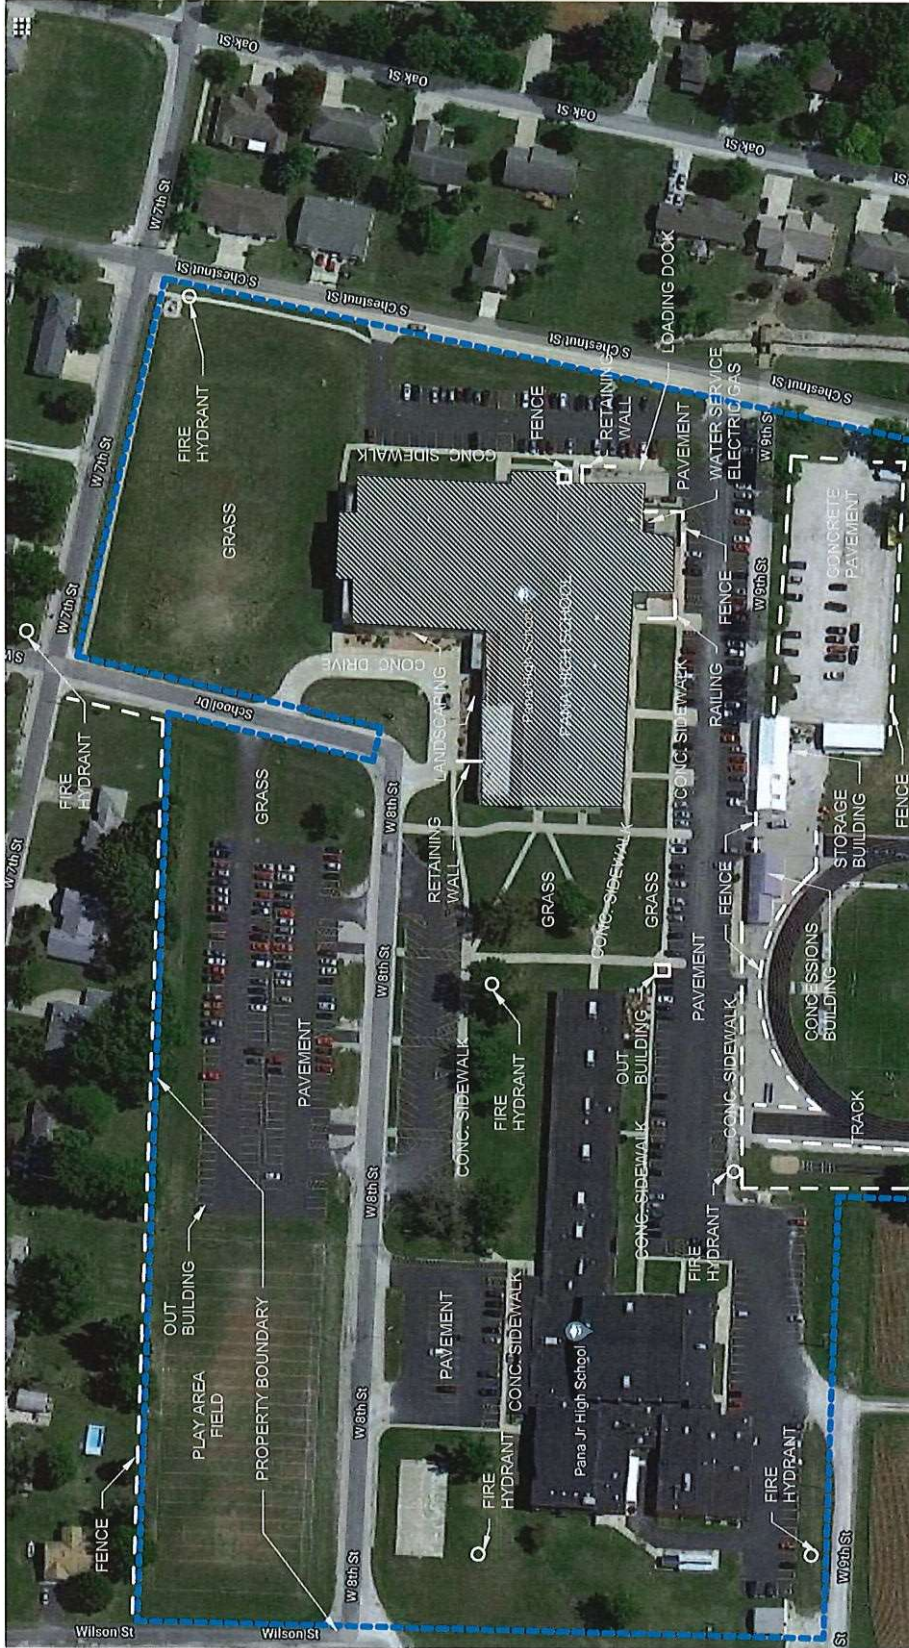
**SITE PLAN**  
**SAFETY REFERENCE PLAN**  
 PANA HIGH SCHOOL  
 201 WEST 8TH STREET  
 PANA, IL 62557

GRASS  
 PLAY AREA FIELD  
 PLAY AREA FIELD

CONSTRUCTION: Type II, non-combustible  
 PLAN CLASSIFICATION: Plan Type "CP", multi-story with enclosed interior  
 PROTECTION CLASSIFICATION: sprinklered

AUTOMATIC HEAT DETECTION:	
Smoke Detectors	Located per Safety Reference Drawings.
Heat Detectors	Located per Safety Reference Drawings.
Duct-Mounted Smoke Detectors	Located per Safety Reference Drawings.
Carbon Monoxide Detectors	None noted.
Sprinkler System Tie-In	Yes
STANDPIPE HOSE LINES:	
Stage	N/A
FIRE EXTINGUISHERS:	Portable fire extinguishers are located per Safety Reference Drawings.
VII. <u>SECURITY SYSTEM</u>	
Camera-Controlled Access	Vestibule-303 and Entry-101.
Security Cameras	Yes.
Security System	Yes.
VIII. <u>ENERGY CONSERVATION</u>	
Control Type	Digital.
Compressor Location	N/A
Air Dryer Location	N/A
Comments	Honeywell controls St. Louis Office.
IX. <u>ASBESTOS ABATEMENT</u>	
	There are no ACM products in the building, according to an affidavit on file at the district office.
