**WEATHERFORD
INDEPENDENT SCHOOL DISTRICT**

FACILITIES CONDITION ASSESSMENT REPORT

Prepared By: PBK Architects, Inc.

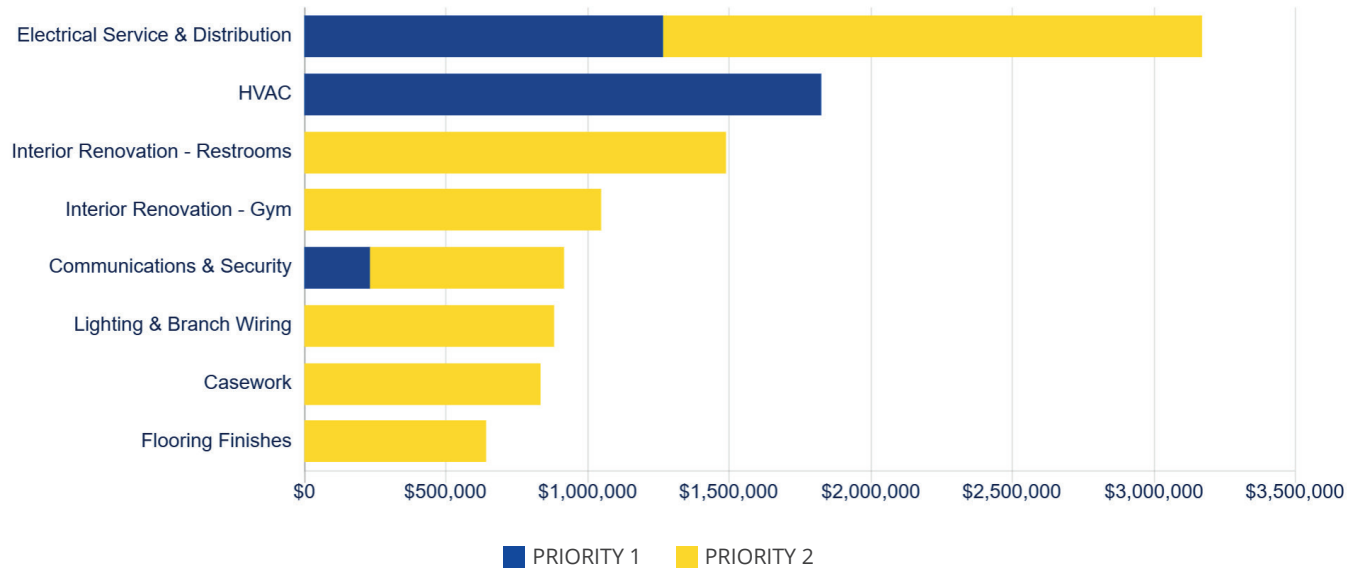
Top Systems to be Addressed in the next 5 Years (Priority 1 & 2 and Items \$400,000 or Over)

Cost estimates are in 2025 dollars and include soft costs. Inflation values are based on priority assigned.
