Facility Energy Assessment Report

Smart Energy Design Assistance Center (SEDAC)

Putnam County Elementary School

Published:	January 19, 2023
SEDAC	
Building Energy Specialist:	Ryan Siegel, SEDAC
Facility Location:	326 N 5 th St, Hennepin, IL 61327
Site Visit:	November 1, 2022

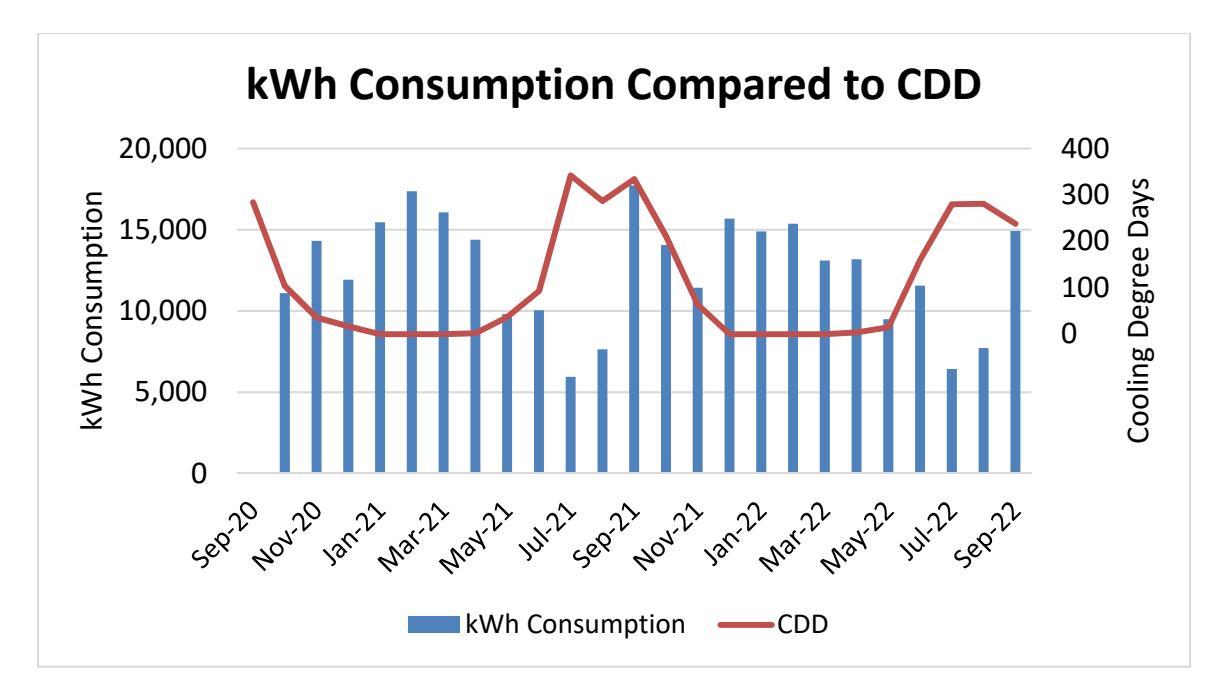
Figure 1: Comparison of Regional Cooling Degree Days versus kWh

Figure 1 represents the comparison of electricity consumption (kWh) and annual cooling degree days (CDD). A degree day compares the outdoor temperature to a standard indoor temperature of 65 degrees Fahrenheit. The more extreme the outdoor temperature, the higher the degree day number. Therefore, degree-day measurements can be related to the amount of energy needed for space heating and cooling as compared to the outdoor temperature. The elementary school has a low base load of around 8,000 kWh per month. This is due in part to the HVAC systems being unitary systems serving individual rooms or small clusters of rooms. These systems also only operate when there is a call for heating or cooling, which minimizes operating hours. Since this building does not host summer school and the systems allow only rooms that are occupied to be conditioned, a noticeable drop in electrical usage can be seen during the summer months.

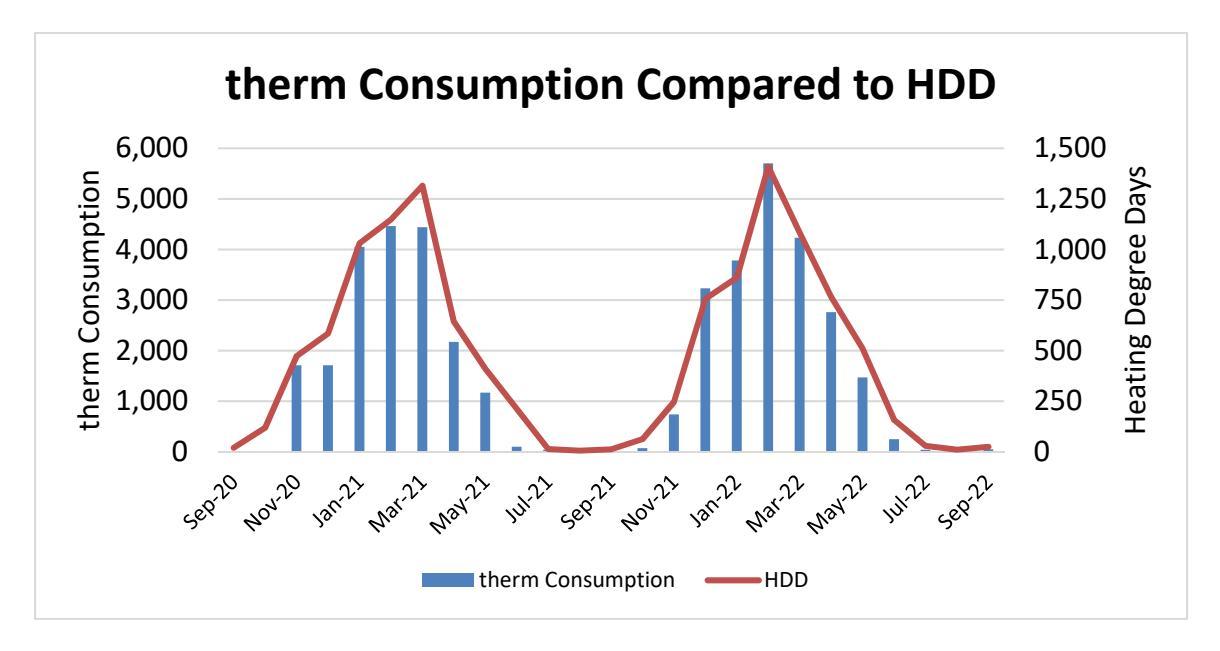
Figure 2: Comparison of Regional Heating Degree Days versus therms

Figure 2 represents the comparison of natural gas consumption (therms) and annual heating degree days (HDD). Natural gas consumption is highly corelated to outdoor weather which is expected as building heating is the primary use of gas in the building. The other uses such as domestic hot water and kitchen use are limited. The majority of the gas consumption is driven by the building envelope and ventilation.

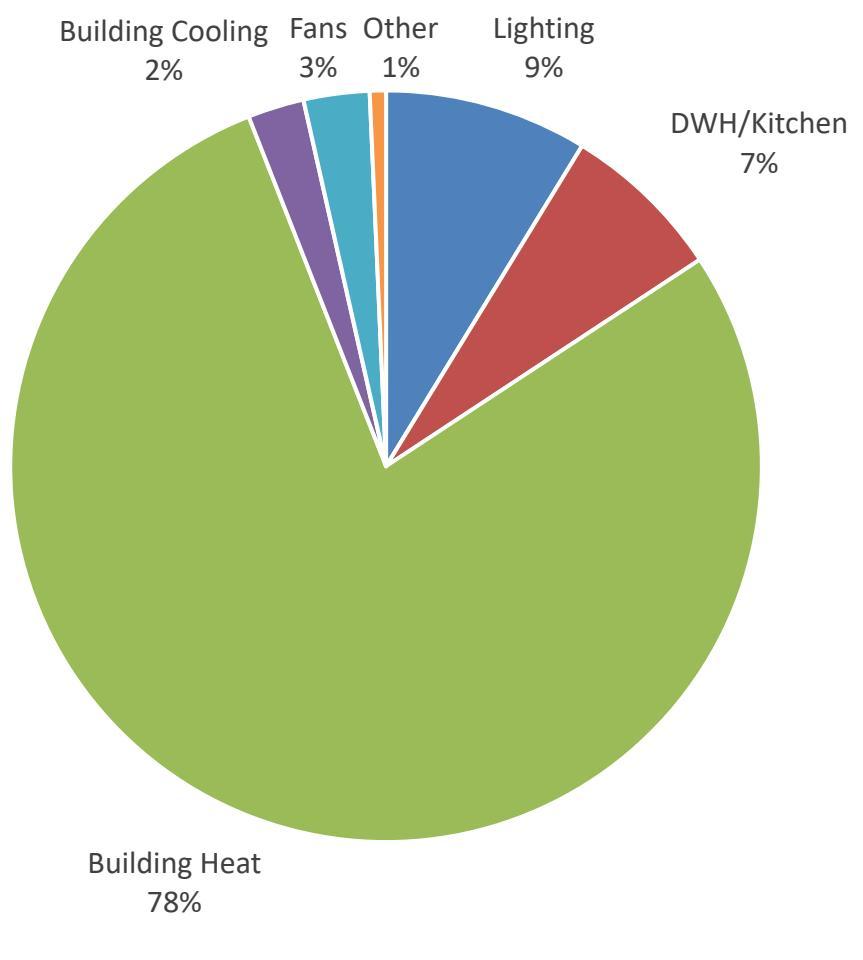
Figure 3: Energy Use Breakdown

Figures 3 and 4 help visualize energy and money flows and give an indication of possible areas for improvement. Most of the school's energy is used by the heating systems. The lighting is the second largest user. Improving the efficiency and operations of these areas can provide abundant savings. Measures address these areas later in this report.

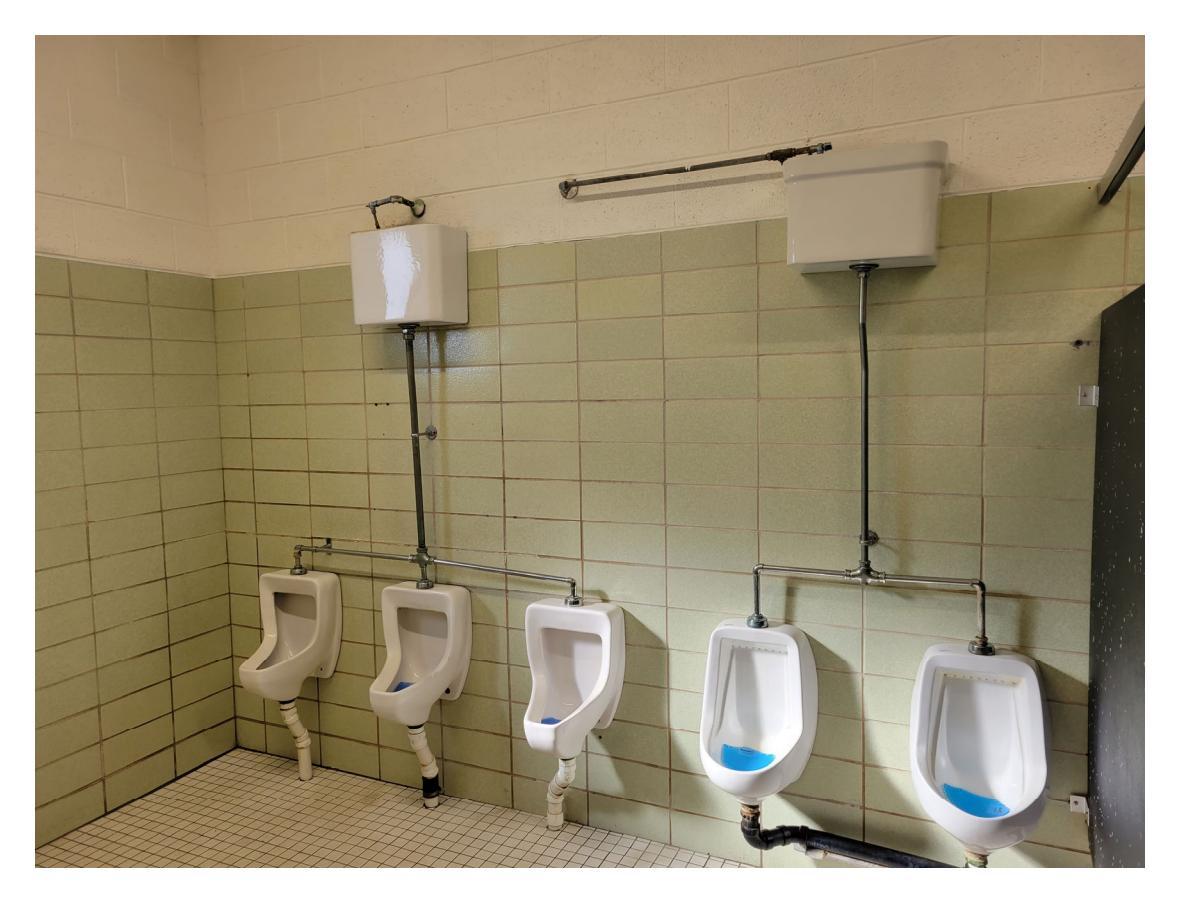
Urinals installed when the school was originally constructed are still in use. They are equipped with common overhead flush tanks that serve up to 3 urinals each. Each tank flows approximately 1 gallon per minute to the urinals, or over half a million gallons per year. While this limits the maximum flow at any given time, water is used even when the urinals are not.

It is recommended that the urinals be plumbed to individual flush valves. This would allow the urinals to only flush when used. This would dramatically decrease the volume of water used and avoid the need for the building maintenance staff to turn the tanks on and off to save water. Ameren does have an incentive for water savings, but the very short payback may make this ineligible for incentive.

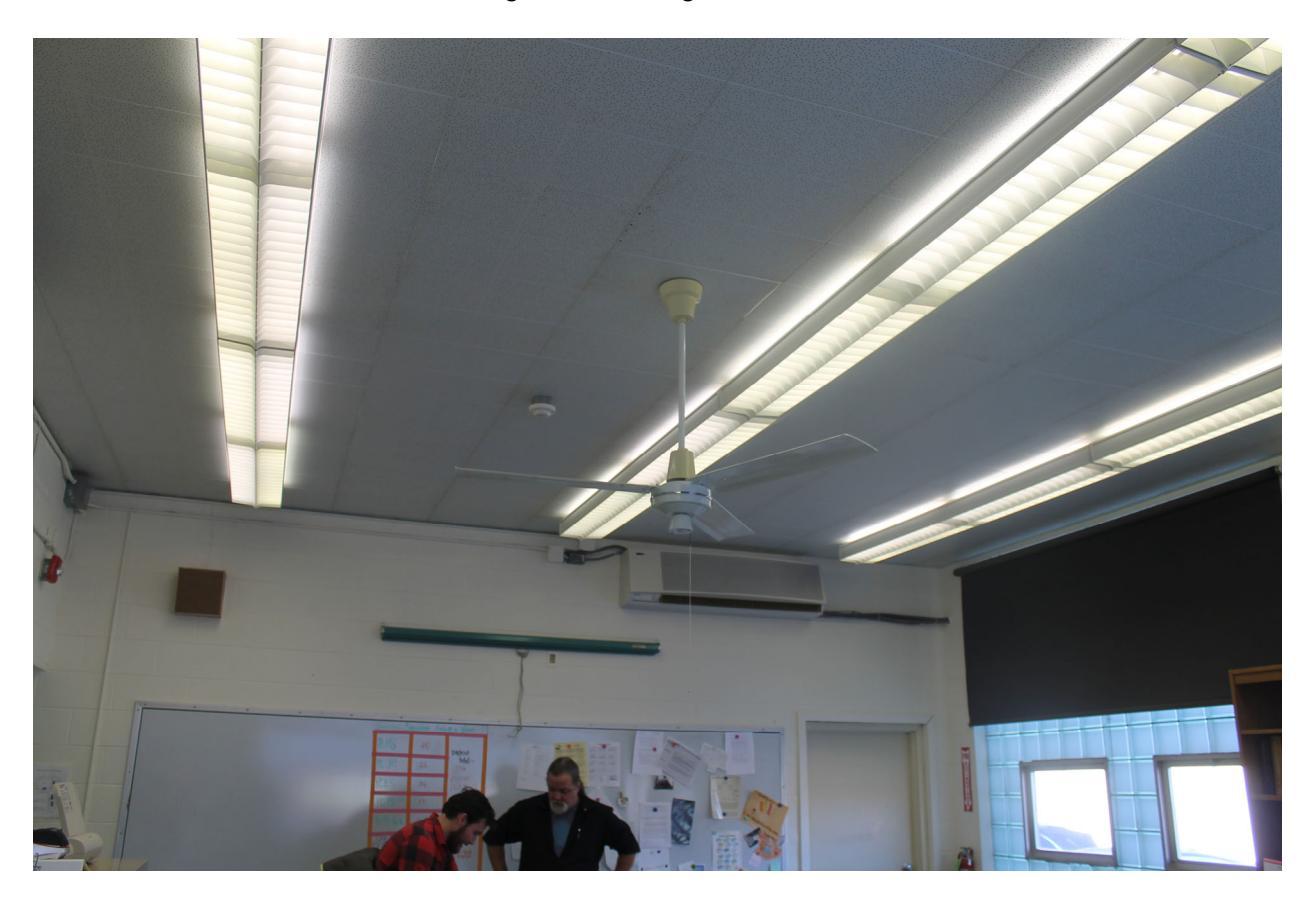
Most of the lighting throughout the elementary school has been upgraded from the original T-12 lights to newer T-8 technology. Many of these fixtures use 8-foot lamps using 59-watt lamps. There were a few of the older T-12 lights remaining.

It is recommended that all the fixtures be upgraded with LEDs. The simplest and most costeffective way would be to use tubular LED retrofits. SEDAC recommends using Type B lamps, which do require some rewiring to bypass the ballast, but this avoids the ballast compatibility issues that Type A lamps have. Additionally, they remove the ballast as a future point of failure in the fixture.

An alternative that would likely be more costly but may be desirable if the fixture tombstones are in poor condition, would be to replace the fixtures or to install a strip light retrofit kit. These may have better performance and avoid the need to reuse the existing fixture tombstones but come with added cost.

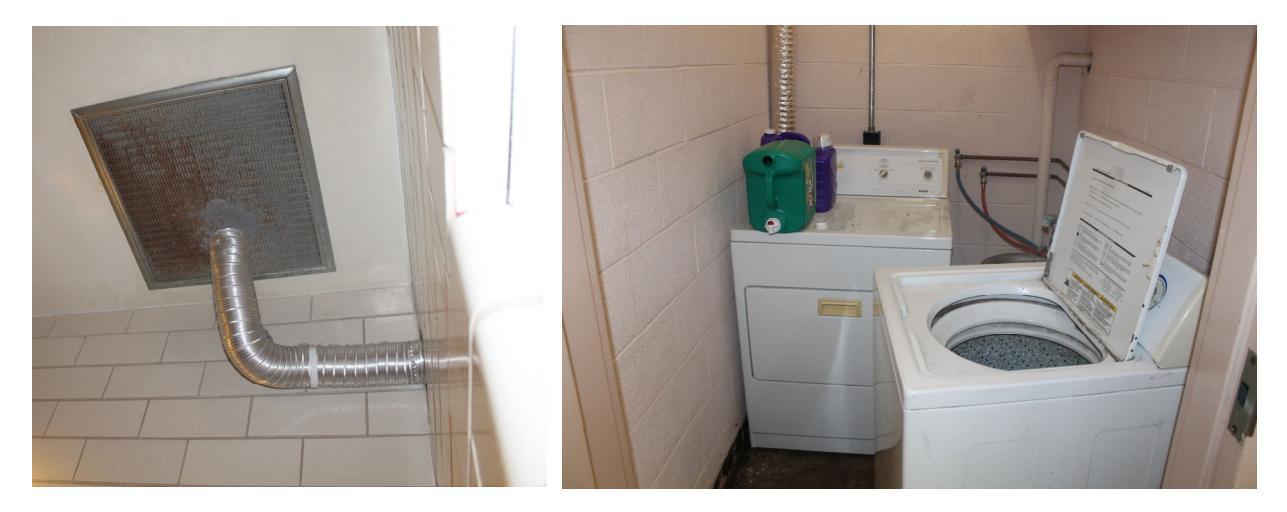
To save costs of laundering rags and mops, the school had installed a washer and dryer to allow staff to do the laundering on site. The dryer is ducted to an exhaust vent, which is exhausted using the exhaust fan that was installed to serve the former locker room. This exhausts substantially more air than required for the clothes dryer itself. It also was observed that there was an accumulation of lint on the vent which needs to be periodically cleaned and there is likely a similar accumulation inside the ductwork. Traditional clothes dryers operate by heating clothes to drive moisture out of fabrics and into the air which is then deposited outside. It was stated that there are presently 2 loads per week done at the school.

It is recommended that the clothes dryer be replaced with a heat pump model. These work like heavy duty dehumidifiers and are closed systems with a pair of coils to remove and condense moisture from fabrics, which can then be sent down the drain. This would eliminate the need to discharge large quantities of air out of the building using the locker room fan. Additionally, heat pump dryers use less than a quarter of the energy of traditional clothes dryers.

Heat pump clothes dryers have a condenser coil/filter that will need to be periodically cleaned and loading them with too many items may impair the performance. Placing the dryer up on a platform may make the task of cleaning the coil easier, depending on the coil location.

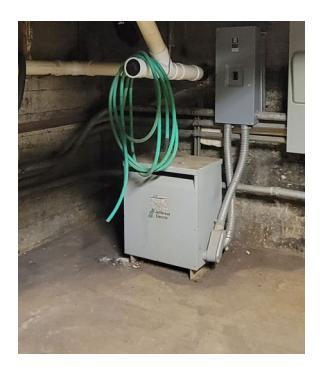
The boiler room contains a transformer to take 240V and step it down to 120/208V. This may be done for two reasons. First would be the school may not have 120V service which would be very unusual. If that is the case, the school should work with the utility to remedy this. Alternatively, some of the school's equipment may not be dual rated to operate on either 208V or 240V leading to the need to transform the 240V utility voltage to 208V; most equipment built in the last few decades is dual rated and can operate on either 208V or 240V service which would negate the need for this transformation. Despite the transformer being located in the warm boiler room, it was producing a substantial quantity of heat, indicating substantial energy losses. It is estimated the present transformer is losing 3 KW of electricity or the same as 2 personal space heaters on high. Given the improvement of equipment efficiencies over time which reduce loads, it is likely that the transformer is also larger than it needs to be if it is even still required.

It is recommended that the need for this transformer be evaluated to verify that the equipment that it serves is not able to take the utility provided voltage without transformation. If the transformer is no longer needed, it should be bypassed. If this transformer is still needed, then it should be replaced with a modern, energy efficient transformer, rated as DOE 2016 compliant or better.

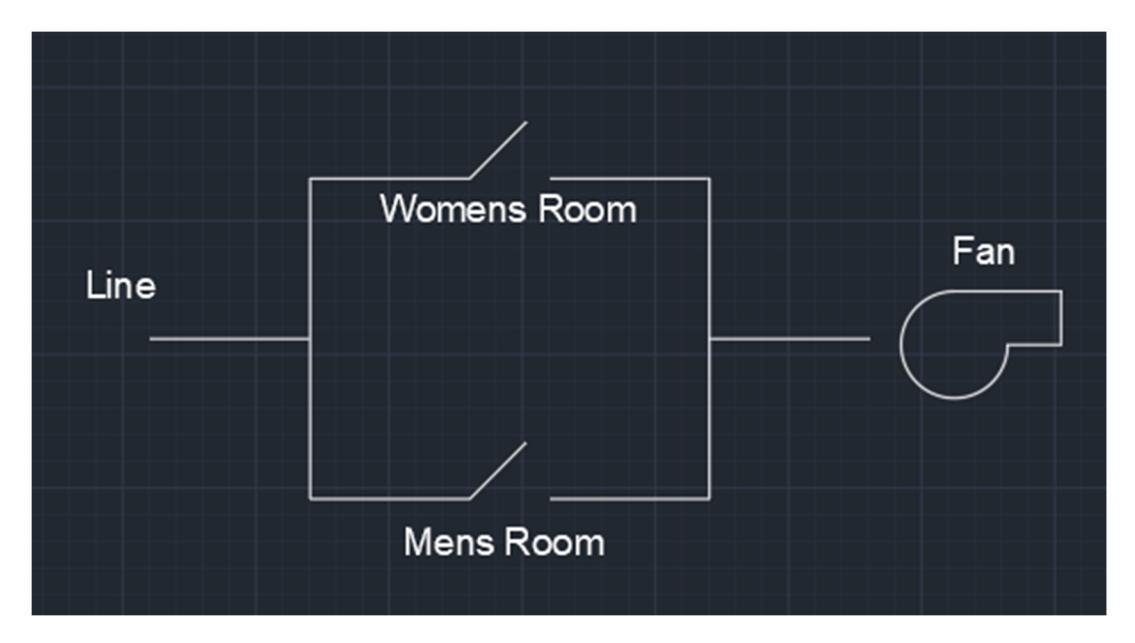
It is recommended to install occupancy sensors within both the men's and women's restroom to control the exhaust fan. Connecting the sensors in parallel, as shown below, would allow the fan to operate any time either bathroom is occupied and for a period of time after it is vacated.

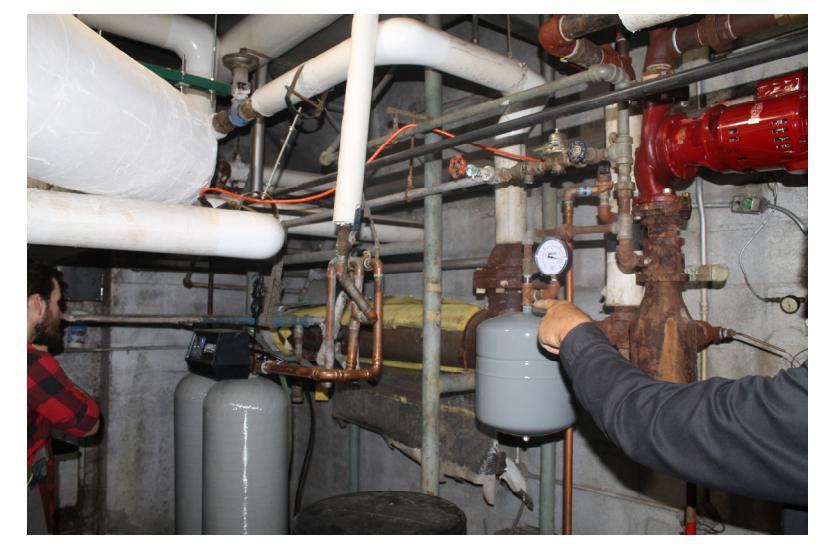
Putnam County Elementary School has a substantial quantity of piping and a steam heat exchanger with insulation that is failing and falling off. This contributes to the overheating of the boiler room.

Unfortunately, there is a substantial quantity of asbestos and a tight working space, increasing the difficulty and cost to install insulation.

It is recommended that all the hot water and steam piping and the heat exchanger be insulated. At a minimum, they should be insulated in compliance with the International Energy Conservation Code. An excerpt of Table C403.12.3 from the IECC is provided here for reference. It is estimated that 100' of 2" pipe, 40' of 3" pipe, and 6' of 6" pipe/tank will be insulated. Insulating additional piping will further increase the savings and corresponding increases in utility incentives would be realized.

SEDAC frequently finds that insulation above these values is often cost effective. The savings calculation is based on insulation values of $\frac{1}{2}$ " greater than the values below. Installing insulation above this level would increase the savings further.

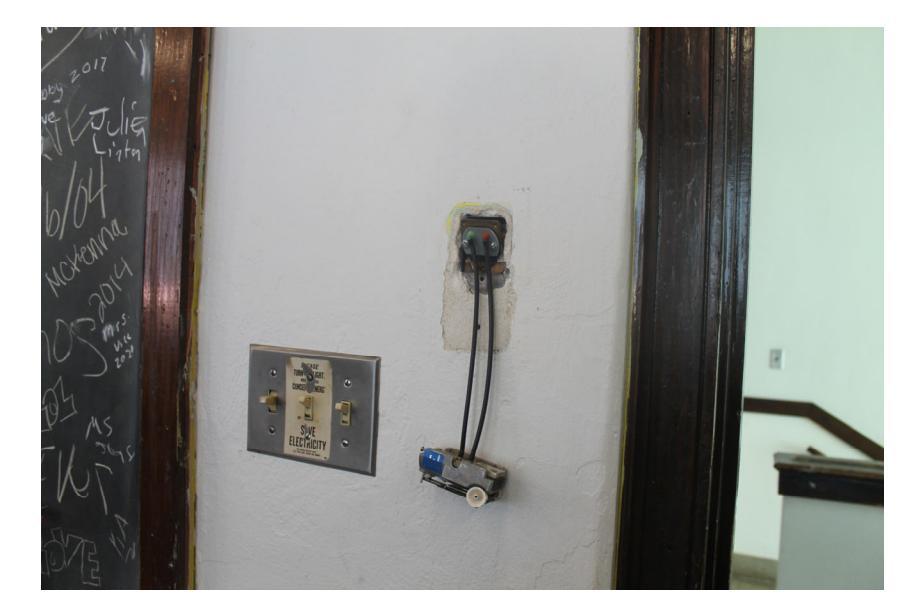
The school has a variety of thermostats including some pneumatic thermostats and some digital thermostats. None of those observed were programmable and maintain a set temperature setpoint. However, it was reported that users are fairly good at adjusting thermostats when they leave, which would be in line with the low energy consumption for the school.

The district should install programmable thermostats to allow Putnam County to further reduce the energy consumption of the HVAC systems. These can include wi-fi pneumatic thermostats for locations such as the one pictured, along with other wi-fi connected thermostats that can interface with the mini-splits and other HVAC systems. One downside to some wi-fi thermostats may be the use of batteries that need to be replaced periodically. If batteries are not replaced in these thermostats, the systems may over condition– either heating or cooling. If they are able to integrate with the current district BAS, the new thermostats may also provide more visibility into the operation of the building systems, including fault detection.

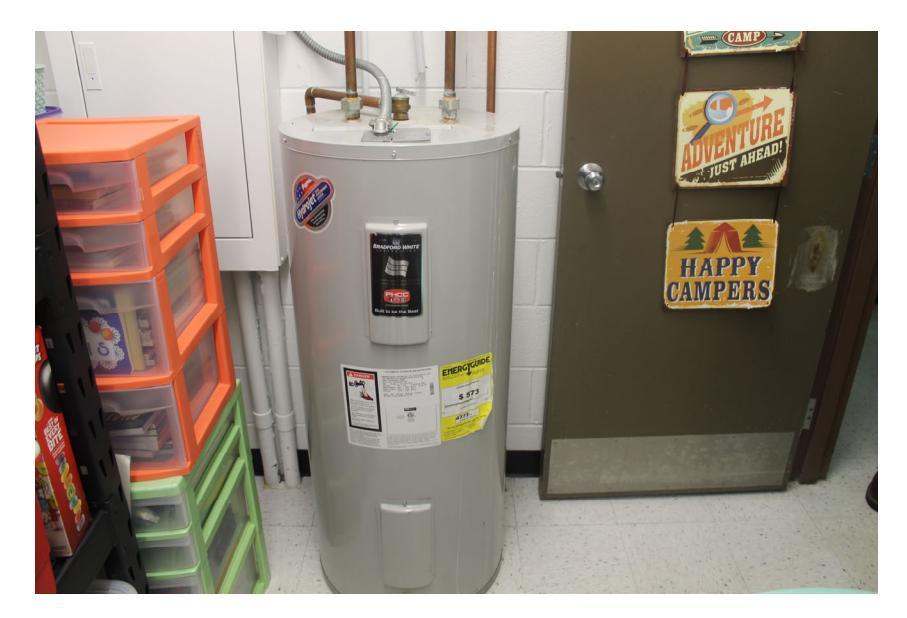
The school has a traditional electric resistance water heater to serve bathrooms. The boiler room contains a pair of natural gas water heaters with atmospheric venting that serves the kitchen. The gas-fired units are 6-year warranty water heaters, which are already over 10 years old and are likely reaching the end of their lives.

When the time comes to replace these water heaters, heat pump models should be considered due to their lower operating cost. They also do not require exhaustion of combustion gasses through a hole in the building envelope. They additionally do not have the carbon monoxide poisoning risk that natural gas water heaters have. Heat pump water heaters also provide some nominal cooling and dehumidification as they extract heat from the space around them of which there is plenty in the boiler room.

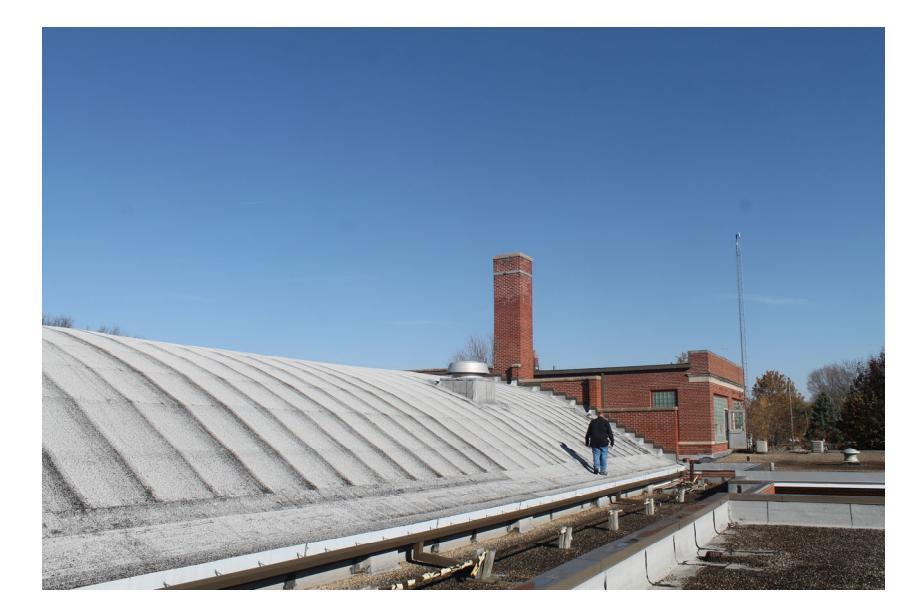
Due to the age of the school and the low profile of the roofs, it is anticipated that the roof only has R-10 insulation. Additionally, there are substantial quantities of equipment on the roof. The existing exhaust fans have very low equipment curbs, which would need to be raised to accommodate more roof insulation.

When equipment on the roof is replaced, the equipment curbs should be raised; it will cost less to raise the equipment curb when equipment is replaced rather than during roof replacement. Raising the equipment curbs will allow for installation of additional roof insulation when the roof is replaced in the future. Installing additional roof insulation will reduce winter heat loss and summer heat gain and increase the resiliency of the building in the event of loss of utility supply.
